Land at Crealy Adventure Park, Clyst St Mary, Devon

Interim report on the results of an archaeological trench
evaluation

Planning ref. East Devon District Council 07/3218/MFUL

Document No: ACD294/2/0

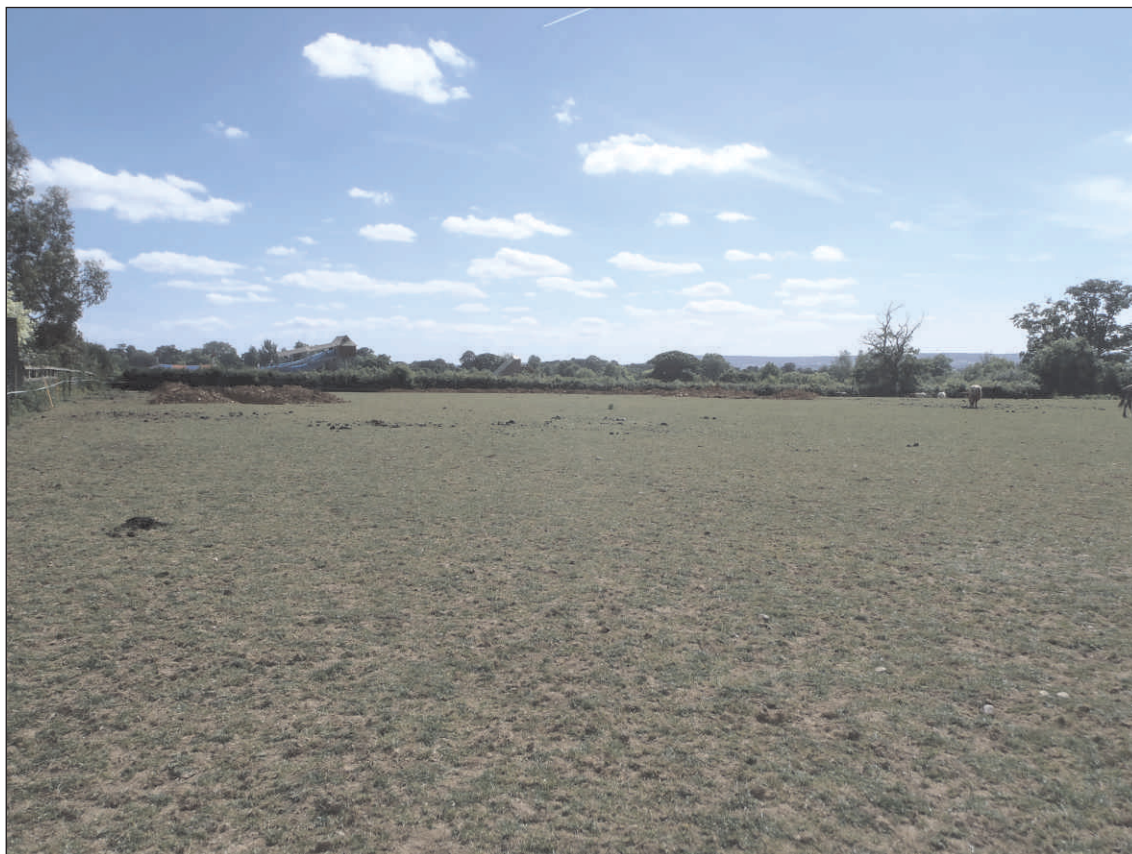
Plate 1. General view including Trenches 2 and 3, looking south

- 1.3 The application site covers a total of approximately 5.7 hectares of land to the east of Clyst St Mary and south of Sidmouth Road (the current A3052). The dispersed proposed development includes 12 plots of largely arable and pasture fields (Plate 1), as well as the location of a paint ball business. Across the site the ground generally slopes gradually from the north and south to a low-lying plateau bisected by two tributaries of the River Clyst, including the Grindle Brook. The site lies between 36m and 22m OD, with the underlying solid geology comprising Exmouth Mudstone and Sandstone formation.

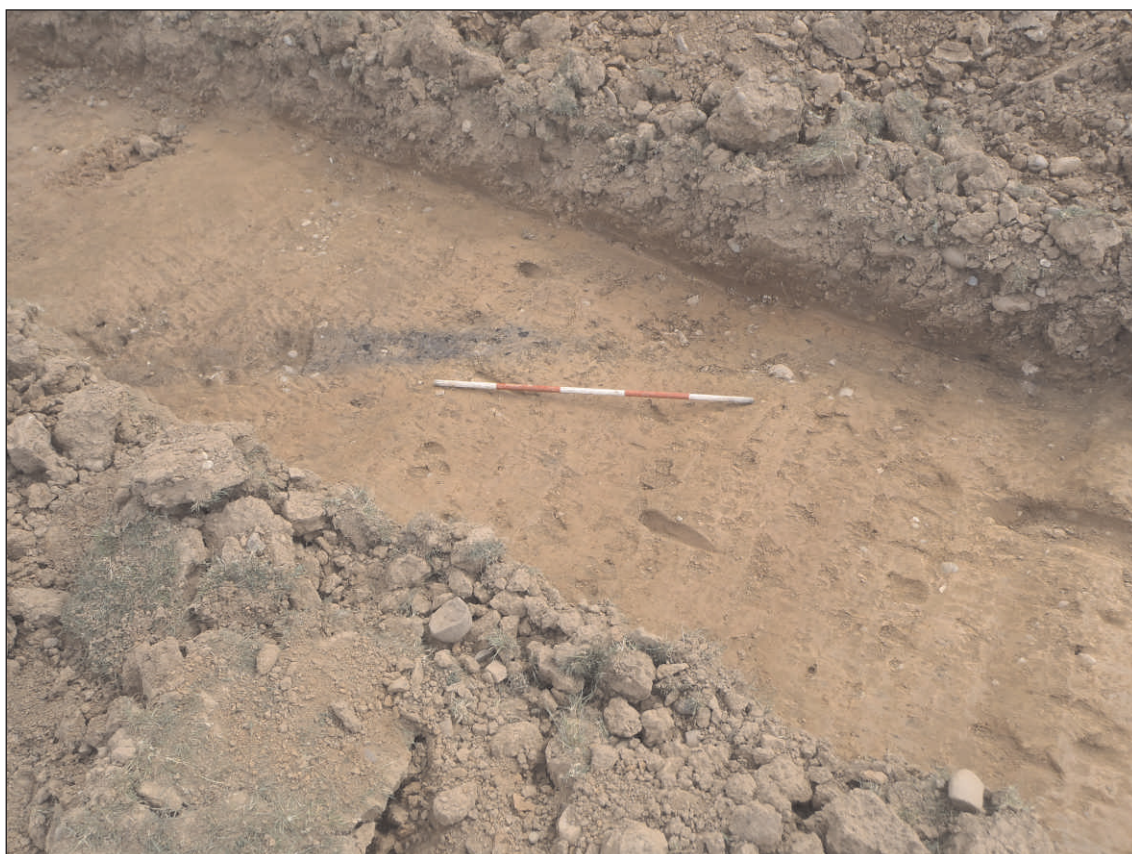
Plate 2. Trench 2, linear feature F203, view to northeast (scale 1m)

5.2 Trench 2 (Detailed plan and section Fig. 2, Plate 2)

6.1 All three of the evaluation trenches contained the same layer sequence of topsoil directly above natural subsoil. The only archaeological feature recorded was a small linear feature (F203) in Trench 2. The function of this feature is uncertain, but it could represent remnants of a former field or drainage ditch, although it was very narrow, had irregular sides and contained frequent charcoal. There are also no field boundaries shown in this location on the 19th and early 20th-century historic maps.
