Land to the rear of 1-2 High Street, Ilfracombe,
Devon

Results of historic building recording and an archaeological
watching brief

Document No: ACD77/2/2

Date: August 2011

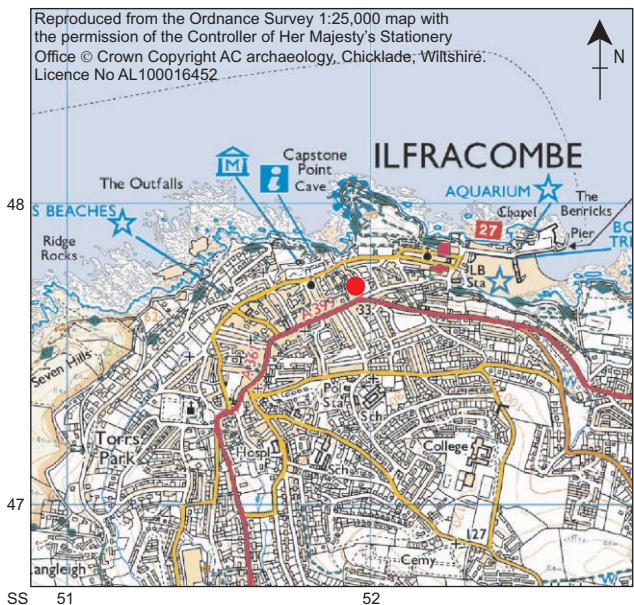
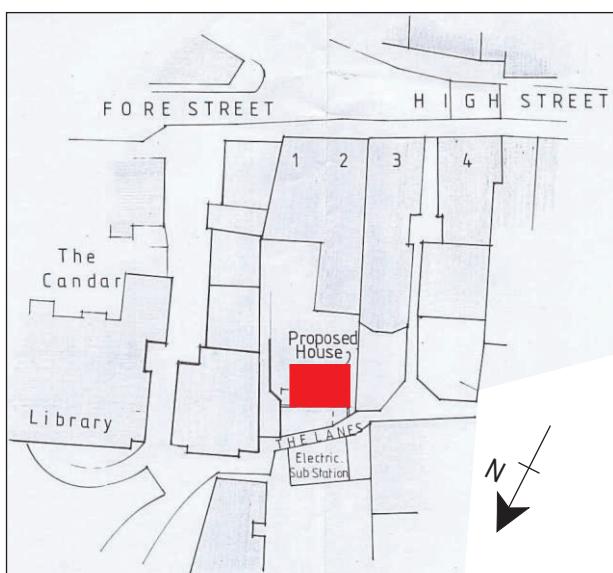
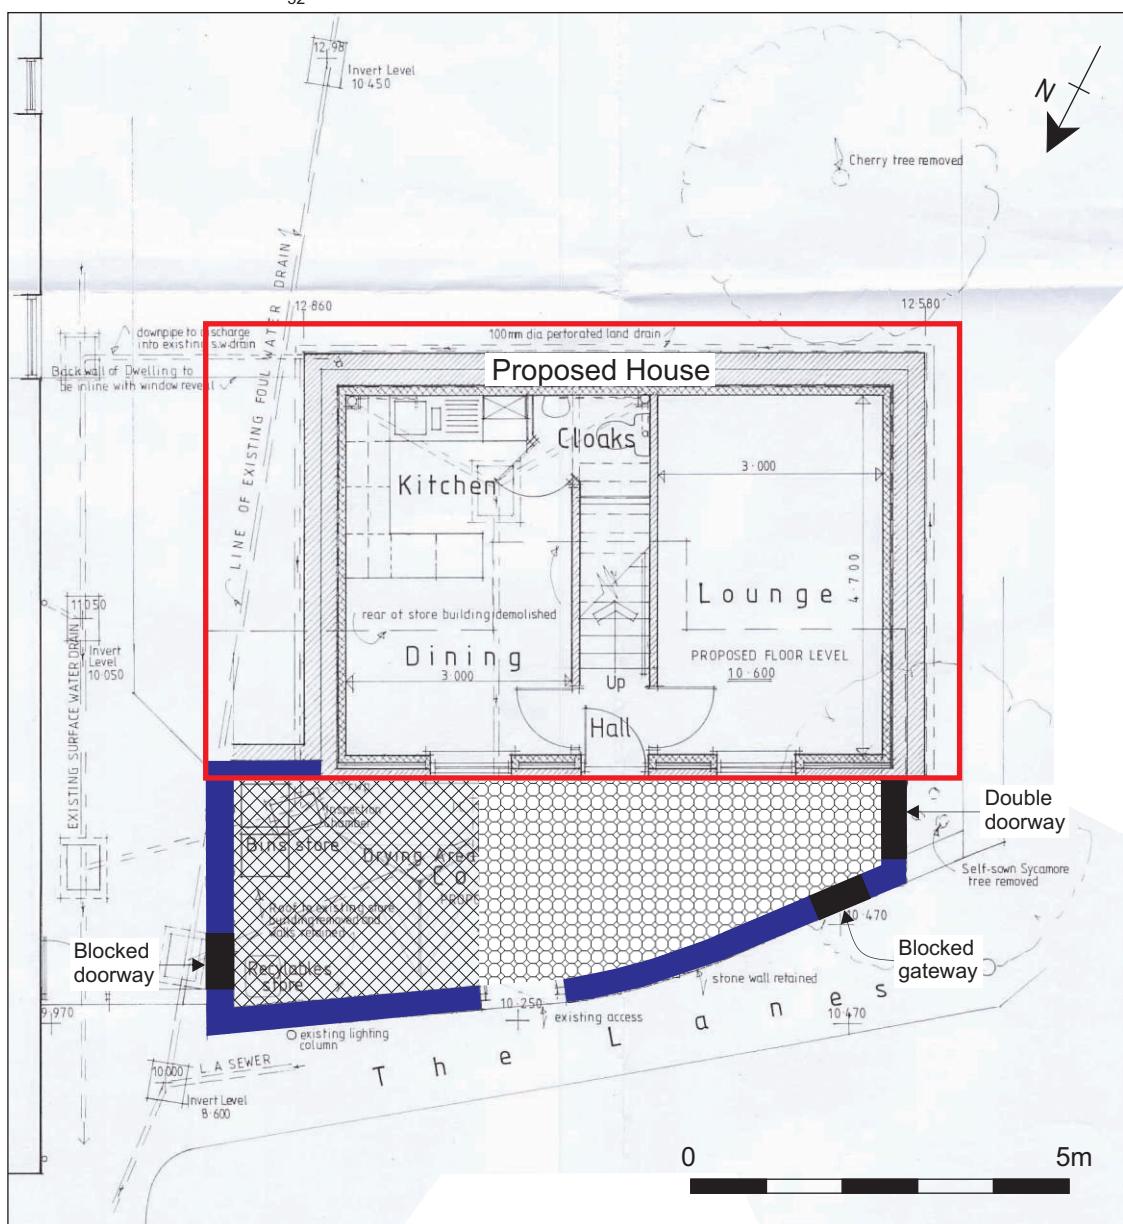
Fig 1. Location of site, stable building and area monitored

Stable building

Blocked openings

Extent of 19th century pavements

- 5.5** Oddly, the sequence appears differently when viewed internally and it seems that there are in fact two separate openings, a doorway opening from the building and a separate gateway, at right-angles to this, opening upon the back lane (Fig. 1). The doorway visible from within the building was originally a double doorway in the end wall of the building facing southwest. It has also been partially blocked, to form a narrower doorway with a window alongside, all within the earlier opening and beneath the lintel of the original doorway, which still remains *in situ* (Plate 3). Above the lintel, perforated brick is employed in association with the modern flat roof. The narrow doorway was finally blocked in concrete blocks in the 20th century. This doorway originally opened onto an alley running alongside the southwestern wall of the building which debouched into the back lane through the gateway described above. The alley seems to have run from southeast to northwest along the southwestern boundary of the property, probably linking the High Street with the back lane. The gradual descent of the alley is probably reflected in the boundary wall to the southwest side of the property, which may reflect the original slope of the land prior to any levelling.

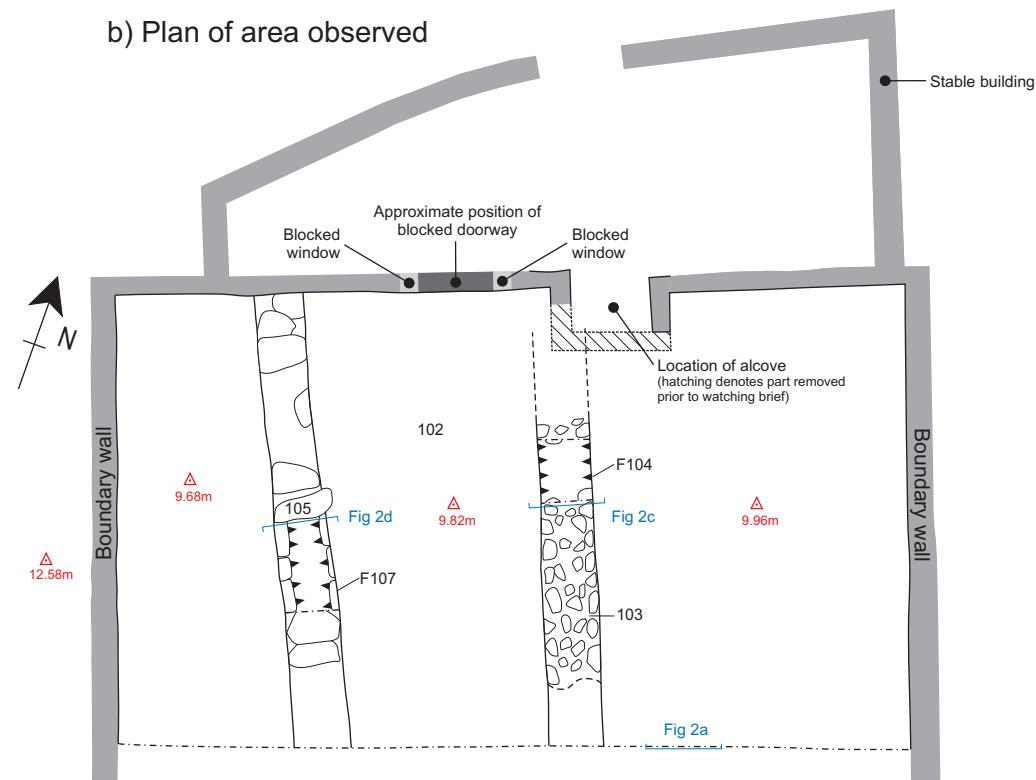
Fig 2. Plan and sections

a) Section through complete sequence

b) Plan of area observed

c) Section F104

d) Section F107

- 6.1** The footprint of the dwelling was reduced to a total depth of 2.9m below ground level onto the top of undisturbed shillet natural subsoil (102). The overlying layer sequence comprised 2.5m of mixed made ground (100) comprising dark brown, dark grey and black silt, sand and clay, with frequent-common small-large stones and shale fragments, overlying 0.4m of light yellow brown silt clay subsoil (101) (Fig. 2a).

- 6.2** Two archaeological features were exposed within the base of the reduced building footprint; stone wall F104 and stone drain F107 (Fig. 2b). Wall F104 was northwest to southeast aligned, measured 0.75m wide and survived to a height of 0.25m. It was constructed of large, randomly coursed sub-angular stone blocks (103) which measured 0.10-0.25m in length and were set within a clay bond (Fig. 2c, Plate 7). Drain F107 was similarly northwest to southeast aligned and was 0.65m wide. It comprised two vertical, and parallel, built walls of large coursed shale stones (105), 0.08m thick and forming a 0.3m wide internal chamber which was infilled with loose dark grey silt sand (106). The base of the drain was not exposed (Fig. 2d, Plate 8). The drain was capped with large shale slabs up to 0.65m in length and 0.15m thick. Both the stone wall and drain were cut into subsoil layer (101).

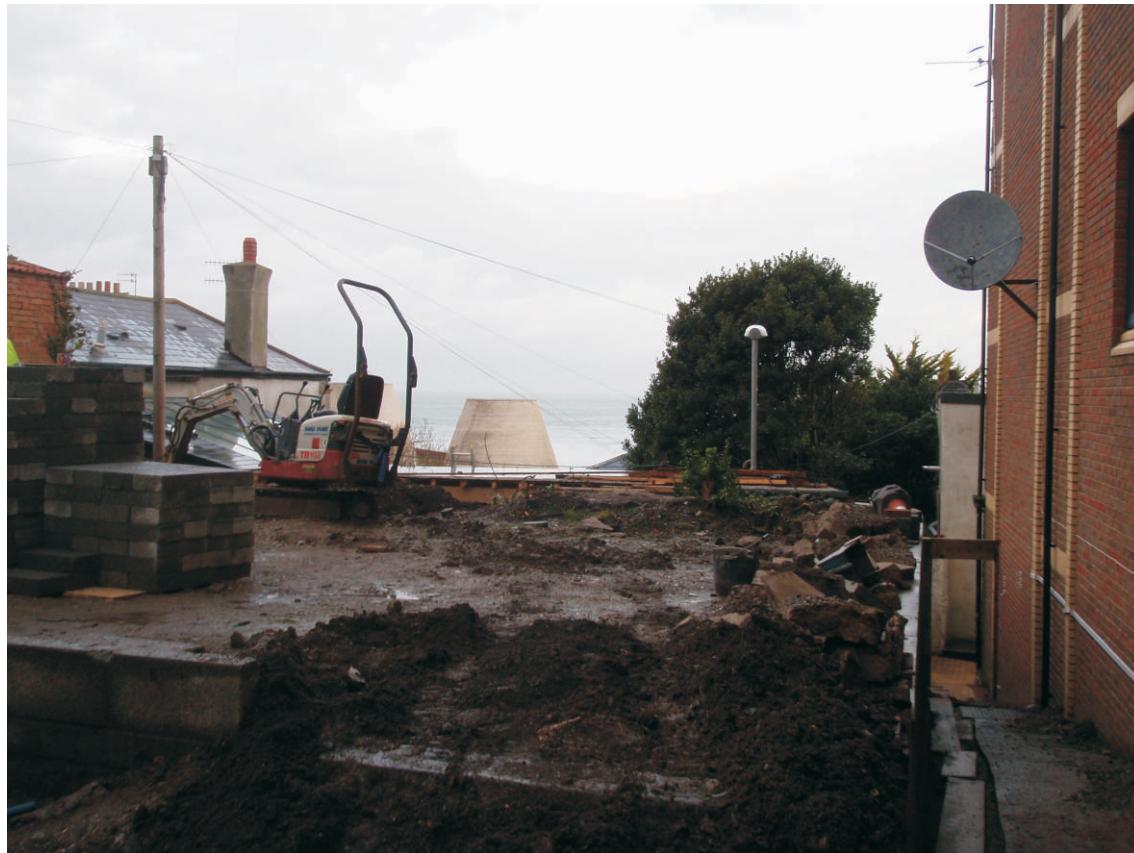
Plate 1. General view of site, facing northwest

- 1.2 The site is located within the rear garden of the property at 1-2 High Street, Ilfracombe, which comprises two houses standing on the northwest side of the High Street, close to the junction with Fore Street and Portland Street. The site measures approximately 10.5m long by 6m wide and is situated on ground sloping down to the north at around 30m OD (Fig. 1 and Plate 1). The underlying geology comprises sandstones and slates of the Devonian Ilfracombe Beds.

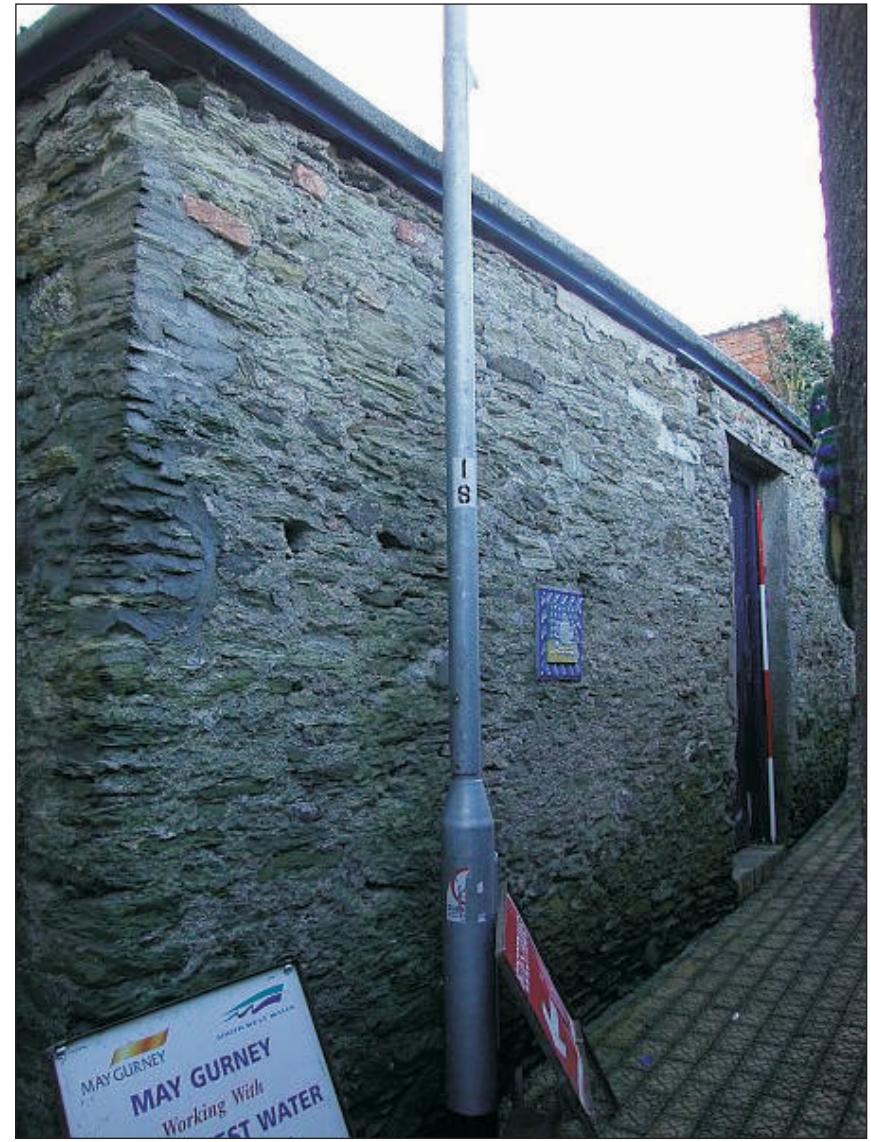
Plate 2. Northwest external elevation of stable, view to south
(Scale 2m)

- 5.4** The northwestern elevation towards the lane is blind, and is constructed of a pale, grey/green limestone pointed with a coarse white lime mortar containing water-rounded gravels and flecks of coal (Plate 2). Some of the surface mortar may represent the remains of render. The wall facing the lane curves around to the southwest, where traces of a blocked opening may be observed (Fig. 1). This opening appears to have been narrowed before it was finally blocked. The doorway was narrowed by the addition of new masonry on a slightly different angle to that of the wall, forming the jambs of the narrowed doorway. The upper part of the eastern jamb incorporates large blocks of quartz, now much obscured by modern pointing in cement. Quartz was popular in 18th and 19th century garden buildings and ornaments and it may be that these blocks originally formed part of some such ornamental feature, or that they may have been set here for decorative effect. The doorway was finally blocked in concrete blocks in the twentieth century.

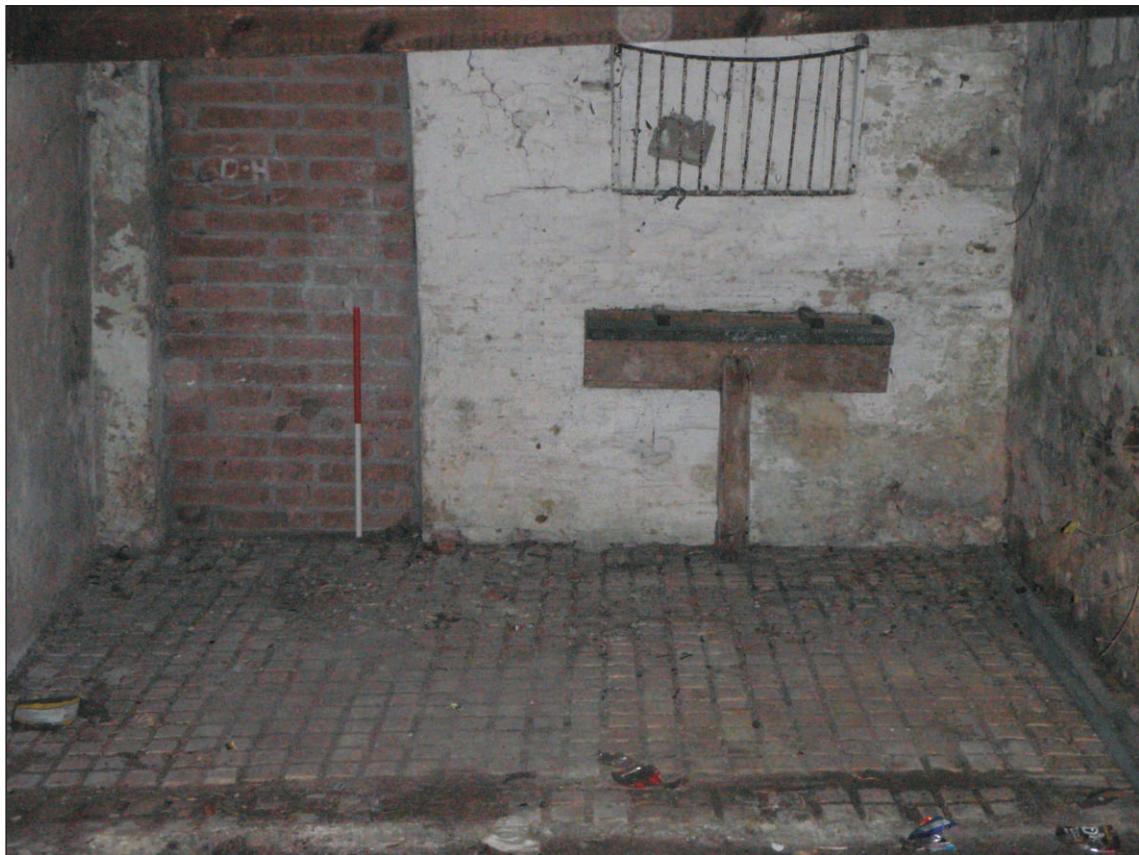
Plate 4. Northeast internal elevation showing blocked doorway, floor surface and original stable fittings, view to northeast (Scale 1m)

- 5.7 The northeastern wall of the stable contains a further blocked opening. This is unlikely to be primary, since it opens into an area formerly occupied by stallwork. Its jambs could not be examined in any detail as they are rendered over both internally and externally (Plate 4). The doorway is blocked with concrete blocks laid on their faces, from which we may conclude that this wall is of some thickness, perhaps measuring as much as 0.4m. It may be contemporary with the north-western wall.

- 5.10 The floor surfaces have been much disturbed, but some areas of historic flooring survive. In the northeastern section of the building is a 19th century floor of brick paviours or setts, with a drain and traces of two posts (Plate 4). This implies division of this area into two or three stalls, or perhaps two stalls with a passage to the eastern doorway alongside. These stalls were secondary, replacing an earlier set of stalls, the profile of which is preserved in the plaster of the northwestern wall (Plate 6). These stalls do not extend as far southwest as the brick floor and drain, showing that this floor and the stallwork associated with it are later. The remains of stable fixtures in this area include an iron manger, set high upon the wall, and a timber trough, lined with metal, which was fixed to the wall and supported by a short post with a notched end (Plate 4). These features lie across the line of the secondary stalls and presumably relate to a third

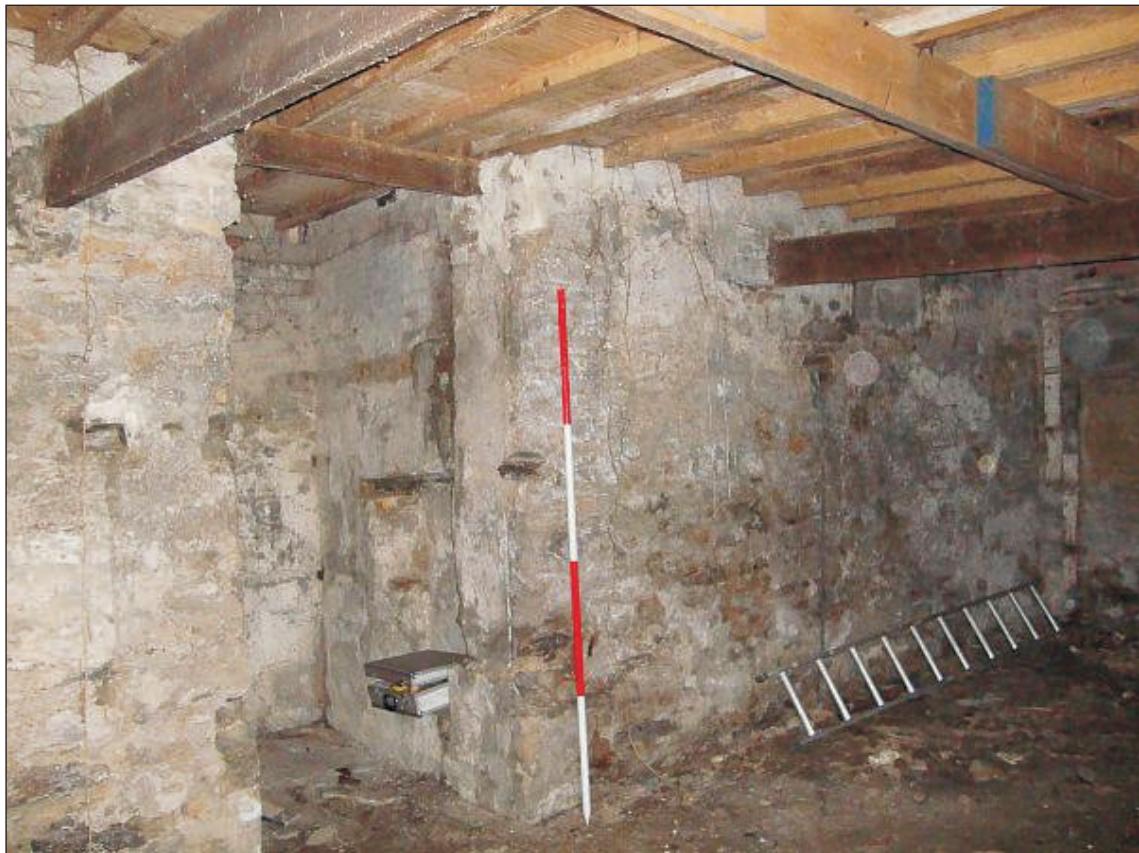
Plate 5. Southeast internal elevation showing alcove, view to south (Scale 2m)

- 5.9 Beyond the doorway in the southeastern wall is a strange walled recess or alcove (Fig. 2b, Plate 5), the walls of which butt against the walls of the building and which must therefore be of later date than the main structure. The lower parts of these walls are of rendered stonework, stepping upwards to meet the rear of the building. The upper parts of the walls are in later brick. It is possible that the lower parts preserve the remains of an external staircase to the upper floor and that the alcove below this was utilised as a tack room or store. This is perhaps confirmed by the traces of shelving and a recessed cupboard still visible here. Examination of early maps shows that by 1888 a glazed structure had been built over the alcove, presumably supported on the brickwork. The function of this structure remains unknown: the alcove might have been utilised as a light well with a glazed skylight or, alternatively, a garden building such as a cucumber frame or a glazed porch to the room in the upper storey might have been constructed above it.

At some point after the construction of the building an alcove was added to the southeast side of the original building, perhaps to provide a tack room, or to support an external stair to the loft.

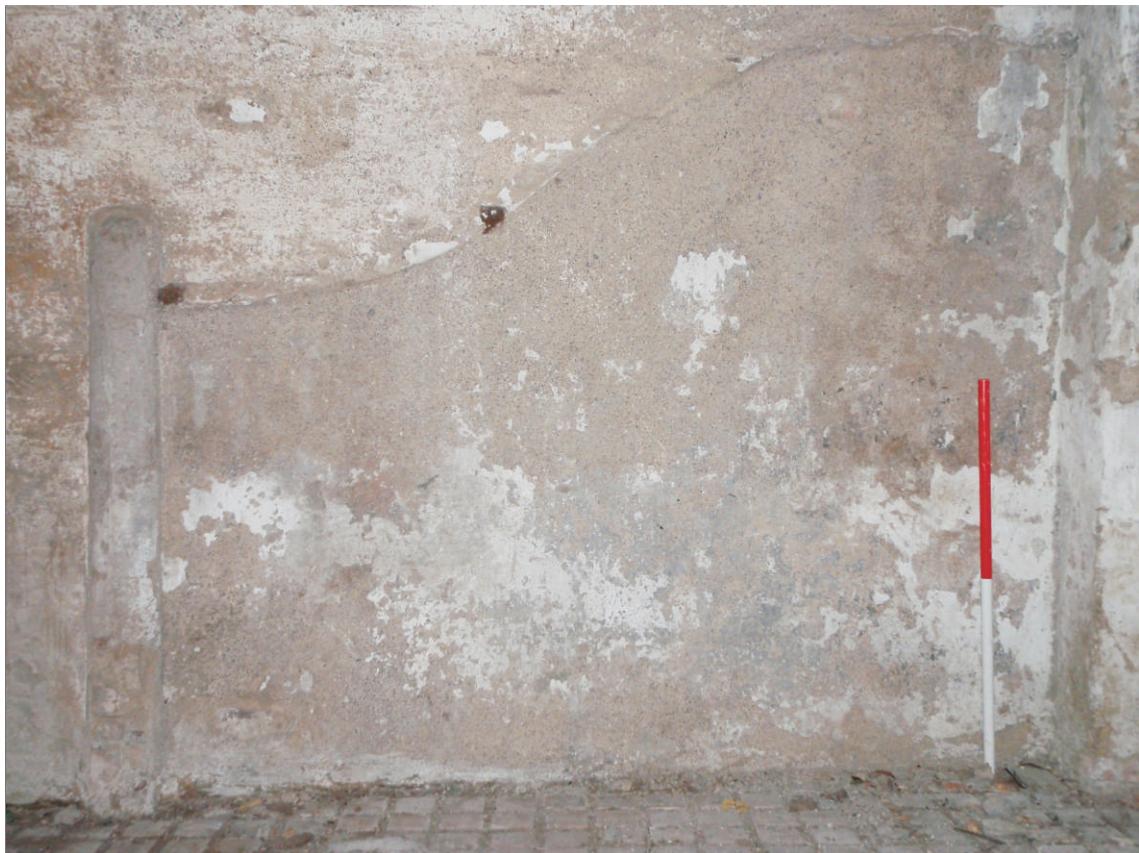
Plate 6. Northeast internal elevation showing evidence of stalls, view to northeast (Scale 1m)

phase of reorganization of the stallwork in the late 19th or early 20th century, perhaps when two or three 19th century stalls were replaced by a single loose box.

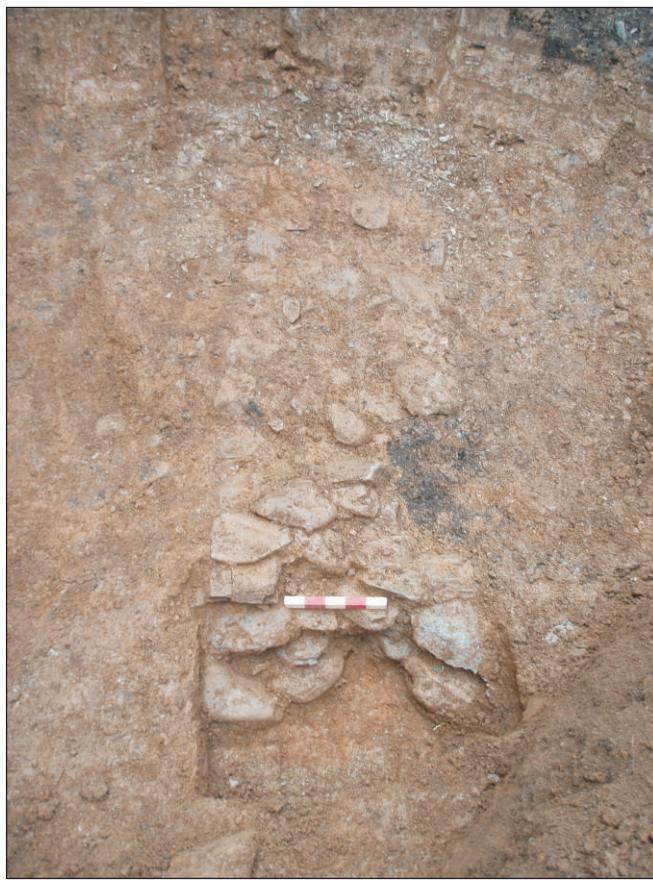
Plate 7. Stone wall F104, view to southeast
(Scale 0.25m)

Wall F104, which cut centrally across the building footprint, represents a former stone boundary wall, of which little now survives. This is first shown on the first-edition Ordnance Survey map of 1888 and continues to the southeast up to the two properties at 1 and 2 High Street to divide the two rear garden areas. Whilst the boundary wall is likely to post-date the construction of the stable, its relationship with the small alcove (a later addition to the stable) along the southeast facing wall of the outbuilding is less clear

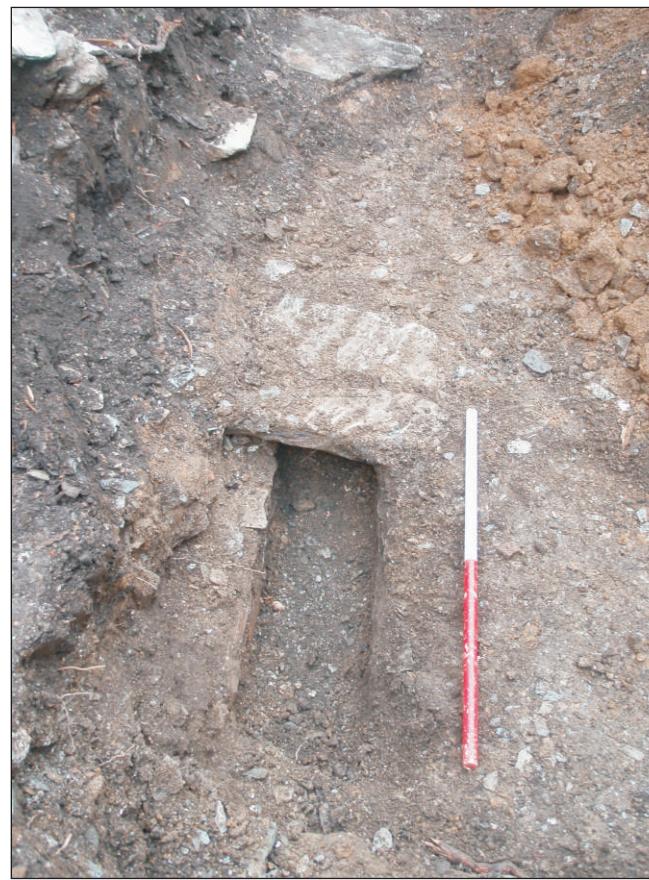
Plate 8. Stone drain F107, view to northwest
(Scale 1m)

Stone drain F107, located along the western part of the site, is fairly typical in design and are widespread features of the 19th century as a means of diverting waste water away from houses.
