Land adjacent to Vine Passage, Honiton, Devon

Results of an archaeological watching brief

Planning ref. East Devon District Council 10/1837/FUL

Report No: ACD290/2/0

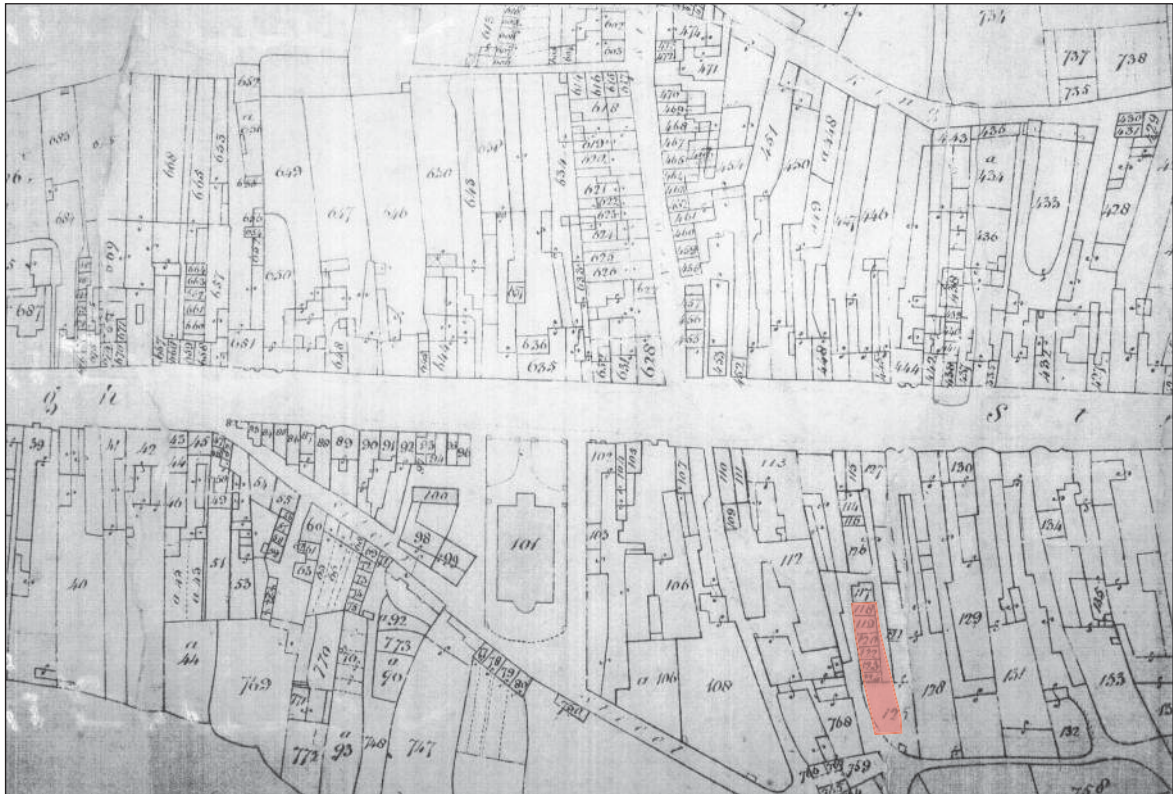
Fig. 2: Extract from the Honiton title map of 1842

- 2.3 The 1842 parish tithe map (*Fig. 2*) depicts the site as being occupied at that time by what appear to be a terrace of six small worker's cottage. These buildings are still present on the 1888 and 1903 Ordnance Survey 25-inch maps, with the latter depicting a total of seven cottages (*Figs. 3a-3b*). These houses are still present in 1959, but had been removed by 1970, when a printer's workshop was built on the site. This workshop was subsequently demolished and the site left as open waste ground used for *ad-hoc* parking. The house occupying the frontage of the plot dates to c. 1820.

- 7.4 Building Nos. 1 & 3 are similar in dimension, while Building No. 2 is almost twice their size suggesting that it represents the amalgamation of two properties shown on the 1842 tithe map and later Ordnance Survey 1st and 2nd edition 25-inch maps of 1889 and 1905 (*Figs. 2, 3a & 3b*). This is

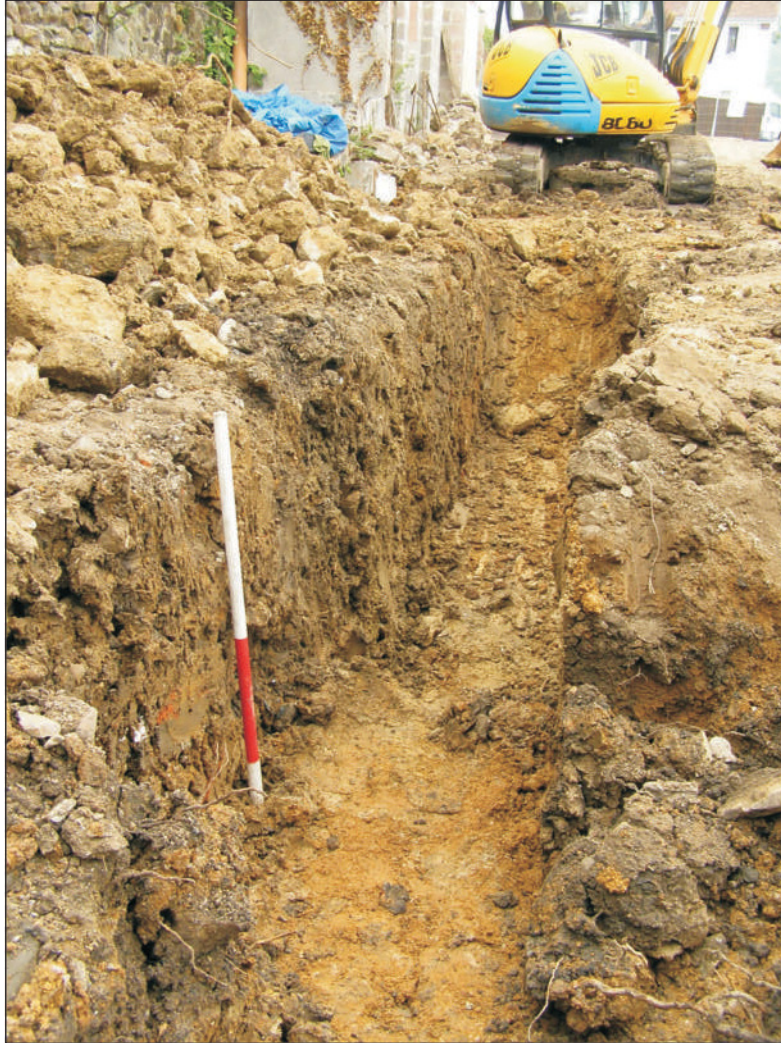
Plate 1: Pit F120 and rubble infill 121 (view to north)

A large number (11) of probable extraction pits (features F120, F123, F125, F127, F130, F133, F135, F137, F143, F145 & F147) were noted in the foundation trench sections across the whole of the site, cut into the natural orange and grey clay (*Fig. 5*). At the southeast end of the site, there was evidence that one of these extraction pits feature (F120) had been re-excavated prior to the construction of Foundation F105 and infilled with stone rubble (layer 121) to underpin the wall (*Plate 1*). This deposit also contained some large, overfired, brick fragments which may indicate the purpose of the pits.

Six fragments of ceramic building material weighing 1972g, were recovered during the groundworks from foundation F105 and context 121, the fill of pit F120. These consist of four hand-made, reddish-brown brick fragments. One has perforated holes while another has large firing cracks right the way through the brick, indicating that it is a waster. The presence of these brick fragments is of note as it appears that prior to the development of the site for residential purposes, it was covered by a number of clay extraction pits.

- 7.2 Eleven probable extraction pits (F120, F123, F125, F127, F130, F133, F135, F137, F143, F145 & F147) were noted across the remainder of the site, cut into the natural orange and grey clay. Pit F120 had been re-excavated and infilled with stone rubble prior to the construction of Foundation F105. The pits varied considerably in both depth and size; all had similar fills comprising grey to mid-brown, loose silty clays containing building rubble (stone and brick), plaster and mortar fragments as well as charcoal flecks and fragments. The nature of these fills suggests deliberate backfilling with little evidence for slow, natural silting. Post medieval pottery was recovered from the fills 121, 131, 134 & 136 of pits F120, F130, F133 & F135.
