A new maintenance compound, Exeter Science Park Drive South, Clyst Honiton, Devon, Devon

Results of an archaeological trench evaluation

Document No: ACD314/4/0

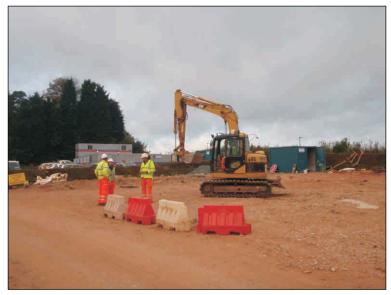
Plate 1: General view of site, looking to northwest

The site lies to the immediate east of an existing site compound on land that had been previously stripped of topsoil and re-laid with compacted hardcore. It is situated to the north of the A30, to the east of the M5 and to the immediate south of Blackhorse Lane, on ground that lies between 35-38m OD. The underlying geology comprises Dawlish Sandstone with Monkerton Formation head deposits and outcrops of Breccia clay. The location of the site and trench is shown in Fig. 1 and Plate 1.

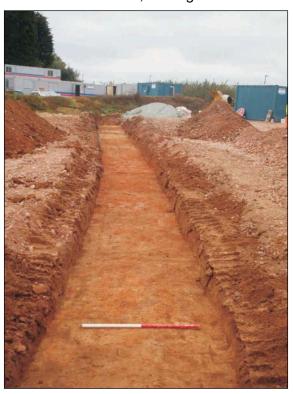
Plate 2: View of trench, looking to northwest (Scale 1m)

The trench was excavated within an area of previously disturbed ground, to a depth of 0.65m below ground level onto undisturbed light-mid orange sand natural subsoil (102). The overlying layer sequence comprised 0.30m of compacted crushed concrete chippings (100), forming the existing yard surface, which was above 0.35m of mid greyish-brown silty sand cultivation subsoil (101). A single modern cable trench was present at the northwest end of the trench.
