Hemyock Motors Workshop site, Culmstock Road, Hemyock

Results of an archaeological trench evaluation and watching
brief

Document No: ACD207/2/0

Date: 19th March 2013

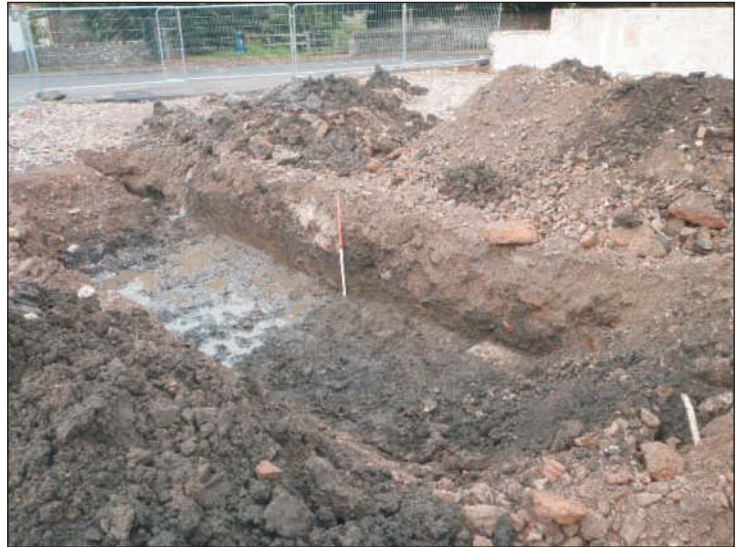
Plate 2: General view of Trench 1, view to west. Scale 1m

Trench 1 was excavated to a maximum depth of 0.8m partly into a buried soil layer similar to that identified during earlier investigations (Fig. 3 & Plate 2), with natural subsoil not reached due to flooding in the trench by heavily contaminated groundwater. At the northeast end of the trench there was deep disturbance caused by a former vehicle inspection pit.
