National Cycle Network, Anderton Lane to Horrabridge, River Walkham Crossing, Gem Bridge, Tavistock

Results of an archaeological watching brief

Document No: ACD279/1/0

Date: October 2011

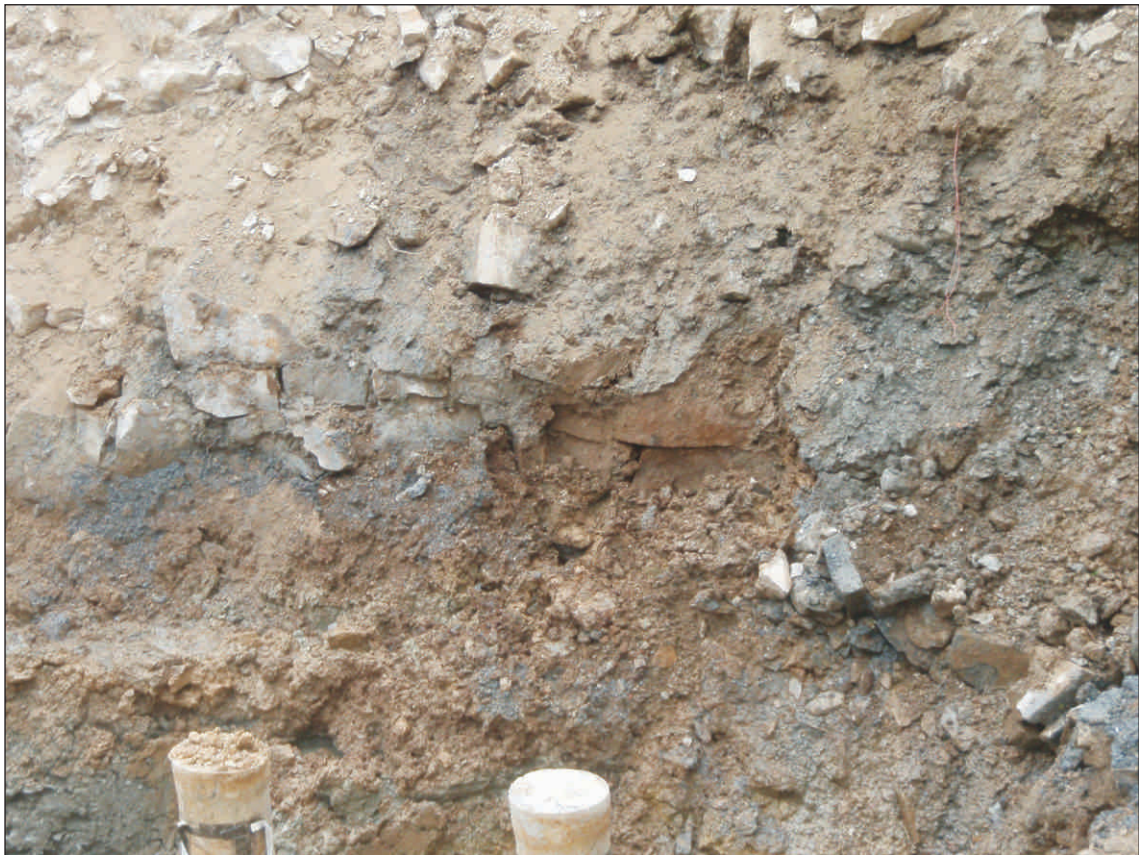
Plate 1: Short length of leaf wall exposed in Pier B excavations, view to south

The Pier B foundations measured 8m long, 4m wide by approximately 6m deep. The excavations encountered bridge demolition material, overlying the dark grey sandy clay deposits as seen in the nearby temporary bridge footings. Within the clay deposits and in the north facing section of the foundations a short length of granite wall was exposed (Plate 1). The wall was uncovered approximately 3m below the existing ground level and the exposed masonry measured approximately 2m long and stood at a height of 1.5m. The wall forms one – probably the upper – side of a leat that is visible as an earthwork west of the rubble from the demolished viaduct.

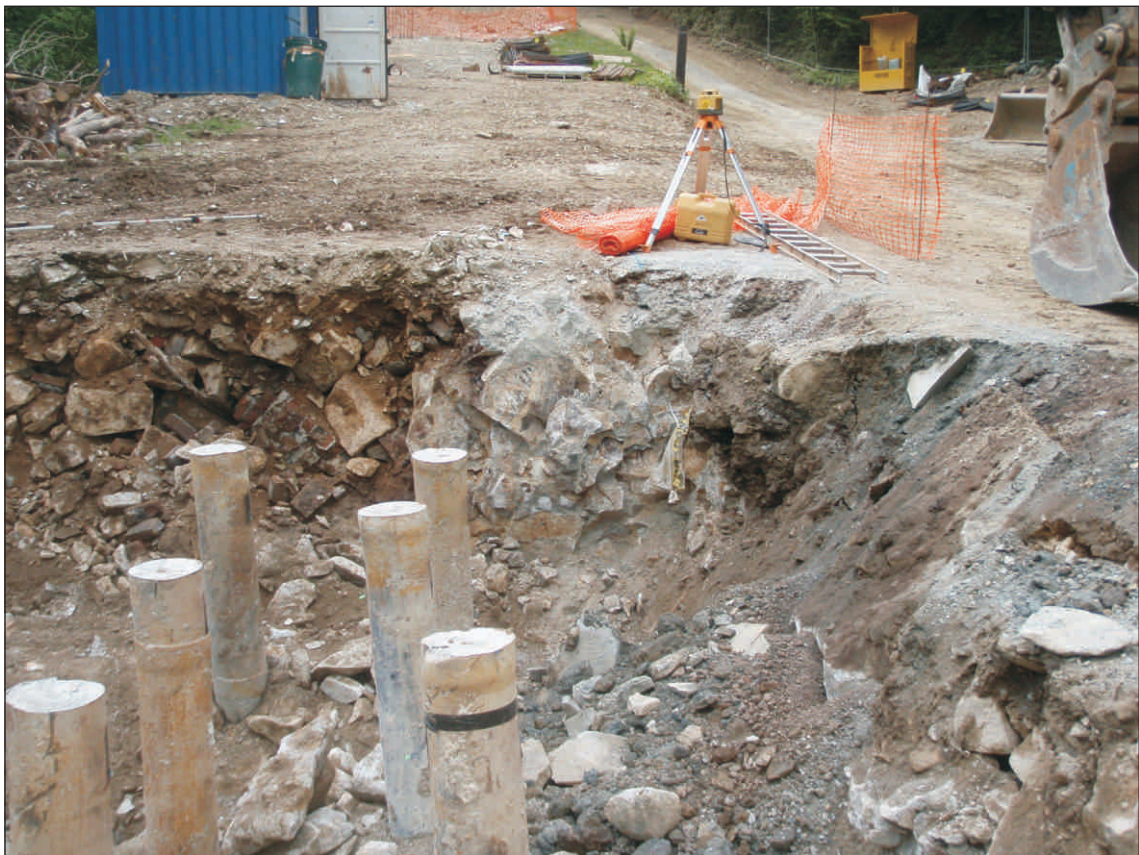
Plate 2: Remains of original viaduct pier base in Pier C excavation, view to north.

The Pier C foundations measured 8.4m long, 7.3m wide by approximately 3m deep. At this location an original viaduct pier base had been encountered in a geotechnical trial pit (TP2A), where it was recorded as extending to a depth of about 4.2m from the surface (Gifford 2011, 4). A 2m-wide area of masonry, comprising granite blocks bonded with a stony lime mortar, including what appeared to be the western face of the pier base was exposed in the northern part of the trench (Plate 2). The pier was overlain by demolition material containing brick, metal debris and large masonry fragments.

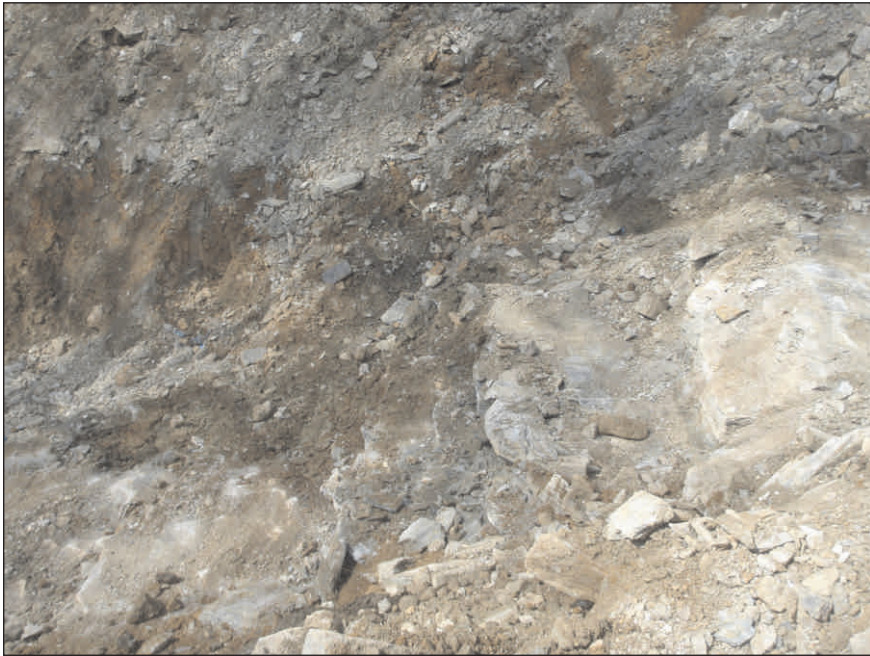
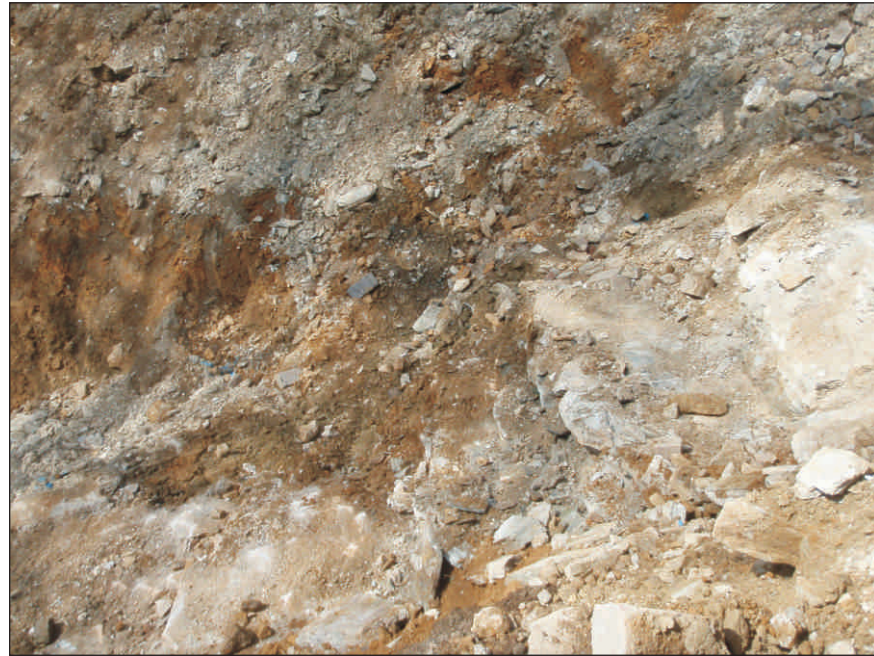
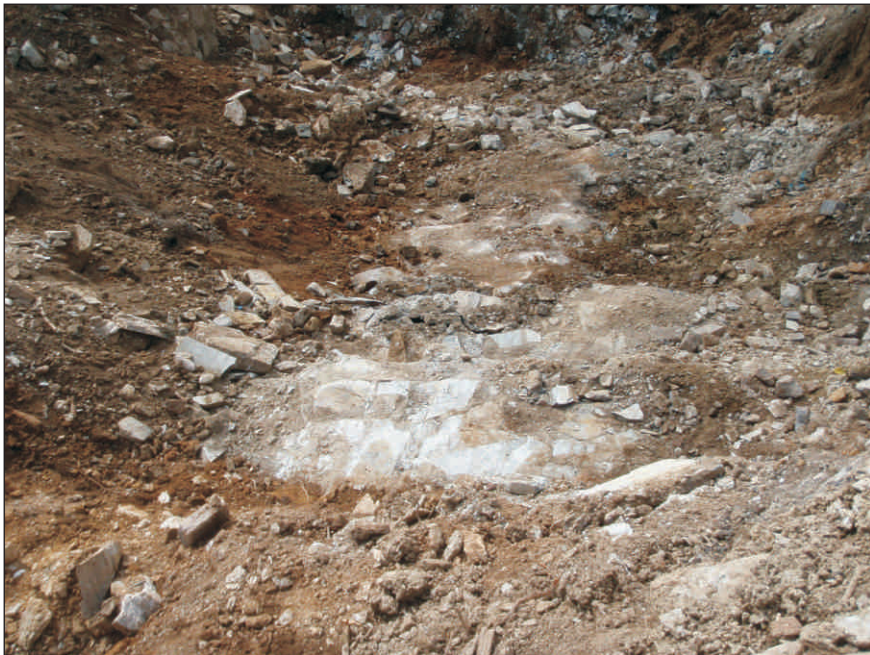
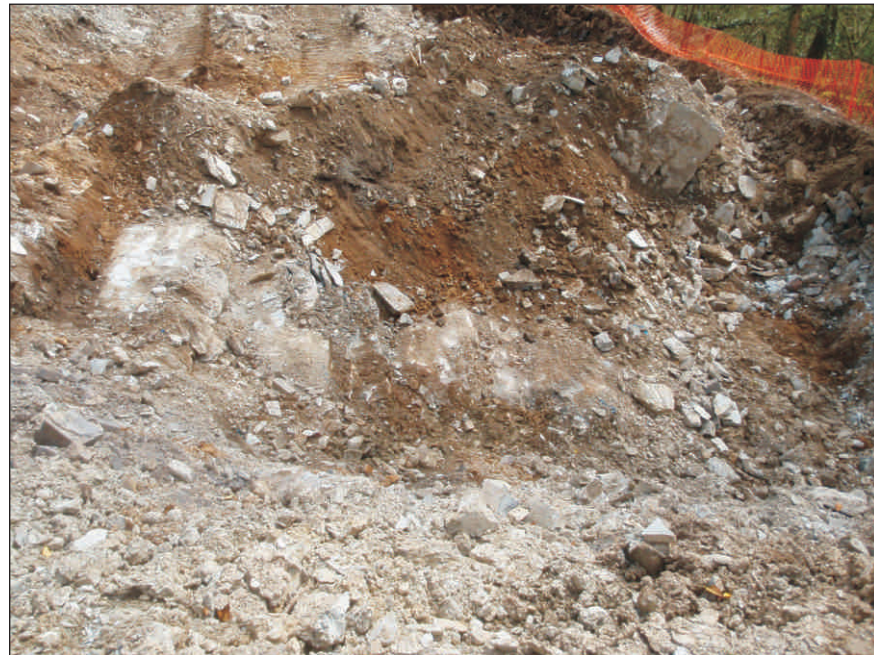
Terraced footings
of original viaduct
pier base on
northern abutment
excavation

The excavated area for the north abutment measured approximately 10m square by 10m deep. The northern section showed a general layer sequence comprising 0.6m of modern bank material of mid brown silty clay with abundant slate. This overlay 0.4m of mid orangey-brown silty sand topsoil, which in turn overlay approximately 5m of viaduct demolition material comprising large granite boulders, brick, slate and mortar. This covered a dark brown-black black gritty sandy silt deposit measuring 0.3m thick and which probably represents buried topsoil, i.e. the 19th-century land surface. Below this was a mid-orangey-brown clay silt deposit measuring approximately 3.7m thick and which probably represents a colluvial build up. This overlies a possible stepped/terraced structure in the very eastern edge of the abutment (Plates 3, 4, 5 & 6). The structure comprised slate bonded with a limestone mortar. It measured approximately 6.3m across and approximately 2m thick (Figure 2a). It appears to follow the slope of the valley was cut into slate bedrock. The feature may represent the footings of one of the original viaduct piers.

- 6.2** Partial remains of three piers from Brunel's 1859 viaduct were uncovered during the groundworks. Different construction materials were observed. The footings for the piers (as observed in the northern abutment excavation) were constructed of local slate, whereas the main above-ground masonry of the piers was constructed of granite, which corresponds with descriptions of the standing structure. The brick structure uncovered in the southern abutment excavations corresponds with the projected position of the end pier from the 1859 viaduct. However, the use of blue industrial bricks probably indicates that this masonry relates to the 1910 rebuilding of the upper superstructure. It is therefore likely that the exposed brickwork forms a 'buttress' around the original pier, perhaps to support the weight of cranes working from the end of the structure.

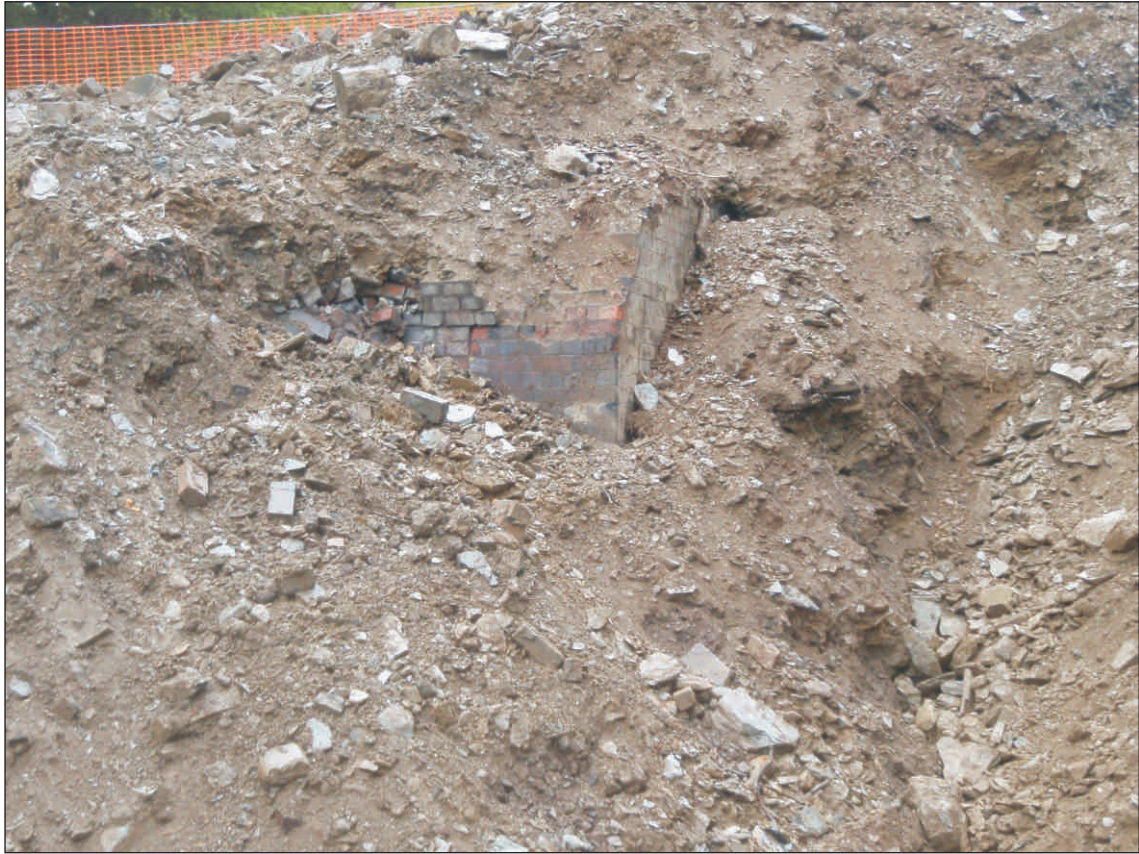
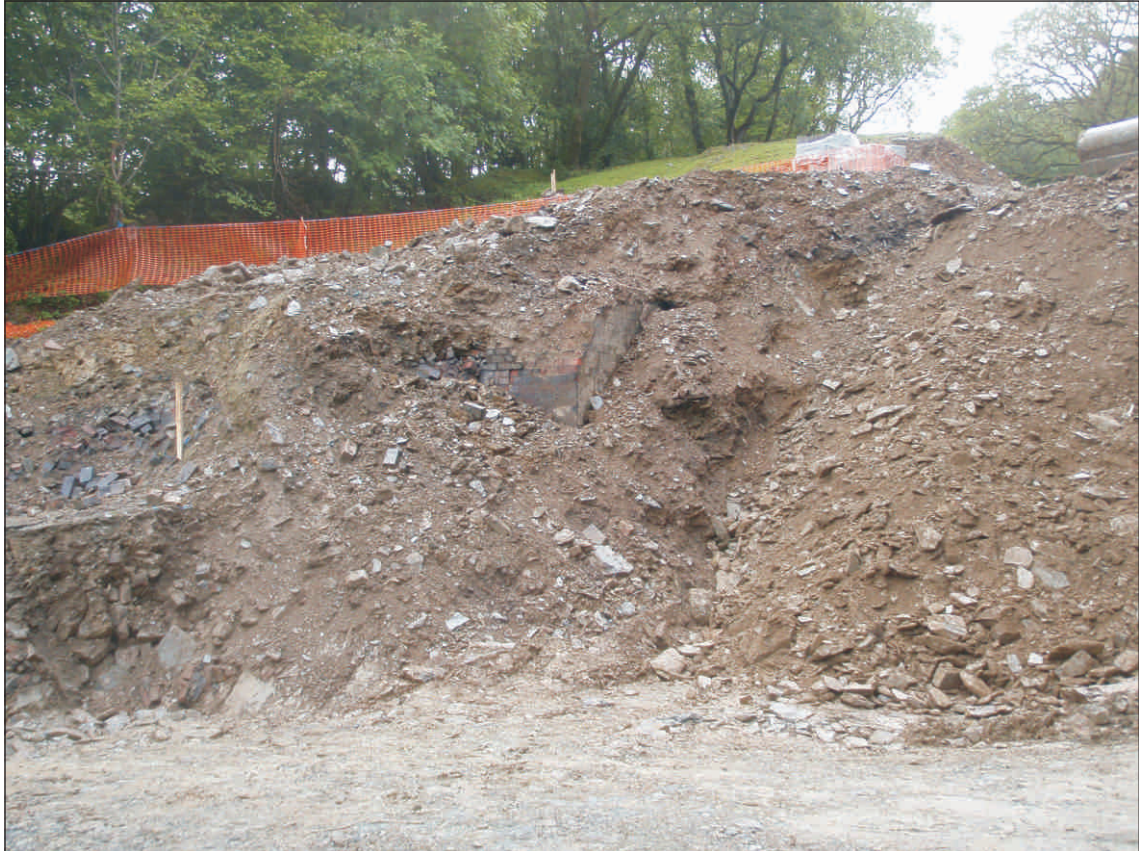
South abutment excavations showing brick pier bas exposed after landslide, view to south.

The north facing section of the abutment showed demolition material had slumped down to the east and at its deepest was approximately 3m below ground level (Plates 7 & 8). At the north end of the trench solid slate bedrock was exposed, overlain by orange-brown clay silt subsoil. The natural topography slopes down to the east and at the west end of the trench the subsoil was approximately 4m thick. (Figure 2b). At this stage no in-situ structural or archaeological remains were exposed.

However, after a period of heavy rain the southern abutment witnessed a landslide, and the demolition material behind the excavated area collapsed. This exposed the north-west corner of a viaduct pier base (Plates 7 & 8). The base was visible approximately 2m below existing ground level, and an area of approximately 2.20 square metres was exposed.
