Shilstone, Drewsteignton, Devon

Results of historic building recording and watching brief

Document No: ACD364/2/0

Date: November 2011

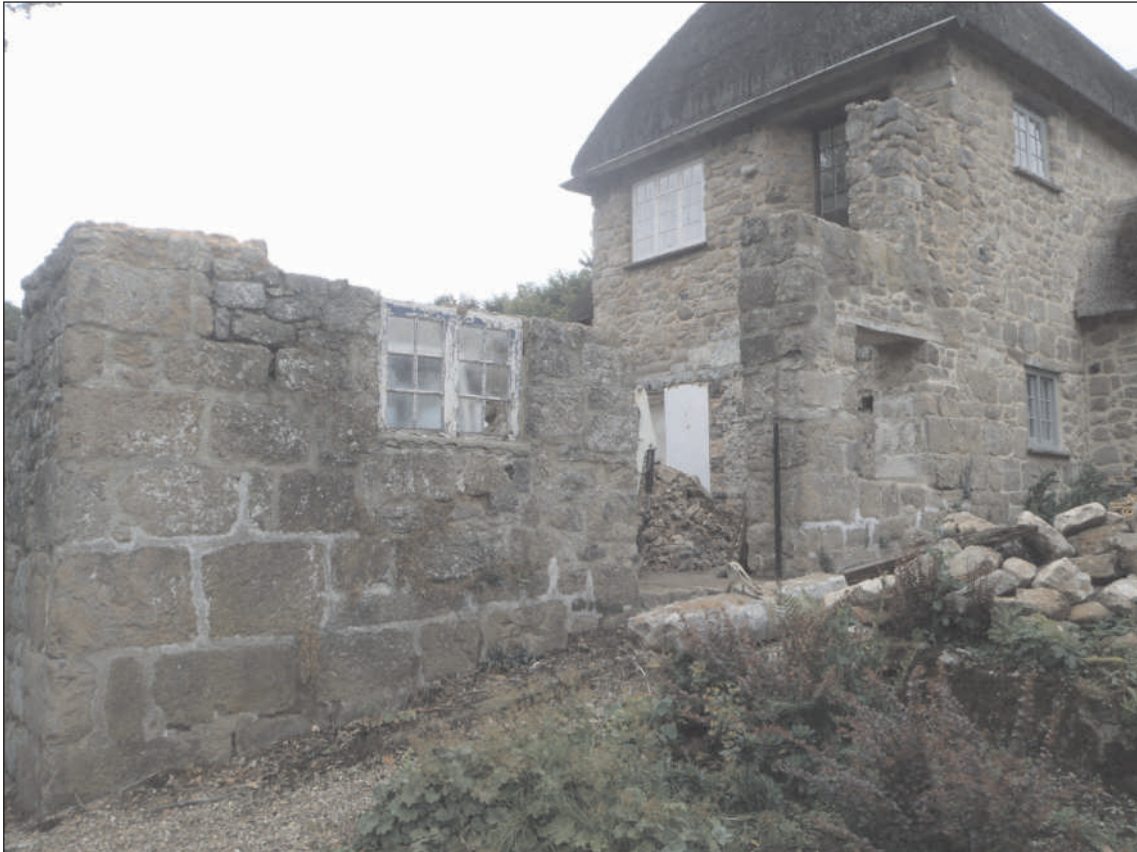
5.1 The single-storey shippon is located at the south end of the present farmhouse and consists of an open room (Plate 1) with a small secondary extension attached on the western side. The shippon measures 6m by 4.6m, whilst the extension measures 4m by 2.5m. Externally, the shippon is constructed of coursed granite with larger ashlar blocks utilised for the lower courses and quoins. Undressed granite masonry is used for the upper courses and the interior elevations.

Plate 1: The shippon, viewed from the southeast

The fenestration of the principal east elevation incorporates a single central entrance flanked by window openings on either side. The southern opening contains a mid-20th-century timber casement window. The present window is within a smaller opening, the lower part having been infilled. The northern window has recently been heightened, and its 20th-century timber casement window removed. On the interior elevation the wall below this window is plastered. None of these openings are likely to be original features. Between the doorway and the north window is a scar of a removed modern wall. This is also visible as a scar on the concrete floor.

The surviving masonry of the outshut comprises the south and west walls, and is constructed of rubble granite with ashlar blocks utilised for quoins. In the south elevation there is a doorway that has been partially blocked and converted into a window opening. In the west elevation there is a further blocked doorway. The extension was formerly divided into two rooms; the scar of the removed internal wall can be seen in the internal west elevation.

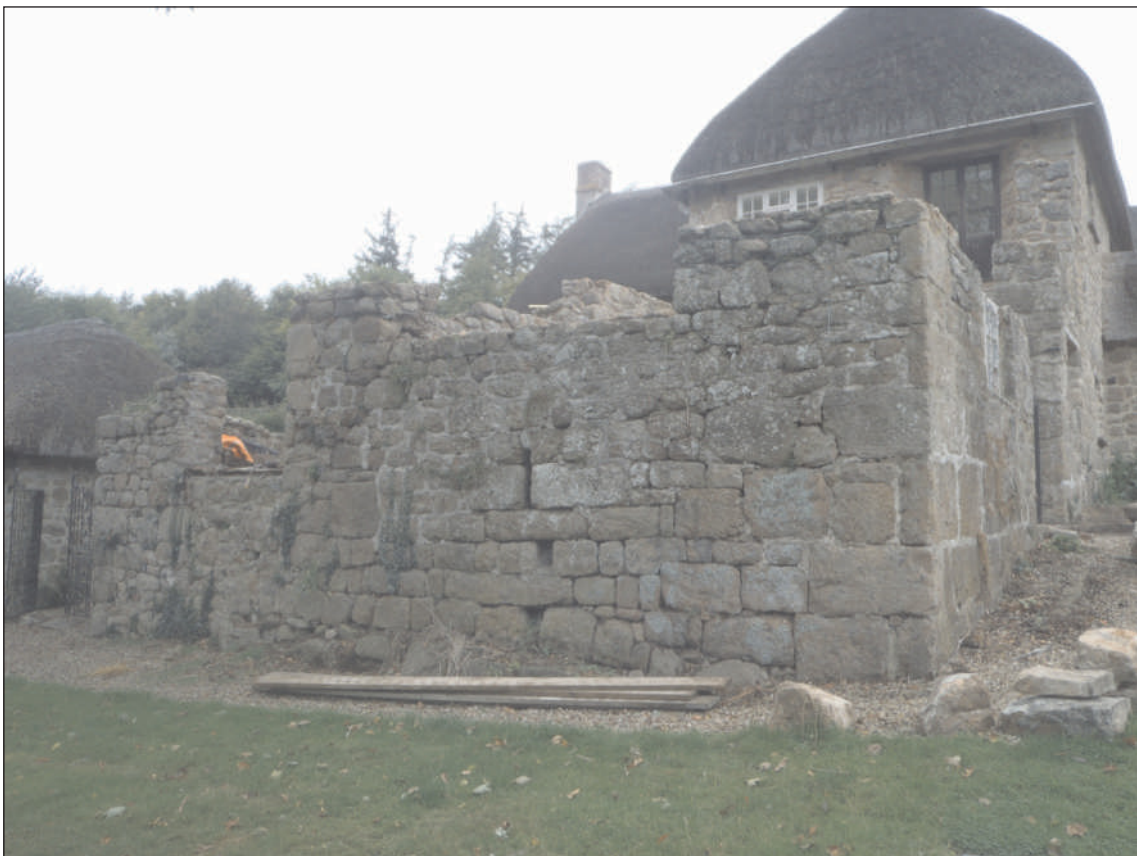
This elevation incorporates two near-central small drains, above which is a larger splayed ventilation opening. The drains are not visible on the interior elevation, and are obscured by the raised 20th-century concrete floor.

Plate 2: The south elevation of the shippon showing drain outlets and vent, with the outshut to the left, viewed from the southeast

7.1 The shippon was an integral part of the longhouse where animals were housed, away from the occupants in the other half of the building. The two early architectural features – the drain holes and the splayed vent – are typical features of such agricultural buildings. The use of ashlar on the external elevations is also known from other longhouses, such as Sanders at Lettaford. At this date the shippon was probably open to the roof.

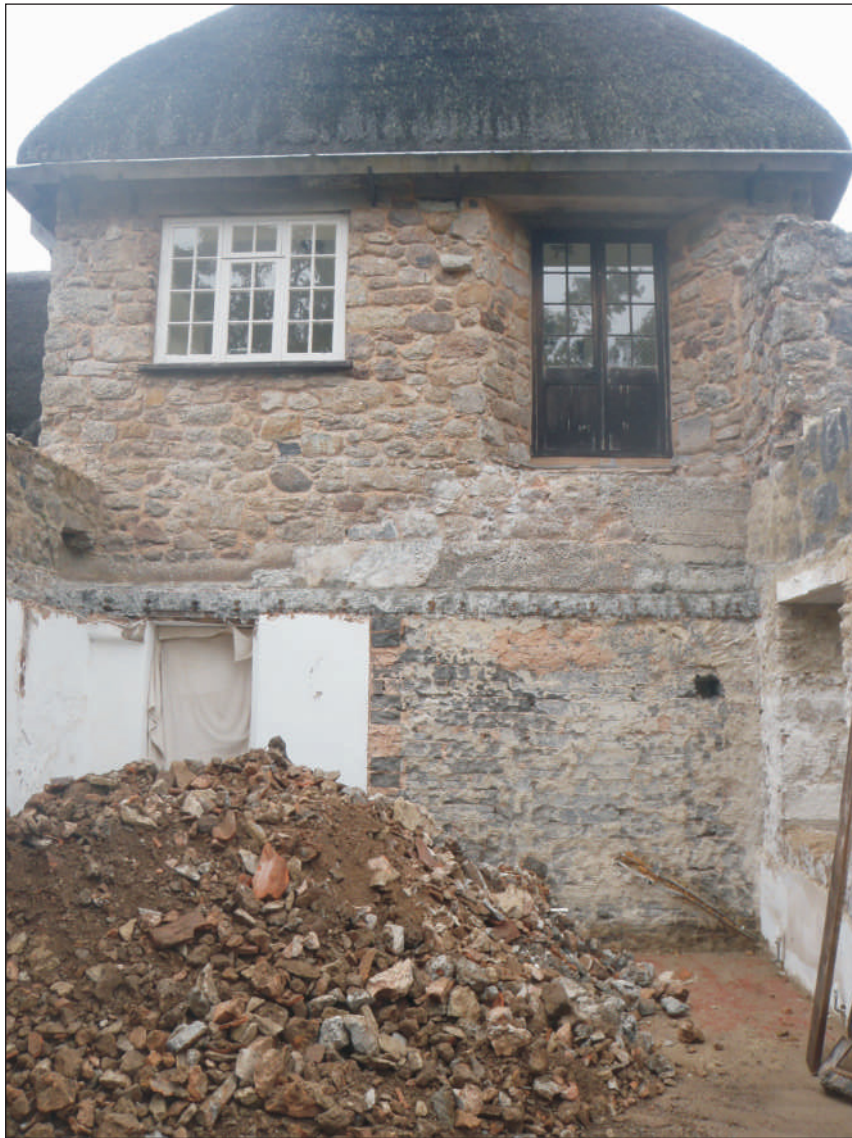
Granite masonry is present at first-floor level, although the antiquity of this build is unclear. The lowest five courses may represent the remains of a 17th-century wall, perhaps inserted when first floor was added. The masonry above, also of roughly-coursed granite, is of more recent date, and may date to as late as the 1950s. It incorporates a window and a doorway within a splayed external opening. The ground-floor fabric is of 1950s date and is constructed of concrete and concrete block. This area incorporates a doorway at ground floor level, as well as the scar of the first-floor terrace and a scar of stairs from the terrace to the first-floor door.

Plate 3: The east end of the shippon showing the gable wall of the farmhouse with C20 ground-floor wall, viewed from the south

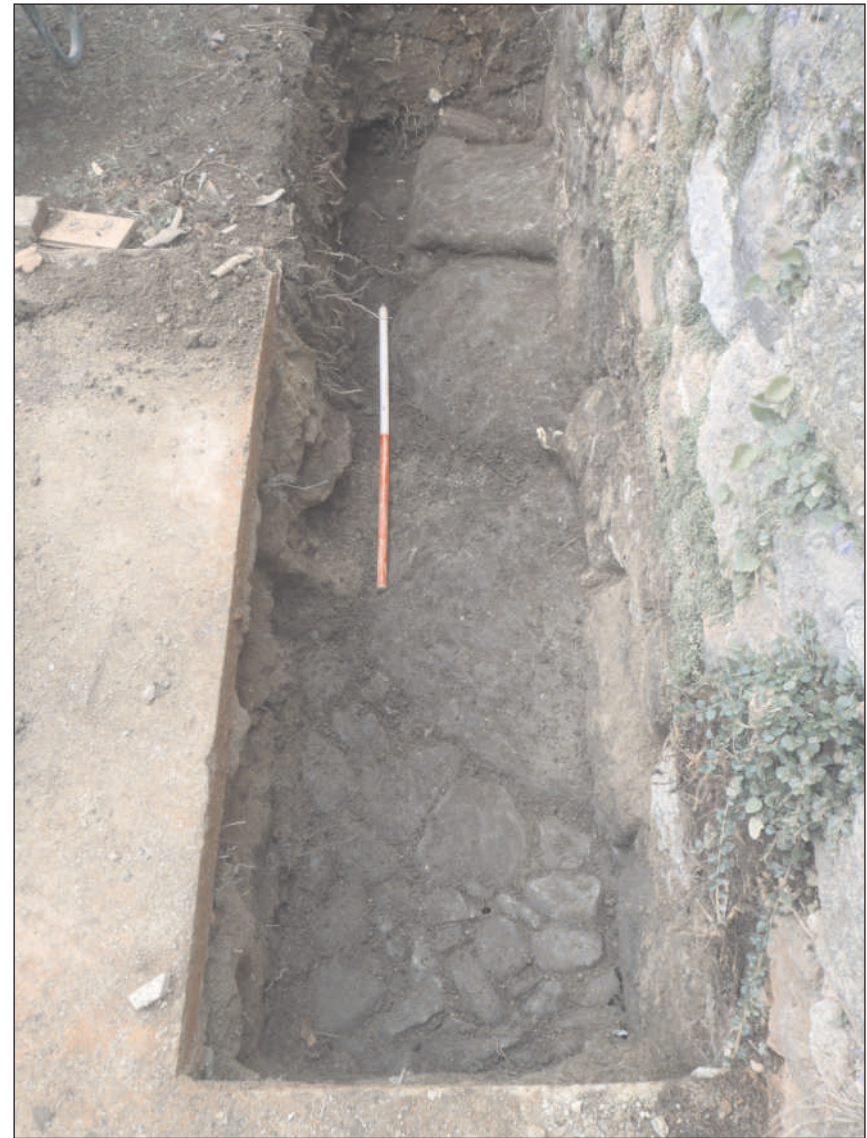
Exposed within the base of the trench were three large granite stones (107) forming the foundation to the primary build of the shippon. These were sealed beneath a 0.35m thick homogenous garden soil type deposit (106). Within the centre of the trench, cutting through (106) and sealing part of (107) was an east-west aligned wall (104), measuring 0.45m wide and constructed of irregularly coursed granite fragments bonded by an indurated lime mortar. This wall represents the remains of the demolished internal wall of the outshut. Associated with wall (104) and sealing the southernmost stone in 107 was an internal cobbled surface (103). During the immediate post-use of this surface an accumulative layer was deposited (102) consisting of a dark grey clay included with frequent mortar flecking. Overlying this is a 0.50m (max) demolition deposit (101) of granite fragments all with adhered lime mortar derived from the demolition of wall (104). Abutting the north face of wall 104 and overlying deposit (106) is the present garden soil (105). Both the garden soil 105 the demolition deposit 101 are overlain by the present concrete surface of the outshut (100).

Plate 4: The foundation trench showing the footings of the shippon (107) and later cobbles (103), viewed from the south. (1m scale)
