Treskilling Farm Barns, Luxulyan, Cornwall

Results of an historic building survey

Document No: ACD344/2/1

Date: December 2011

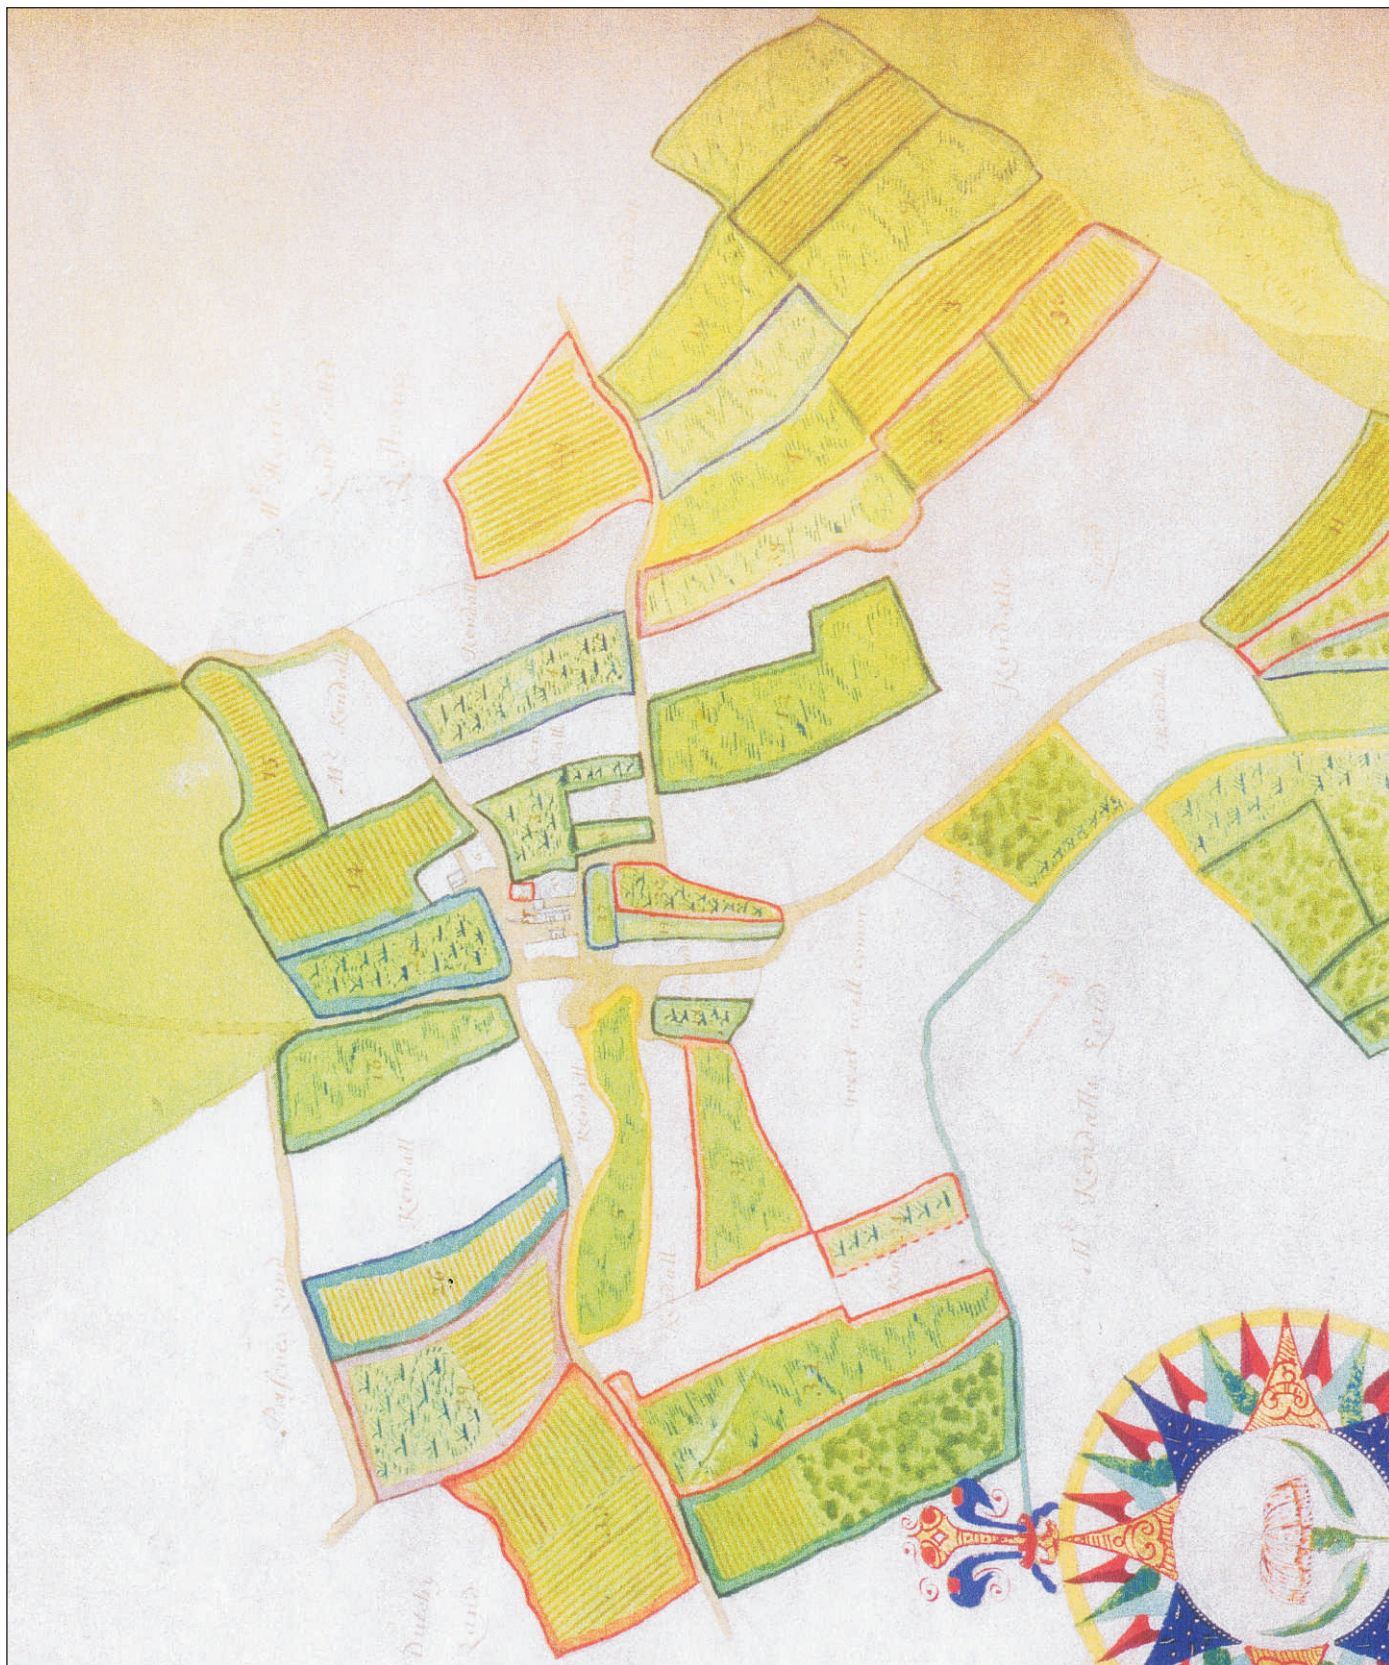
Fig. 2: Treskill in 1695 (CRO FS/2/32/3/24)
Note that the map has been rotated to face north - the original arrow is wrong.
