FORMER METHODIST CHAPEL AT CHY-AN-GWYTH, SCORRIER, CHACEWATER, CORNWALL,

Results of historic building recording

Document No: ACD376/2/0

Condition 5 of Cornwall Council planning consent PA11/03390

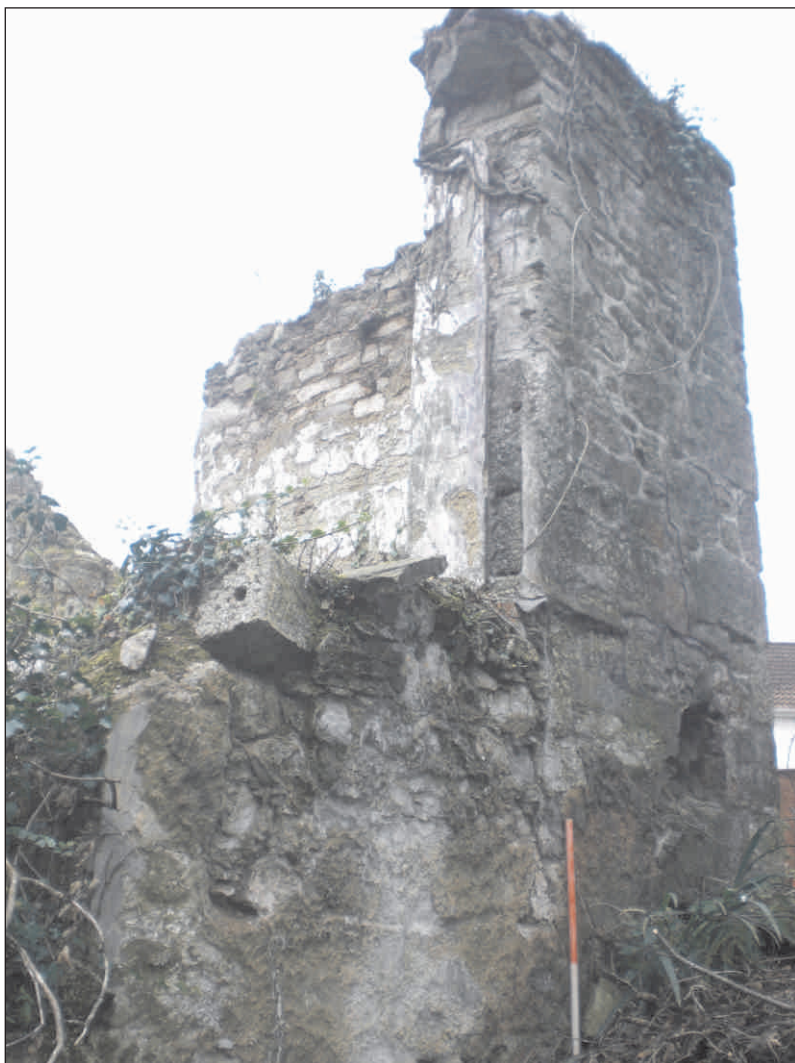
Plate 1: Chapel entrance within southeast elevation, view from east. 1m scale

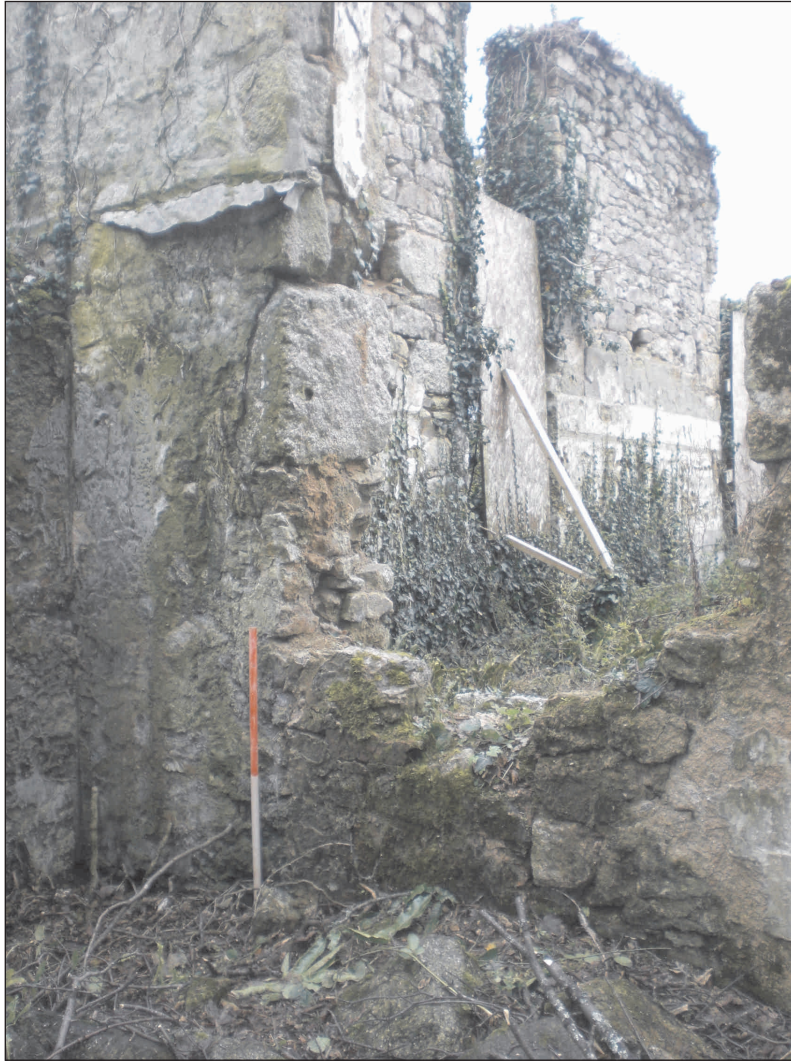
Plate 2: Partial blocking of primary tall window within northwest elevation, view from north. (Scale 1m)

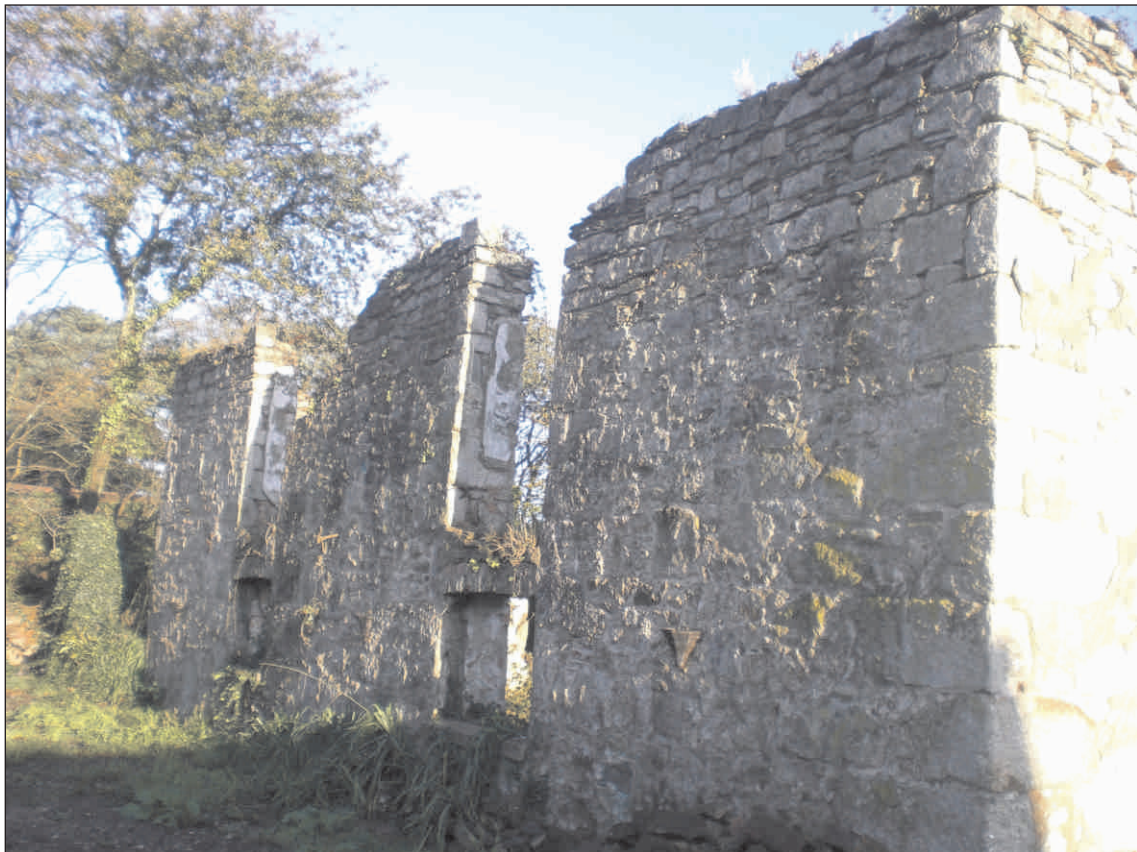
Plate 3: Remains of blocked phase 2 doorway in northwest wall of chapel showing primary window opening above, view from west. (Scale 1m)

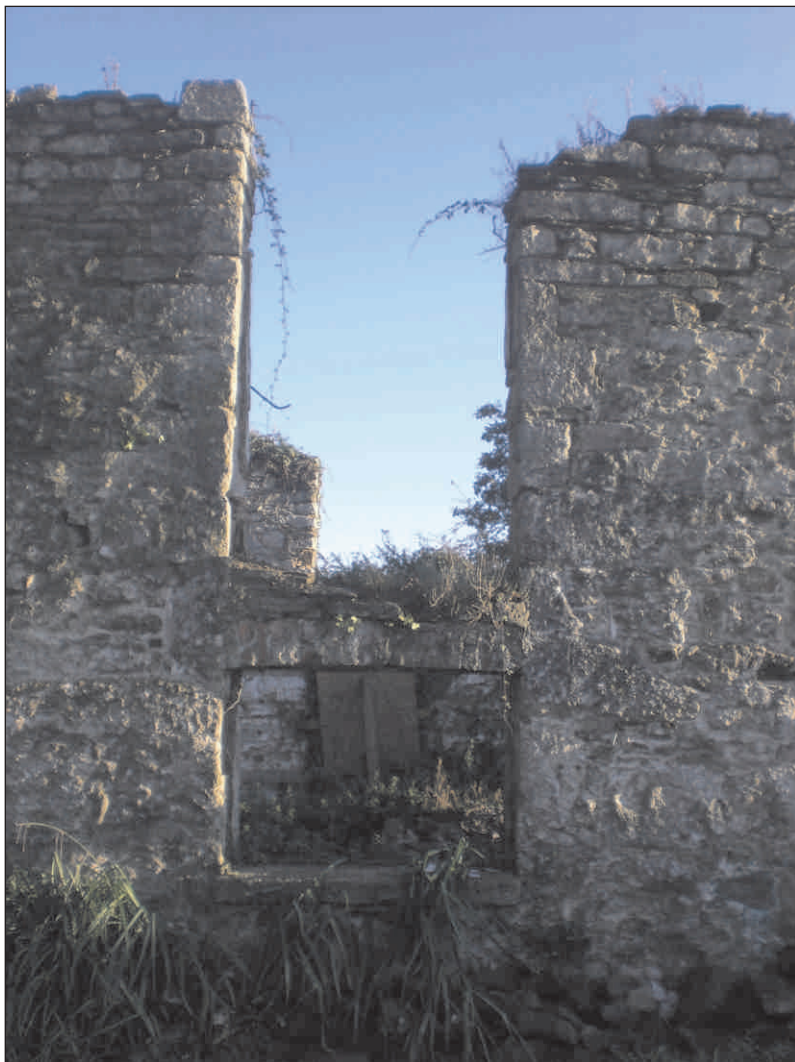
Plate 5: Window opening within southeast elevation, view from southwest

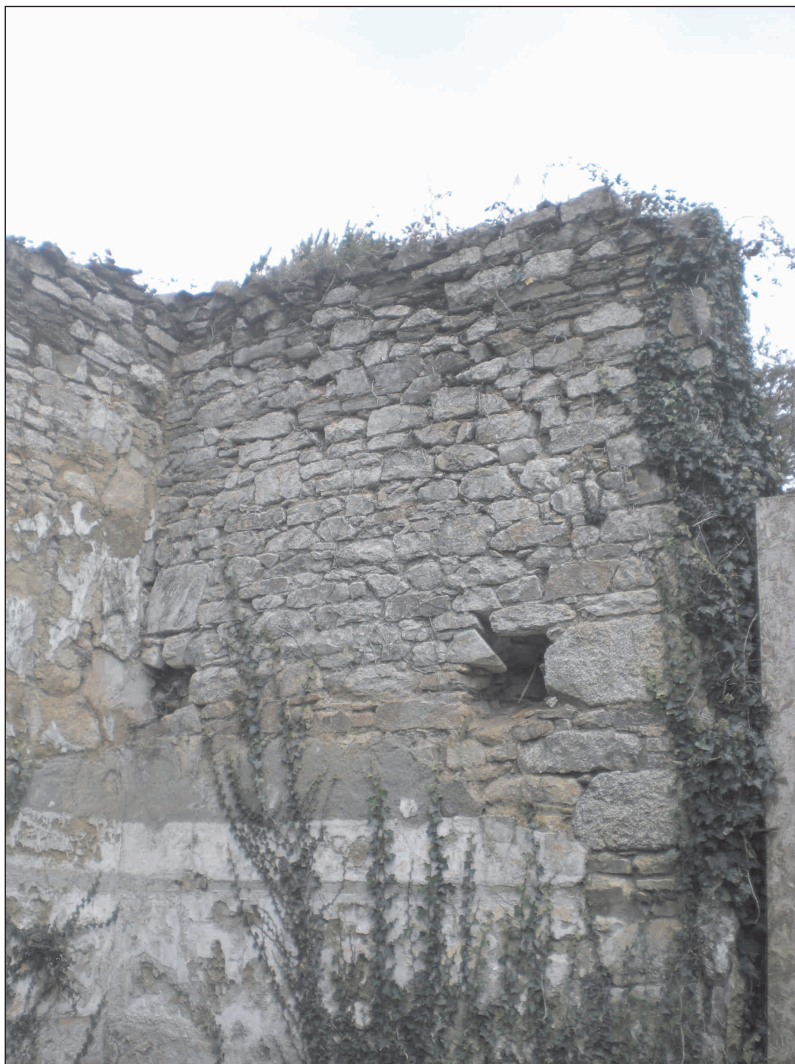
Areas of rendered mortar survive throughout all the walls and partially within the window recesses; the mortar scarring here indicating the base of the windows were splayed. This mortar also displays evidence for three first-floor galleries (Plates 6-7). The rear (south) gallery above the entrance appears to have been approached by a now lost staircase in the south corner as indicated by angled scarring to the render (Plate 8.). The mortar scars indicate that the seating was stepped. No indication of former access to both the northeast and southwest galleries was observed inferring the gallery was continuous to three sides of the building. Both of these former longitudinal galleries would have cut across the pairs of windows within the side walls. It is not uncommon, and can be paralleled in other chapels across the Southwest (Stell 1991). Again, the seats in these galleries would have been stepped, and there is also evidence for metal fittings above the top of the galleries. The mortar also includes scars associated with the ground- floor seats and associated panelling.

Plate 6: Southwest elevation, internal face showing scars of galleries in mortar, view from west

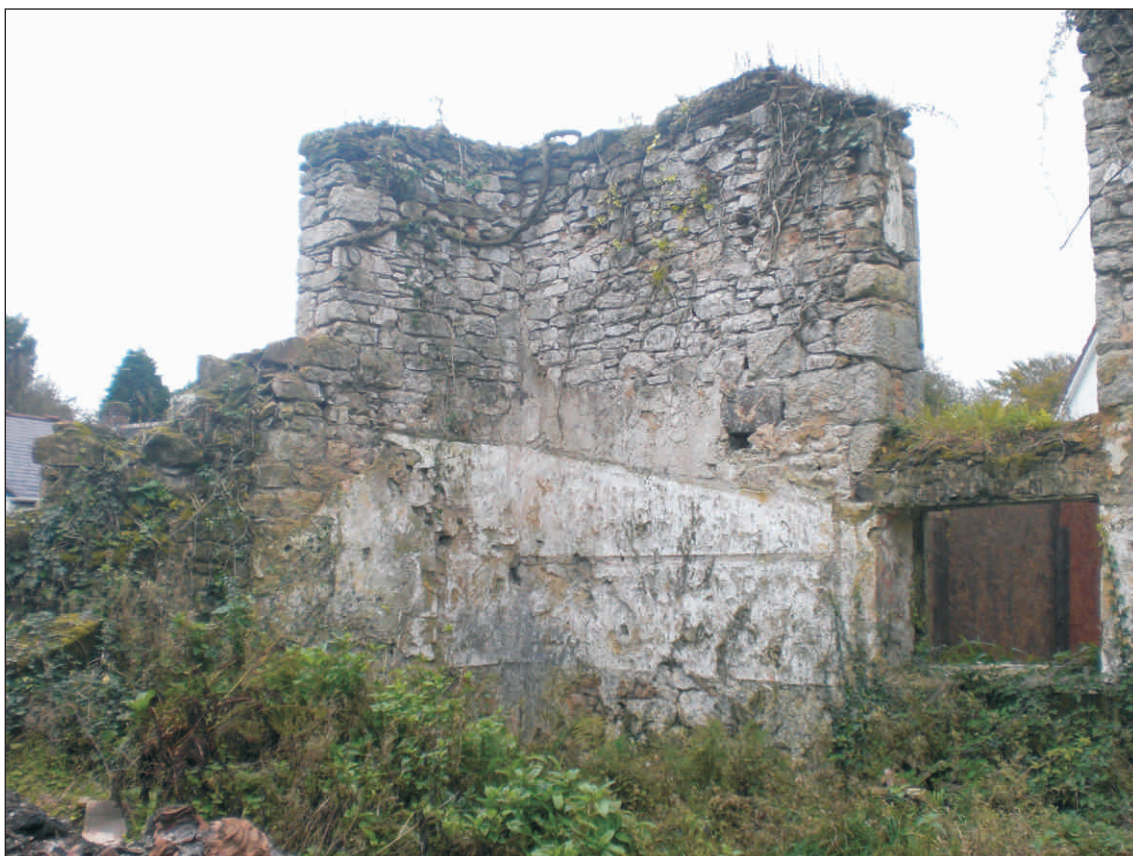
Plate 7: Northeast elevation showing sockets and scars in mortar associated with galleries, view from west.

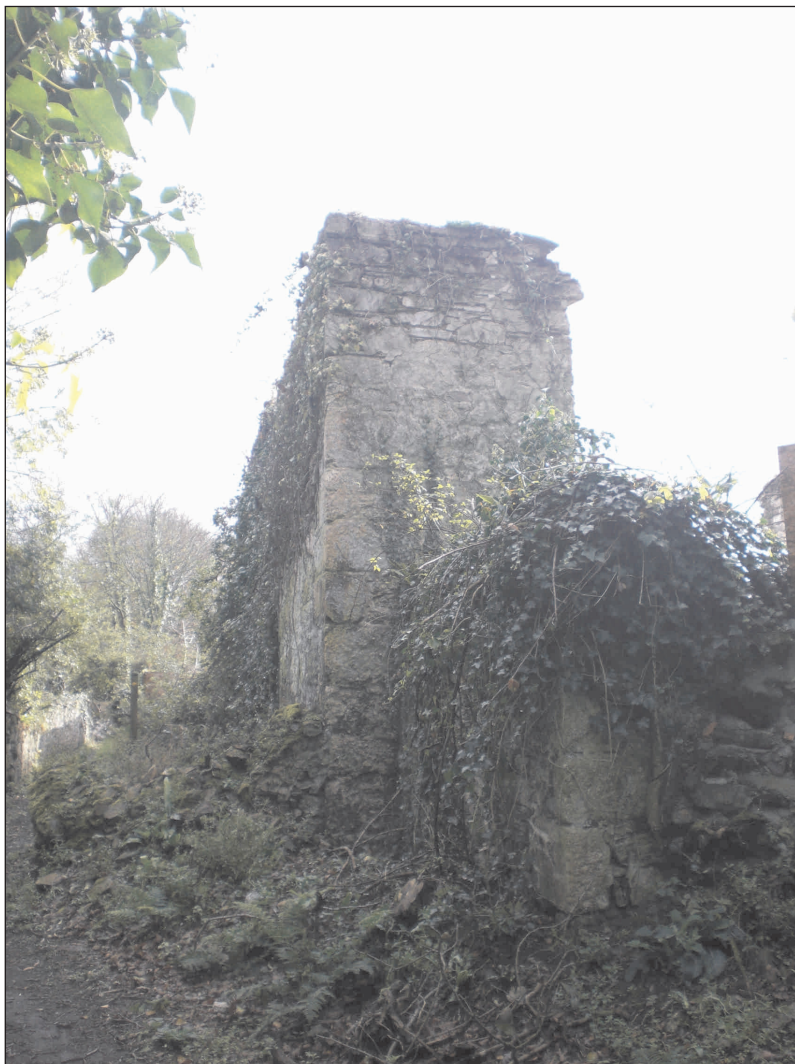
Plate 8: South corner of chapel showing scars of galleries and associated staircase, view from south

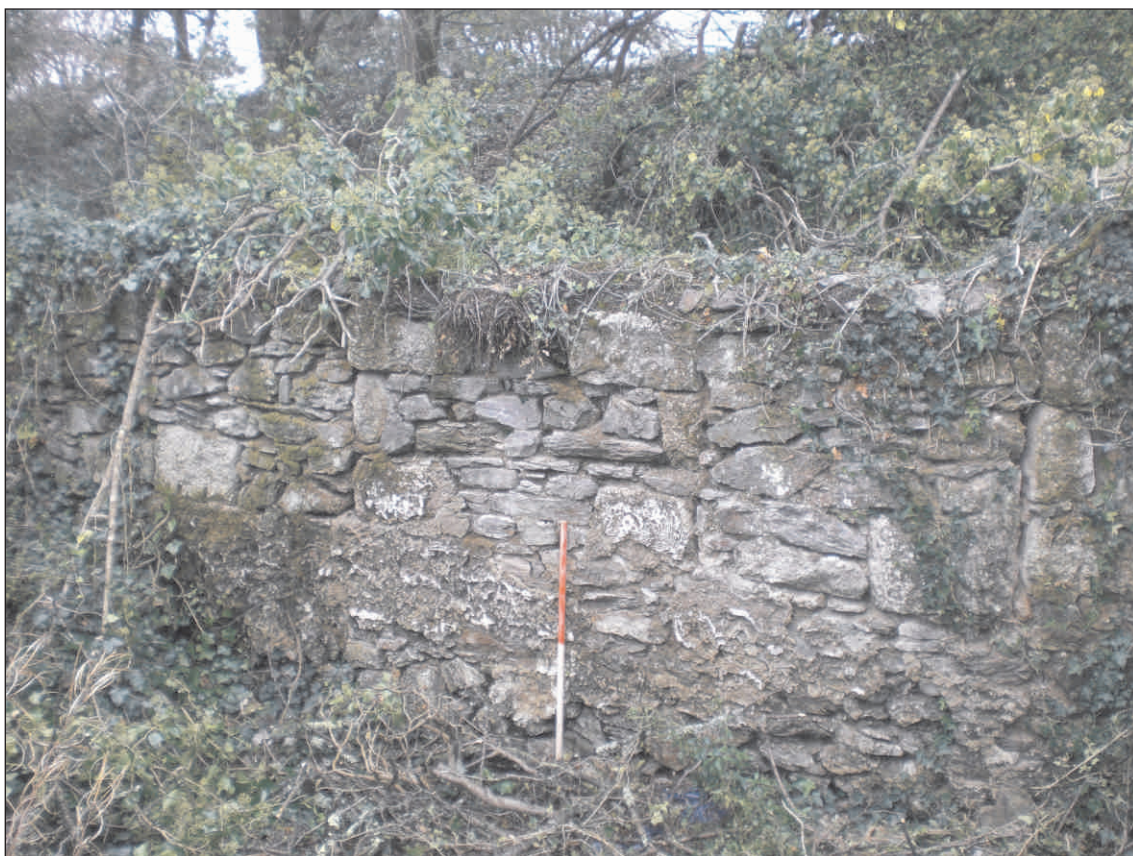
Plate 9: North corner of chapel with later vestry to right, view from the west

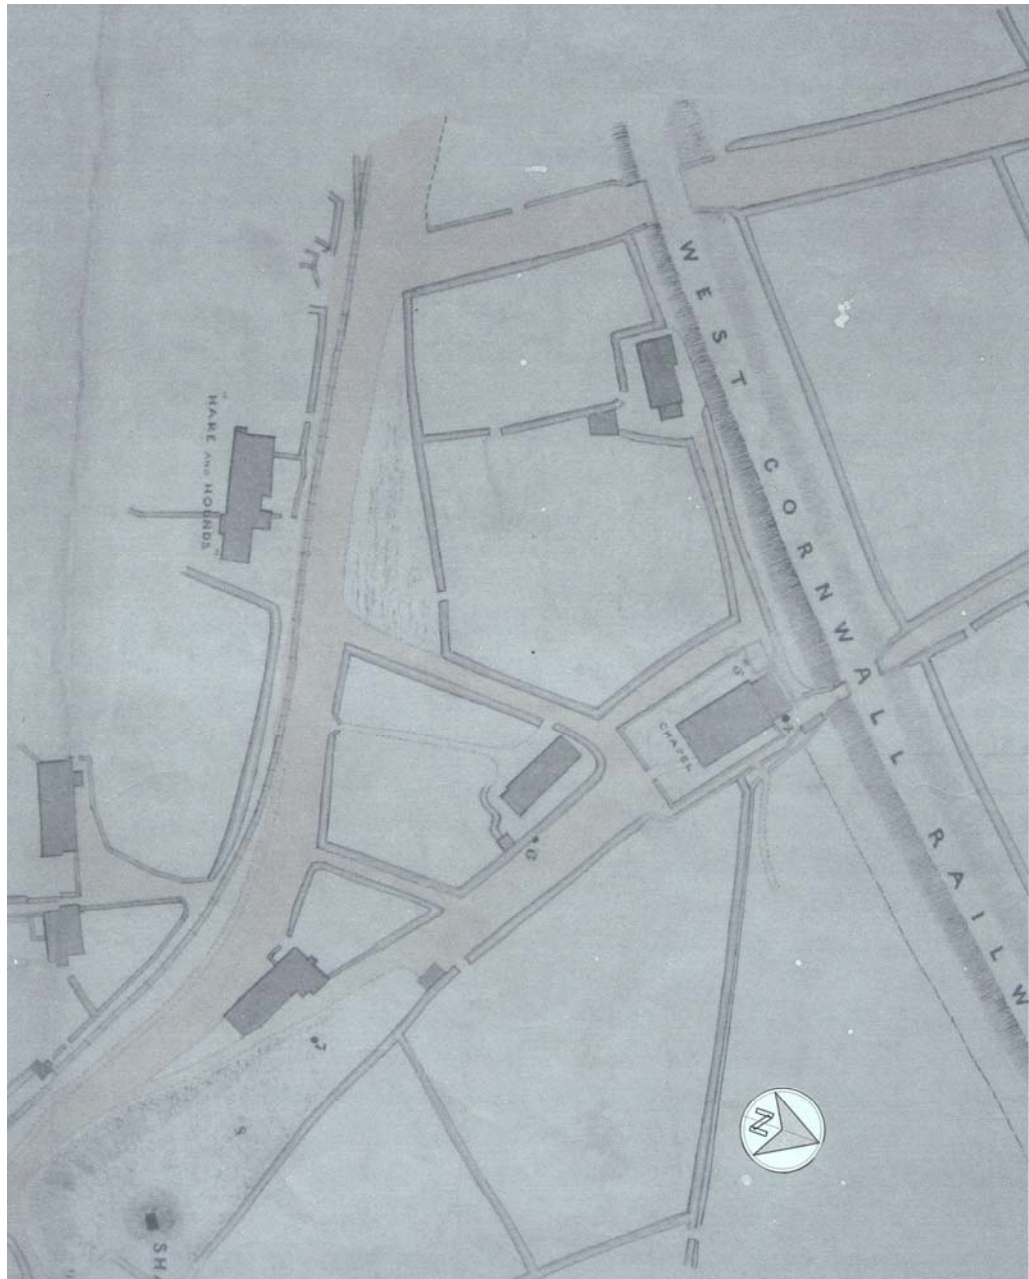
Blanchland and St Day Manors Boundary Plan

- 1.1.7 Extracts from the 1865 Plan of the Boundaries between the Blanchland and St Day Manors show the West Cornwall Railway now in existence and labels the building as a “Chapel”. The plans clearly show the main building with its annexe on its north-western end, the walls enclosing the chapel grounds, all of which still exist apart from that on the south-west side, the rectangular building at the western corner of the annexe, see Photographs 14 & 15, the pedestrian gateway which still exists, and the footpath along the north-east boundary. The numbered dots refer to

marker stones and delineate the boundary between the Manors. The existing neighbouring “Sun Cottage” is shown as is the “Hare and Hounds”, now the Fox & Hounds, public house but the building adjacent to the railway below the word “WEST” has long since been demolished as have some of the Cornish hedges to the south and west of the chapel.

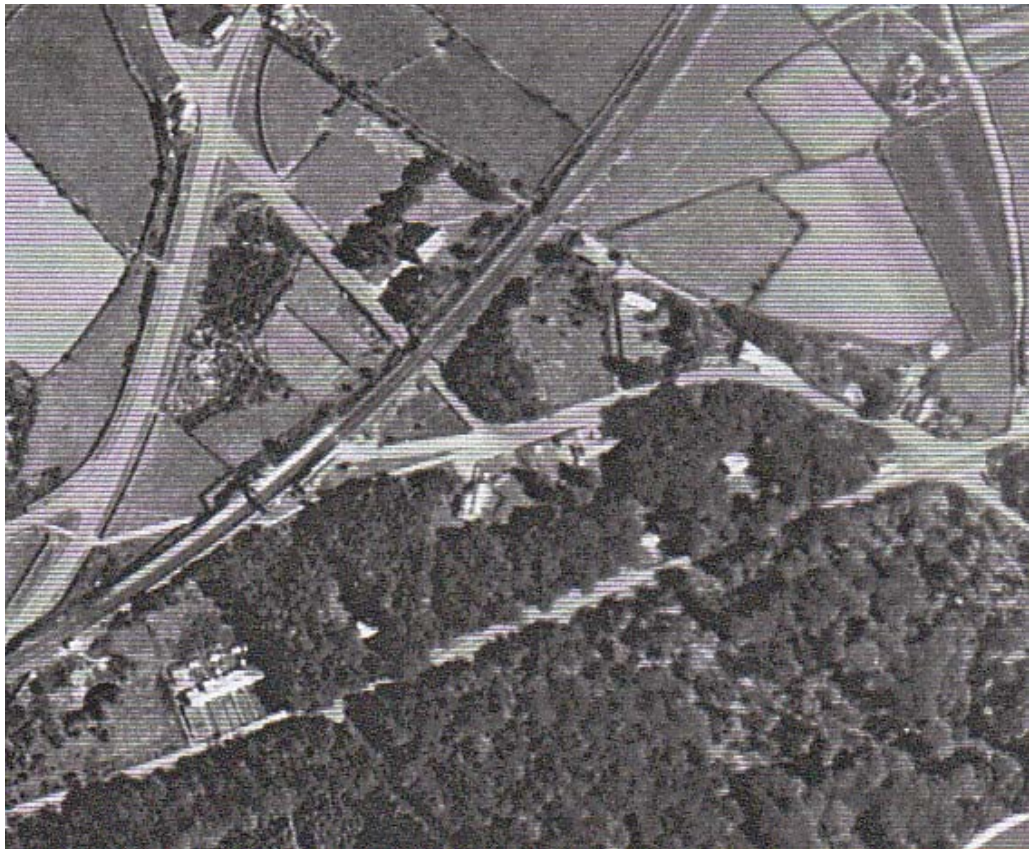
- 1.1.9 A number of aerial photographs of the area have been taken over the years and it is clear from Photograph 1 taken on 12 July 1946 that the roof was still intact at that time and was a fully hipped roof. The shadows indicate that when the photo was taken the sun was shining from the south-east, and a few degrees to the north of the main ridge line of the chapel. The south-eastern hip is just distinguishable by being slightly lighter than the north-eastern and south-western roof slopes, however, the north-western hip is clearly defined as a dark triangular area. Sun Cottage is clearly visible with its fully gabled roof.

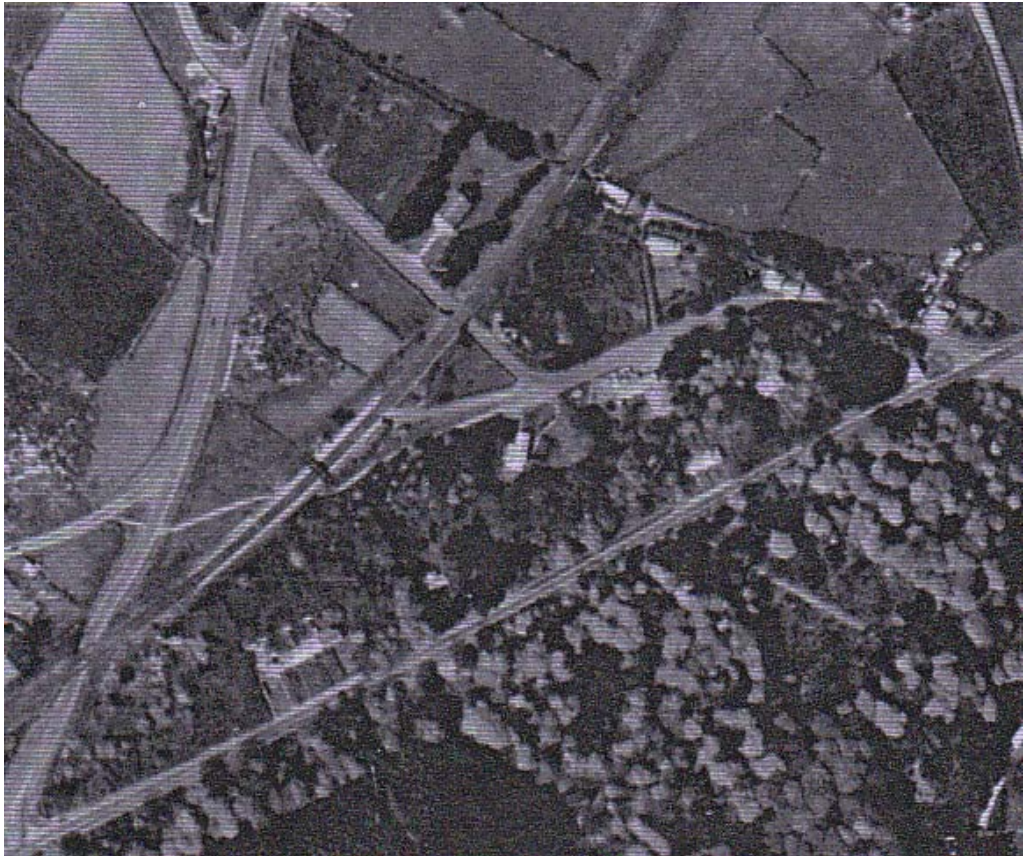
- 1.1.10 The chapel image in Photograph 2 taken on 12 May 1951 is more difficult to interpret with regard to the roof but the darker triangle at the north-western end of the building still suggests the existence of a hipped roof.

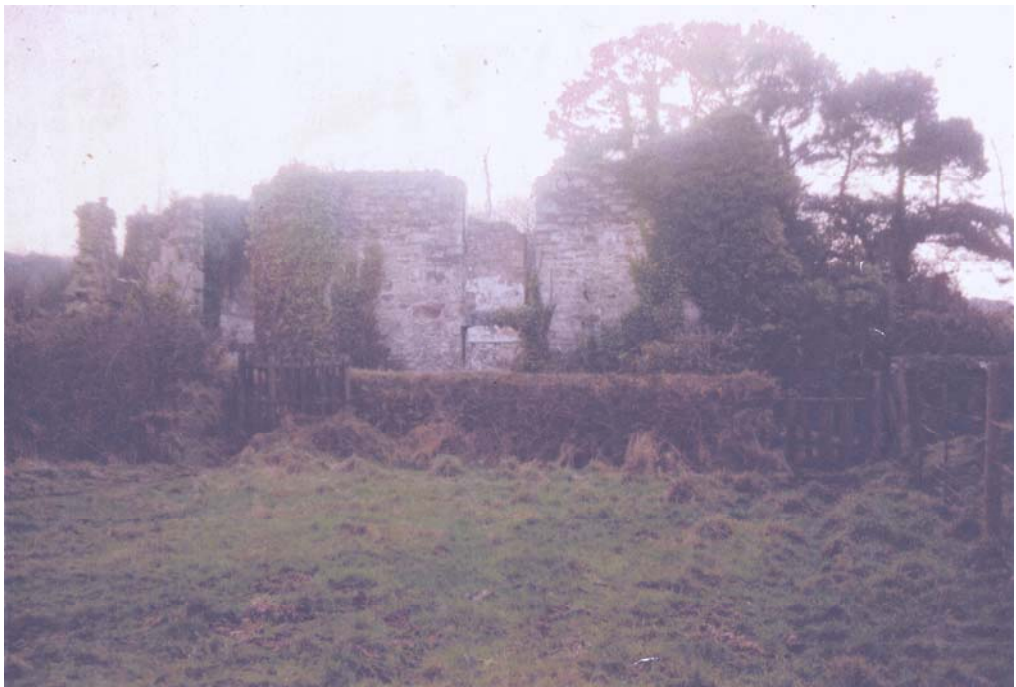
Photograph 3 – taken from the field to the north-east shows the north-eastern wall to be in a similar condition to now, it shows that there has been very little deterioration over the last 46 years.

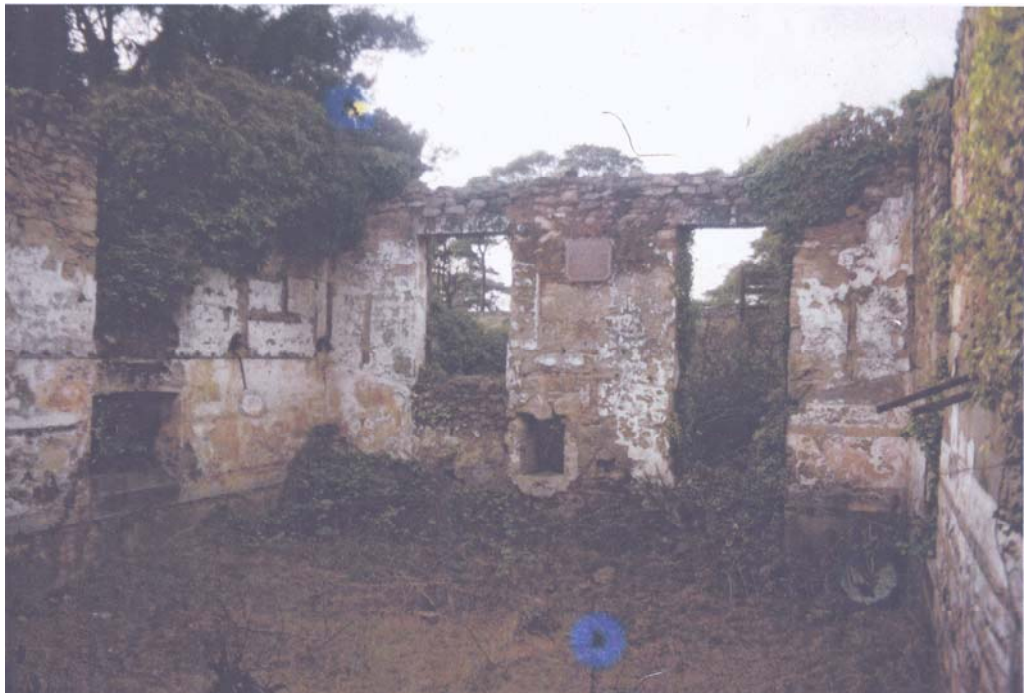
Photograph 5 – taken from inside the building looking at the north-western wall. That wall was still at full height in 1965 with its rectangular openings and lintels still intact. The centre section has since collapsed but the remaining walls show little deterioration over the period.

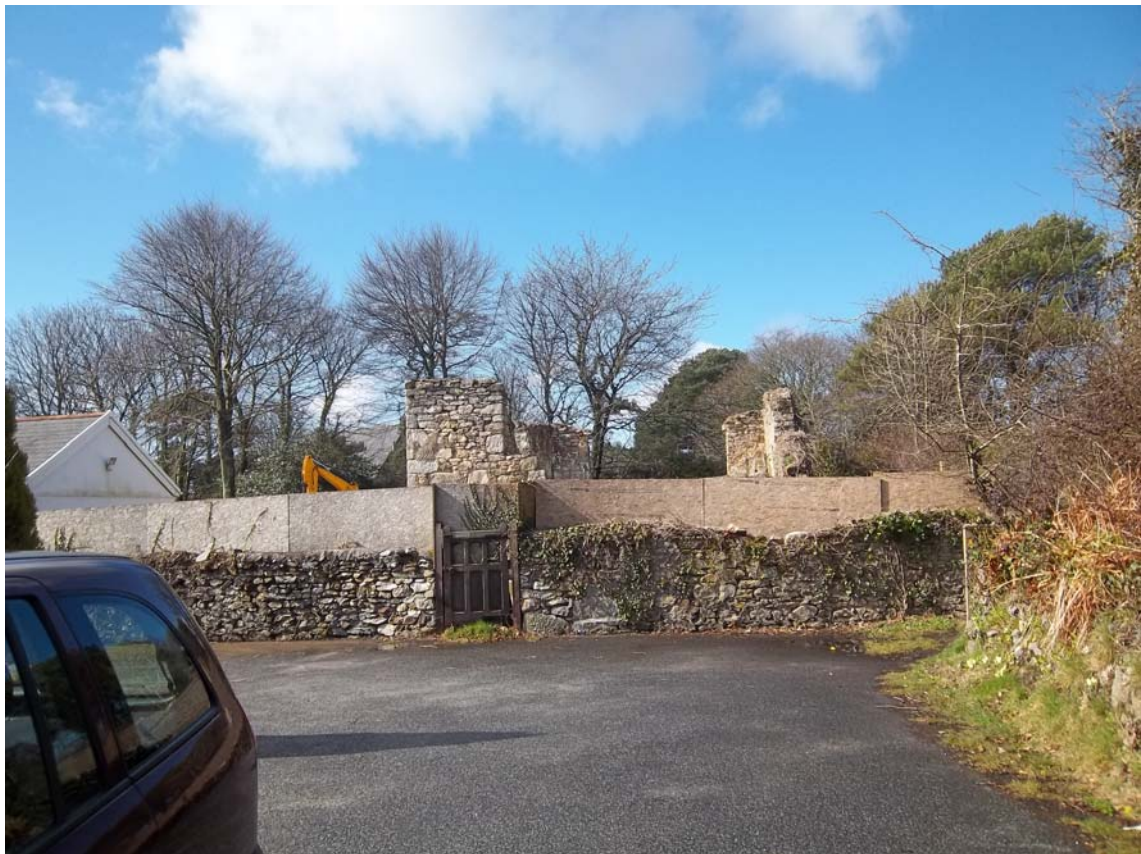
8 Chapel remains as seen from the footpath approach from the south-east.

Original wall and pedestrian gate access shown in the foreground.

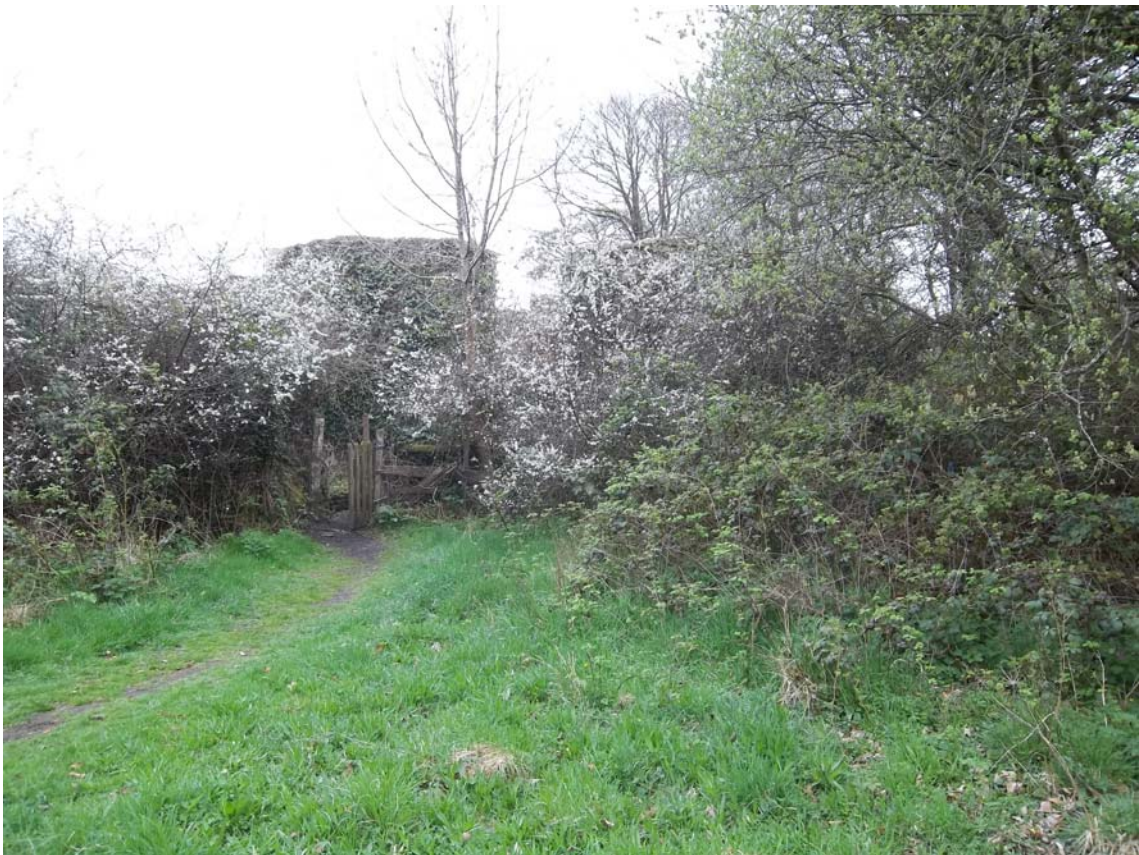
10 View from the field to the north-east. Shows comparison between it and the view from a similar place shown in photograph 3 taken in 1965

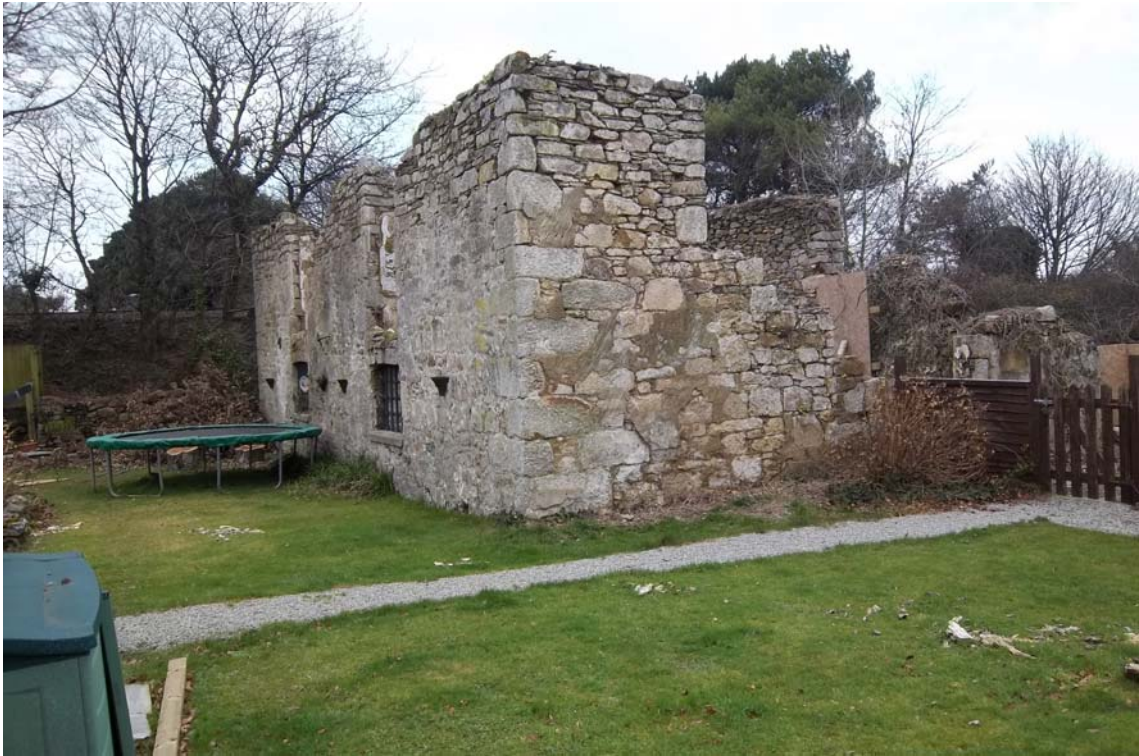
13. The south-western and south-eastern walls as seen from the south corner of the site.

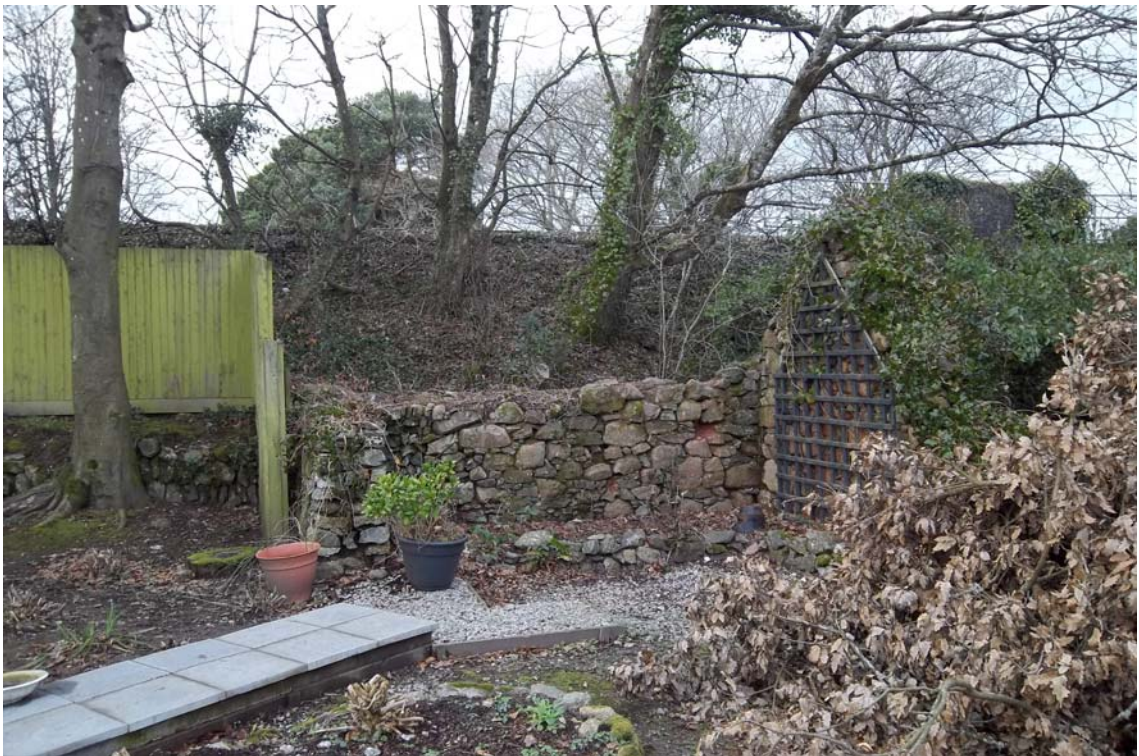
14. The remains of the original outbuilding in the western corner of the site. These remains to be removed and the garage located here.

- 3.7 It is proposed to construct a single garage in the western corner of the site to replace the original building at that location which is believed to have been the boiler room for the heating of the chapel. The new garage will be of painted and rendered cavity blockwork with granite quoins. The driveway and turning space is to be laid out as per drawing 134101.

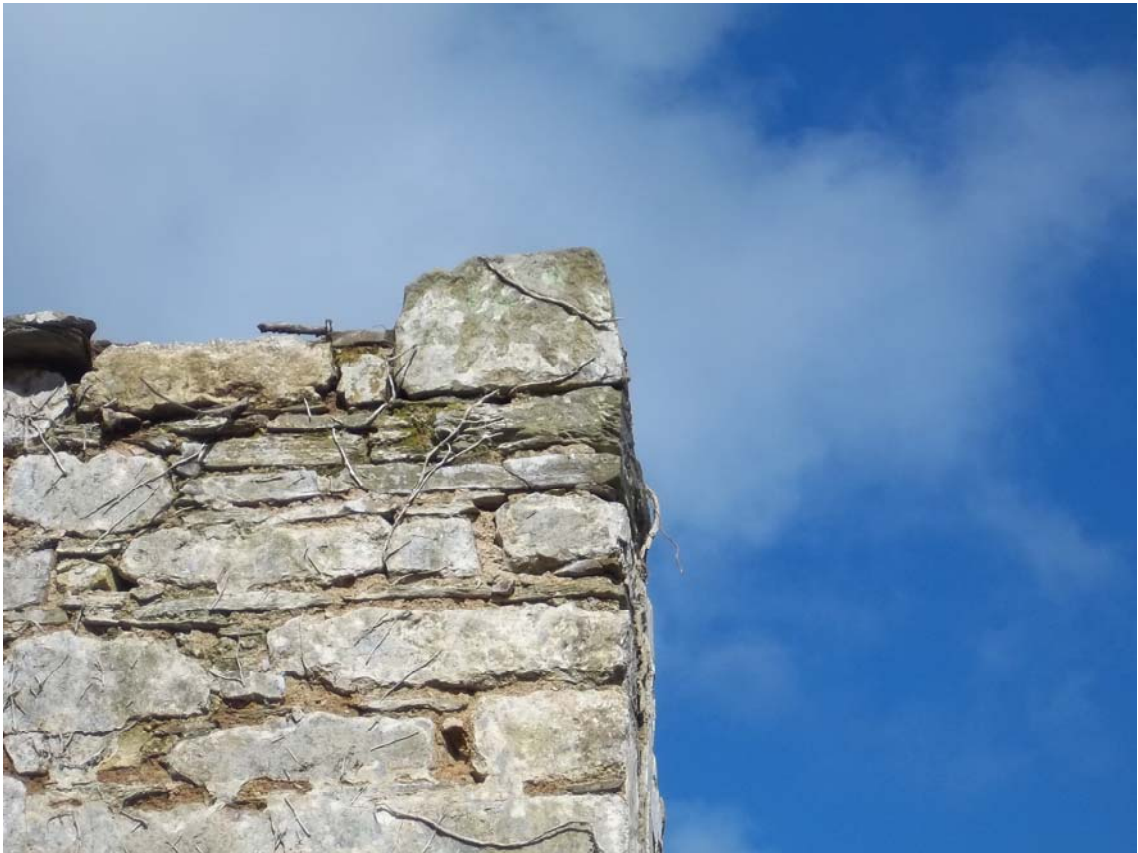
16. Upper quoin stone of south-eastern opening in south-western wall showing angled seating for upper brick arch.

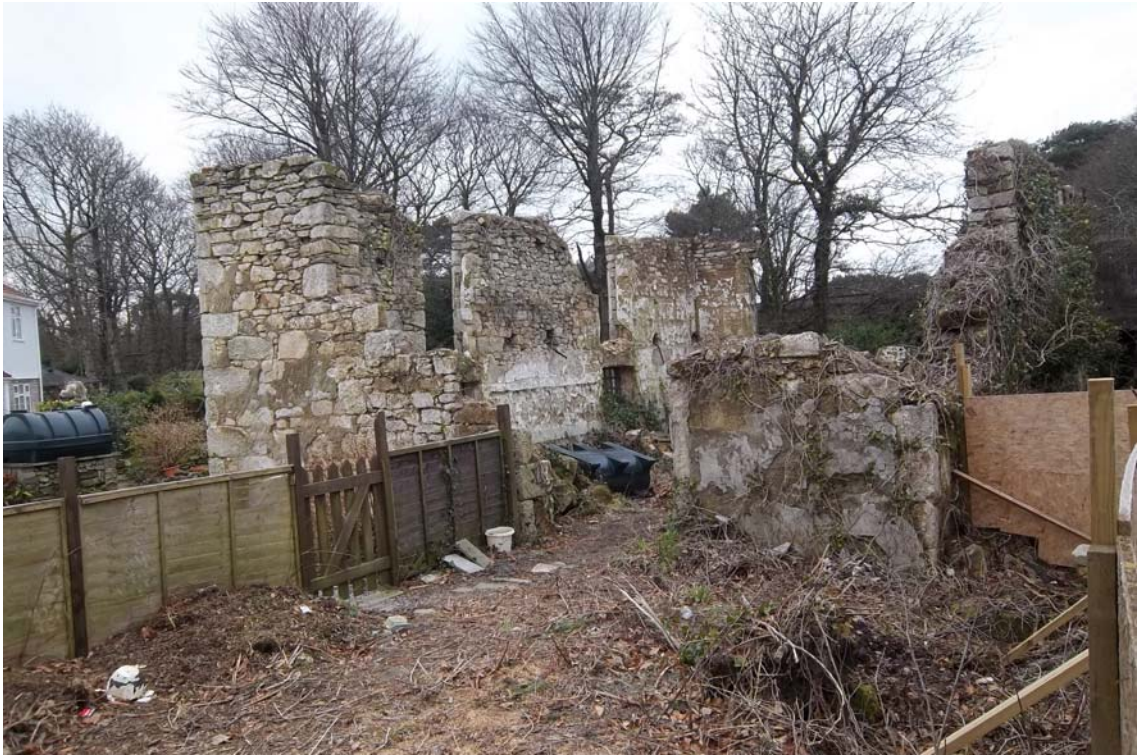
17. The south-eastern wall as seen from the eastern corner of the site. Ground levels in this area will be lowered by about 300 mm back to approximately what would have been the the ground level of the pedestrian approach to the original chapel.

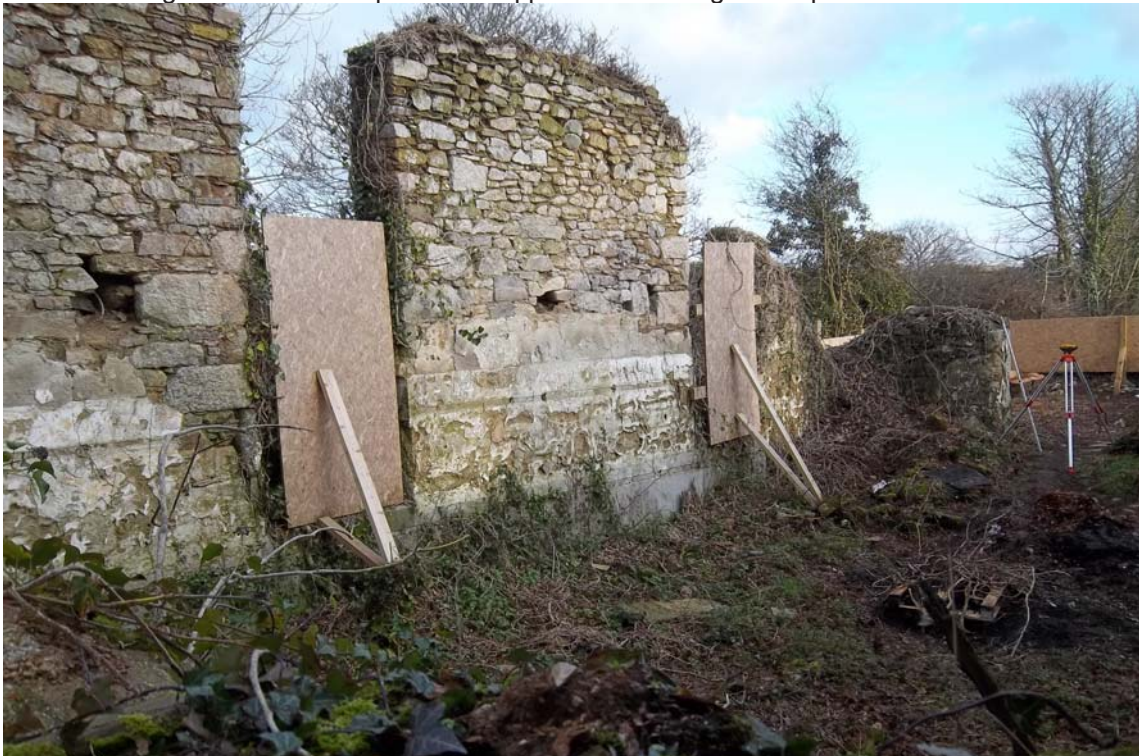
18. View of the inside of the north-eastern and south-eastern walls.

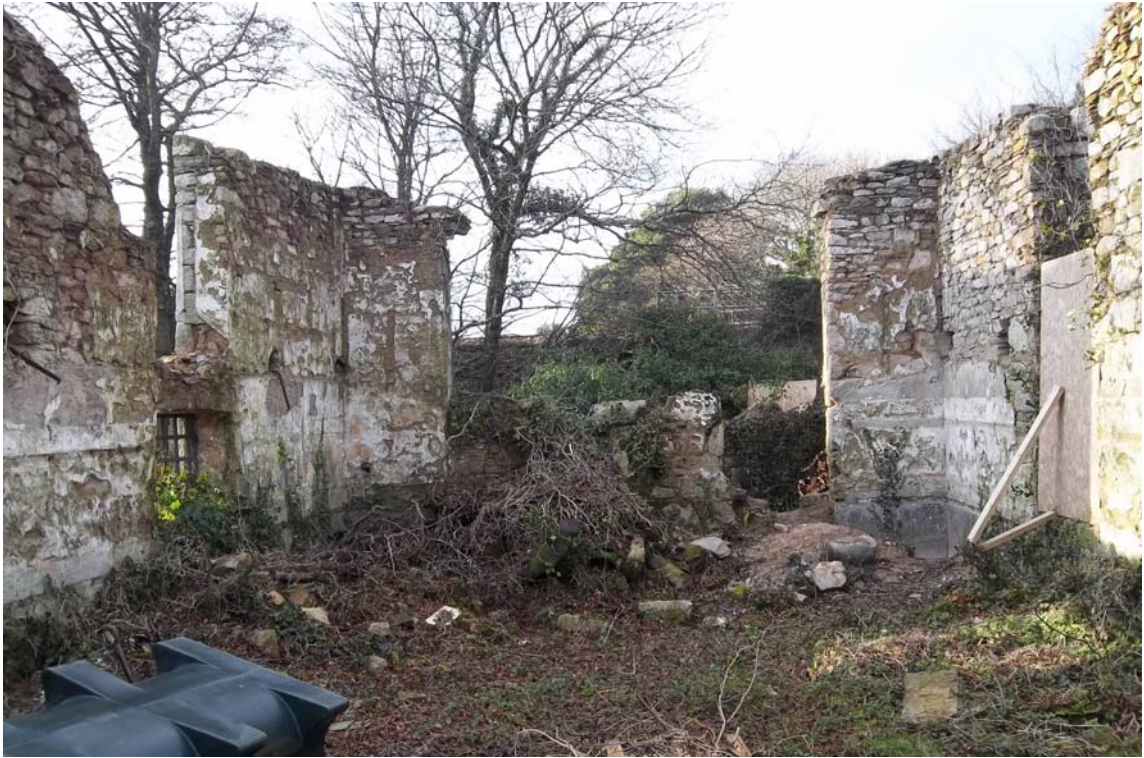
19. View of the inside of the north-western and north-eastern walls. Shows existing condition in comparison with 1965 photograph 5.

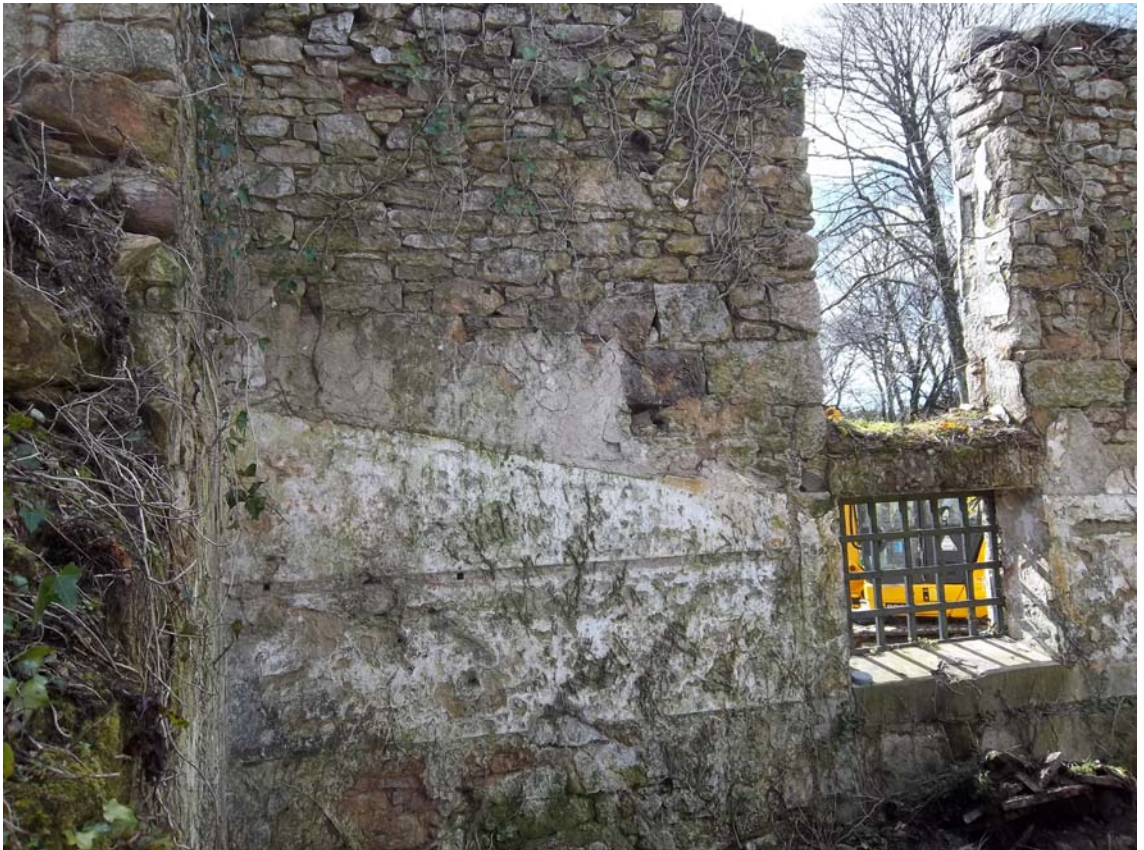
20. The inside of the south-western corner showing the lines of the upper congregation tiers, support beam sockets and brick arch.

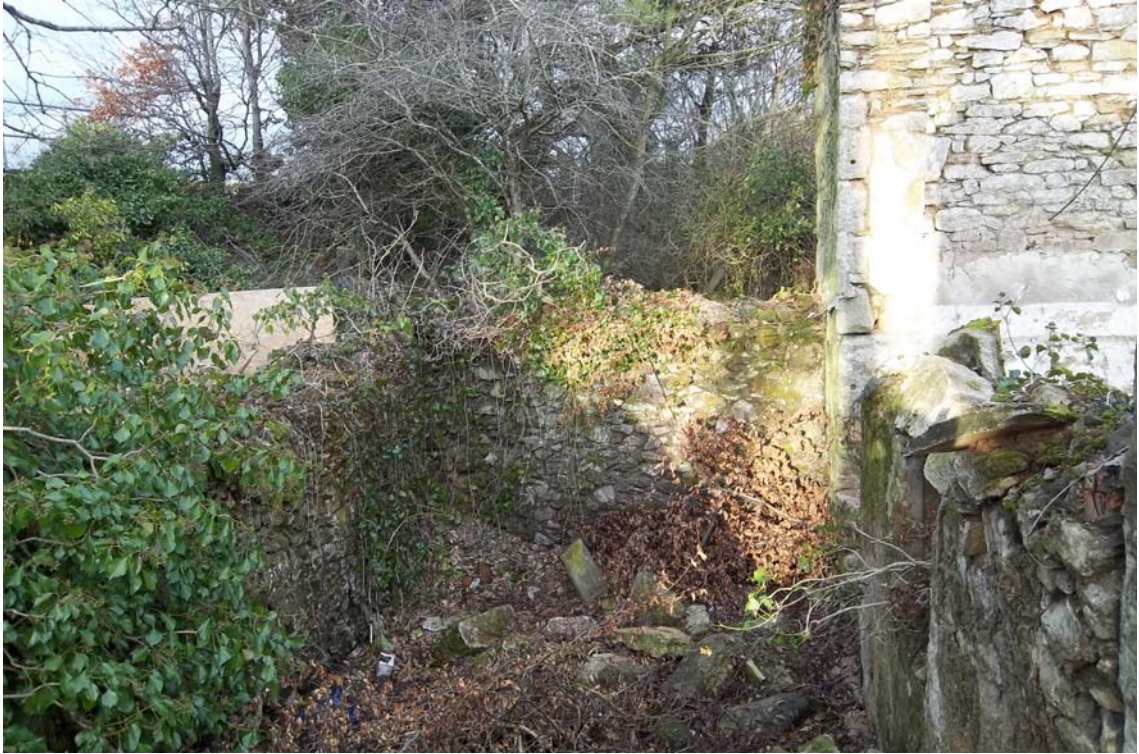
21 The inside of the annexe on the north-western end of the building. Shows some of the stones from the collapse of the central section of the north-western wall of the chapel.

- 3.6 The stonework to the annexe on the north-western end of the chapel is different to that of the main building and is in poor condition, it is therefore proposed that this be demolished and replaced with painted and rendered cavity blockwork with granite quoins.
