Land at Holsworthy Livestock Centre, Holsworthy, Devon

Results of an archaeological trench evaluation

Prepared by
Richard Sims

Document No: ACD398/2/0

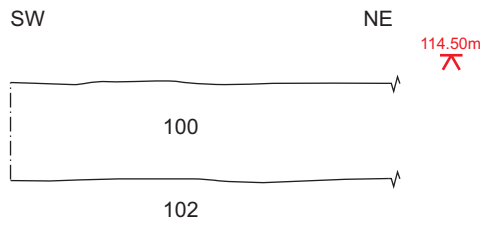
a) Representative section of Trench 1

- 5.2 **Trench 1** (Section Fig. 2a)
This trench was L-shaped in plan, was aligned northeast-southwest and northwest-southeast and was 20m in total length. The trench was excavated to a depth of 0.25m below ground level, through a dark brown silty clay topsoil (100) and directly onto a light yellow brown clay and shillet natural subsoil (102).

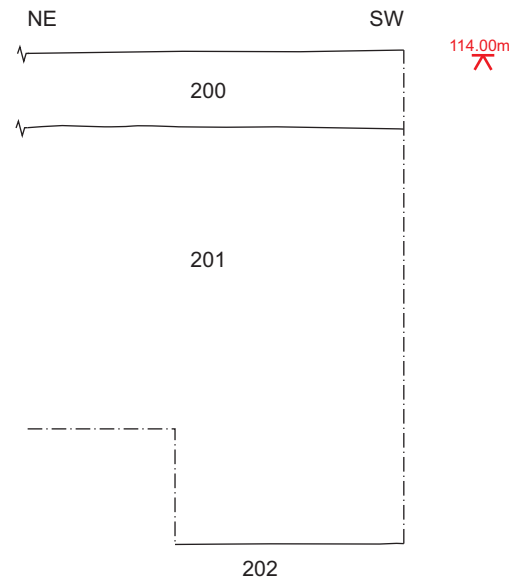
b) Representative section of Trench 2

- 5.3 **Trench 2** (Section Fig. 2b, Plate1 & 2)
This trench was northeast-southwest aligned, 20m in length and was excavated to a maximum depth of 1m below ground level. The recorded layer sequence comprised 0.20m of reinstated dark brown silty clay topsoil (200) over 0.80m of modern dump and levelling material (201). A sondage was excavated through this to a depth of 1.40m below ground level onto a dark grey silty clay dumped deposit (202), containing a fragment of 19th/20th century brick. Modern finds (brick, tile, metalwork, ceramics etc) were present in overlying layers, but these were not retained.

- 6.4** The waterlogged deposit noted within the base of the sondage within Trench 2, located along the crest of steep south sloping ground, is unlikely to be an *in situ* layer and more likely represents redeposited alluvial material from the clearance of lower-lying land within the river floodplain.

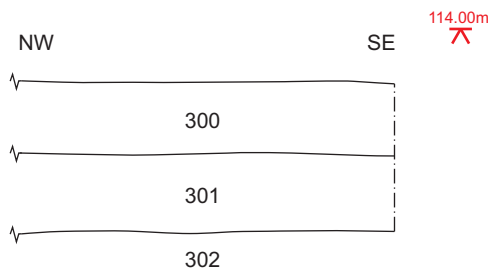
c) Representative section of Trench 3

- 5.4 **Trench 3** (Section Fig. 2c)
This trench was northeast-southwest aligned, measured 3.50m long and was situated across steep south sloping ground forming a natural bank to the north of an access track. The trench was excavated to a depth of between 0.40-0.60m below ground level onto a light yellow brown clay

and shillet natural subsoil (302). The overlying layer sequence comprised 0.20m of reinstated dark brown silty clay topsoil (300), over between 0.20-0.40m of light yellow brown silt clay subsoil (301).

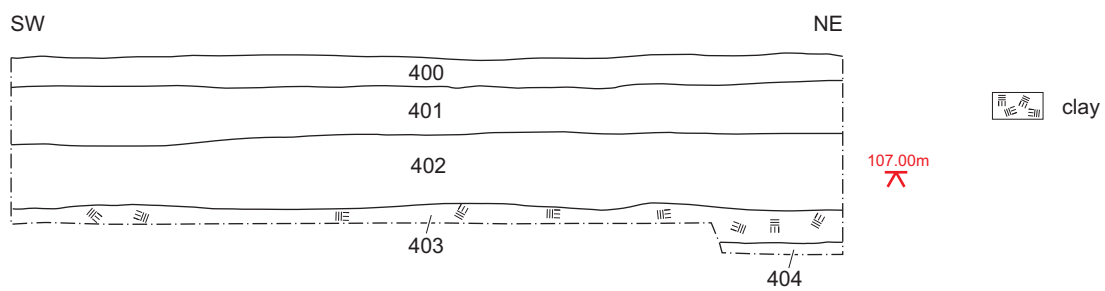
d) Southeast facing section of Trench 4

This trench was northeast-southwest aligned, measured 5.50m in length and was excavated to a maximum depth of 1.10m below ground level onto a soft dark grey silty clay alluvium (403). The overlying layer sequence comprised 0.20m of reinstated dark grey brown silty clay topsoil (400) over 0.90m of mixed modern dump/levelling deposits (401) and (402). A sondage was excavated through alluvial layer (403) to a depth of 1.30m below ground level onto a light grey silty sand alluvial deposit (404). Modern finds (brick, tile, metalwork, ceramics etc) were present in overlying layers, but these were not retained.

- 6.3** Alluvial deposits were exposed within Trench 4, which was located within the floodplain of the River Deer in the southeast part of the site. These were present at a depth of 1.10m below ground level, beneath modern overburden. The absence of alluvial deposits within Trench 5 to the southwest helps provide a clearer indication of the extent of these river floodplain deposits. The two alluvial layers identified within the trench were generally sterile and undated, with no organic material, charcoal or other palaeo-environmental remains present.

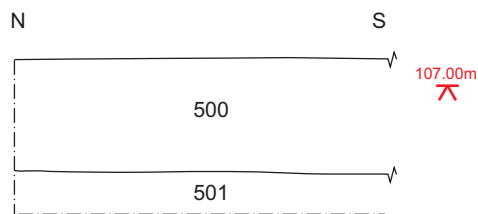
e) Representative section of Trench 5

This trench was north-south aligned, measured 4.50m in length and was located across the bank of the River Deer. It was excavated to a depth of 0.40m below ground level through 0.30m of reinstated dark grey brown silty clay topsoil (500), which was directly overlying a light yellow clay natural subsoil (501).

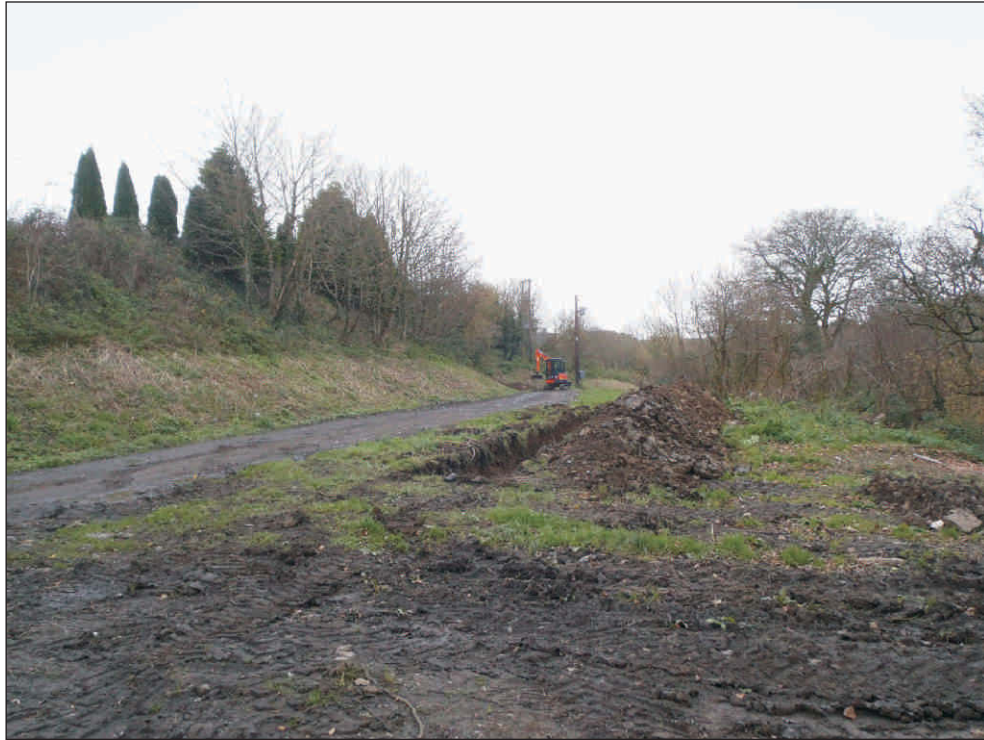
Plate 1: General view of site in vicinity of Trench 2, showing raised ground. Looking to northeast.

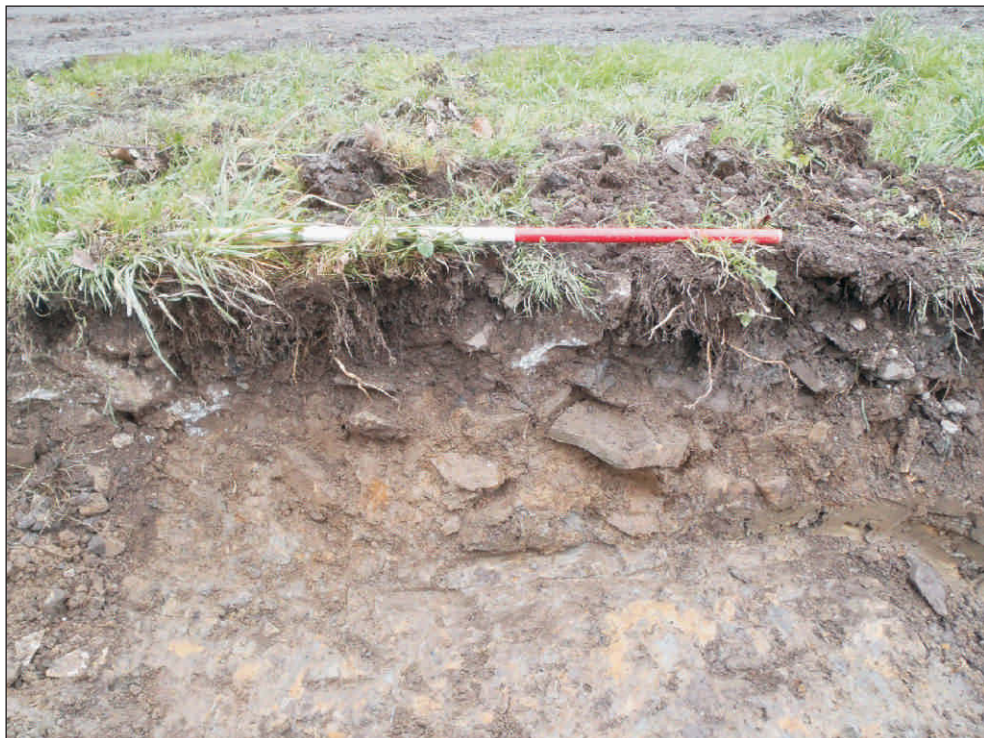
Plate 2: Recorded layer sequence Trench 2, showing modern dumped layer (201). Looking to northwest (scale 1m).

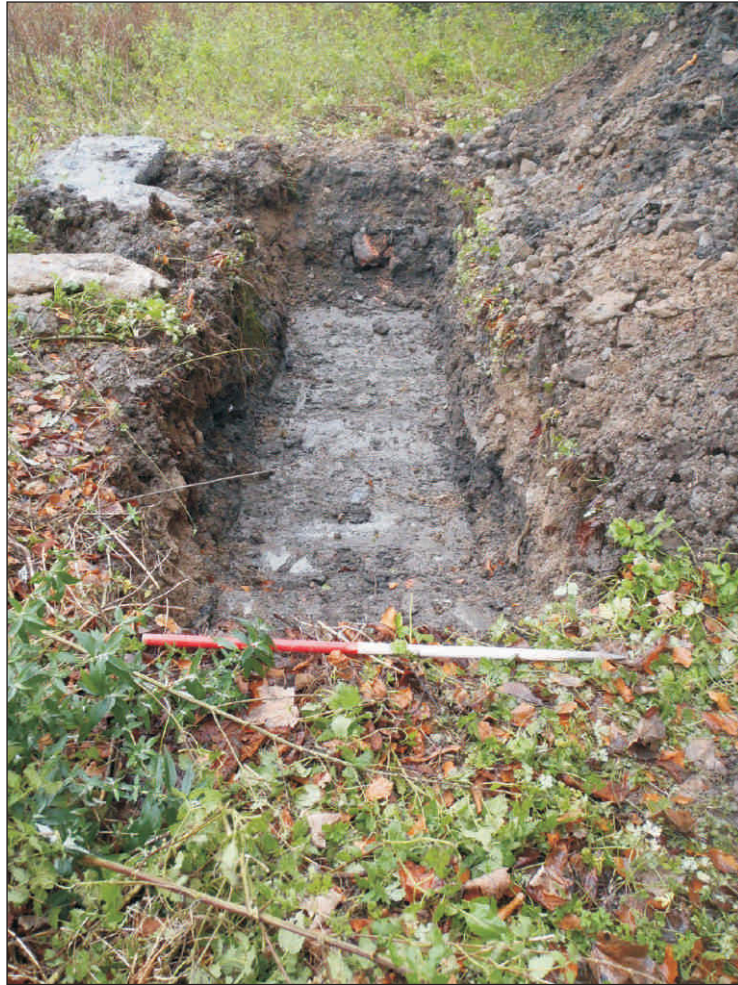
Plate 3: Alluvial deposit (403), Trench 4, looking to northeast (scale 1m).

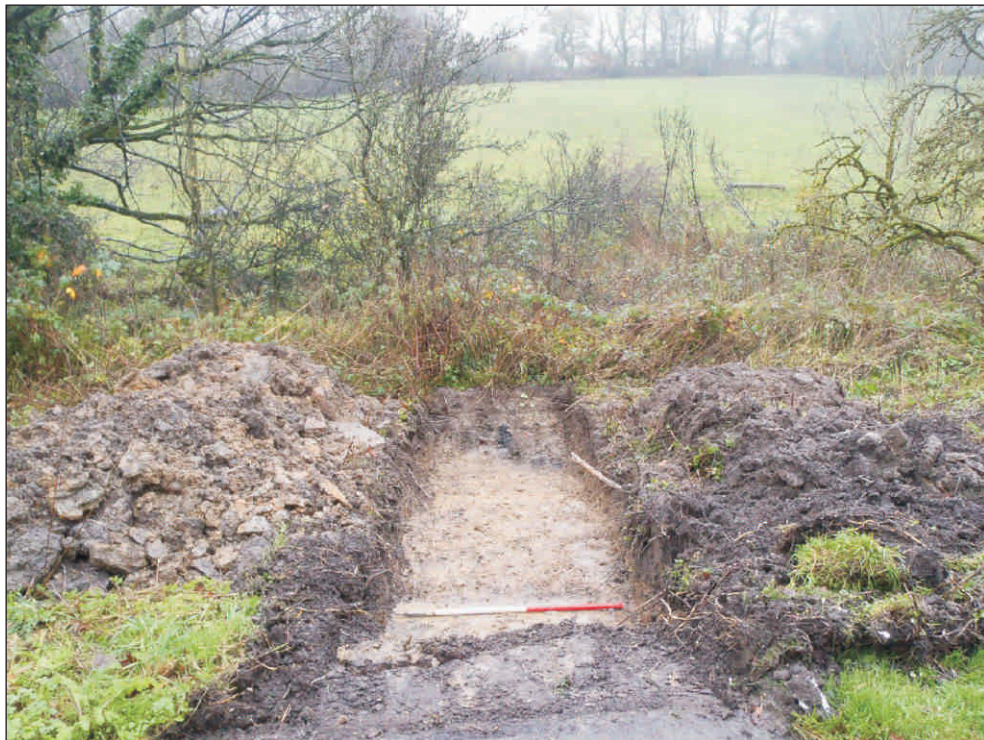
Plate 4: General view of Trench 5, looking to south (scale 1m).
