1-11 Sidwell Street, Exeter, Devon

Results of an archaeological watching brief and recording

Condition 4 of planning permission no. 11/0332/03

Document No: ACD368/2/1

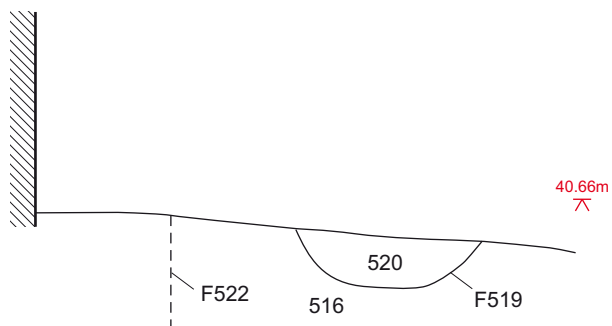
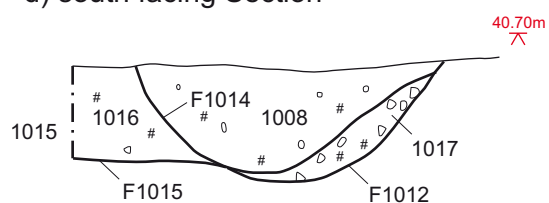
Fig.4: Sections

a) west facing Section

b) south facing Section

c) east facing Section

d) south facing Section

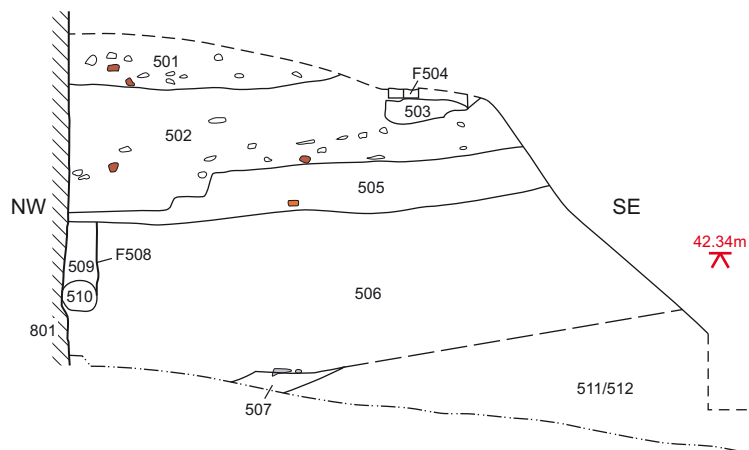
a) section at south end

In the initial exposed section of the bank, natural deposits were not exposed, and a construction trench for the original boundary wall was not present. The earliest soil (512) contained a sherd of Roman pottery. The bulk of the mound dated to the late 18th century and comprised layers of red-brown clayey silt with gravel, coal, brick and mortar inclusions (506 and 505), and dumps of redeposited natural red-orange clay (502) and brown clayey loam (501). A vertical cut (508) through 506 is probably associated with a small rebuild of the boundary wall (EMAFU 528). Its backfill (509) contained common flecks of lime mortar, brick and fired clay. Cut into the top of 502 was a concrete footing (503) and lowest course of a wall (504) constructed of Candy bricks. This is probably of 20th-century date and may represent an attempt to stabilise the upper (now partially-removed) modern deposits.

A wide, near-vertical cut (F619/705) was observed cutting through 606 (see Fig. 5a). This contained two fills of dark reddish brown compact silt clay (617) and light-medium reddish brown compact silt clay (616/706). In some areas, but not across the site, this cut continued down through 607 and 610 (see Plate 4). This feature appears to represent a construction trench for the rebuilding of the boundary wall (masonry 800/827).

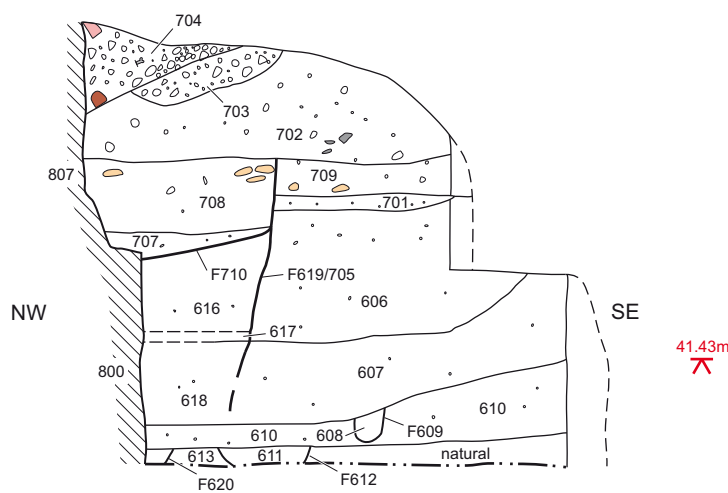
b) section at middle of site

A construction trench (F521/620/900/908/1102) for the boundary wall was exposed across most of the excavated area cutting through the natural. It was between 0.2m and 0.45m wide and contained a single fill (522/621/901/909/1103), dark reddish-brown firm clay silt with sparse small sub-angular gravels and sparse charcoal and ceramic building material flecks. Finds from this fill included animal bone, slag and pottery dating to the 14th and 15th centuries.

All features cutting into natural were sealed by a 0.41m thick medium reddish-brown compact silt clay with sparse medium-sized, sub-angular stones (610), equivalent to 511 recorded in the south section. This layer was cut by a small posthole (F609, measuring 0.17m wide by 0.17m deep. It contained a single fill (608) of compact silt clay with sparse brick fragments. Above the posthole were thick dumps of very dark reddish brown, compact silt clay (607) and medium reddish brown, compact, silt clay (606/700). This may be equivalent to 505.

Further rebuilding of the wall (masonry 805, 807, 809, 821 and 821) is represented by a further construction trench (F710) that had been cut through thin layers 701 and 709 that physically overlaid 606. The construction trench was filled with dumps of stony dark reddish-brown compact silt clay (707) and light-medium reddish brown compact silt clay (708). This was sealed by a 0.94m thick dump of dark reddish brown, loose silt clay with large blocks of rubble including standard red bricks and patches of fired clay (702), equivalent to 502. Above this layer were later 20th-century deposits (703 and 704).

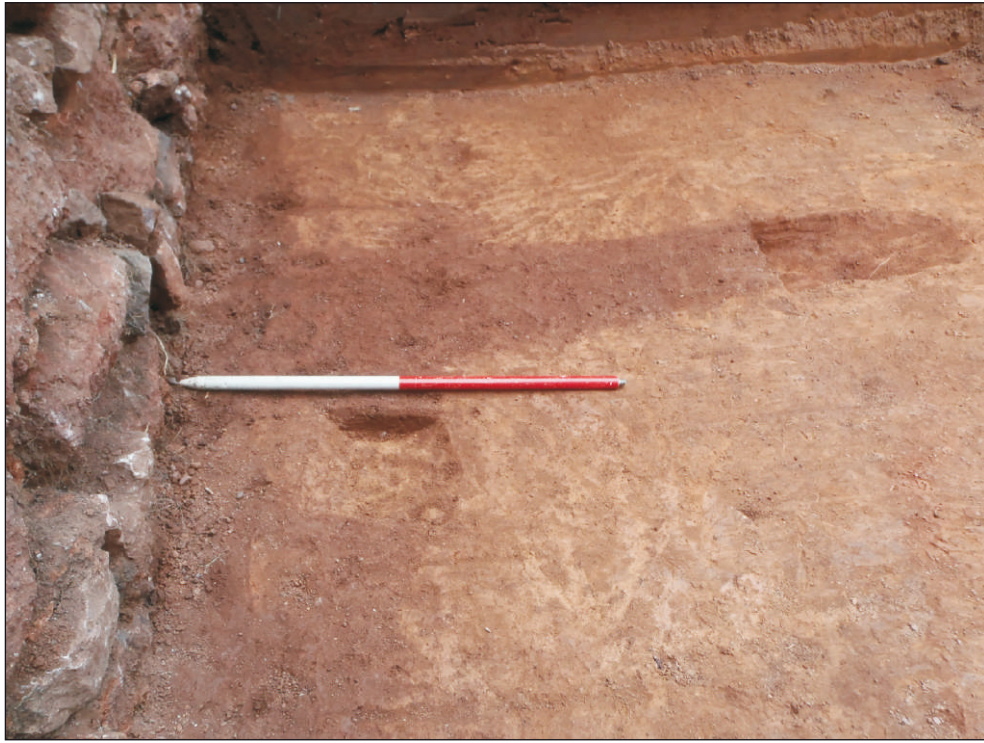
Two further undated, but almost certainly medieval or earlier, features were excavated to the south of F906. Linear ditch (F519/611/902/904) was exposed for a distance of 7.5m and was orientated northeast-southwest. It measured up to 0.6m wide by 0.11m deep, and contained a single fill (520/612/903/905) of reddish-brown compact clay silt with occasional charcoal flecks and ceramic building material flecks, and frequent small, sub-angular gravels. Ditch F517 was exposed for a distance of 2.4m and terminated in a narrow, rounded end. It contained a single fill (518), of reddish-brown compact clay silt with occasional charcoal flecks and frequent small, sub-angular gravels. The relationship of this feature with F519 was uncertain due to the similarity of the fills.

Plate 1: Ditches F517 and F519, viewed from the south. Scale 1m.

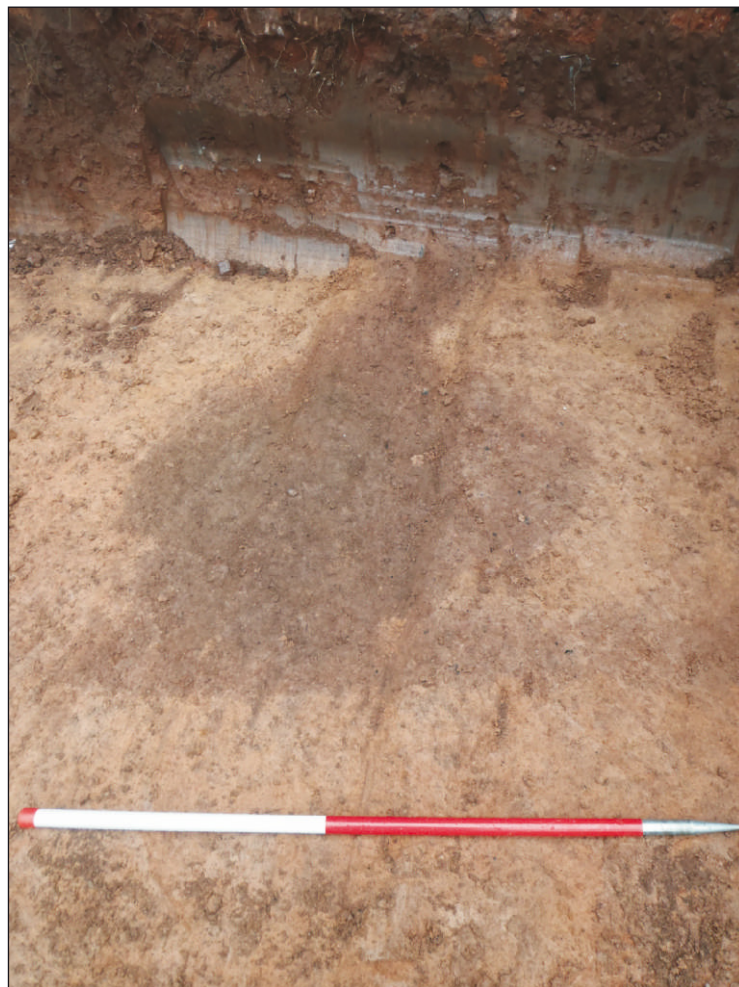
- 5.2** The earliest dated feature was an oval-shaped pit (F1014) that measured 0.65m long by 0.55m wide. It contained two fills, a lower fill (1017), of compact dark brown, sand silt clay, with common patches of redeposited natural and charcoal inclusions as well as common small angular stones and a single sherd of Saxo-Norman Bedford Garage Ware pottery dating to 950-1100AD, and an upper fill (1018) of dark reddish brown, sand silt clay, compact with common charcoal inclusions. Several sherds of 10th-13th-century pottery as well as animal bone were recovered from this fill.

This pit had been dug through two earlier features. Ditch F906/1005/1012 was aligned north-south and exposed for a distance of 3.75m. It measured up to 0.55m wide by 0.22m deep and contained a dark-medium brown compact silt clay fill (907/1004/1017), with common charcoal and fired clay flecks as well as sparse burnt stones. To the west was a narrow ditch (F1015/833) that measured 0.6m wide by 0.4m deep. It contained a compact dark brown sand silt clay, with common charcoal inclusions and occasional sub-angular stones (1016/834). Any physical relationship between these features had been truncated by the excavation of pit F1014.

Plate 2 Pre-excavation shot of ditches F1012 and F1014, and pit F1015, viewed from the east. Scale 1m.

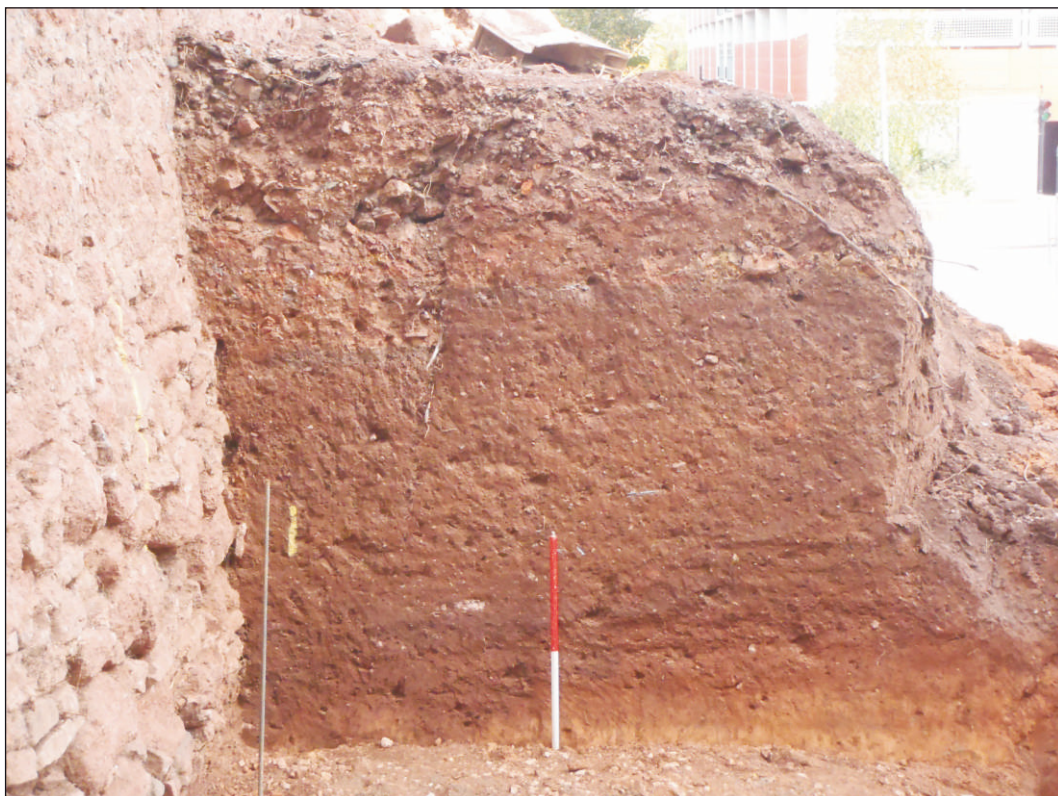
Plate 3 South-facing section of earth bank, middle section, viewed from the south. Scale 1m.

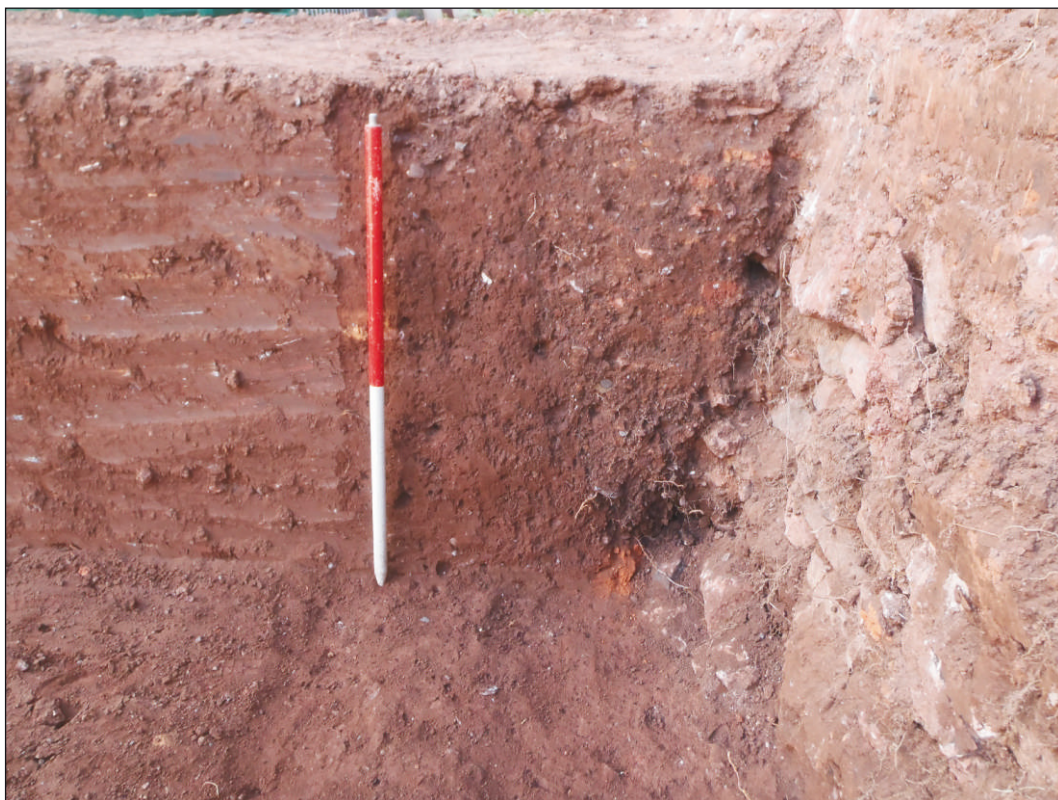
Plate 4 North facing section of earth bank, south end, viewed from the north. Scale 1m.

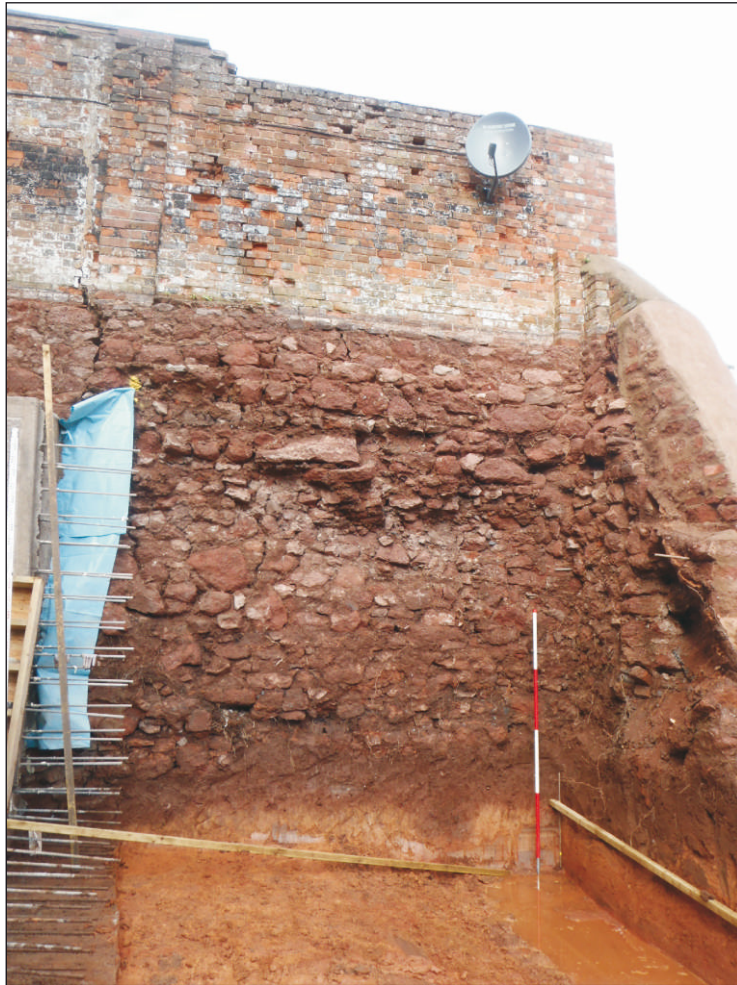
In the 19th-century the wall was further raised in brick (811 and 822; EMAFU group 5) and at its north end a series of features including a scar, buttress (817) and volcanic trap layer (818) appear to be associated with a building constructed against the wall.

Plate 5 East-facing boundary wall elevation, north end, viewed from the east. Scale 2m.

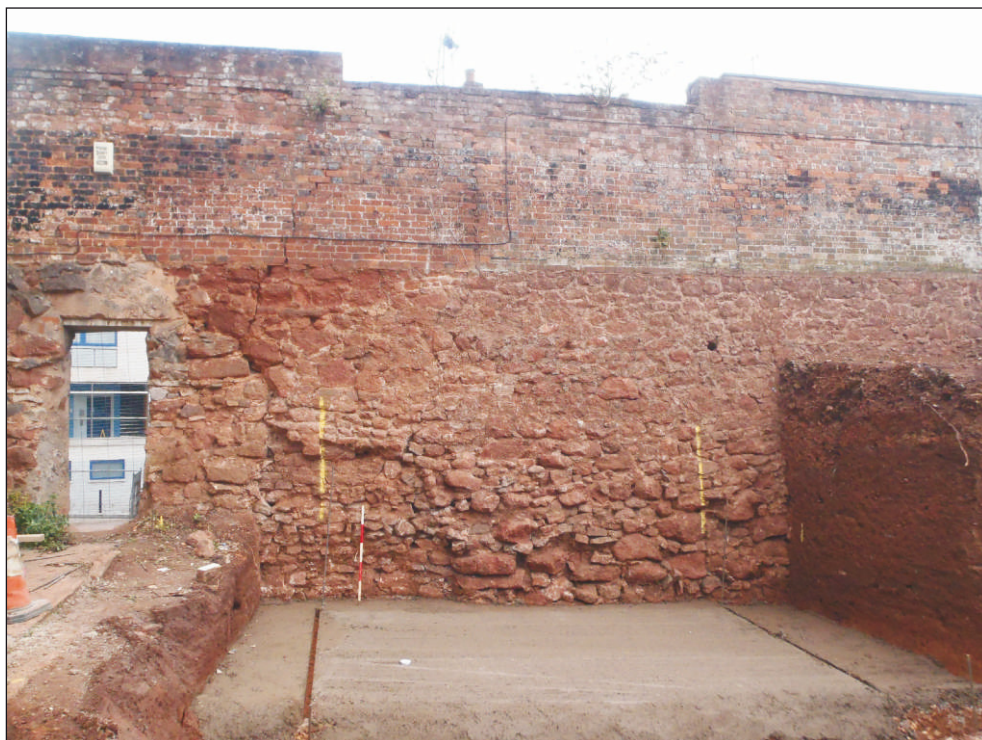
Plate 6 East-facing boundary wall elevation, south end, viewed from the east. Scale 1m.
