Proposed new dwelling on land adjacent to Hardston, Church Lane, Urchfont, Wiltshire

Results of archaeological evaluation

Document No: ACW420/2/0

Date: January 2012

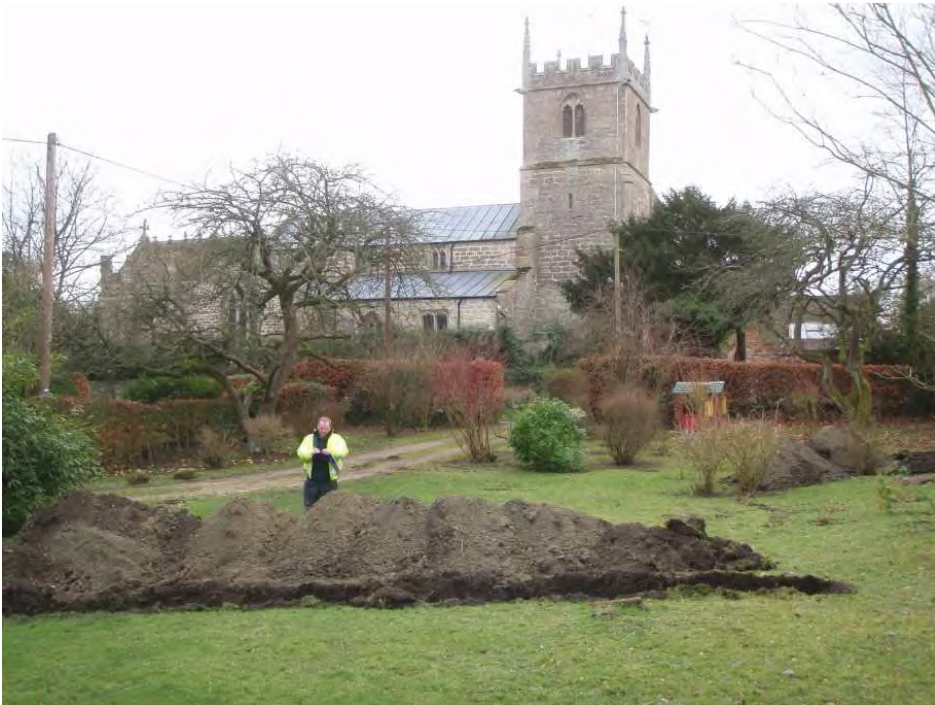
Plate 1: View of site from the north

- 1.3** The proposed application area covers approximately an area of 300m² and comprises an area of garden, formerly part of an orchard and adjacent to the existing property named Hardston (Plate 1). The topography comprises ground sloping down gently to the east and lies at around 116m OD. The underlying solid geology comprises Upper Greensand.

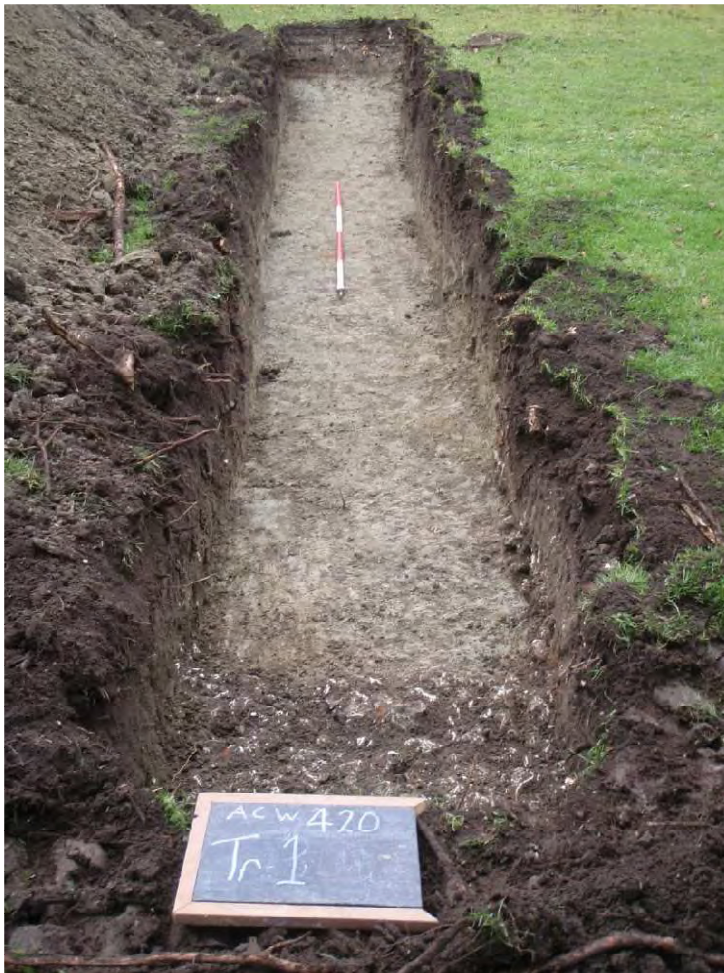
Plate 2: Trench 1. View from the east

5.2 The trench was excavated to a maximum depth of 400mm through topsoil and subsoil overlying natural Upper Greensand. Part of a post-medieval deposit, undetermined in nature, was revealed at the east end of the trench. A deposit of buried material of 20th century origin was revealed at the far west extent of the trench. Both these deposits are described below with the recorded layer sequence summarised in Table 1.

5.3 This deposit was present below subsoil (101) and overlying natural greensand (104). It was only partly revealed in plan and situated at the east extent of the trench, continuing beyond the trench limits both to the north-west and south-east. Where exposed, it had plan dimensions of 2.2 x 1.2m, with a maximum thickness of 200mm. It comprised a rubble layer of predominantly chalk pieces up to 200mm in size, with occasional greensand pieces and flint nodules, within a dark, greenish brown, sandy clay. A small quantity of ceramic building material and a single sherd of 19th century pottery were recovered from this deposit.

- 5.4** This deposit was present below topsoil (100). It was only partly revealed in plan and situated at the west extent of the trench, continuing beyond the trench limits to the west. It comprised a dump of relatively modern debris, consisting of numerous metal containers, including cans and a quantity of glass bottles, all of mid 20th century origin.

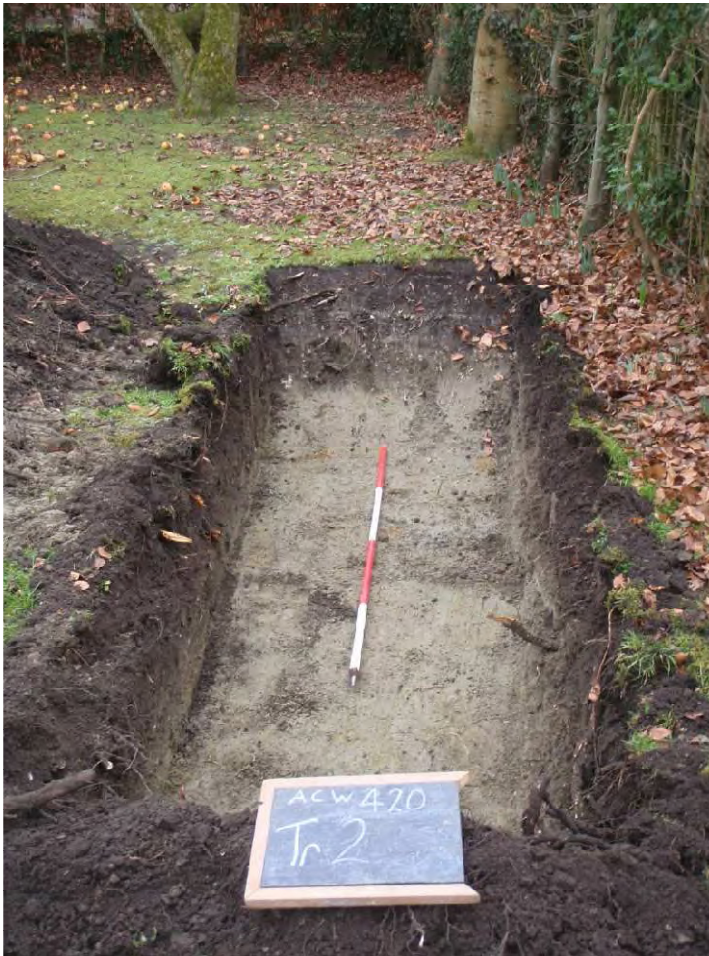
Plate 3: Trench 2. View from the north

- 5.5** The trench was excavated to a maximum depth of 400mm through topsoil and a subsoil horizon before natural Upper Greensand was revealed. No archaeological deposits were present. The recorded layer sequence is summarised in Table 2.
