Lower Wotton Farm, Yeoford, Colebrooke, Devon

Results of historic building recording

Mid Devon District Council planning reference 11/0099/LBC

Document No: ACD366/2/0

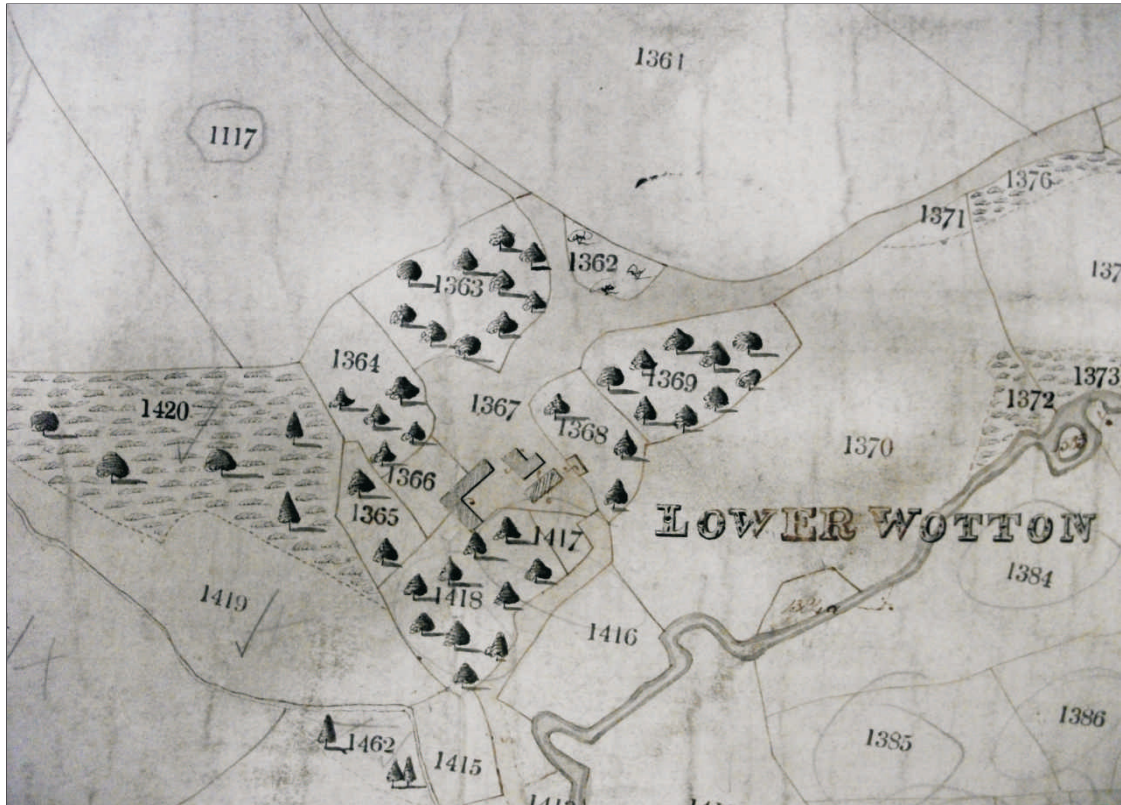
Fig. 2: Historic maps

Extract from the 1845 Colebrook tithe map

Extract from the Ordnance Survey 25" map sheet. 66.1, surveyed 1888, published 1889

- 2.3** The historic nature of the farm has been noted from the listed building descriptions (above), and this is reflected in the historic mapping (Fig. 2). The 1845 Colebrooke tithe map depicts the farmhouse, with agricultural buildings to the north and west, surrounded by woods and orchards. The accompanying apportionment of the same date records the owner as John Henry Hippisley Esq, with the farm being occupied by John Dart. The 1885 Ordnance Survey (OS) 1:2500 map depicts further agricultural buildings as well as a new horse engine house attached to the north-west corner of the farmyard.

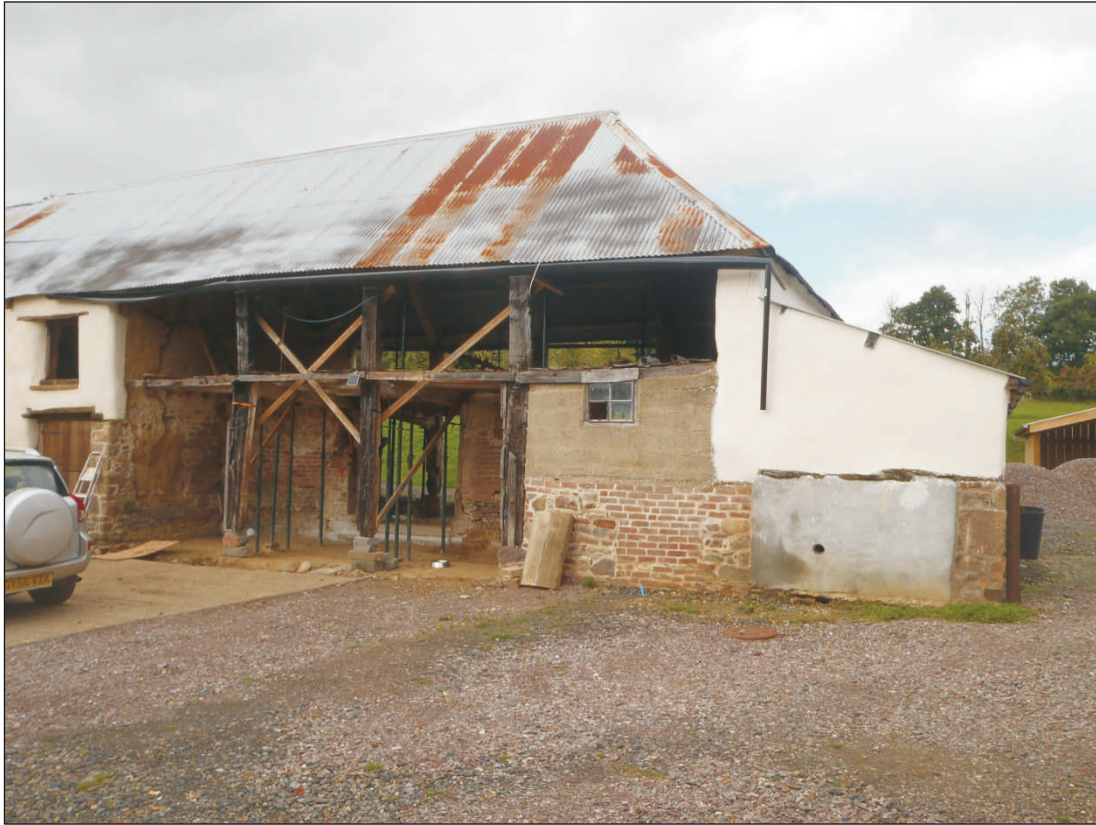
Plate 1: The linhay viewed from the east.

- 5. THE LINHAY (Figs 3-4; Plates 1-6)**
- 5.1** The linhay is an addition to the farmyard, and adjoins an earlier byre. It measures 10.3m by 4.5m, and is divided into four bays by timber posts. A piggery has been added to its north-east elevation (see section 5.6 below). The building has an usual design, being double fronted with open elevations facing both the farmyard to the south and an access track to the north (Plates 1-2). The ground-floor stalls are divided by an axial yellow cob wall laid on a stone footing; the tallet above is fully open. A wide opening has been inserted into one of the central bays. Here the cob has been refaced with bricks, and two large timbers inserted as a doorframe that also support the first-floor beams (Plate 3). Both timbers have four sockets on their inside faces and two sockets on their south faces. These may relate to an earlier use, although it is possible that the sockets facing the doorway could have held wooden bars blocking the opening. Tethering chains are attached to the posts, as is a wooden bar, probably associated with a door latch. Elsewhere, the cob has been partially refaced using red bricks that abut the earlier bricks of the inserted opening. The 20th-century concrete floor had been removed from the barn, and no evidence for earlier stone or cobbled surfaces was visible.

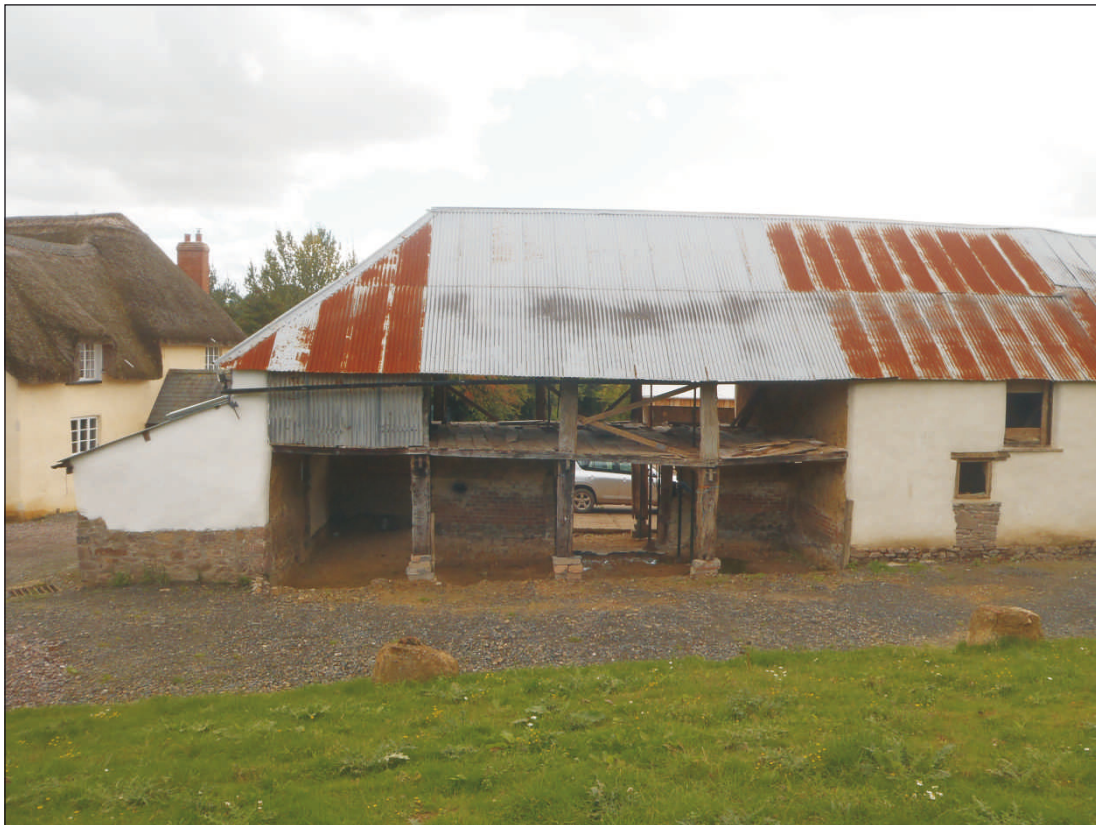
Plate 2: The linhay viewed from the northwest.

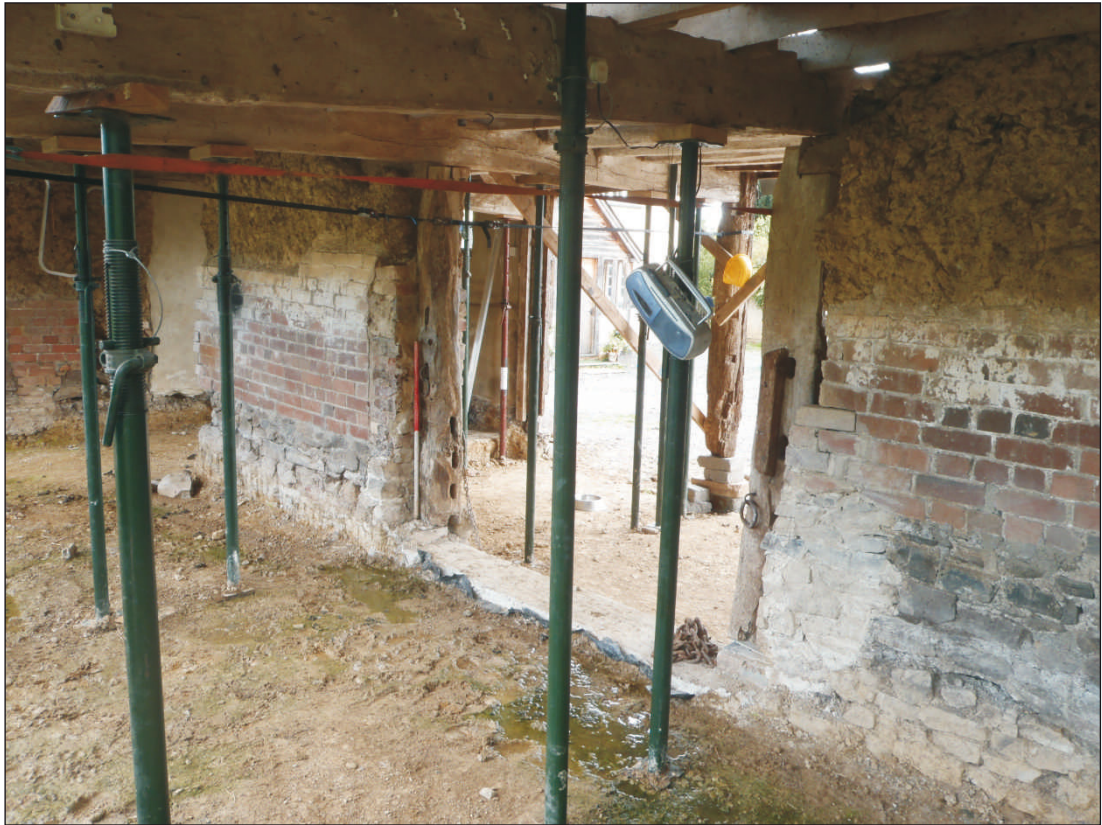
Plate 3: The inserted opening in the spine wall, viewed from the east.

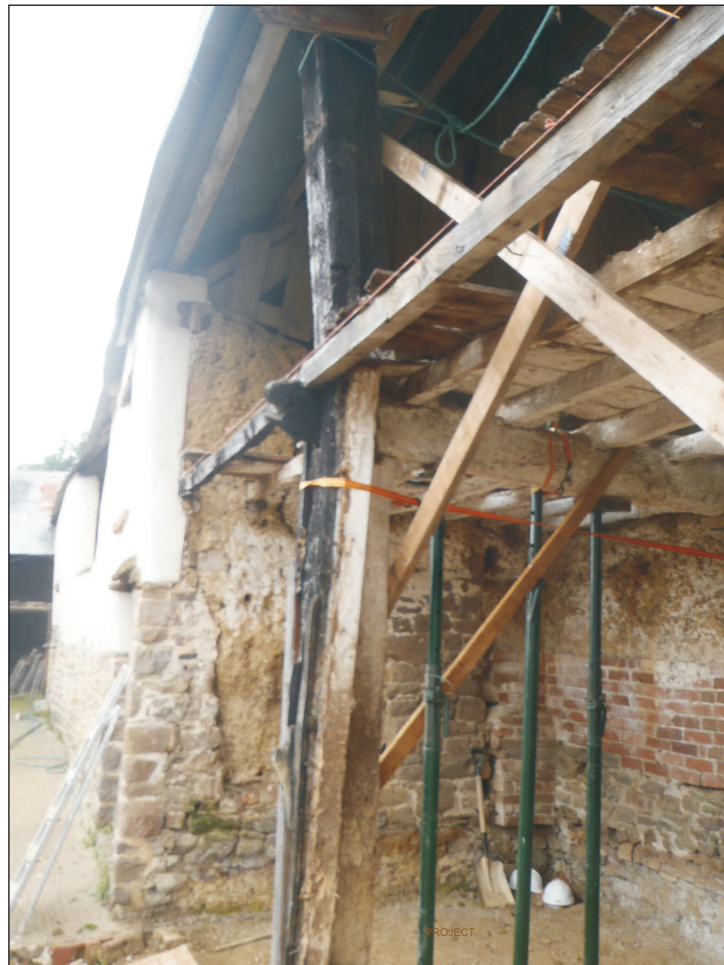
One of these timbers is of massive scantling, and has mortices for other timbers in three of its sides [Type **A**]. The fourth side of the timber has been carved into a deep, shallow cove, which may well have formed the face of a jetty bressumer overlooking an open hall. The opposite side of this timber contains a row of regularly spaced, pegged mortices, which clearly represent the sockets for first-floor joists forming a storeyed end to the hall. The 'underside' of the timber contains sockets compatible with a stud-and-panel screen or partition containing at least one doorway, and the 'upper' side has sockets suitable for vertical studs forming the wall of the first-floor chamber overlooking the hall. Unfortunately it was not possible to establish whether the timbers were smoke-blackened, and the existence of a central hearth in association with this structure remains conjectural.

Plate 4: The Type A post in the south-east elevation, viewed from the northeast.

- 5.3** The roof and first-floor beams are supported on rows of three vertical posts, five of which are reused. Three types of timbers are present. Type A is a jetty bressumer and has been previously been recorded by Parker (section 2.4 above). Type B posts are beams from a first-floor structure (Plate 5) and have also been noted by Parker (section 2.4 above). Three of these beams were noted in the linhay. Type C is a plain rectangular timber with series of widely-spaced stave holes (presumably for a wattle and daub partition) in one side. It may have formed the head or cill of a screen.

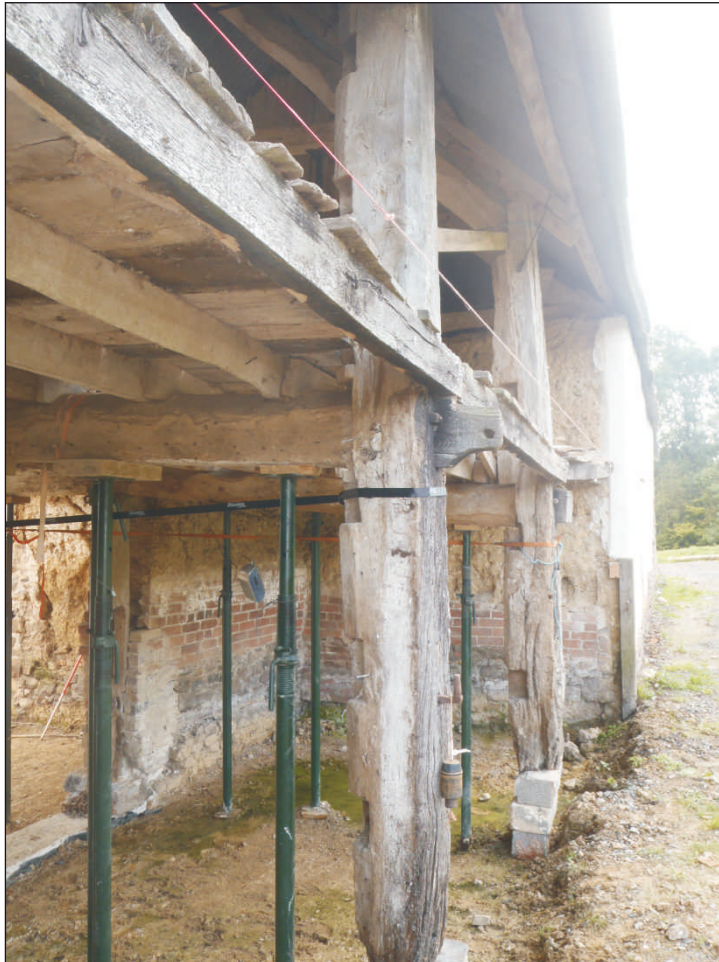
- 5.4** The first floor – consisting of wide wooden planks – is supported on a substantial timber superstructure. Large beams set into the central cob wall are attached to the vertical posts by long tongues fixed using single wooden pegs (Plate 5). The undersides of some of the tongues are curved. These beams support floor joists that overlap on top of the beams. Further joists have been laid outside the posts on top of the tongues. The first floor is almost entirely open on the long axis allowing access for storage from both sides. One bay has been infilled using corrugated iron sheets.

Plate 5: Type B posts in the north-west elevation, also showing pegged tongue on the first-floor beam. View from the northeast.

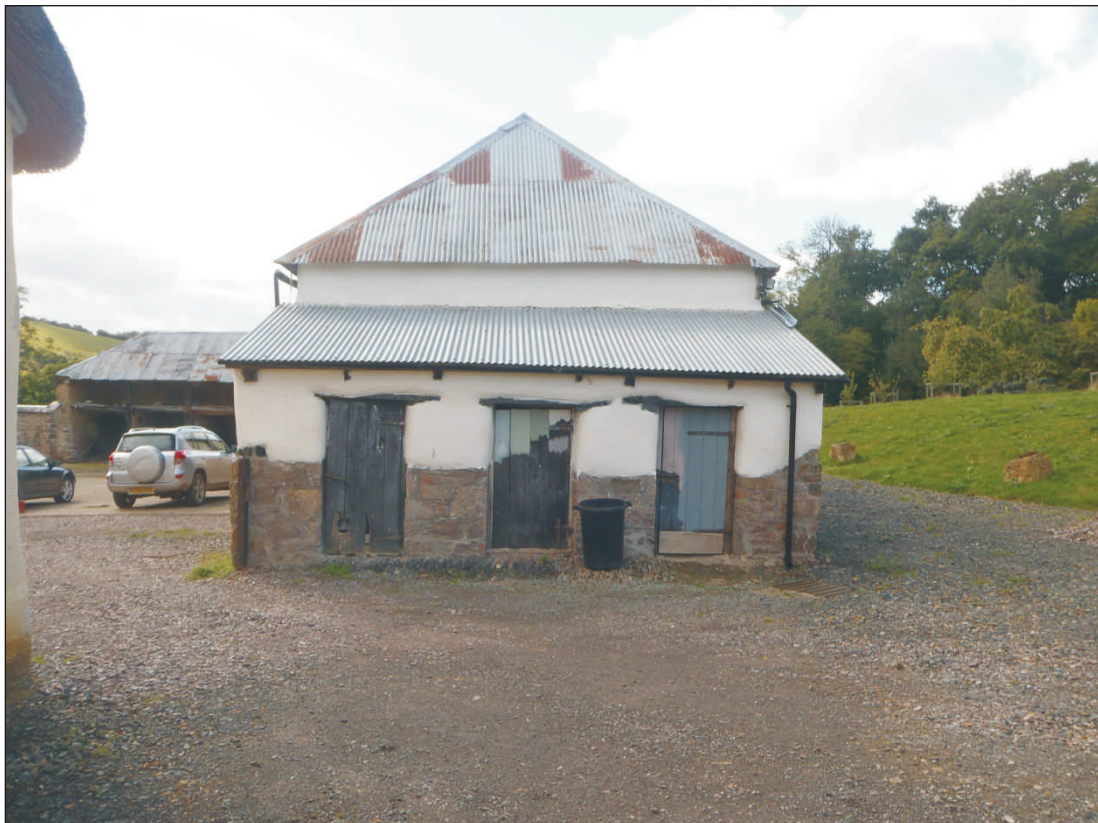
- 5.6** The piggery is a single-storey addition with a pitched roof (Plate 6). It is largely covered by modern plaster, but large rubble stonework, along with a cill beam on the south elevation, is visible below. This beam also appears to have been reused since what appear to be sockets are filled with plaster. Although the building is shown on the 1905 OS 1:2500 map and is probably also depicted on the 1888 OS map, the character of the masonry, in conjunction with the fresh state of the plaster above, probably indicates the building has been restored in the recent past. The east elevation incorporates three plank doors, each with different strap hinges. Against this wall an early surface of pitched rectangular slate cobbles survives. This building has a modern corrugated iron sheet roof.

Plate 6: The piggy viewed from the northeast.
