Lynmouth Pavilion, Lynton and Lynmouth, Devon

## Results of Historic Building Recording

Exmoor National Park Authority planning reference 62/41/11/035

Document No: ACD423/1/0

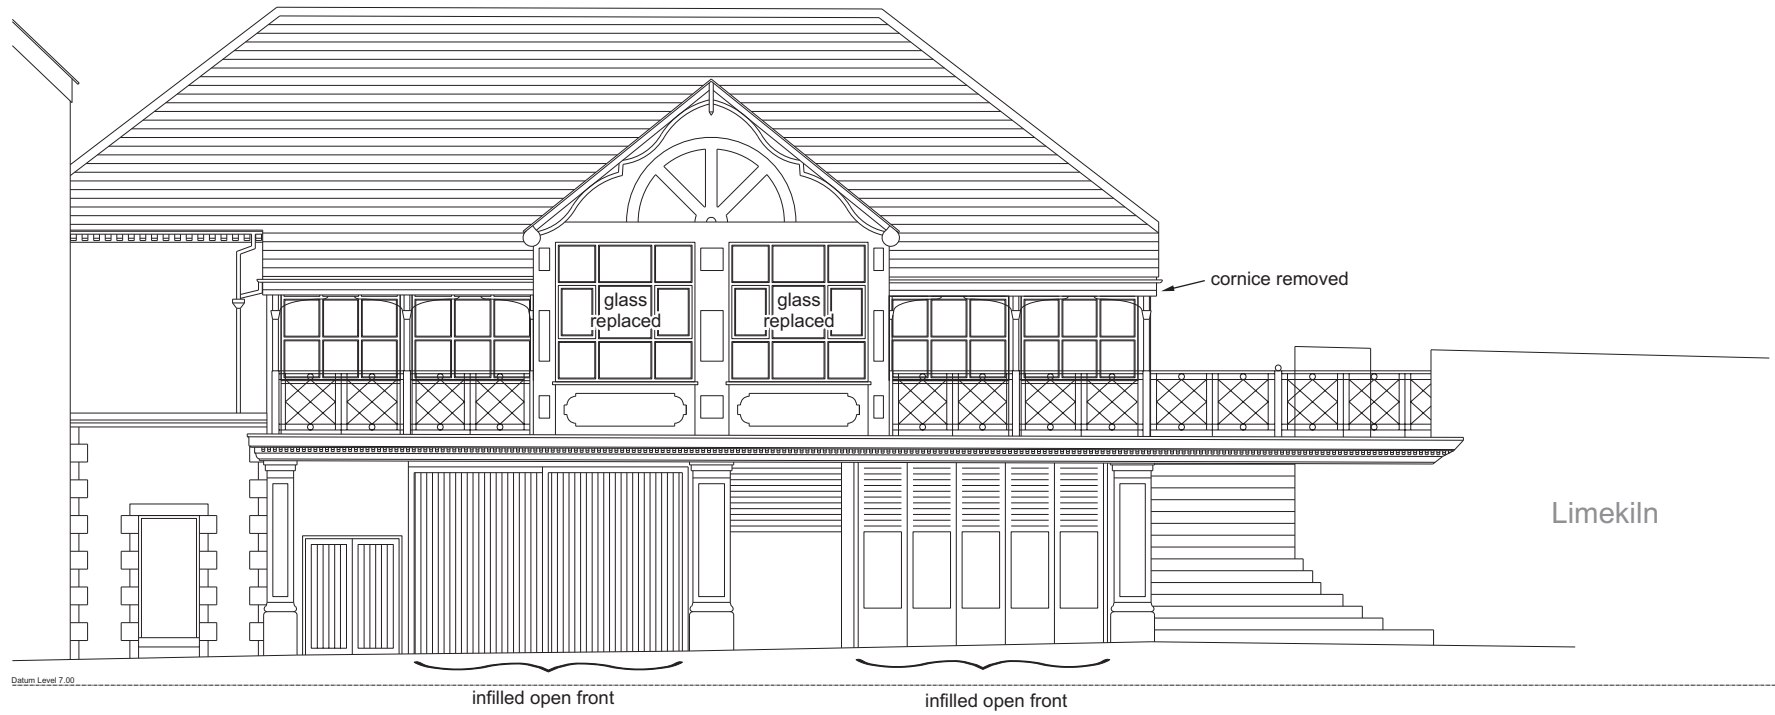
TITLE  
Fig. 4: The (north) front elevation  
(based on RGP Architects Ltd  
drawing No. 10055/S1a)

NORTH ELEVATION

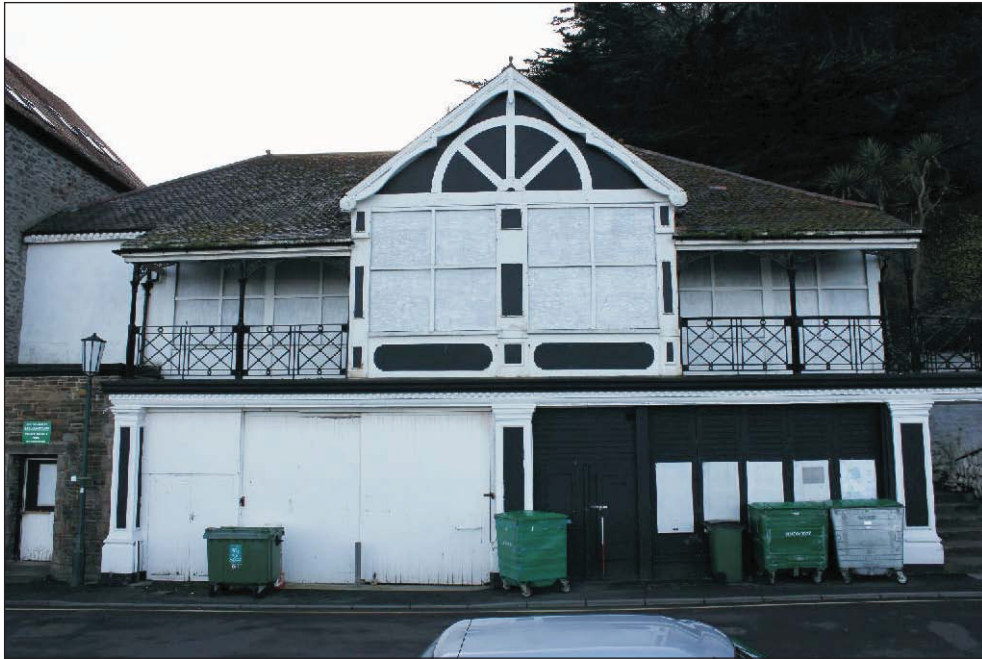
The building is two storeyed, with the ground floor entered from the Esplanade (Plate 1), and the first floor from a small rear yard. The latter was originally accessed via a sloped path between the pavilion and limekilns that has since been replaced with steps. A number of different building materials were utilised during the building's construction. Much of the fabric is currently visible, although there is photographic and archaeological evidence that all of the walls were originally rendered.

Plate 1: The front elevation, viewed from the north. 1m scale.

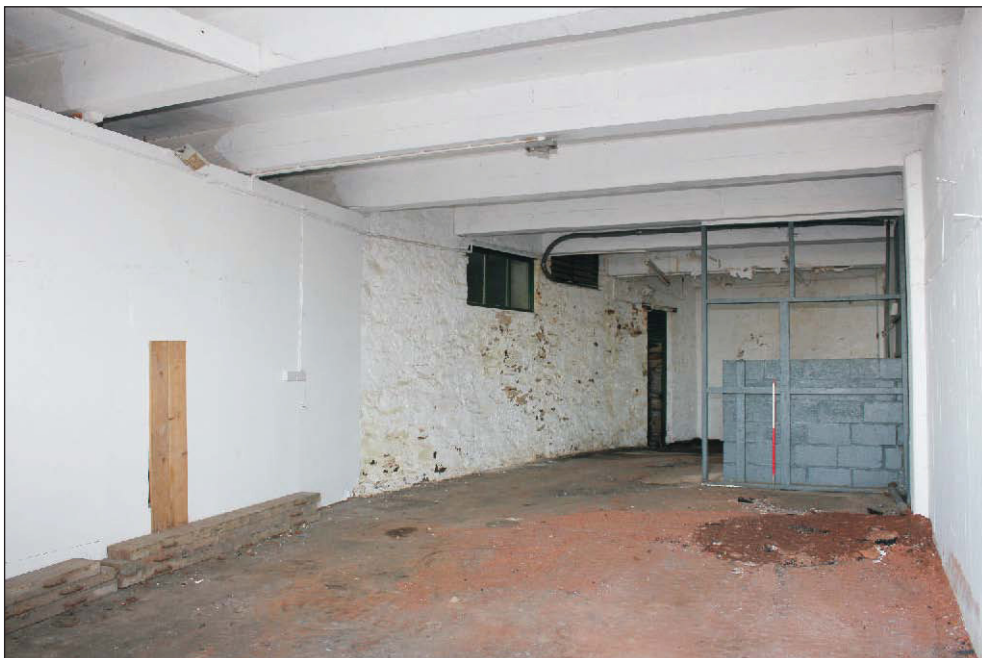
Plate 4: The ground-floor east room, viewed from the south. 1m scale.

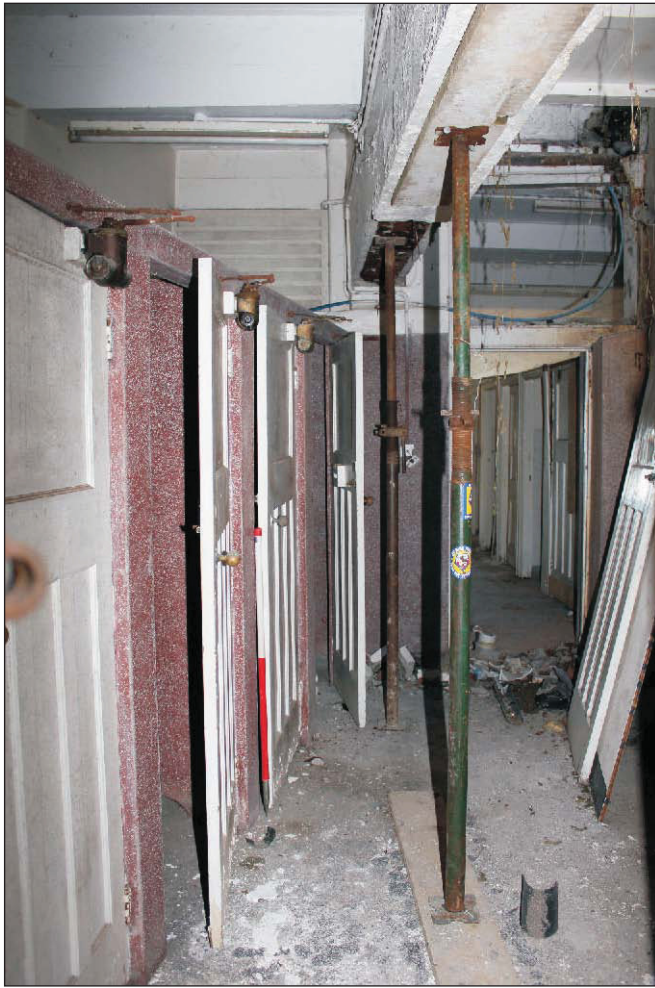
The entrance door leads into what was a small lobby that has lost its internal door. Beyond is a corridor and six cubicles. Four of the doors are 4-panelled, whilst the southern two have 3 lower panels with a large panel above. The former are set within thin moulded architraves. These open outwards rather than inwards. Attached to each of the doors are signs 'PLEASE BOLT THE DOOR', as well as associated bolts. Each cubicle is tiled to 2/3rds of the partition height, and most retain the pan and cistern. Other walls of the toilets have a waterproof covering with paint above. The floor is concrete.

At the end of the corridor is a further doorway with a slatted wooden vent above. Both the door and the slats have been removed. Beyond the doorway are a further six cubicles with the 3 and 1 panelled, doors that open outwards. Fittings in this area include four sinks and a hand-dryer; mirrors were formerly positioned above the sinks but have been removed. At the end of the toilets is a small store containing shelves. The roof of this part of the toilets is double pitched inwards towards a central gutter and downpipe, and is partially finished with plastic corrugated sheeting laid on a wooden frame. This may replace an earlier, lower flat roof.

Plate 5:  
The ground-floor ladies' toilets showing  
the rear area viewed from the south.  
1m scale.

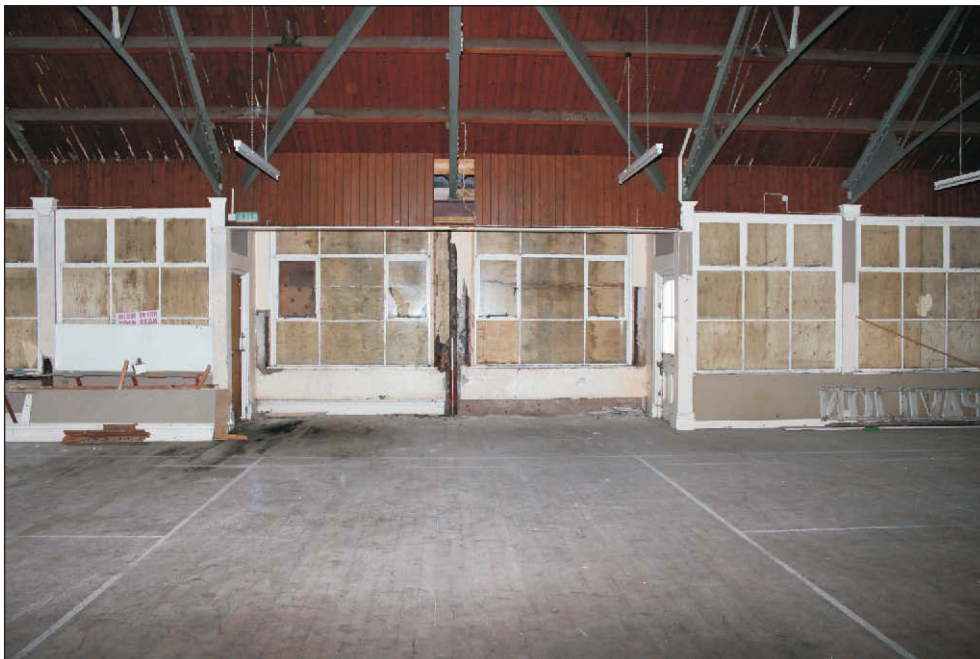
Plate 6: The first floor showing the replacement glazing in the north elevation,  
viewed from the south. 1m scale.

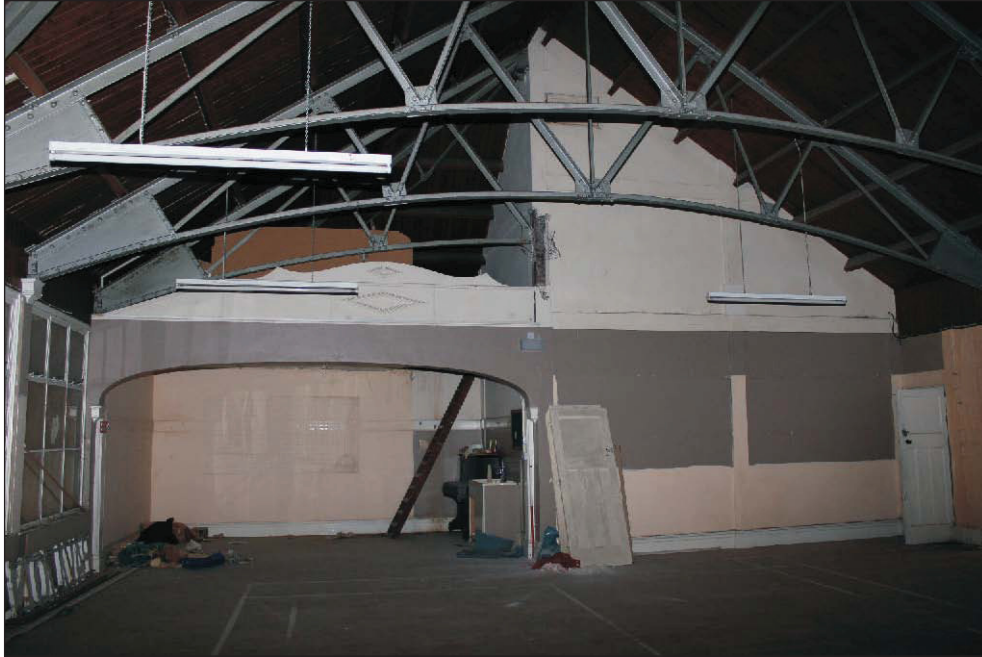
Plate 7: The first floor showing the store area and lighting box at the east end, viewed from the west. 1m scale.

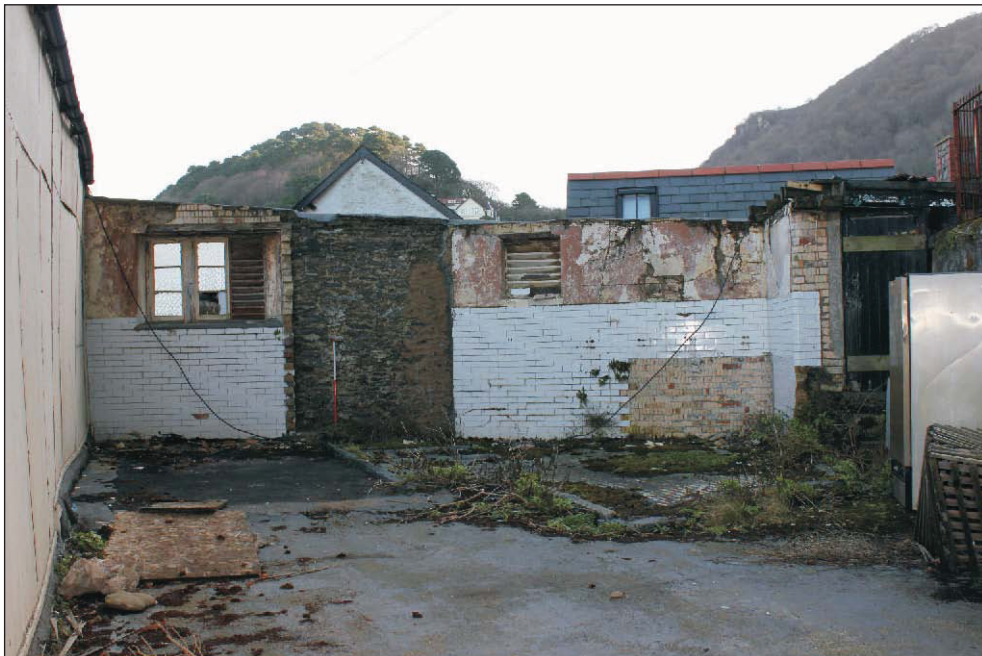
To the south of the theatre was a stage and men's toilets. These have been demolished, although the east elevation and part of the south elevation survive (Plate 8). The latter forms a revetment for an adjacent path and is rendered, with post-demolition concrete capping. The east elevation incorporates an area of pre-pavilion stone masonry that is abutted by yellow brick walls. The lower two-thirds are faced with white-glazed pale red bricks, whilst the upper third is plastered and painted white. The brick walls incorporate slatted vents and a window. Within the toilets the bases of four cubicles and the urinal are visible, as is the black and white tiled floor. To the rear of the toilets are steps up to a small store. The stage has a concrete floor, and this along with the stubs of the toilet walls are covered in a post-demolition asphalt. The position of the west wall of this stage is defined by a slight change in floor level and the end of a modillion cornice above the first-floor entrance. The angle of the top of the east wall indicates the roof over the toilets and stage sloped slightly downwards.

Plate 8: The former men's toilets and stage, viewed from the west. 1m scale.

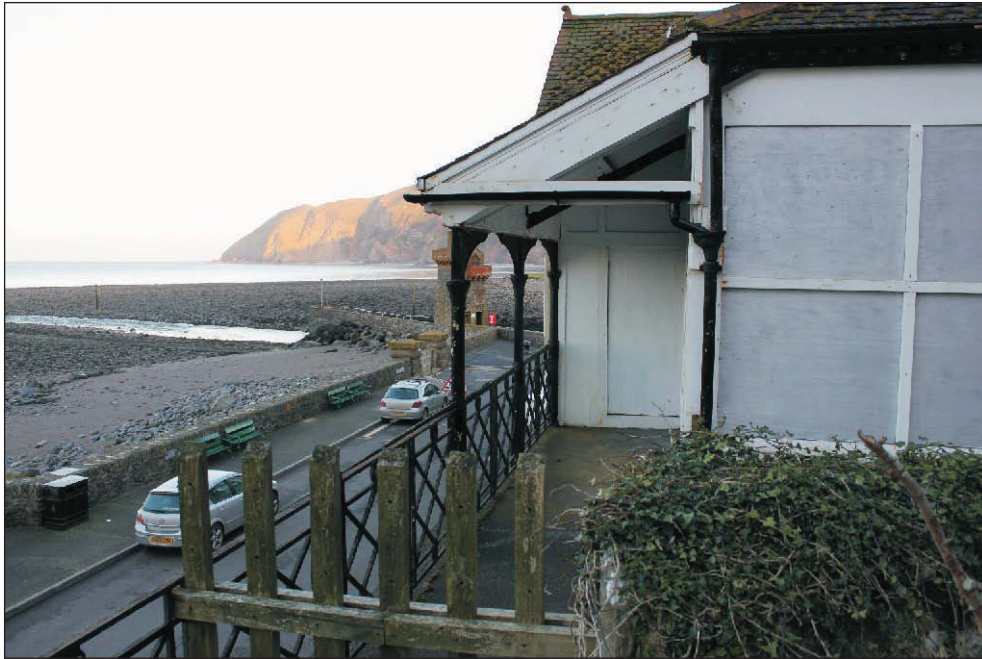
The front terraces have a pitched tile roof supported on cast-iron columns with curved brackets, all fixed using bolts (Plate 9). Between the posts are railings that also extend across both sides of the west terrace to the limekiln. These have a pattern of diagonal bars, and horizontal bars set between circular spacers. A wooden handrail partially survives on the front railings.

Plate 9: The western balcony, viewed from the west.

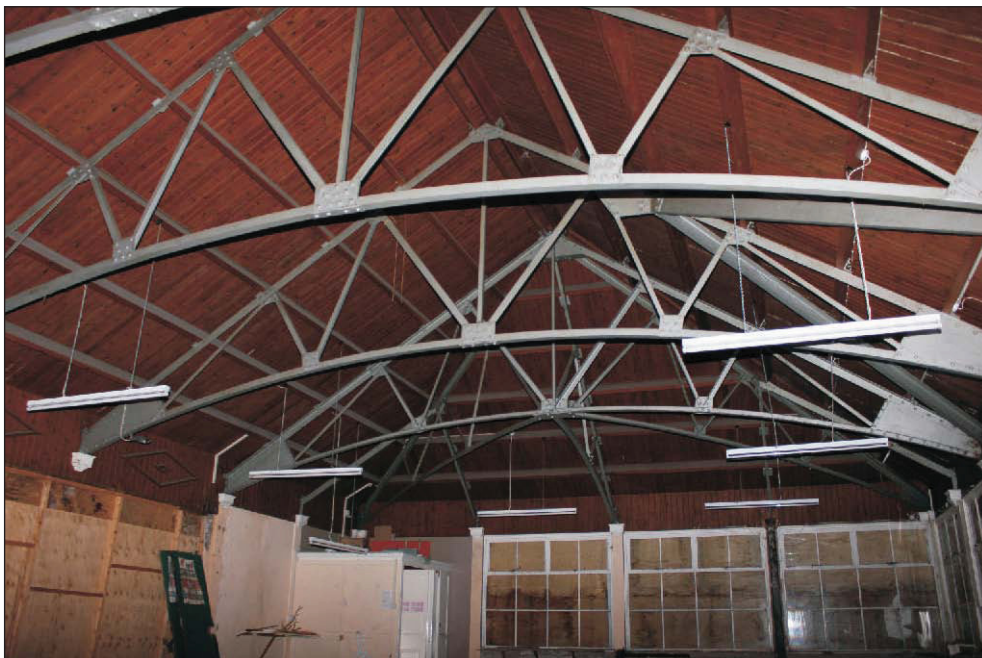
The roof is supported on four-and-a-half trusses. The half truss is over the lighting box, with the adjacent wall having a straight gable. The west end of the roof is hipped, as is the section of the front pitch over lighting box. The trusses are steel frames, formed from L-plates and fixed using bolts. The lower ties are curved and attached to the rafters by diagonal struts. The trusses support thick wooden purlins that are attached using brackets. The inside of the roof is lined with dark brown stained tongue-and-grooved boards. The roof is covered in red tiles with ceramic ridge tiles and finials. At eaves level there is a modillion cornice along the rear elevation above the first-floor door that continues along the west elevation. This was originally painted white and black, but has been repainted in black all over. There is a further length of modillion cornice on the east end of the front elevation above the ladies' toilets. A photograph of the opening ceremony, and a 1983 photograph, shows a further black-and-white painted cornice around the sides of the west terrace (Green 2011, Figs 8 and 10). This has been removed and replaced with plain fascia boards.

Plate 10: The roof trusses, viewed from the east.
