Underground Passages, Exeter

Results of an archaeological evaluation

Underground Passages (Devon 182: National Heritage List 1003851)

Document No: ACD470/2/0

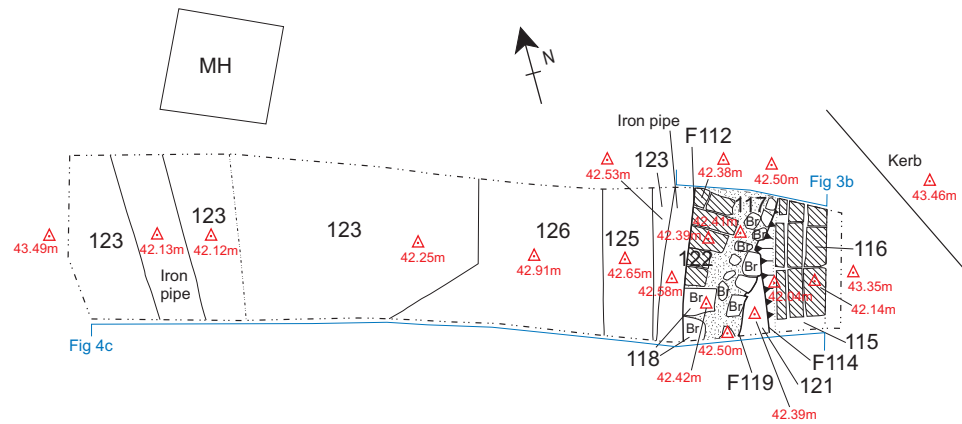
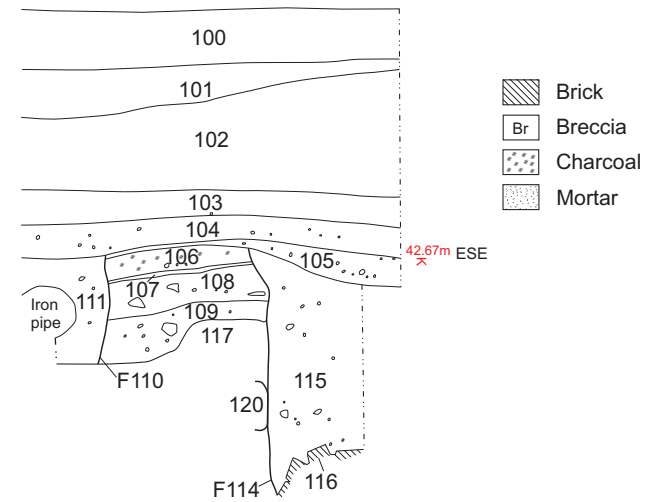
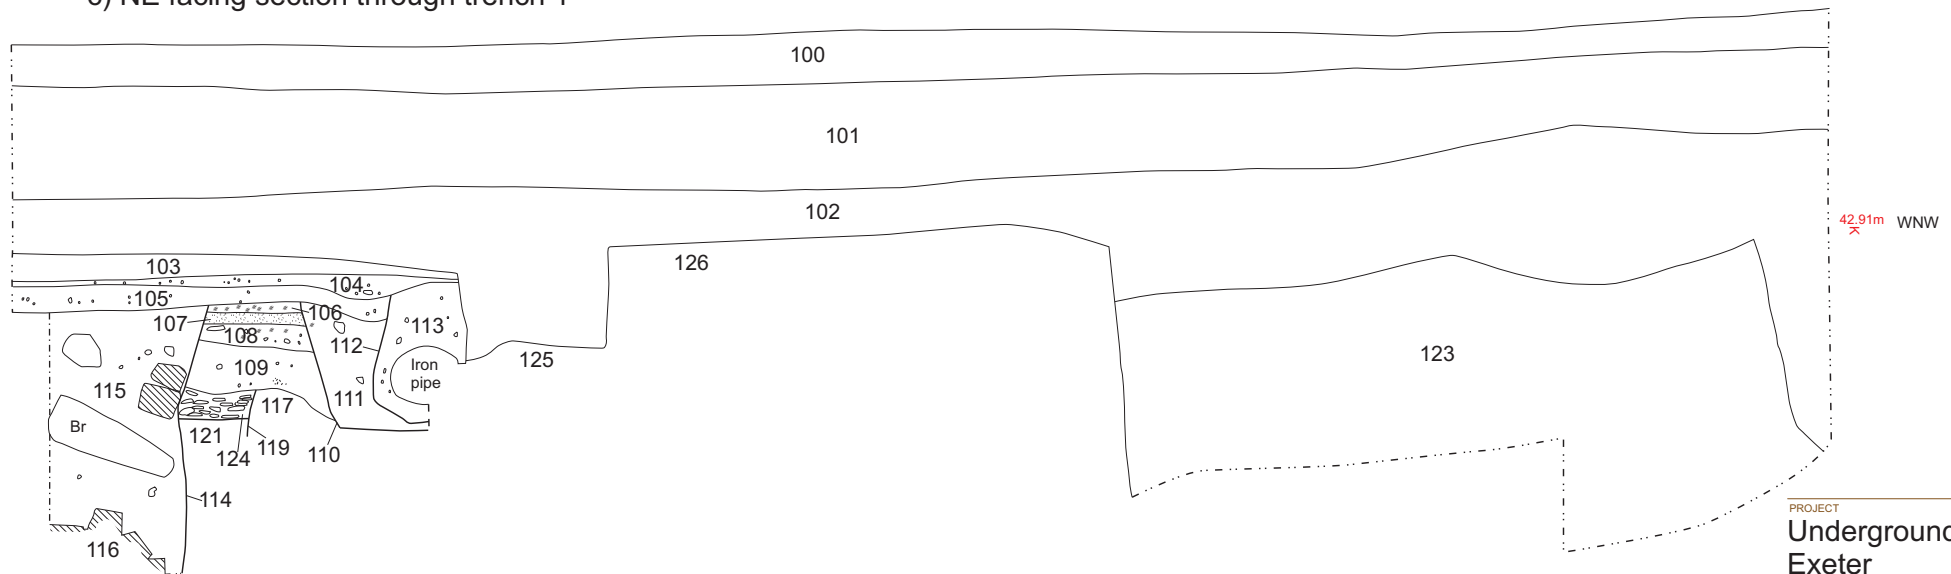
PROJECT
Underground Passages,
Exeter
TITLE
Fig. 3: Plan and sections

a) Plan or trench 1

b) SW facing Section

c) NE facing section through trench 1

A trench was excavated with the aim of precisely locating and exposing the tops of both Passages. The trench measured 5.1m long by 1m wide and was aligned WNW to ESE (Plate 1). Natural subsoil (121), which comprised a mid red sandy-clay, was exposed towards the ESE end of the trench at a depth of 0.99m below current road level.

Cutting through 124 was the probable southeast edge of the construction trench for the Cathedral Passage (F119). Only a short undisturbed length of the construction cut was present within the evaluation trench due to later truncation (by F114). However, within the feature a small section of vertical breccia masonry (120) that comprised part of a single block was exposed (Plate 3), which possibly formed part of the side wall of the passage. Overlying 120 was a build of mixed trap, breccia and limestone rubble, bonded with a lime mortar (117) that extended along the top of the feature (Plates 4 and 5). This mortared deposit also bonded two partially exposed flat, horizontal breccia blocks (118) that may have formed capstones to the passage. To the northeast of stone blocks 118, the capping continued but was formed by a series of unfrogged hand-moulded bricks (122) that each measured 0.11m wide. These were only partially exposed, and it was not possible to demonstrate if these bricks were inserted into rubble and mortar deposit 117 or if they were contemporary. However, a well-worn fragment of brick or tile was recovered from 117, which probably indicates the two are part of the same contemporary fabric.

To the ESE of this sequence layer, 106 was cut by a steep to vertically sided trench (F114) for a brick-lined culvert (116). The culvert was constructed of unfrosted hand-moulded bricks that measured approximately 0.29m long, 0.11m wide and 0.07m deep and were laid in stretcher bond. The construction trench was backfilled with a light brownish-red sandy-clay (115) that contained brick fragments, sub-rounded to sub-angular gravel and stone inclusions, a single roughly faced breccia block, as well as a fragment of faunal bone, a sherd of blue transfer-printed industrial china, two sherds of plain industrial china, and a sherd of South Somerset pottery.

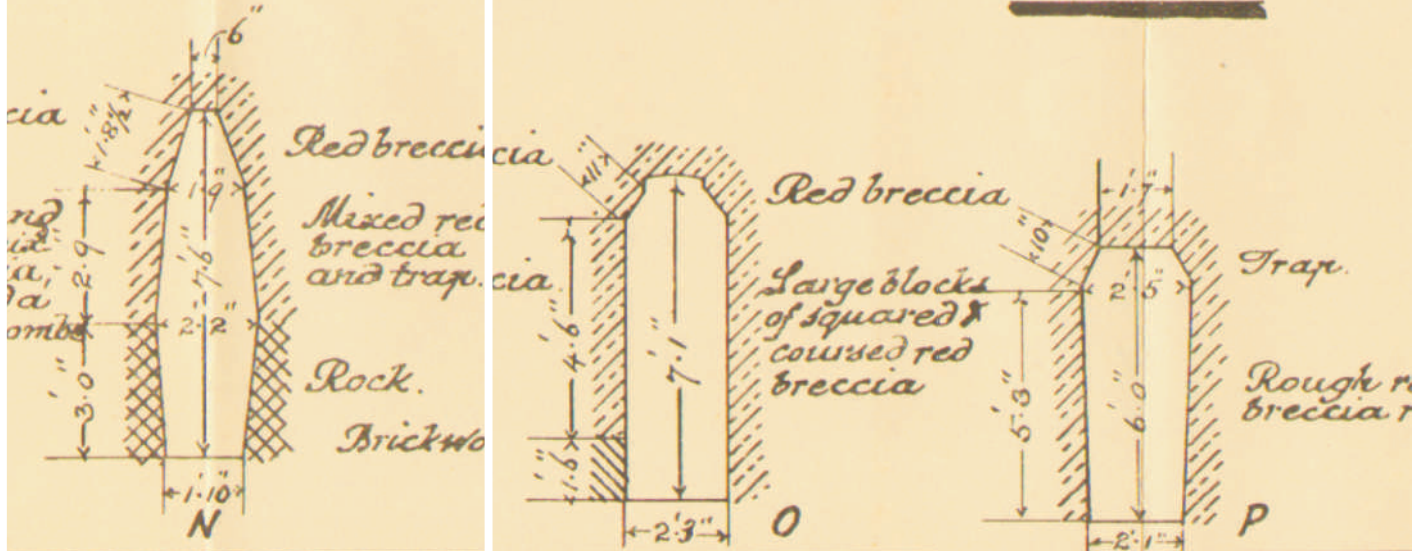
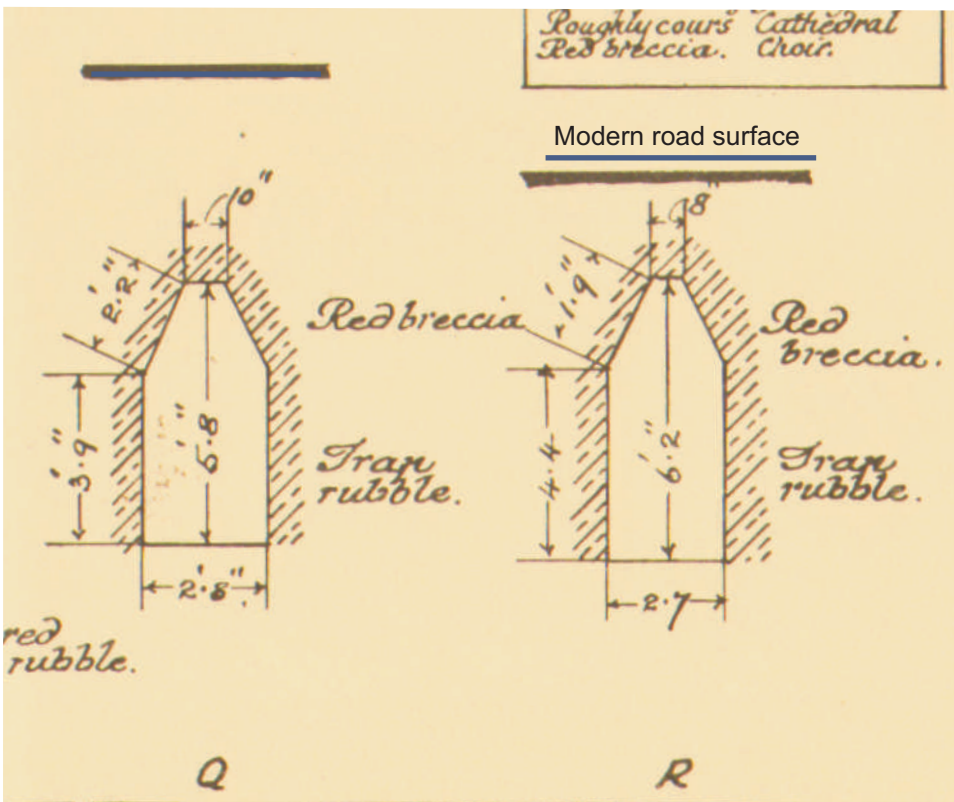
TITLE
Fig. 5: 1932 Sections of the underground passages

Modern road surface

1932 road surface

Datum line
39.624m above O.D.

excavation (i.e. if the trench had been extended, the passage would have been encountered under the central pedestrian crossing island. Profiles drawn during the 1930s survey (reproduced here as Fig. 5) indicate that at the junction of Longbrook Street and New North Road the northern end of the City Passage was constructed at a lower depth than the Cathedral Passage. Comparison of the 1930s survey information against current road levels and data from the trench over the Cathedral Passage indicates that the top of the passage would be encountered (at points N, O and P) between approximately 1.5m and 1.70m below the present road surface at 42.37 and 41.92m aOD.

In summary, the top of the Cathedral Passage was exposed during the evaluation, at a depth of 0.82m below the surface (42.38m aOD). The City Passage was not exposed since it is located to the west of the trench. Comparison with the 1930s profile drawings and the present street level indicates that the top of the City Passage would be encountered between approximately 1.5m and 1.70m below the present road surface at 42.37 and 41.92m aOD. At these depths it is unlikely that alterations to the paving and the excavation of tree pits will impact on the medieval and later fabric of the City Passage. However, in contrast, the relatively shallow depth (at 0.83m below the present road surface) of the roof of the Cathedral Passage means that it could be disturbed by the uncontrolled growth of roots, if the tree(s) were to be sited too close or be planted without appropriate root barriers.

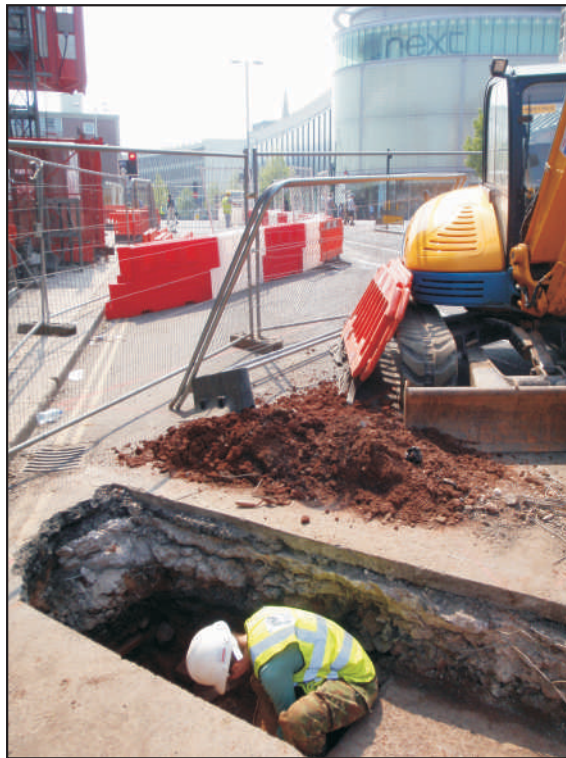
Plate 1: Working shot of site, viewed from the WNW.

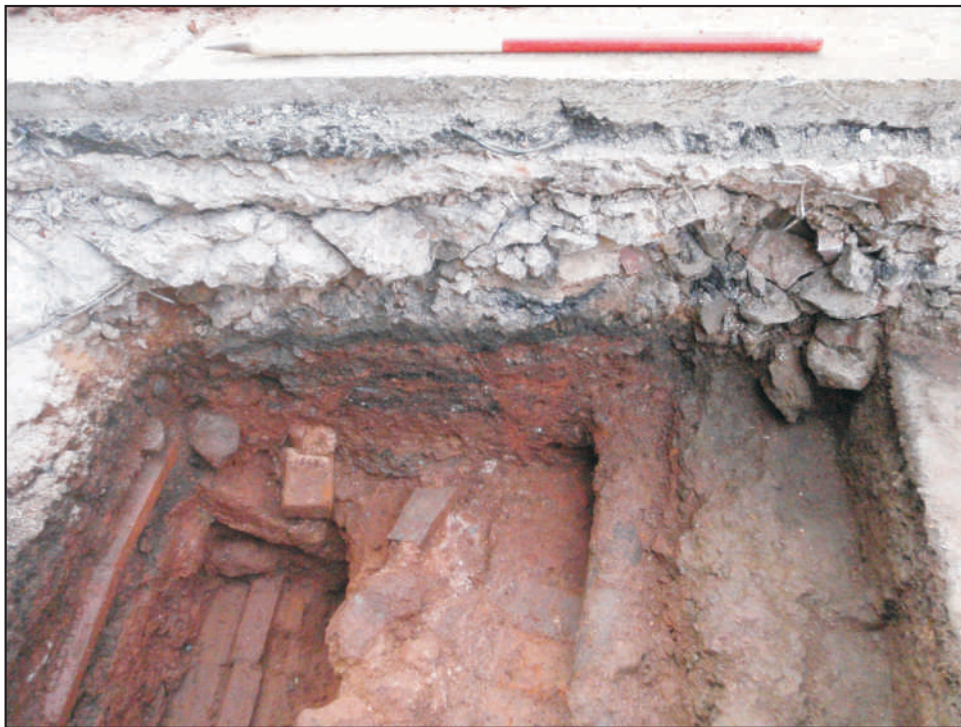
Plate 2: NNE-facing section of Trench 1, viewed from the NNE. 1m scale.

Overlying the natural subsoil was a layer of mixed mid reddish-grey silty-clay (124) that contained abundant inclusions of slate fragments (Plate 2).

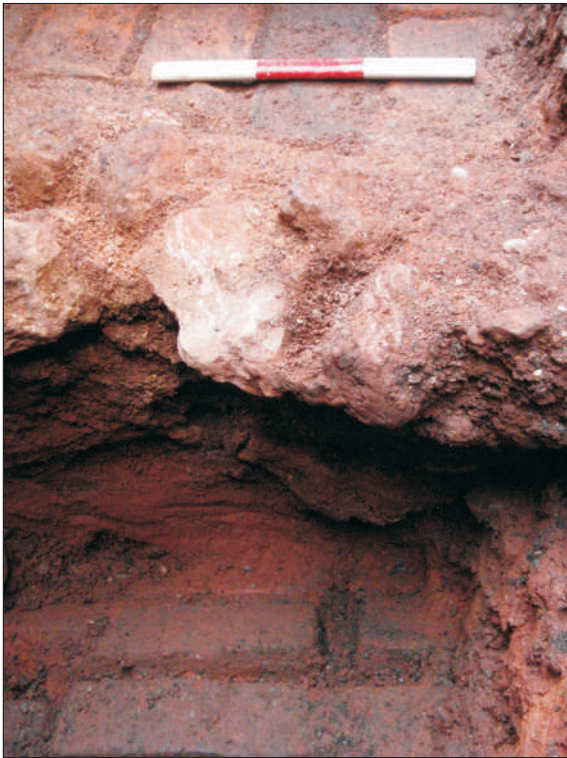
Plate 3: A close-up view of 117 showing 120 below, viewed from the ESE. 0.30m scale.

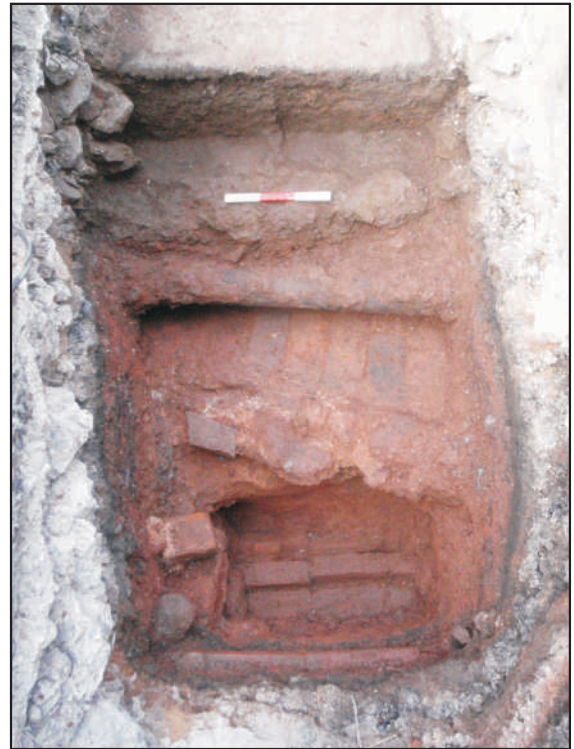
Plate 4: Plan view of the east end of Trench 1, viewed from the ESE. 0.30m scale.

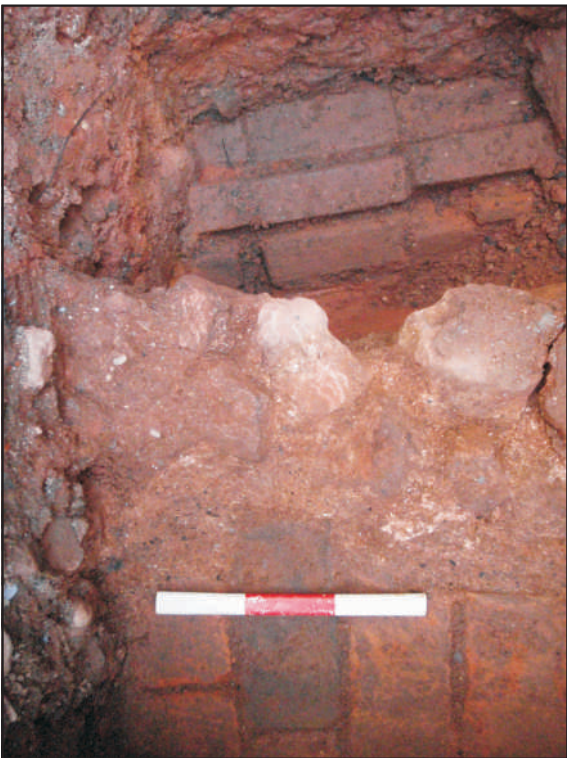
Plate 5: A close-up plan view of 122, 117 and 116, viewed from the WNW. 0.30m scale.

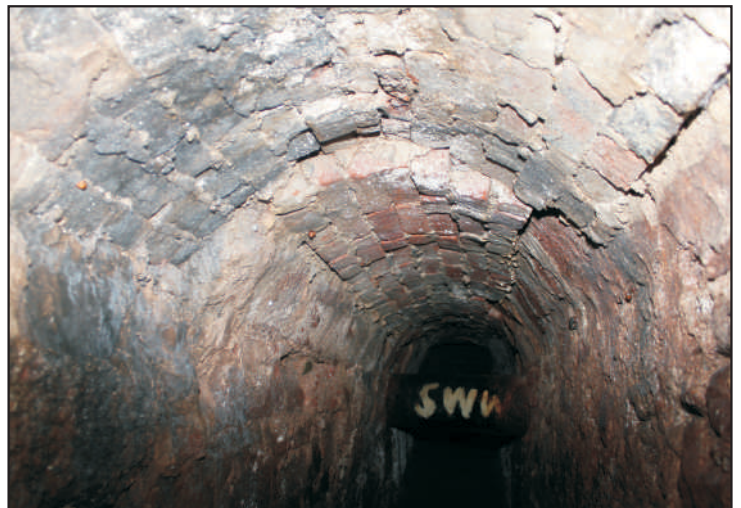
On completion of the evaluation the interior of the Cathedral Passage was inspected to investigate whether capping 117, 118 and 122 represent a repair. The capping of the entire north end of the passage has been replaced in brick. Two distinct repairs were noted (Plate 6).

For a distance of 5.75m from the south edge of the manhole the original capping has been replaced with a shallow arch of dark red coarse, sandy machine-made standard bricks bonded in buff hard cement. To the south (under the evaluation trench), the next 8m of capping had also been replaced using the same materials. The lowest course of the side walls had been removed to accommodate the arch, which was slightly taller than that to the north and had a semi-circular profile. Thinner, hand-made bricks had been utilised for the row of keystones.

Plate 6: Brick repairs to the capping of the Cathedral Passage showing build below evaluation trench in the foreground and lower repair beyond. View to the NE
