Nos 69-73 Sidwell Street, Exeter

Results of an archaeological trench evaluation and historic building recording

Exeter City Council planning permission ref. no. 10/1906/03, condition no. 7

Document No: ACD303/2/1

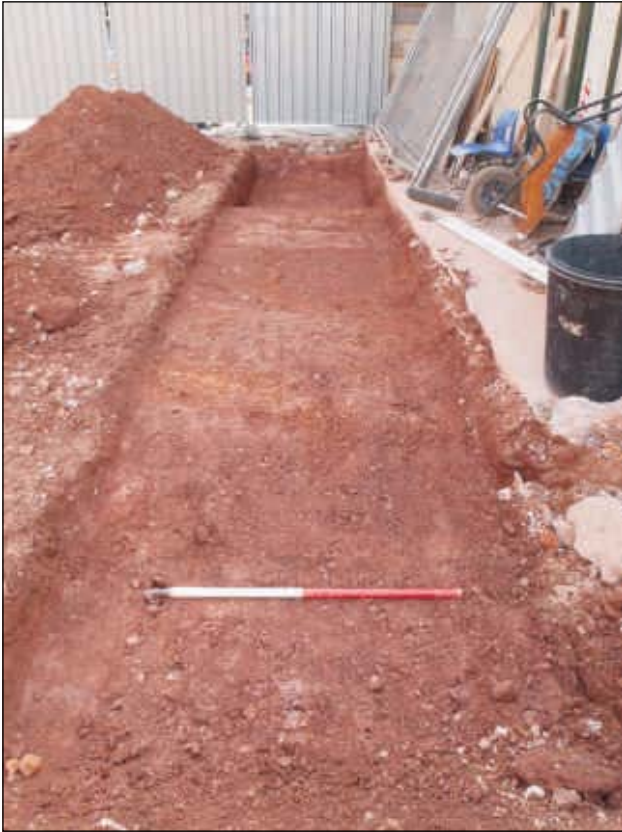
Plate 1: Trench 1, general view looking from the northwest. Scale 1m.

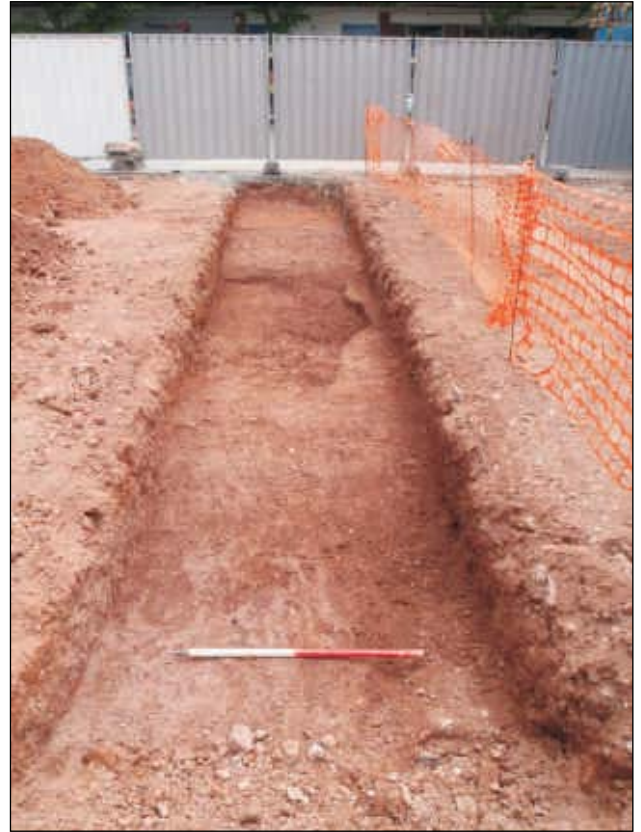
Plate 2: Trench 2, general view looking from the northwest. Scale 1m.

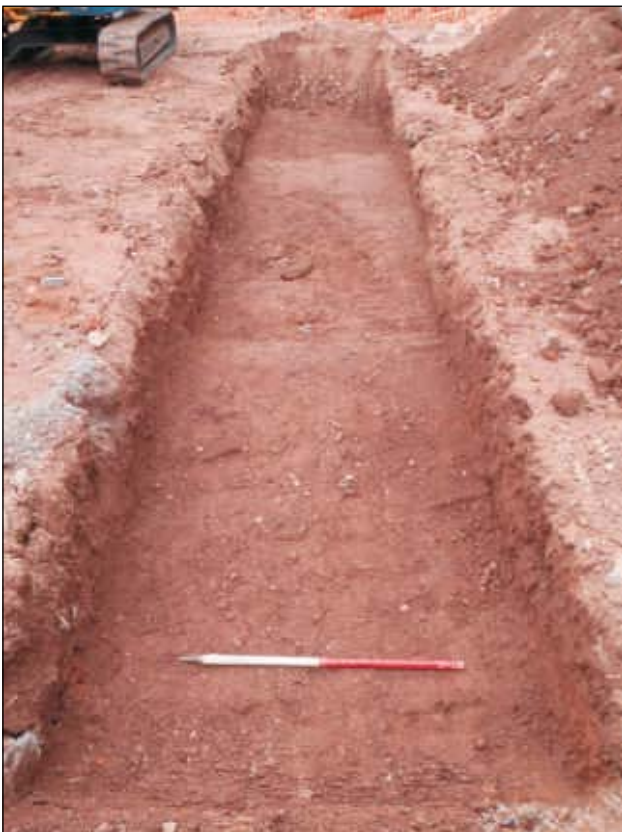
Plate 3: Trench 3, general view looking from the southeast. Scale 1m.

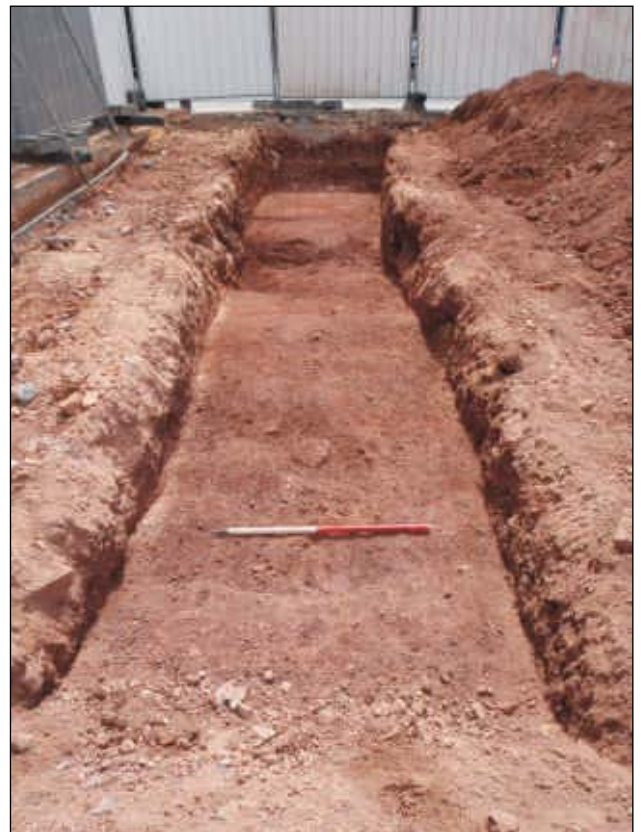
Plate 4: Trench 4, general view looking from the northwest. Scale 1m.

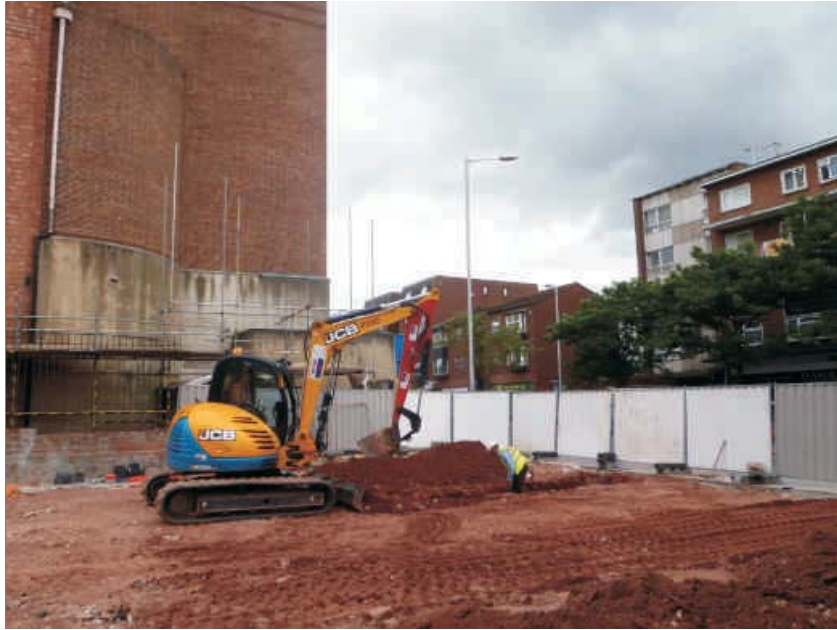
Plate 5: General view of site looking from the west.

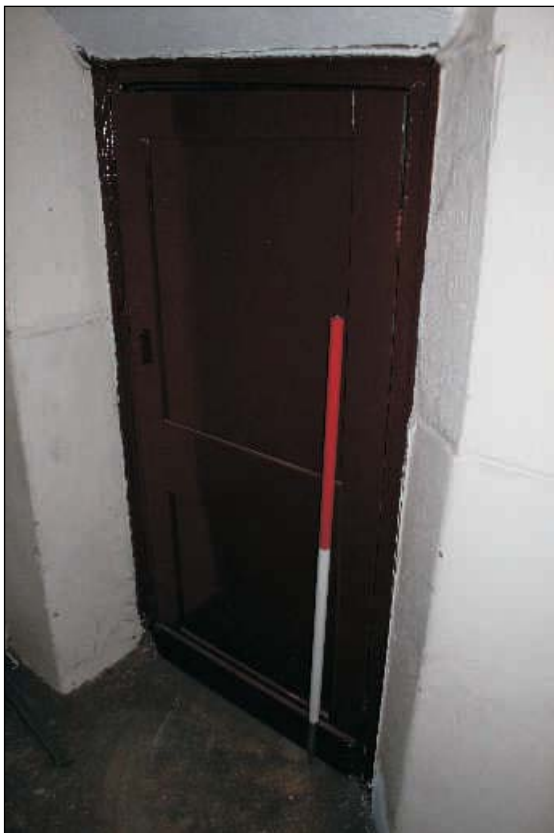
elevation. There is an under-stairs cupboard with a 2-panelled door set within a double ovolo-moulded frame (Plate 6).

Plate 6: Ground-floor cupboard door, viewed from the south. Scale 1m.

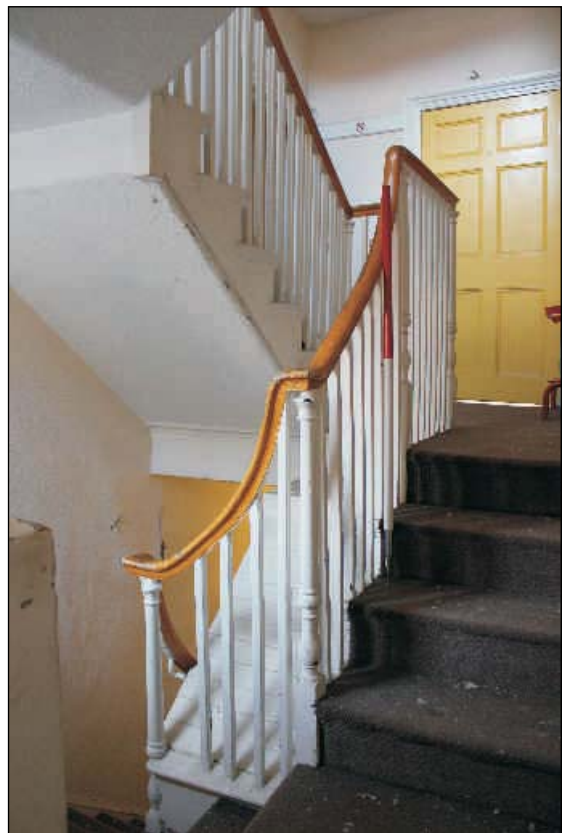
The stairs are continuous from the ground floor to the attic and are furnished with turned newel posts, slender balusters and a ramped handrail (Plate 7).

Plate 7: The staircase looking from the southeast towards the first floor. Scale 1m.

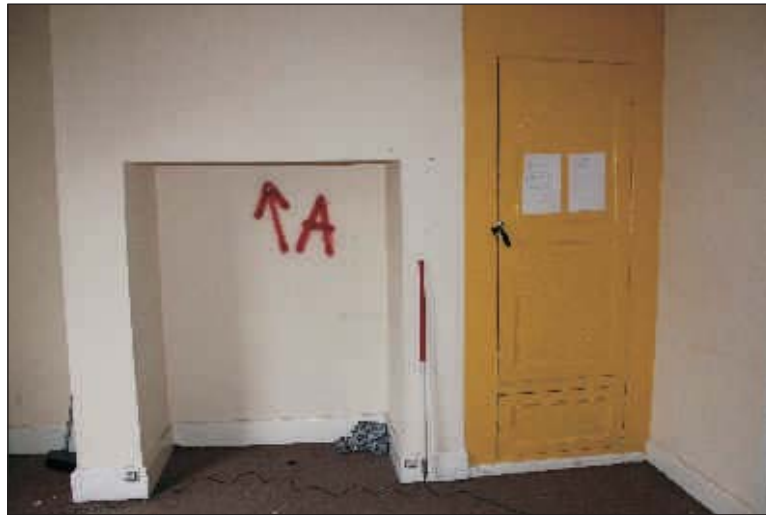
Plate 8: First floor, rear room showing fireplace and cupboards, viewed from the southwest. Scale 1m.

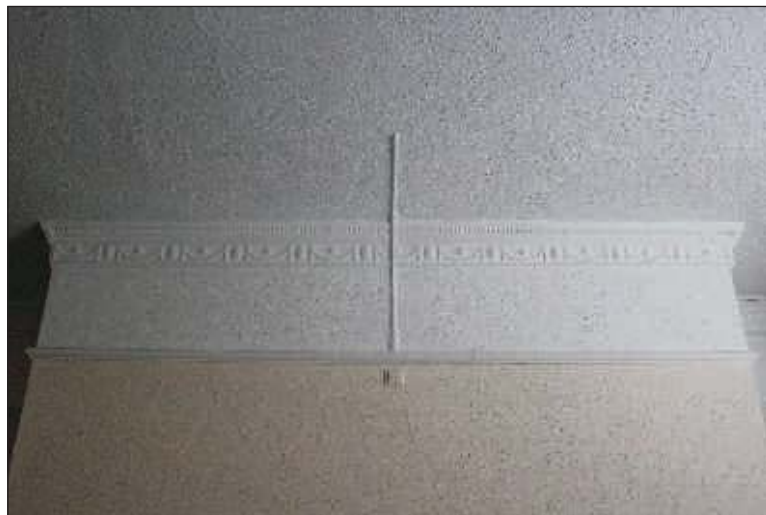
The partitions of the first and second floors are timber frames, covered with lath and plaster. The east elevation is also timber framed, and abuts the plastered masonry of No. 68, indicating that no. 69 was constructed later. A large first-floor landing provides access into the two original rooms – a large front room and a smaller rear room. The rooms have six-panelled doors. The original large front room has been subdivided into two with inserted doorways connecting the spaces. The rear room contains a large fireplace opening in its east elevation flanked by two cupboards in the southern recess (Plate 8). The front room has a blocked fireplace, again in the east elevation. It also retains a picture rail and a two-part cornice rail. The upper section has bead moulding, whilst the lower part has necklace beads and what appear to be leaves (Plate 9). The room has sash windows with turned horns, plainer than elsewhere in the building.

Plate 9: First floor, front room, close up of the cornice viewed from the southwest.

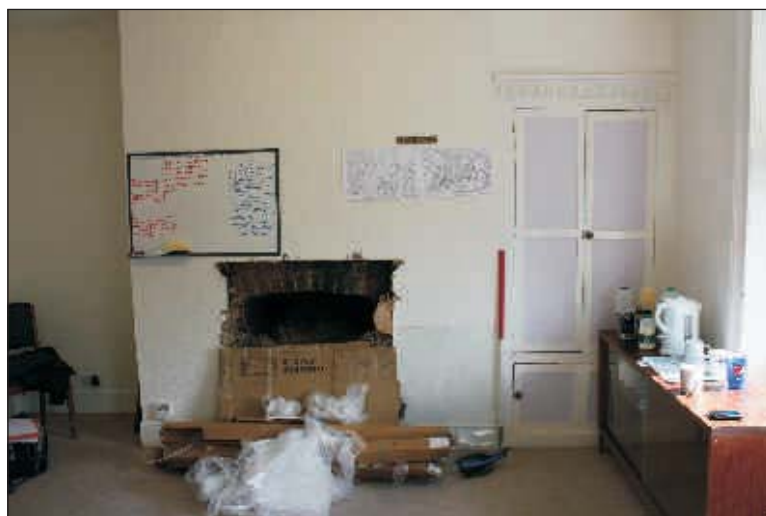
The second floor layout is the same as the original first floor, with a large front room spanning the width of the building and a smaller rear room, although a large opening has been inserted between the two rooms. The original doors have two panels, and the sash windows are hornless. The front room has a fireplace in its east elevation; its cast-iron grate has been removed. There are cupboards in the recess between the fireplace and the front elevation. Above the cupboards is a cornice with both vertical and ovolo mouldings (Plate 10). The only historic feature in the rear room is a blocked fireplace, again in the east elevation.

Plate 10: Second floor, front room, fireplace and cupboards viewed from the southwest. Scale 1m.

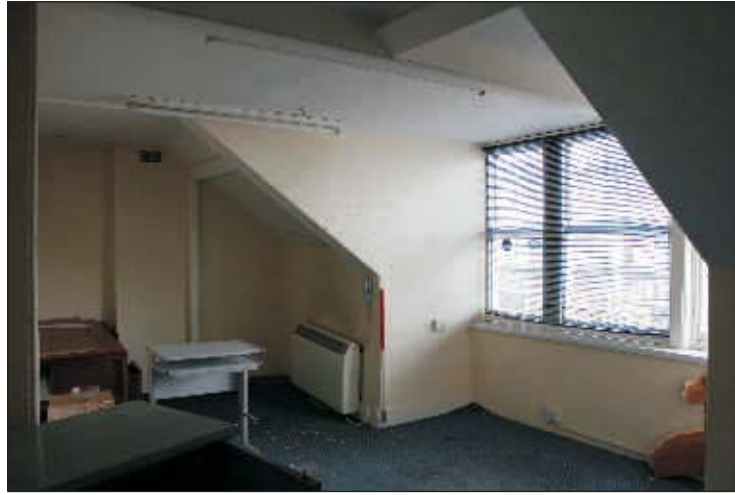
The attic is above the eaves line of No. 68, and the gable elevation is timber framed with slate hanging. The attic staircase is lit by a window with a small bottom-opening light. A small landing gives access to a front room, and a small rear room. The front room is lit by sash windows with flat chamfered horns in a large dormer opening. One window is divided from the others by a big ovolo-moulded mullion that supports a boxed-in tie beam. Elsewhere, a single purlin with ovolo-moulded edges projects below the ceiling (Plate 11). Other features include a 4-panelled door, a metal vent in the eastern chimney stack and a light rose in the ceiling.

Plate 11: Attic, front room. Scale 1m.

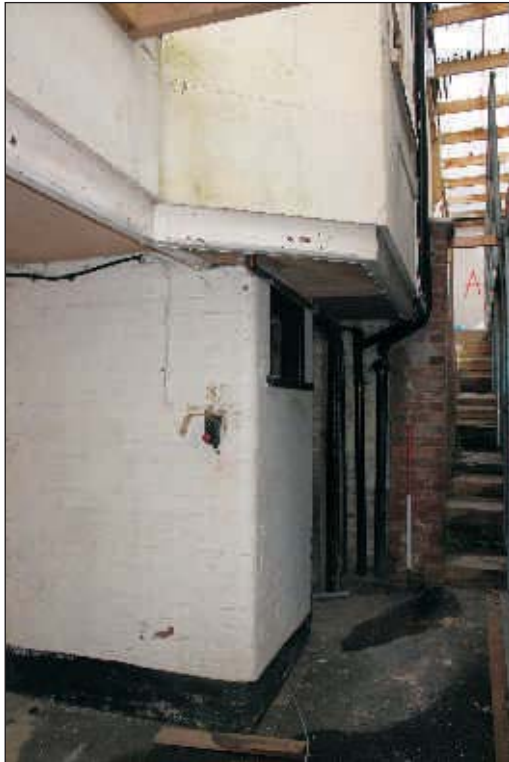
A street frontage level this coal cellar (Plate 12) comprises two rooms (as depicted on the 1876 and 1891 Ordnance Survey maps; Manning and Passmore 2010, Figs 6-7) with a small lobby. The outer face is constructed of brick. This is a re-facing of the original two-roomed rubble breccia structure incorporating an additional lobby and a rebuilt south elevation. The east elevation incorporates a coal chute (Plate 13). The

Plate 12: Coal cellar and courtyard viewed from the southeast. Scale 1m.

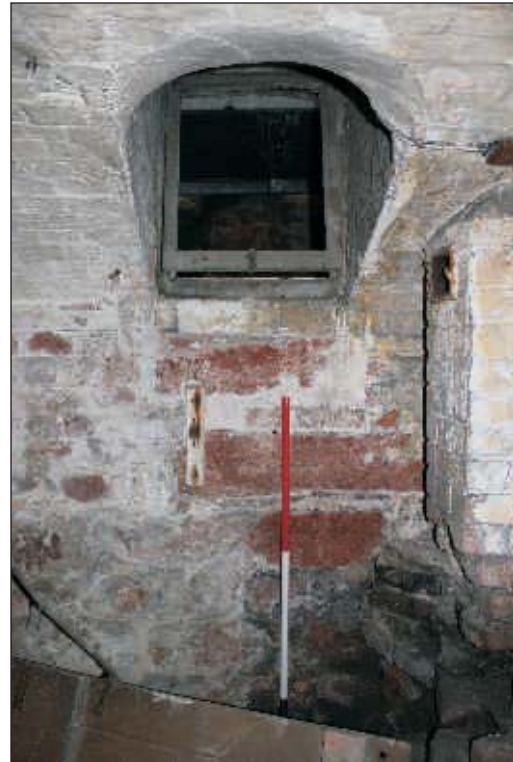
ceilings of the two rooms are brick vaulted, but with a sloping area of lath and plaster inside the coal chute. The east room has a concrete floor, whilst the west room has an earlier brick surface. In the southeast corner of the east room are the remains of a small stove. This may have heated the room/s above.

Plate 13: Coal cellar, showing vaulted ceiling, and coal chute in the east elevation, and stove viewed from the southwest. Scale 1m.

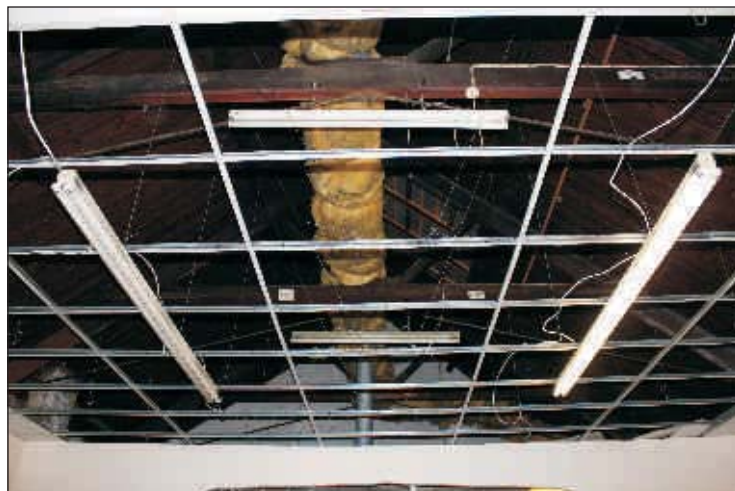
No new observations were made in the western rear outbuilding. In the eastern building, limited stripping out exposed red brick walls throughout incorporating piers that support the roof trusses. These comprise principal rafters with high-level cellars secured by steel ties (Plate 14). There is an additional diagonal steel tie below the collar fixed to the rafters. Above the collar is an open C-shaped strut providing additional structural support. Below the roof is pine cladding, which is supported on three rows of back purlins supported on cleats. The collars and lower ends of the rafters are chamfered.

Plate 14: Gymnasium, roof structure viewed from the southeast.
