NEW PERFORMING ARTS CENTRE, UNIVERSITY OF PLYMOUTH, PLYMOUTH

Results of an archaeological trench evaluation

Report No: ACD535/2/0

Planning ref. Plymouth City Council 12/01476/FUL

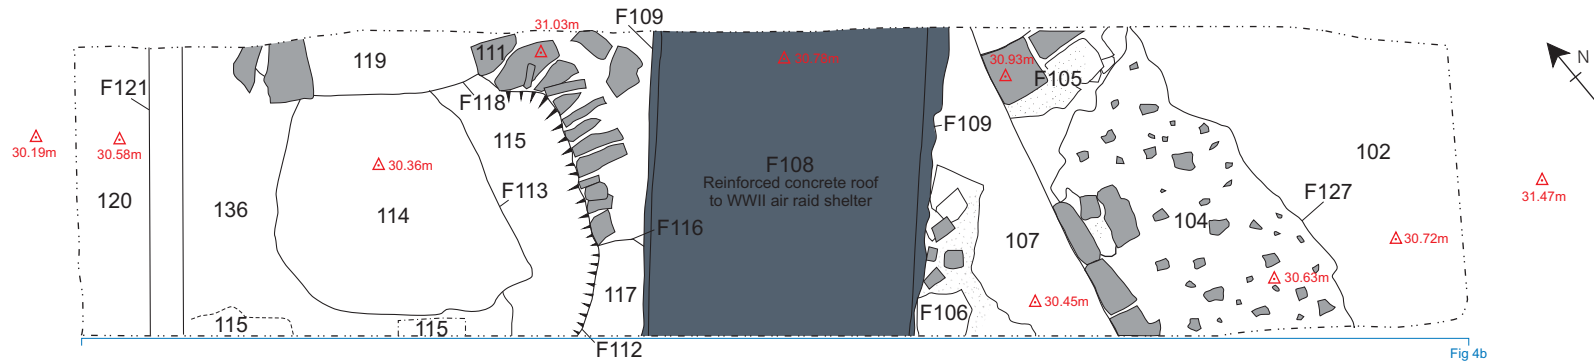
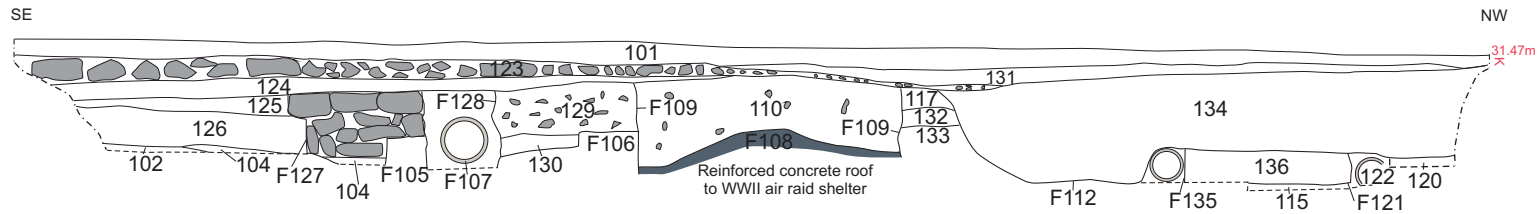
a) Plan

b) Section

- 5.1 **Trench 1** (Detailed plan and section Fig. 4; Plates 1-2)
This trench measured 9m long by 2m wide and was aligned NW-SE within the northern part of the site. Natural subsoil (102), consisting of clay and bedded slate was exposed at the

Feature F108 measured 1.84m wide and was aligned NE-SW, within the centre of the trench, on the line of Plymouth Leat. It was further exposed within Trench 2, where a section of the concrete was broken out and it was established that it represented the steel-reinforced concrete roof to a well-preserved World War II 'tunnel type' air raid shelter, the entrance to which was exposed within Trench 3. As such, the shelter represents a re-use/remodelling of Plymouth Leat. As exposed within Trench 1, the roof was convex in plan with a central high point gently sloping down to either side before levelling off above the underlying supporting walls. There were no visible section breaks within the structure and its upper surface was fairly coarse indicating that it comprised poured, rather than pre-cast concrete. The roof and underlying shelter were contained within a near vertical construction trench (F109) the backfill of which (110) comprised compacted mixed clay and building rubble. The trench extended to 0.24m of ground level and was directly sealed by a post-war tarmac surface (124).

Wall footings F105 lay to the southeast of the air raid shelter roof, aligned N-S, at an oblique angle to the line of Plymouth Leat. Set within a stepped but near vertical construction trench (F127) that cut from the level of soil layer (125) the footings were poorly preserved, with only one course surviving over the greater part of the trench. An underlying bedding layer of crushed slate (104) extended beyond the wall line to the east where a second (possibly internal) wall had joined wall F105 at an angle parallel with the SE side of the trench. The wall footings were of limestone construction, heavily bonded with lime mortar and measured approximately 1m wide to the north, thinning slightly to 0.9m to the south. Pottery recovered from layer 125 through which the wall had been inserted and from the bedding layer (104) dates the building to the 19th century.

A 0.9m wide spread of mortared limestone (F106) between wall F105 and the shelter roof (F108) may be associated with wall F105, perhaps as one side of a stone-lined culvert, with the opposing side formed by the west face of wall F105. It was not, however, possible to confirm this as the upper courses of the structure had been robbed and it had been further disturbed by the insertion of a modern ceramic drain, which would have removed any potentially surviving facing stones.

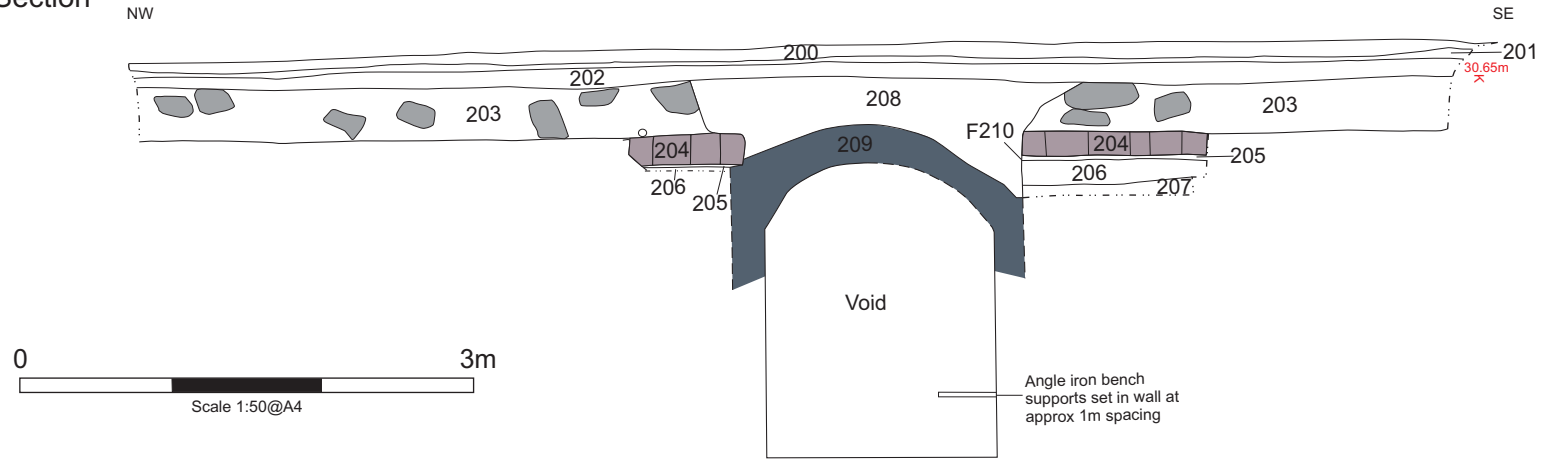
a) Plan

b) Section

5.2 Trench 2 (Detailed plan and section Fig. 5; Plates 3-6)

This trench measured 8.8m long by 2m wide and was aligned NW-SE within the central part of the site. Natural slate subsoil (207) was exposed towards the centre of the site at a depth of 1m below ground level (29.82m AOD). This was overlain by a 0.26m thick layer of very clean brown clay (206) from which was recovered a single sherd of 19th-century pottery. Overlying clay 206 was a thin layer of fine yellowish grey sand (205) onto which had been set a substantial and very well laid surface (204) composed of tightly packed granite setts. Individually, the setts measured 0.28m long by 0.1m wide and 0.16m deep. The setts extended throughout the trench and were laid on a WNW- ESE alignment. During on-site discussion with the PCC HEO it was agreed that this surface would not be removed. The setts were overlain by a very compacted layer of building demolition rubble (203) consisting predominantly of large fragments of broken mortared limestone with occasional fragments of iron and ceramic pipe.

Towards the centre of the trench the demolition layer (203) and underlying granite surface (F204) had been cut through for the insertion of the air raid shelter as seen within Trench 1 (Construction cut F210, concrete roof 209). Removal of a section of concrete, which proved to be steel reinforced, exposed the interior of a linear 'tunnel-type' air raid shelter. The tunnel was 1.92m high and 1.6m wide and the sides and base were of concrete construction, with no evidence of surviving lead fabric. Lengths of angle iron approximately 0.4m long projected out from the SE tunnel wall at regular intervals, at a height of approximately 0.4m above the floor. These would have supported bench seating. The tunnel appeared to be structurally sound, and clear of debris or other obstructions. To the south, it was evident that the tunnel turned course abruptly to the east or southeast.

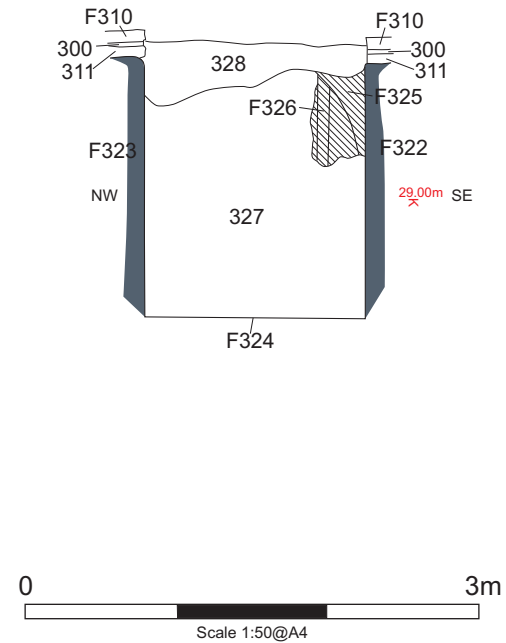
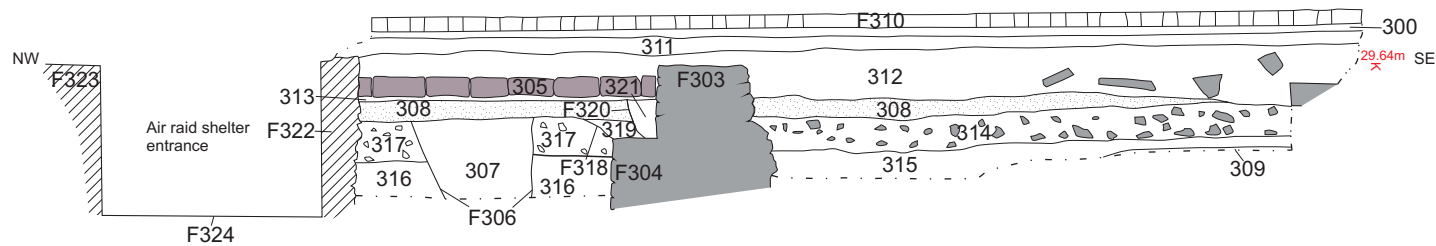
a) Plan

c) Section across shelter entrance

b) Section through trench 3

5.3 Trench 3 (Detailed plan and section Fig. 6; Plates 7-10)

Excavation at the northwest end of the trench exposed a 1.7m wide flight of seven concrete steps (F324), flanked by reinforced concrete walls (F322, F323) marking the entrance to the air raid shelter exposed within Trenches 1 and 2. Access into the shelter was blocked by loose rubble but it was possible to distinguish part of an *in-situ* pre-cast roofing arch (F325) and integral doorjamb (F326). The entrance to the tunnel was aligned NE-SW, and was directly in line with the tunnel as exposed within Trench 1. The preservation of the entrance appeared to be very good, although the top of the walls, and probably the roof of the tunnel above the entrance had been disturbed by a shallow concrete encased service pipe.

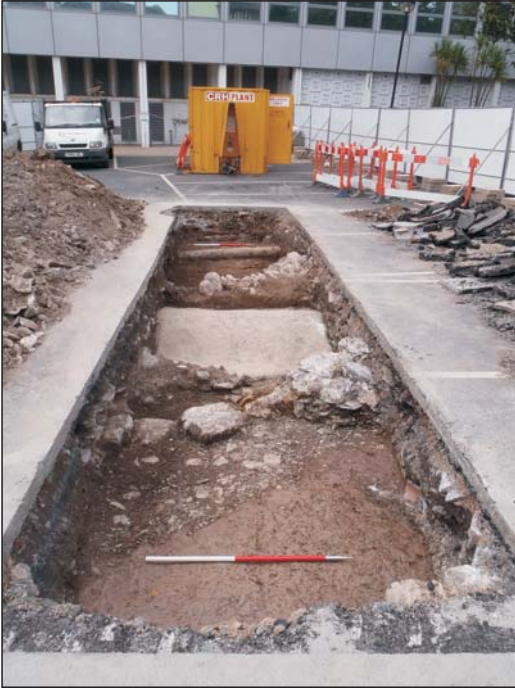
Plate 1:
Trench 1. General view from the southeast
(scale 1m)

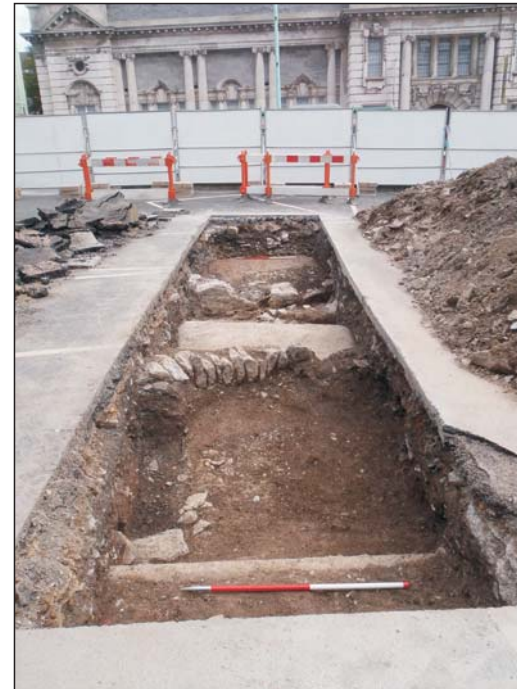
Plate 2:
Trench 1. General view from the
northwest (scale 1m)

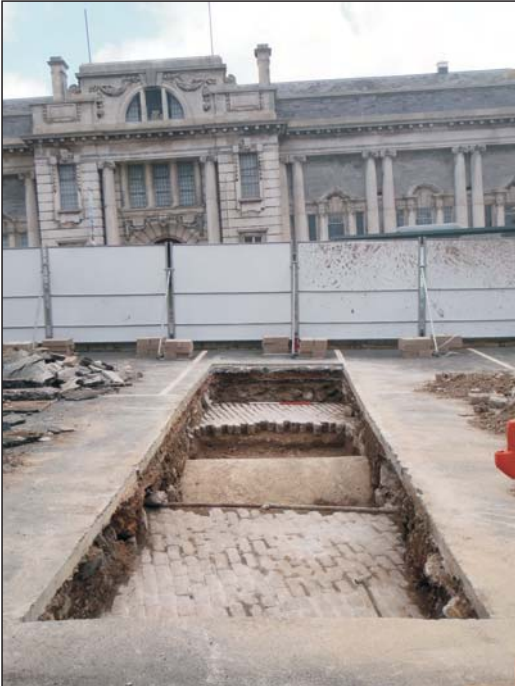
Plate 3:
Trench 2. Air raid shelter roof (F209) with
19th century yard surface (F201) to either
side. View from the northwest (scale 1m)

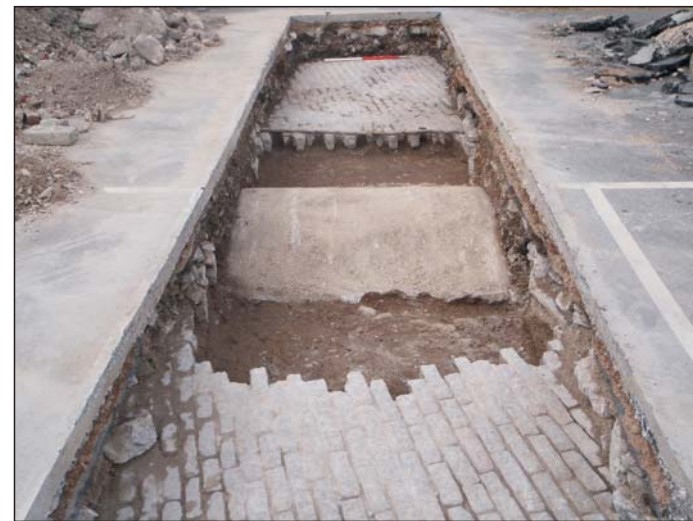
Plate 4: Trench 2. Air raid shelter roof (F209) with 19th century yard
surface (F201) to either side. View from the southeast
(scale 1m)

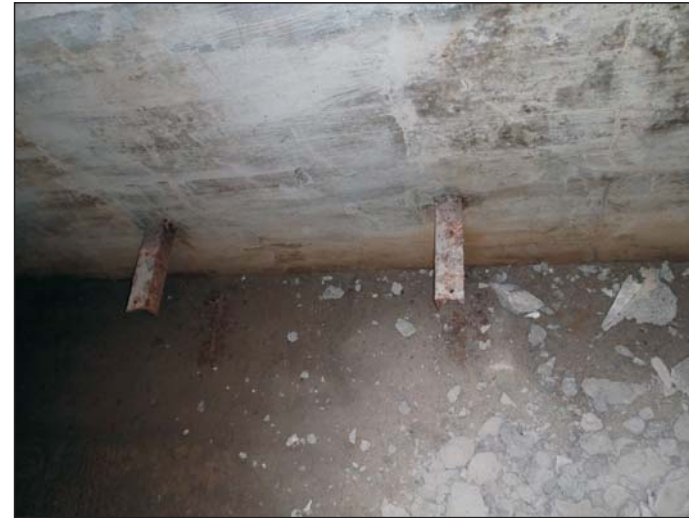
Plate 6: Trench 2. Interior of air raid shelter showing metal bench supports. View from the northwest

- 7.5** It is evident that the shelter survives in a very good state of preservation, although from the limited inspection possible, internal fixtures and fittings do not appear to be extensive. In terms of construction, the tunnel is markedly similar to the Portland Square air raid shelter which lies some 90m to the north of the site, video footage of which is available online (www.youtube.com/watch?v=RZyeNEPf2sk).

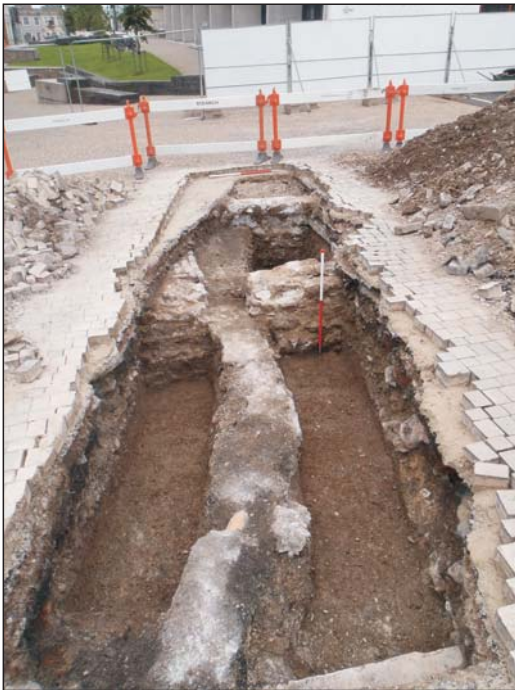
Plate 7:
Trench 3. General view showing wall F303.
View from the southeast (scale 1m)

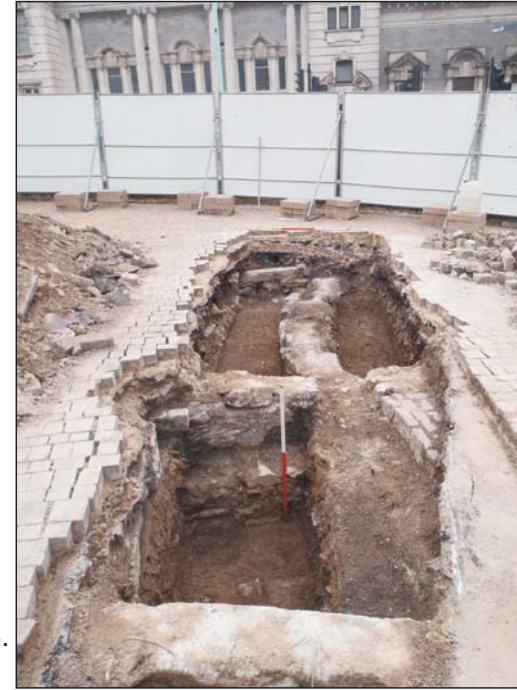
Plate 8:
Trench 3. General view showing
wall F303. View from the northwest
(scale 1m)

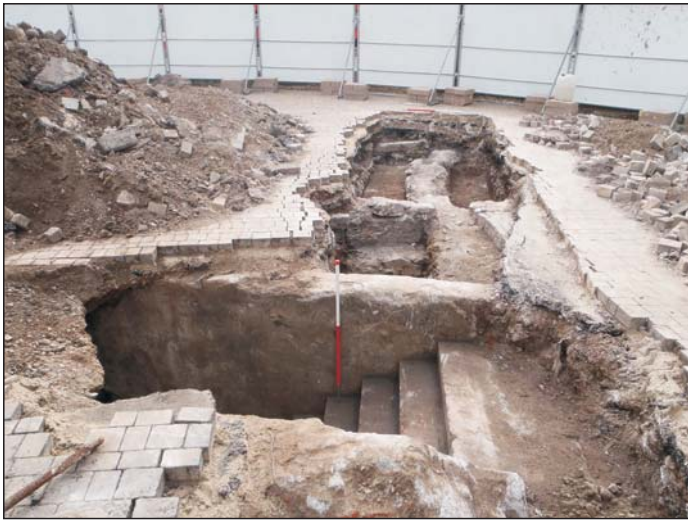
Plate 9: Trench 3. Entrance to air raid shelter. View from the northeast (scale 1m)

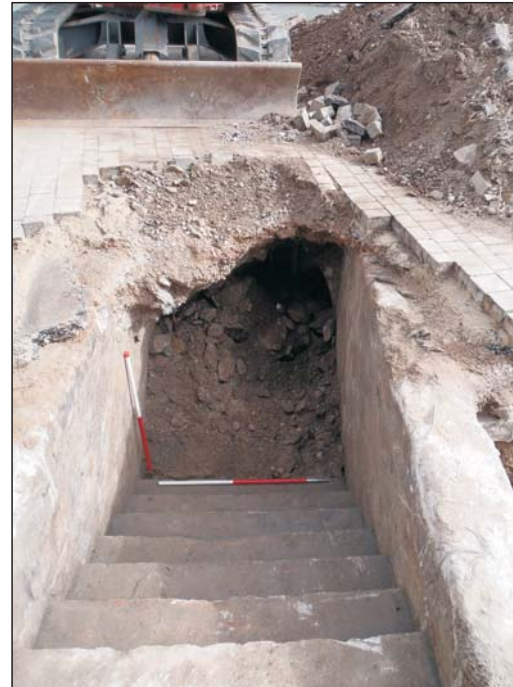
Plate 10:
Trench 3. Entrance to air raid shelter.
View from the southwest (scale 2 x 1m)
