Former Marine Park Holiday Centre, Goodrington, Torbay

Results of an archaeological trench evaluation

Prepared by
Andrew Passmore BSc MIfA

Document No: ACD592/2/0

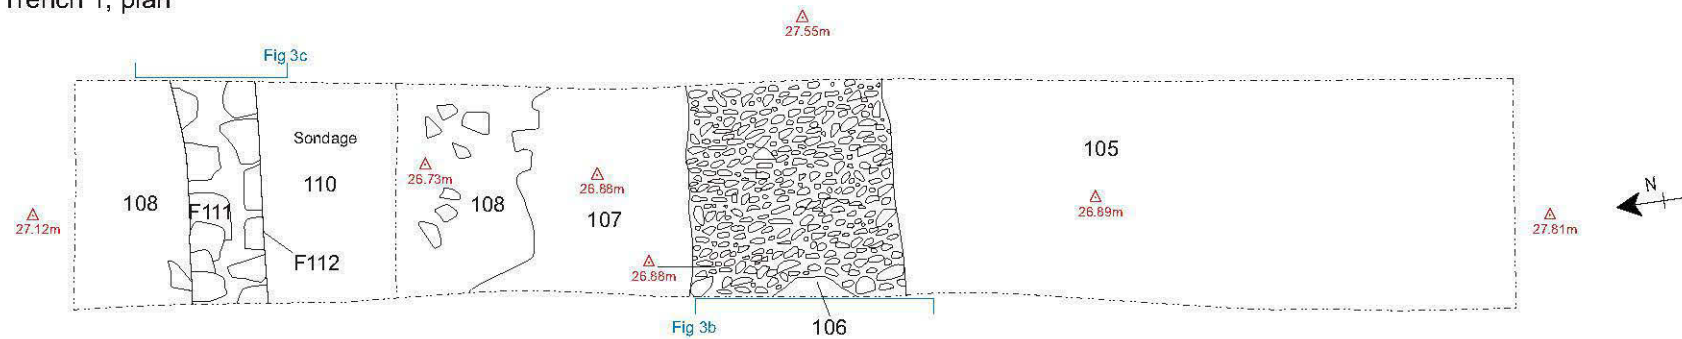
a) Trench 1, plan

This trench was 9.5m long, aligned roughly north-south and was positioned to target the north range of buildings depicted on historic maps. The northern sides of these buildings could not be investigated since the ground level dropped away down to Grange Road. Natural clay subsoil (110) was exposed at a depth of 1m below the surface. The recorded deposits and features are listed in Table 1 below.

The earliest feature in this trench was a dense patch of cobbles (106) that were laid into a bedding layer of mid red-brown and mid-brown firm silty clay with occasional-moderate small-medium sized angular stones (109; Plate 1). The surviving surface was 1.35m wide and had been largely replaced with concrete (105 and 107).

The only other feature was wall F111 whose foundation trench (F113) had been excavated into the natural (Plate 2). The wall was constructed mostly of limestone bonded in mortar, and measured 0.50m wide.

Evidence for farm buildings was exposed in all three trenches. In trench 1 the south wall of north range was exposed (F111). No internal features were present; this part of the site had been landscaped as flowerbeds and dropped steeply down to Grange Road. The earliest external surface (106) was cobbled, and had been laid directly onto natural subsoil. This is likely to predate the construction of an extension first depicted on the 1865 Ordnance Survey map, and was replaced by concrete surfaces 105 and 107. In trench 2, the south wall of the south range of buildings was exposed (F201). In trench 3, lengths of the west and south walls of the east range were

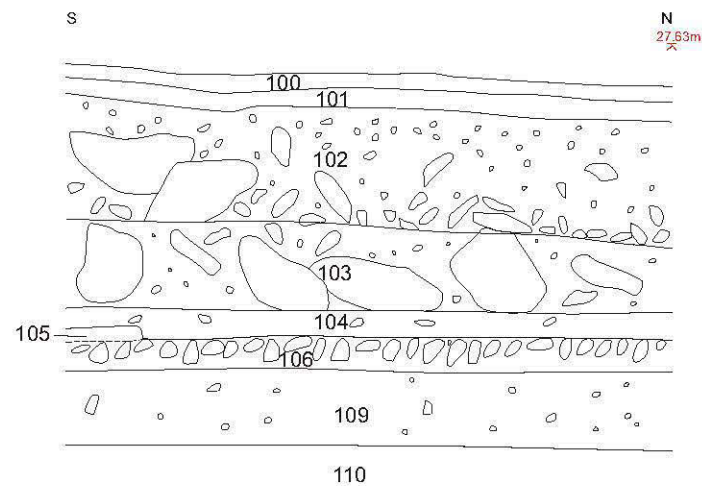
b) Representative section

The wall and surfaces were overlain by a series of demolition and landscaping deposits (100-104, 108, 109 and 112) associated with the demolition of the farm and the construction of the Holiday Centre during the later 20th century.

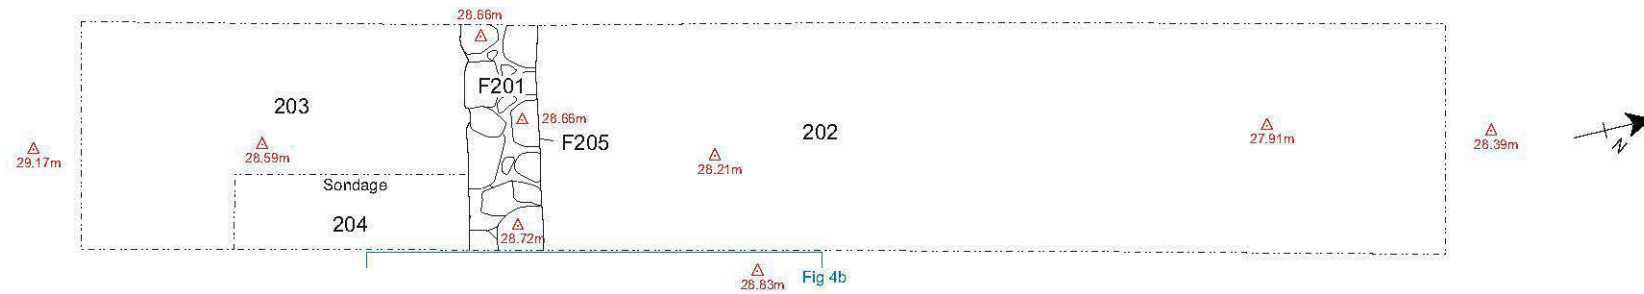
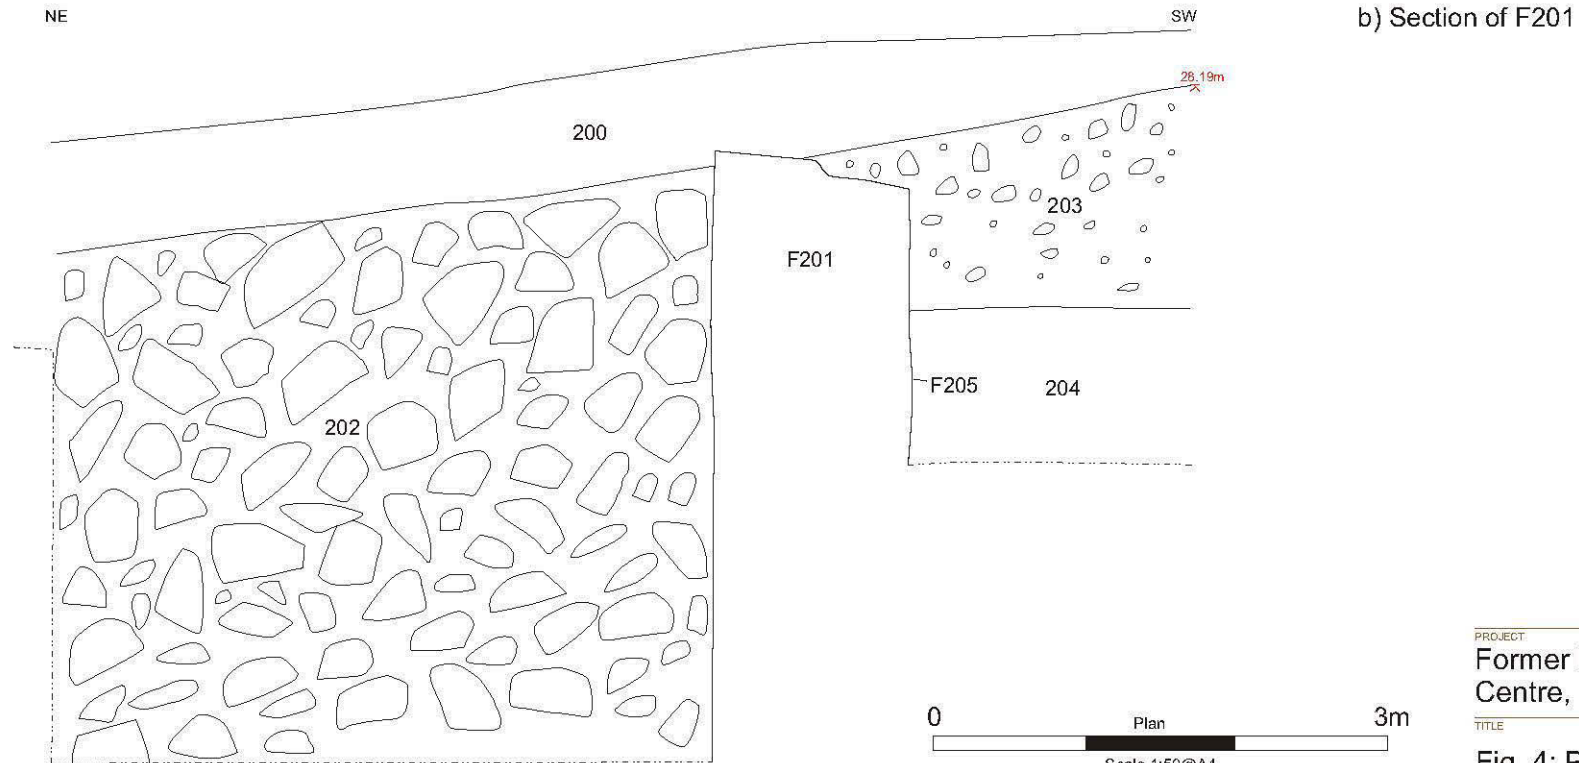
TITLE
Fig. 4: Plan and section, Trench 2

This trench was 9m long, aligned roughly north-south and was positioned to target the south range of buildings depicted on historic maps. It was positioned between a surviving farm building retained within the holiday centre and a modern building set within a terrace whose retaining wall may represent the remains of a demolished farm building. The trench was excavated to a maximum depth of 1.90m. Natural subsoil was encountered at a depth of 1.16m from the surface in a sondage excavated near the south end of the trench. The recorded deposits are listed in Table 2 below.

The natural subsoil had been truncated by the construction of an east-west aligned wall (F201 in foundation trench (F205). The north, interior side of the wall was exposed for a depth of 1.60m; its full depth could not be established, and no interior floor surfaces were exposed. If the floor was level with the yard exposed in trench 1, then it is likely to have been at least a further 0.20m below the base of the trench.

The wall was overlaid and abutted by levelling deposits (202 and 203) associated with the construction of the Holiday Centre. These were sealed by a tarmac road surface and associated make-up (200).

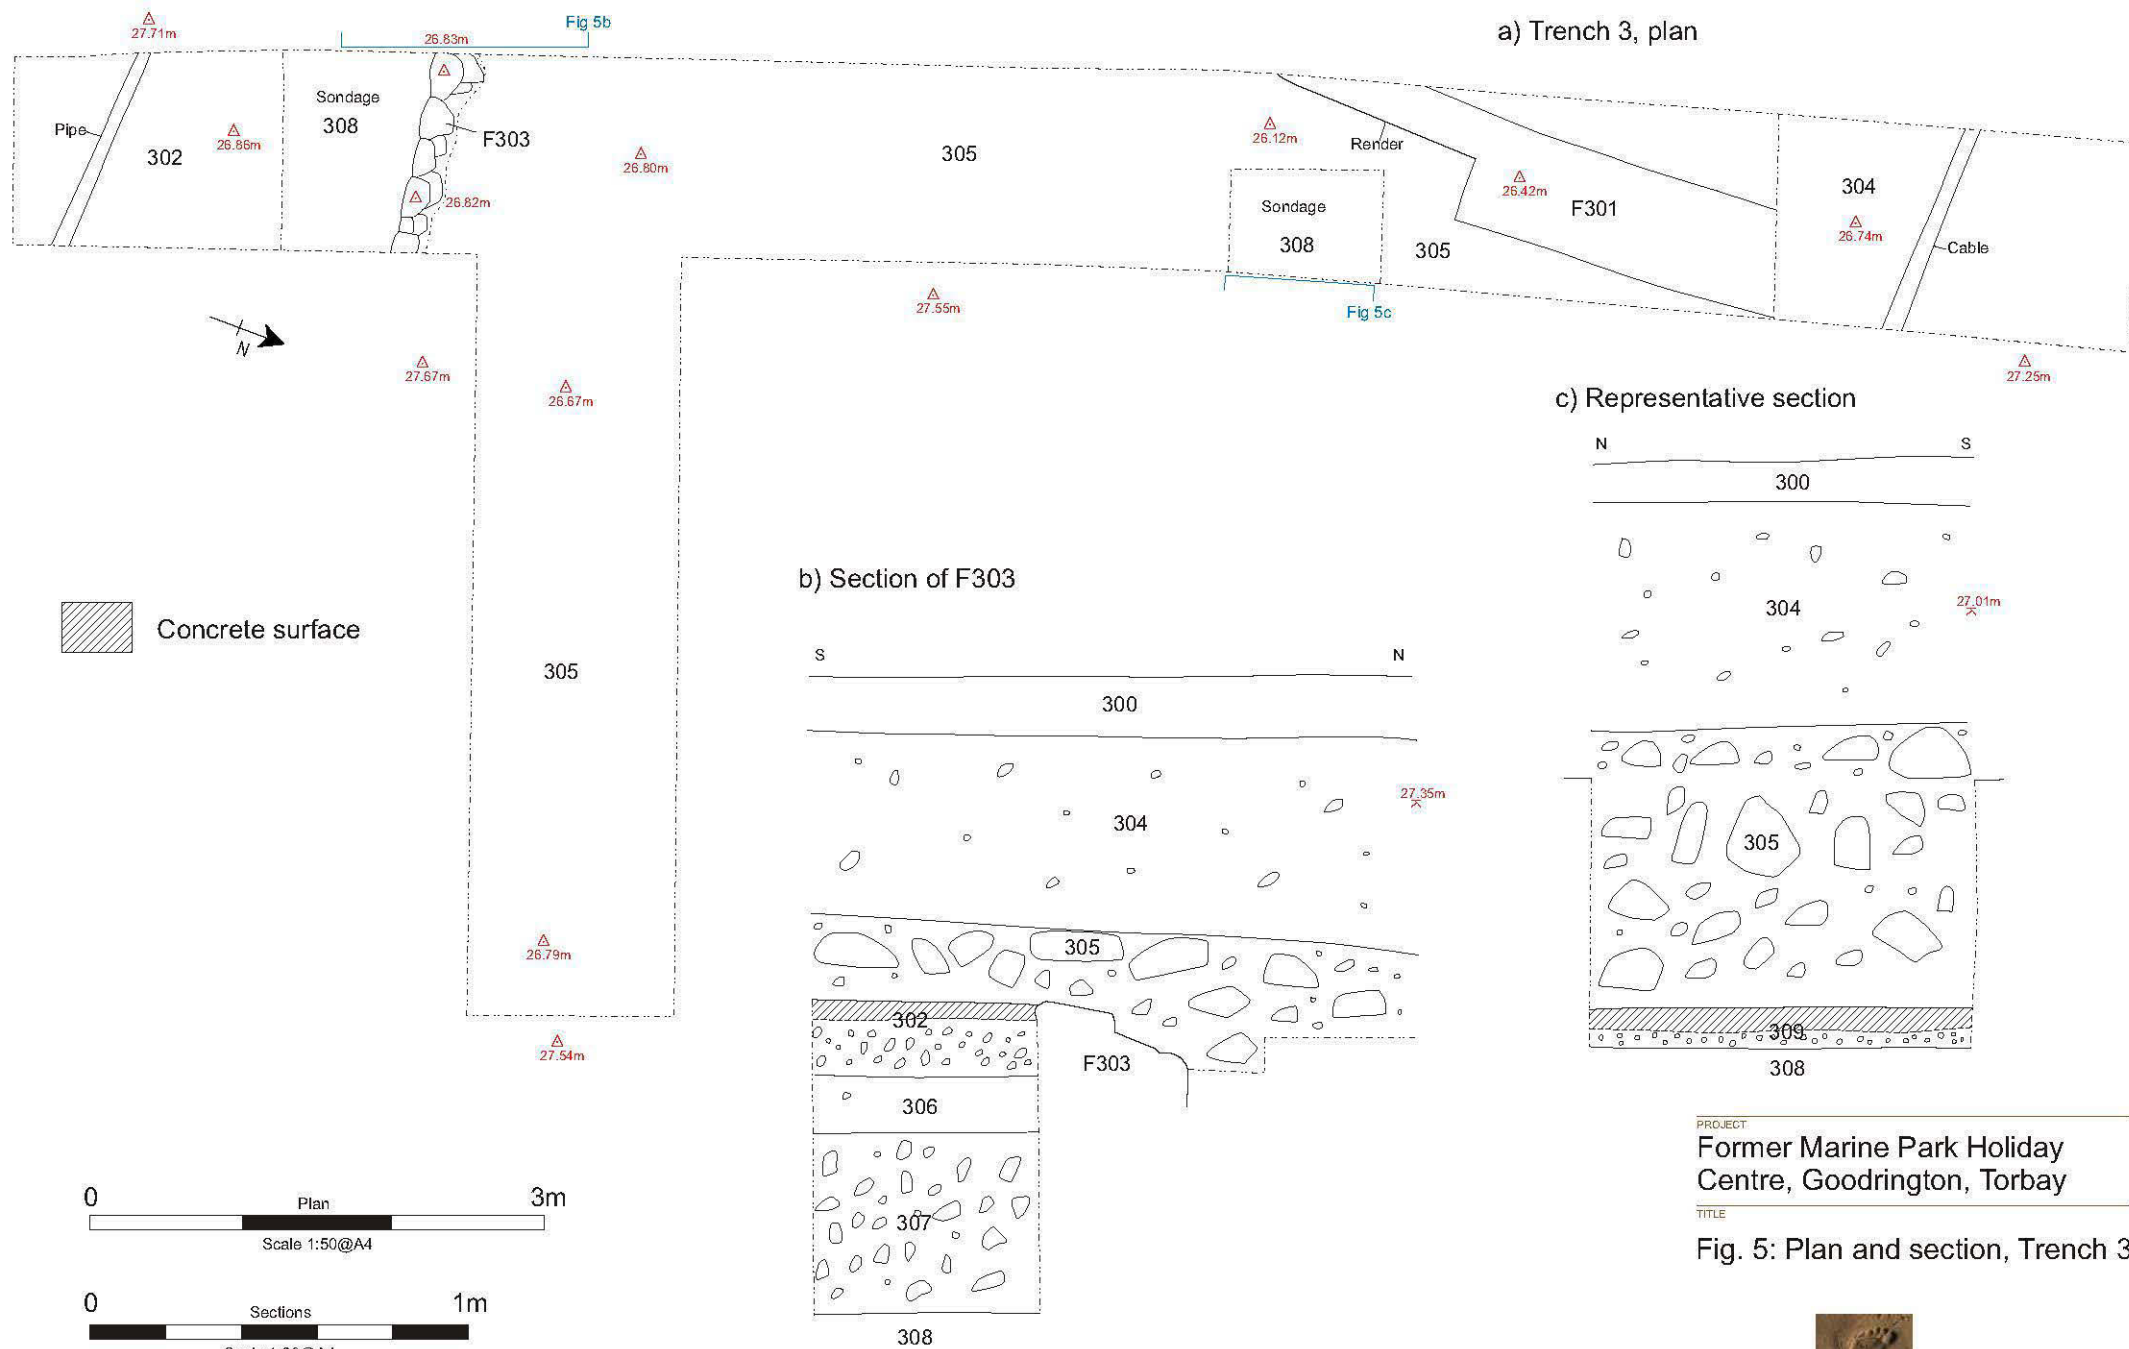
TITLE
Fig. 5: Plan and section, Trench 3

This trench was T-shaped and measured 14m by 5m. The long axis was aligned northeast-southwest, and the trench was positioned to target the east range of buildings depicted on historic maps. The trench was generally excavated to a depth of 1m from the surface. Natural subsoil was encountered at a depth of 1.70m from the surface in a sondage excavated near the south end of the trench and 1.55m from the surface in a sondage excavated near the north end of the trench. The recorded deposits are listed in Table 3 below.

The earliest deposits were exposed in a sondage near the south end of the trench. These comprised layers of stone (306) and redeposited natural (307) that represented levelling deposits for the farmyard surface. The surface itself was concrete, laid onto a stone make-up (302; Plate 4).

The east range of the farm was represented by walls F301 (Plate 5) and F303 (Plate 4) that accurately tied in with the positions of the west and south walls of the building depicted on historic maps. Although the walls stood to a height of up to 0.55m above the contemporary floor surface, they had been heavily demolished, and other elements of the west exterior wall depicted historic maps did not survive.

A concrete interior surface (308) was exposed within a sondage (Plate 6). Its make-up was laid directly onto the natural subsoil, and no earlier surfaces were present. No other features were exposed, and the walls were featureless, although the excavated section of wall F301 stepped out with an area of thicker masonry. The significance of this is not known.

All the walls and surfaces were sealed by thick layers of levelling deposits (304 and 305) associated with the construction of the Holiday Centre. These were sealed by a tarmac road surface and associated make-up (300).

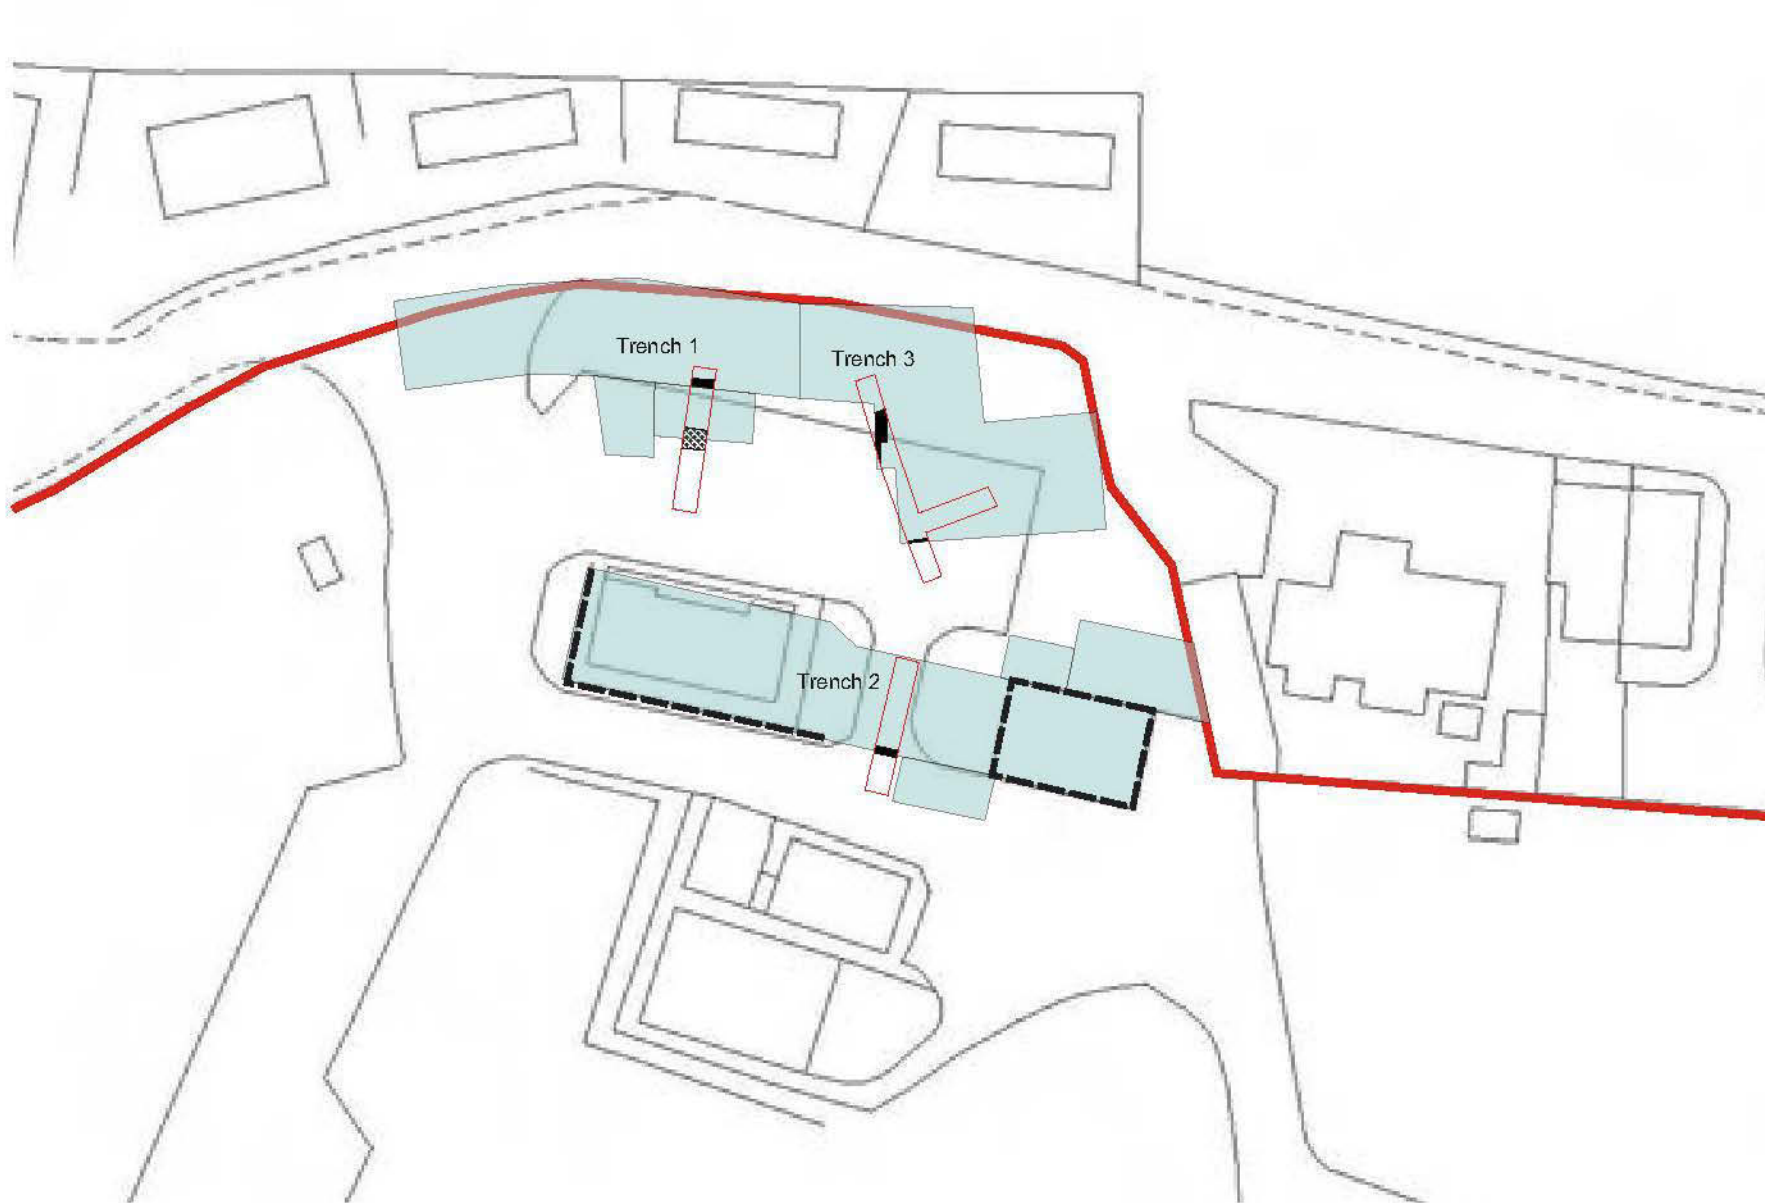
Fig. 6: Summary of
results

exposed (F301 and F303 respectively) along with an internal concrete surface (309) and a yard surface (308).

The functions of the buildings could not be determined, nor whether one of them was a farmhouse. However, surface 309 within the east range was considerable lower than the adjacent yard surface, which may imply that the building was a farmhouse and not an agricultural building requiring a level entry from the yard.

No dating evidence was recovered. However, it is likely that the walls form primary features to the farm complex, since, where excavated, they had been constructed into the natural subsoil. Cobbled surface 106 is also an early yard surface. The dates of these are unknown, but the lack of stratigraphic sequence indicates that they do not form replacements for earlier farm buildings. The other concrete surfaces (105, 107, 302 and 309) are all later and may represent an early or mid 20th-century upgrading of the farm.

- 7.1 The evaluation has demonstrated that remains of the farm buildings and in places associated internal surfaces as well as yard surfaces survive. The buildings are likely to be earlier in date (i.e. of at least 19th-century origin) than the surfaces, which are probably of 20th-century date. The buildings were largely demolished when the Holiday Centre was constructed, and although the area was comprehensively landscaped, surfaces, and to some extent walls, are preserved below thick levels of demolition and levelling deposits.

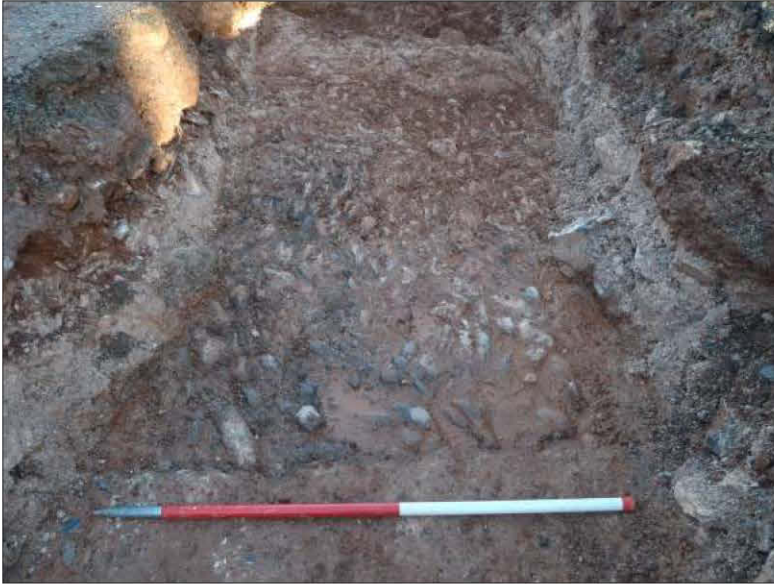
Plate 1: Trench 1, surface 106 viewed from the north. 1m scale.

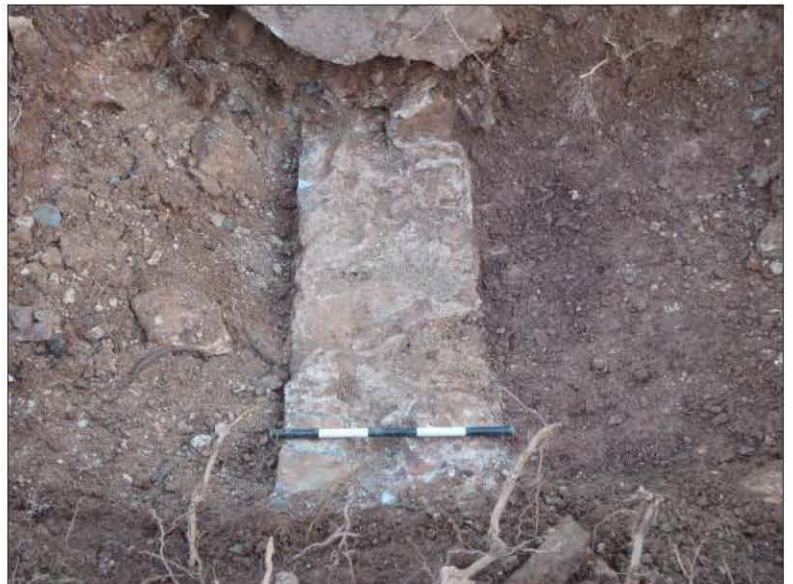
Plate 2: Trench 1, wall F111 viewed from the west. 0.5m scale.

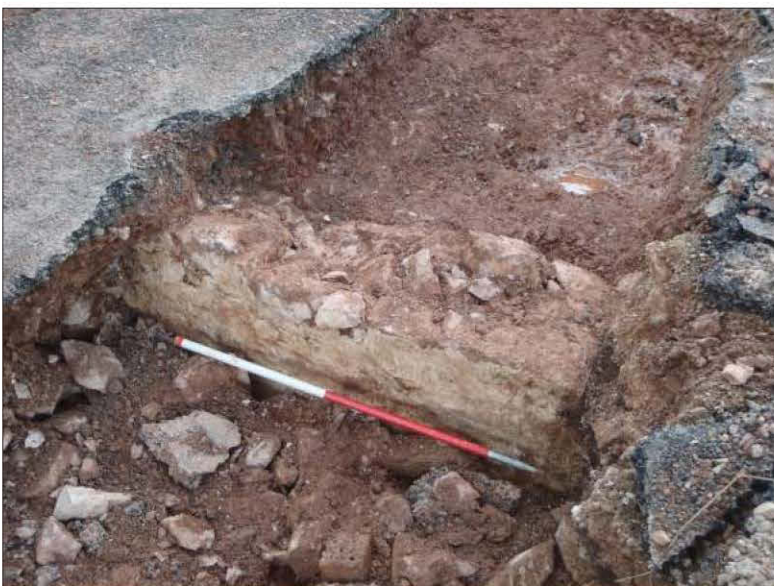
Plate 3: Trench 2, wall F201 viewed from the northwest. 1m scale.

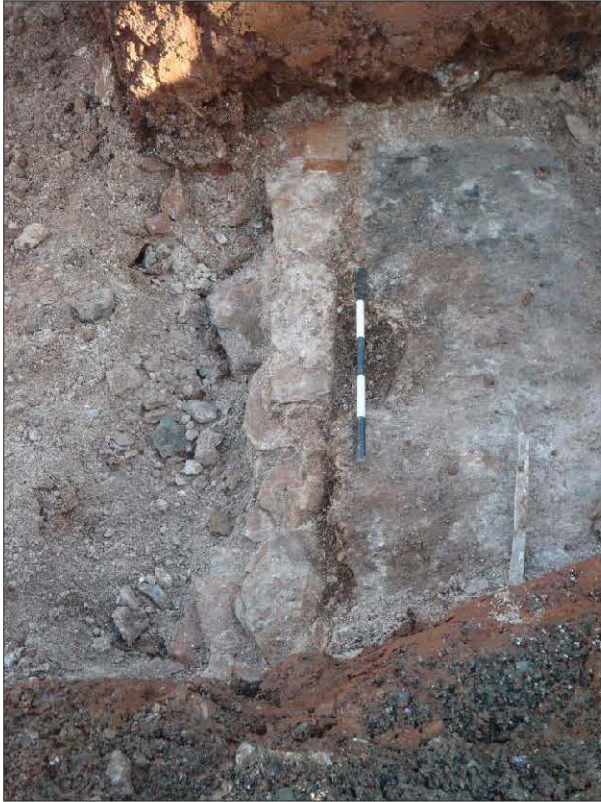
Plate 4: Trench 3, surface 302 and wall F303 viewed from the northwest. 0.5m scale.

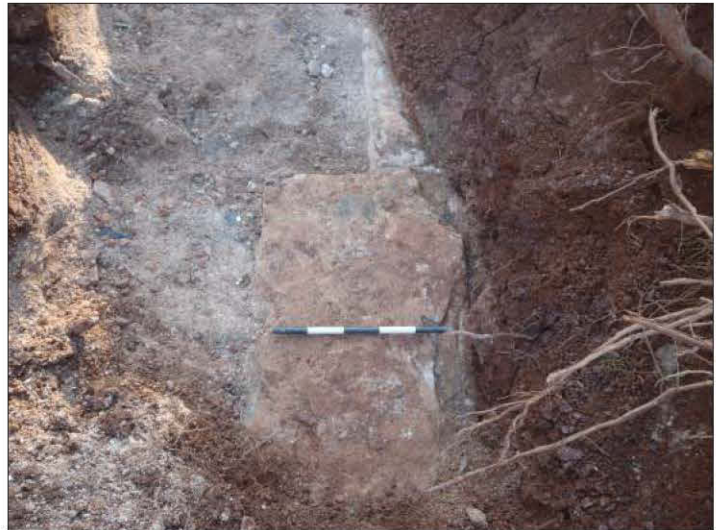
Plate 5: Trench 3, wall F301 viewed from the northwest. 0.5m scale.

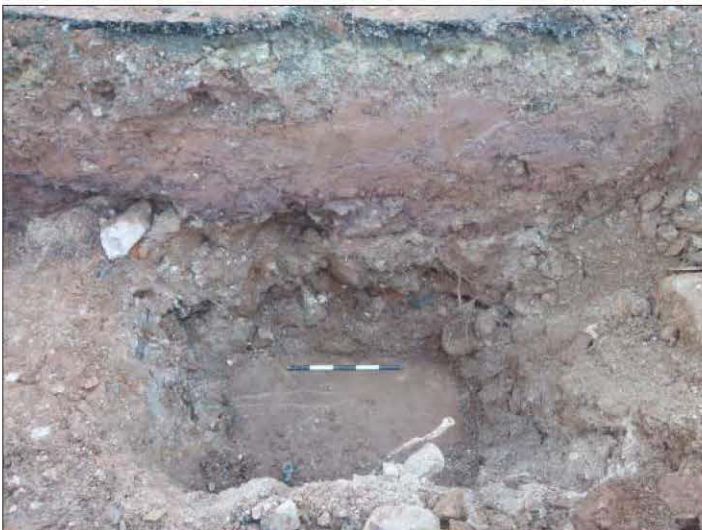
Plate 6: Trench 3, surface 308 viewed from the northeast. 0.5m scale.
