Puslinch Bridge, Yealmpton, Devon

Results of an archaeological watching brief

Devon County Council planning reference DCC/3372/2012

Document No: ACD526/2/1

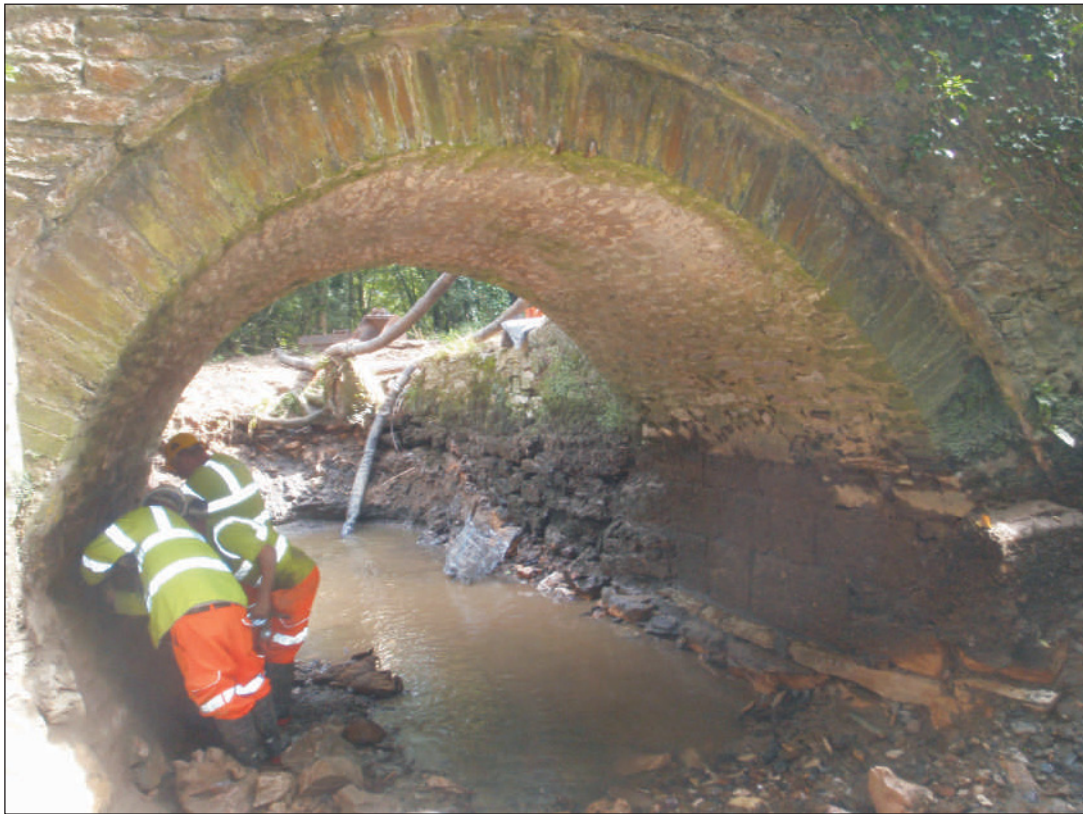
The lowest course of the arch is formed by a row of large dressed blocks of masonry, whose outer edge is vertical. Two further courses of similar, but even larger blocks are present below. Either end, this masonry projects out from the bridge and is constructed of rougher slate blocks. On the upstream side of the bridge this masonry also projects slightly into the river forming a half cutwater. Below this, the abutment sits on a slightly projecting thin course of slates laid onto foundations comprising courses of rough large blocks of slate. Two courses were exposed.

Plate 1: The southern arch showing the south elevation as well as the masonry of the southern abutment, viewed from the northwest

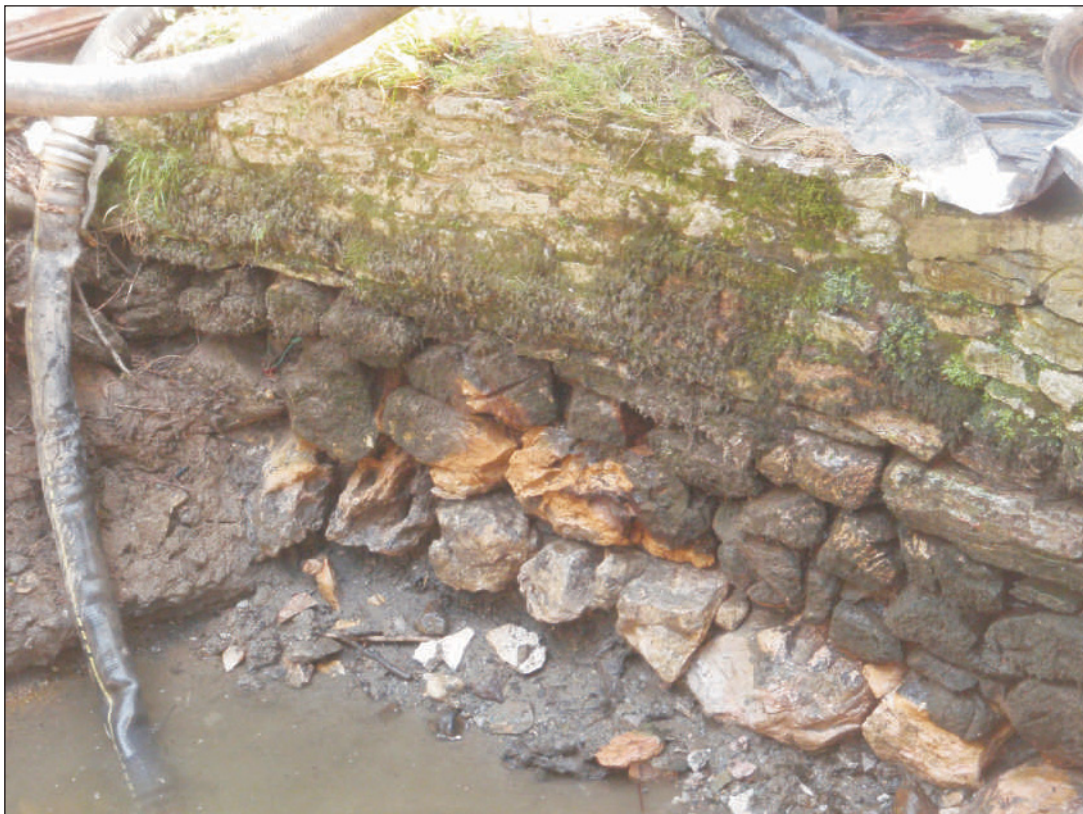
The upstream wing wall on the southern bank overlies the projecting masonry of the south abutment. The lowest fabric is constructed from rubble slates laid roughly in 4-5 rows. Above this, the wall has been rebuilt with mortared smaller coarsely-dressed blocks of slate with some granite, laid roughly in 6-7 rows.

Plate 2: The wing wall east of the southern abutment, viewed from the northwest

was added, and subsequently heightened. Again, this is undated, but given the unusual course of the river (which must be constricted by the presence of the bridge), it may have been added soon after the bridge was constructed to protect the adjacent roads and access to Puslinch House beyond.

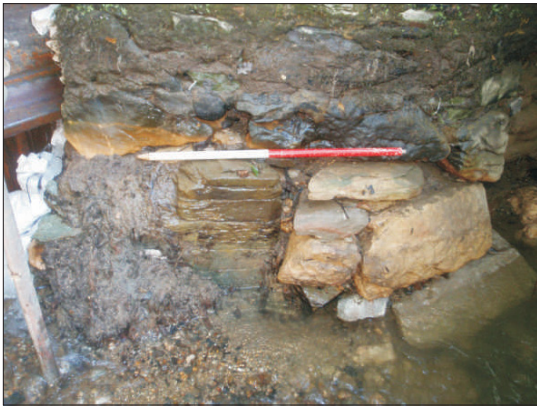
On its downstream side is a counterfort or cutwater with a pedestrian refuge at road level. This was not inspected in detail during the works but it obscures the lower voussoirs of both the northern and southern arch, and may therefore have been added after the bridge was constructed. The foundation of this counterfort comprises a minimum of 7 courses of finely-dressed green thin-laminated slates, whose alignment is set back from the course of the adjacent pier foundations. Some of the stones displayed diagonal tool marks, and overall were characteristically different from other stone used in the bridge. They may have been reused from a high-status structure (cf Evans weir at Tavistock where similar high-quality masonry was used in the retaining wall beside the river; Passmore and Pink 2011, 3). Set around this

Plate 3: The foundation of the counterfort attached to the central pier, viewed from the south. 1m scale

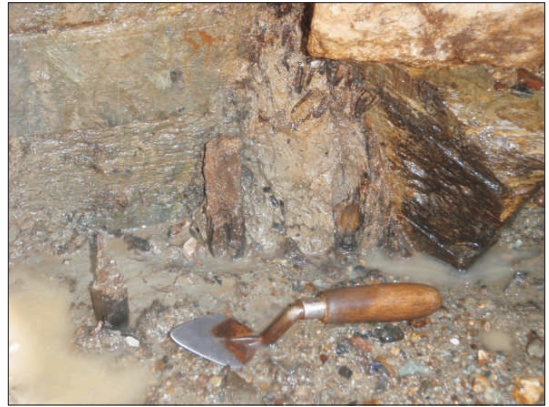
masonry is a mid brownish-grey friable silty clay that contains small fragments of brushwood and three small vertical stakes. These features were interpreted on site as a repair to the bridge, but probably actually form the foundations for the later counterfort. The north side of these foundations had been disturbed, and evidence for the addition is less clear, but a break could be determined between the earlier foundations, and the later counterfort and its foundations.

Plate 4: Close-up shot of the stakes within the clay, viewed from the south

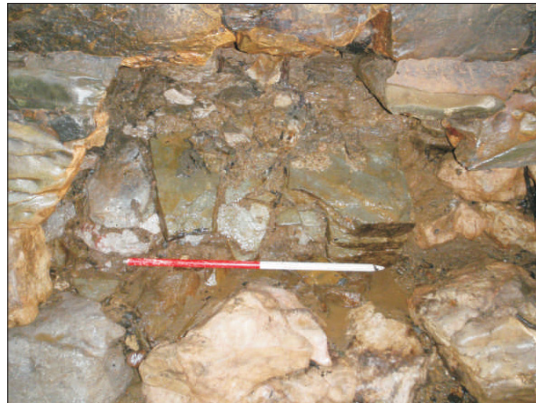
Under the south arch, part of the main foundation of the pier had been previously underpinned and heavily repointed in cement. Removal of this underpinning exposed a stub of north-south aligned masonry, comprising three courses of mud-bonded blue-green slates. This appeared to predate the majority of the pier footings, although its function is not clear.

Plate 5: The possible early wall in the south elevation of the central pier, viewed from the south. 1m scale

- 6.1** No conclusive evidence for a bridge earlier than the present structure was recorded. A short length of possible wall within the masonry of the central pier could be associated with an earlier bridge, but its north-south alignment, and narrow width, do not readily allow an interpretation.
