Clare House, Tiverton, Devon

Results of an archaeological watching brief

Planning ref. Mid Devon District Council 12/01086/FULL

Document No: ACD590/2/1

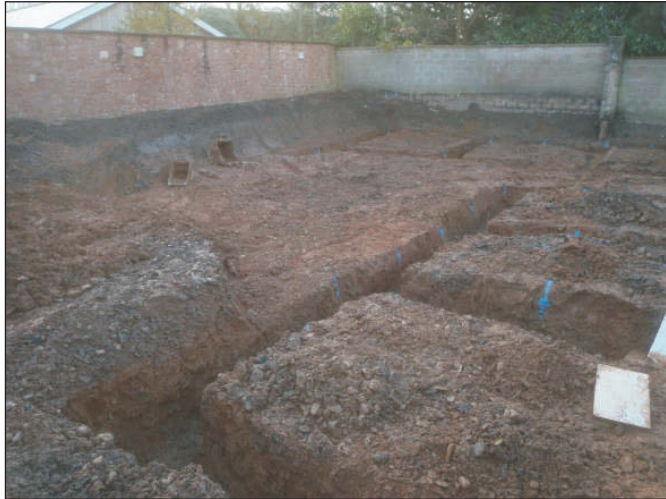
Plate 1: General view of the site after ground reduction and excavation of foundation trenches, viewed from the northeast.

The general recorded layer sequence observed across the site comprised 0.20m of topsoil/garden soil (100), over 0.30m of subsoil (101), which in-turn overlaid a 0.40m deep deposit (102), which contained slate, brick and mortar fragments. This was interpreted during the watching brief on the test pits as being of early 19th-century date but on the basis of present observation may relate to later activity on the site, perhaps the construction of the 19th-century extensions. Prior to the foundation trenches being excavated, this overlying material was removed by machine, under archaeological supervision, to a depth of 0.90m. It was from this depth that the foundation trenches were excavated (Plate 1). Natural gravels (106) were exposed in all of the foundation trenches.

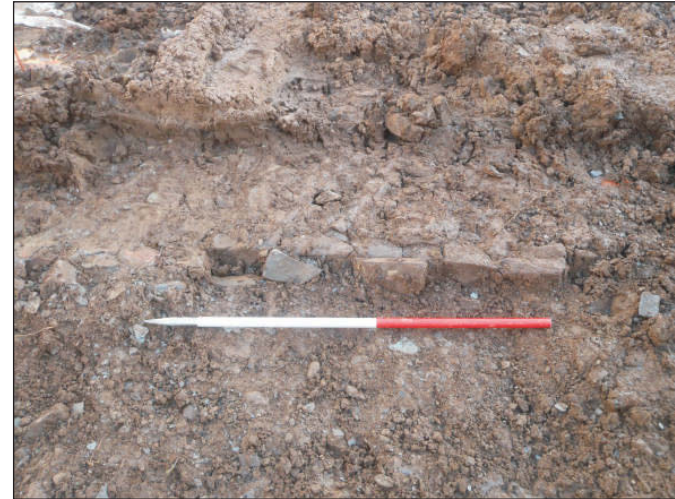
Plate 2: Cobbled surface F103, viewed from the southwest. 1m scale.

In the centre of the site, below deposit 102 were the remains of a former cobbled yard surface. This surface (F103) consisted of a single course of well set cobbles up to 0.12-0.20m long, bonded with a silty clay matrix. This surface was heavily truncated, although its form was determinable. The cobbled area measured roughly 3m in length by 0.5m wide, forming a curved section, with edging stones on the western side. Due to the high level of truncation it was hard to determine if the surface originally formed a yard surface or a pathway. A further area of cobbles was exposed closer to Clare House adjacent to the location of the compound cabins.

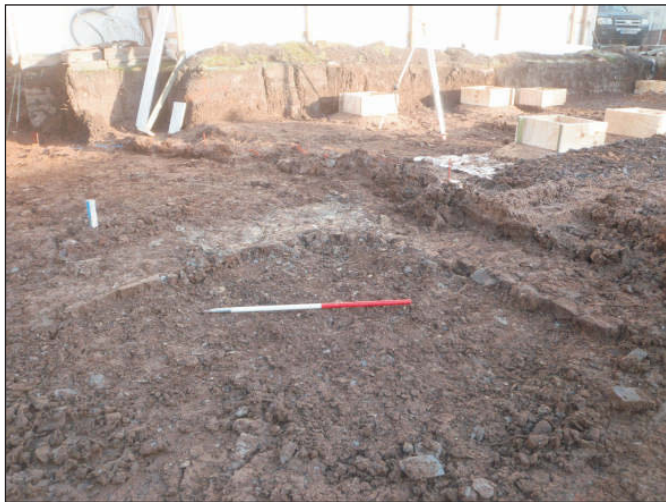
Plate 3: Detail of cobbled surface F103 showing edging stones, viewed from the west. 1m scale.

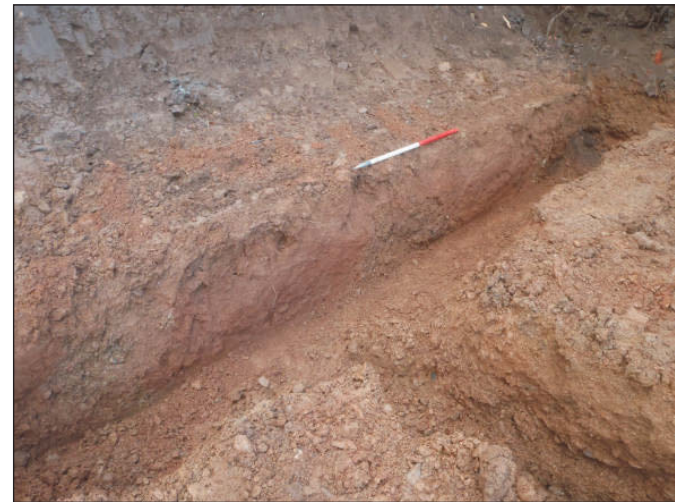
Plate 4: Features F123 to left, F120 centre, and F117 to right, all filled with red clay, viewed from the northeast. 1m scale.

To the far southwest corner of the site, a 5m long section of the foundation trench exposed in section three separate features (Plate 4). All three appeared to be of similar nature, size and fills. The eastern feature (F123) was only partially exposed,

and measured a minimum of 0.35m wide by 0.45m deep. It contained a single fill (124) of dark red sandy clay. Features F117 and F120 were both c. 1.80m wide by a minimum of 0.60m deep. They had similar steep, slightly concave sides, and each contained two fills (118 and 119, and 121 and 122 respectively) of red clay and yellow-brown silty clay. Although the nature of the fills and the lack of finds suggest naturally formed features, the similarities between the three suggest the uniformity of man-made features.
