The Bishop's Palace, Paignton, Torbay

Results of historic building recording and test pit excavations

Scheduled Monument number 1020764; Listed Building entry id. 1208109

Document No: ACD406/3/1

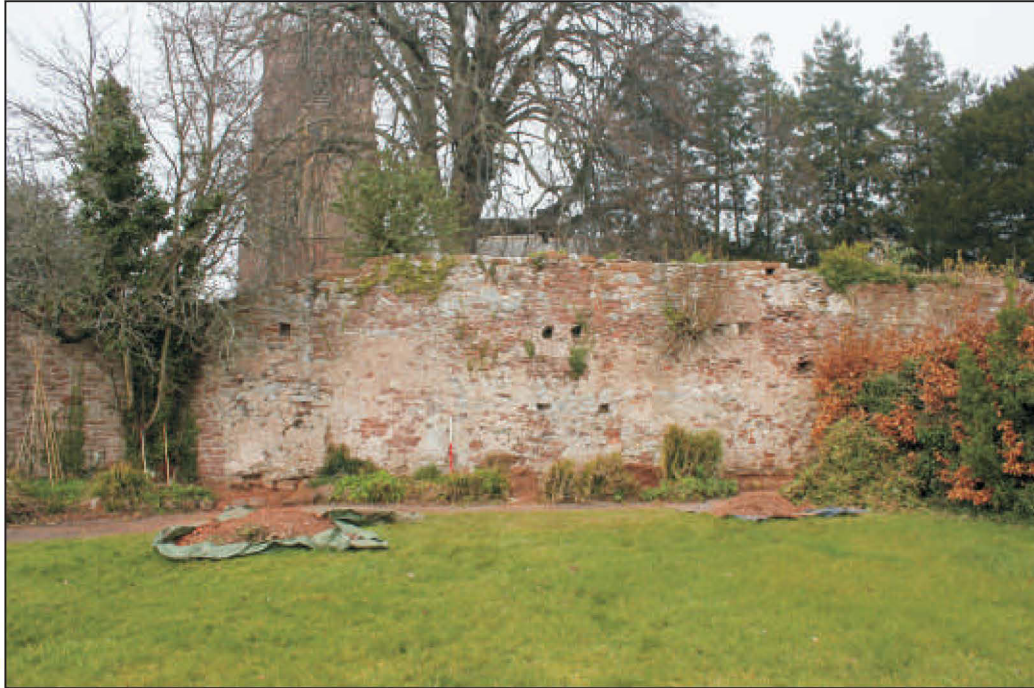
Plate 1: North curtain wall showing F600 with F303 above, viewed from the south. 1m scale.

The earliest fabric in this wall is a 12.5m length of limestone masonry (F600) that incorporates some mid grey breccia, bonded in a soft buff slightly gravelly lime mortar. The wall was constructed on clay-bonded limestone and breccia rubble footings (F114/F204/F403/F500). In places this projected 0.10m out from the wall above, and it is possible that it had been partially removed during later landscaping. The footings were laid onto earlier deposits; these are described in section 6 below. At a height of 1.1m above the present ground surface the masonry incorporates a pair of putlog holes.

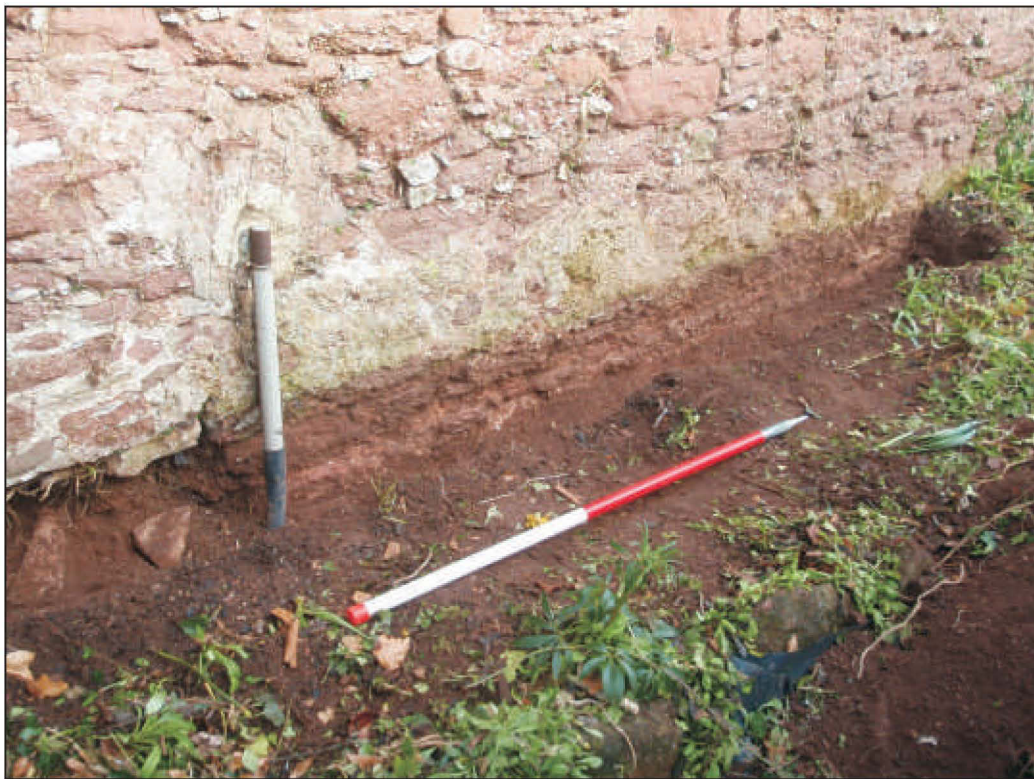
Plate 2: Flush footings of F303 to right, overlying rougher footings of F600, viewed from the southwest. 1m scale.

This pit was located at a junction in the north curtain wall F303 with a demolished north-south aligned wall, and the later rebuild F605. The breccia footings of F303 were flush with the upstanding masonry and are integral to the wall, whereas the footings (304) of the demolished north-south wall projected out from the threshold of the doorway above. They were cut through a soft mid red silty clay containing frequent slate and mortar fragments. It was not established whether the curtain wall was also cut through this layer. The footings were sealed by garden soils and post-medieval and modern levelling (300-302).

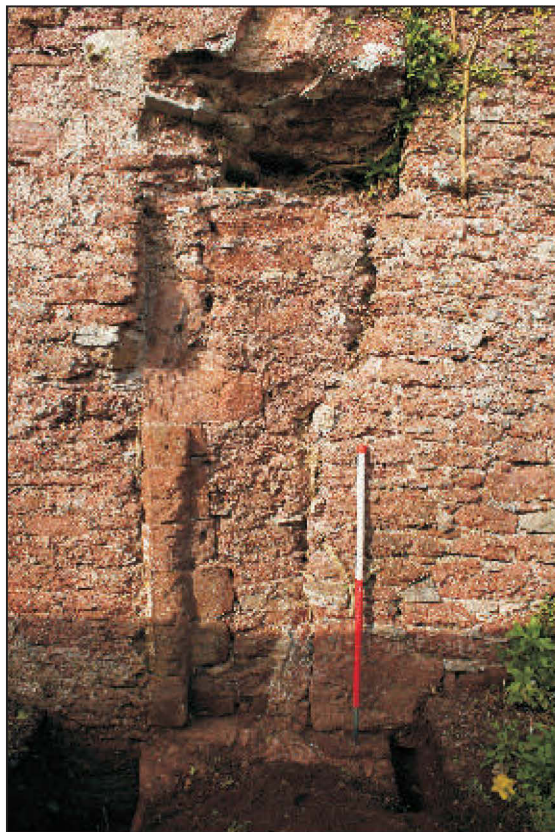
Plate 3: Doorway in wall F303, viewed from the south. 1m scale.

The wall incorporates a large number of features, which are described from east to west. The masonry at its east end, along with the stub of the wall returning to the south, contains two significant architectural features. At ground-floor level are the remains of a doorway in the north-south wall. The surviving masonry comprises seven courses of chamfered sandstone jambs set into splayed stonework. These incorporate a rebate for the door, which opened to the east. There are holes in two of the jambs, one possibly associated with a frame, the other for a lock or latch. The surviving masonry above the doorway is slightly arched. Above the doorway is a void, possibly representing a socket for a lintel. Above this, on the south face, the wall has a ragged break, but on the outside face there are eight red sandstone jambs forming the western side of a former first-floor window opening (see also Bishop 2012, fig. 22a). The window is at different height to the ground-floor doorway and the first-floor

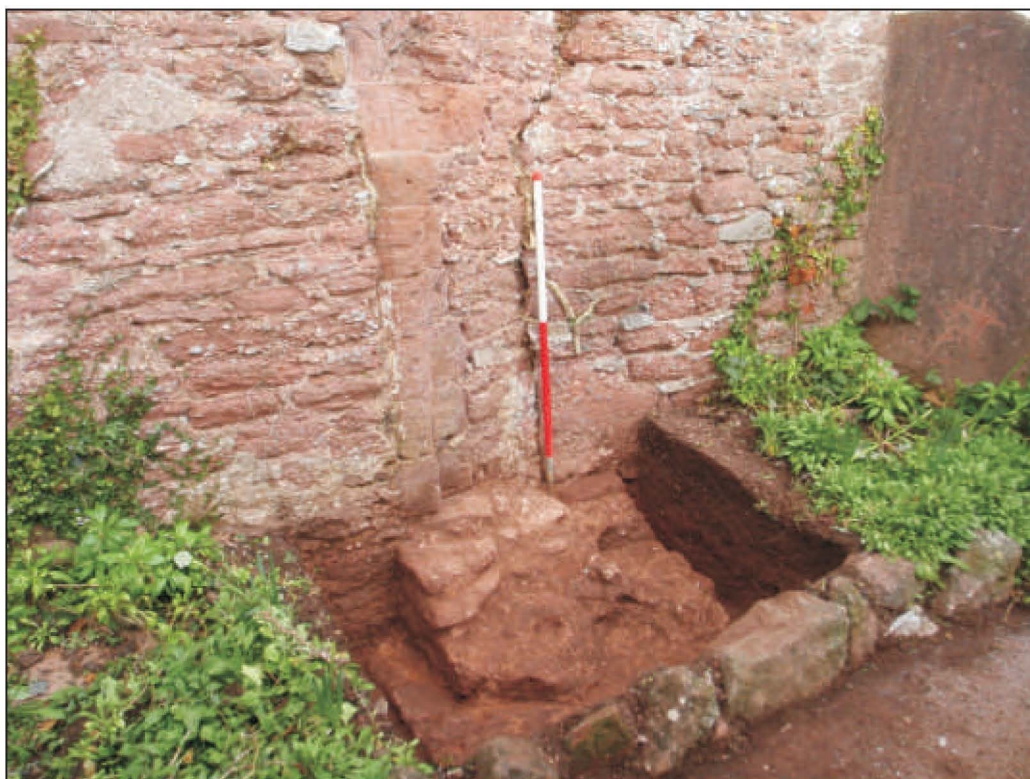
Plate 4: Footings 304 of doorway in F303, with later wall F605 beyond, viewed from the southwest. 1m scale.

constructed of breccia bonded in a hard white lime mortar. The breccia is much coarser than that used in the earlier walls and contains distinctive large grey sandstone inclusions. As noted above, at ground-floor level, the wall underpins earlier masonry F303, but at first-floor level infills a window opening. Here only a 1.6m length of wall survives before it is truncated by the mid 20th-century entrance to the Church Hall. The fabric contains a single putlog hole.

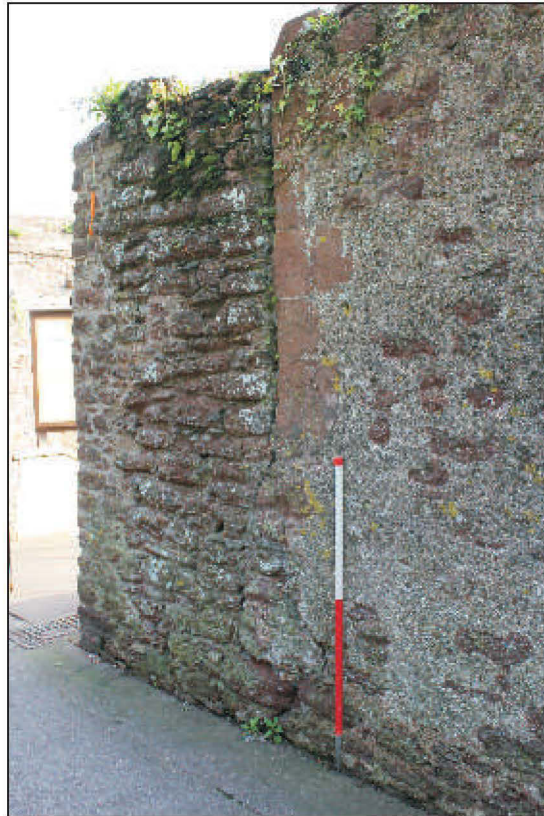
Plate 5: North curtain wall, external elevation showing sandstone jambs of window opening in F303, with later wall F605 beyond, viewed from the northwest. 1m scale.

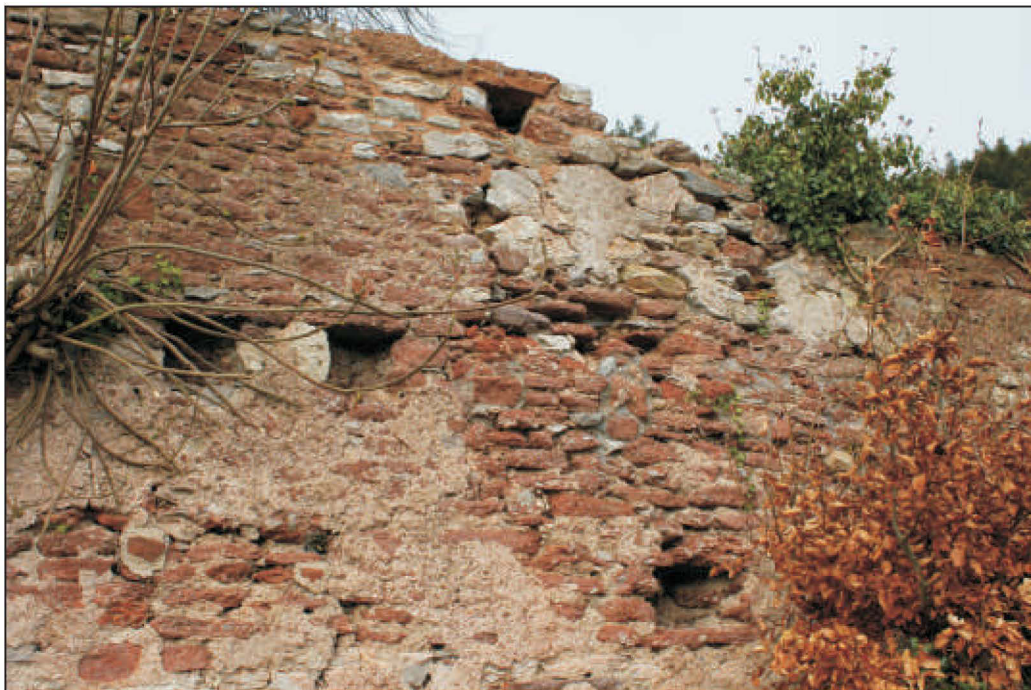
Plate 6: Joist sockets of first floor in F303, viewed from the southwest.

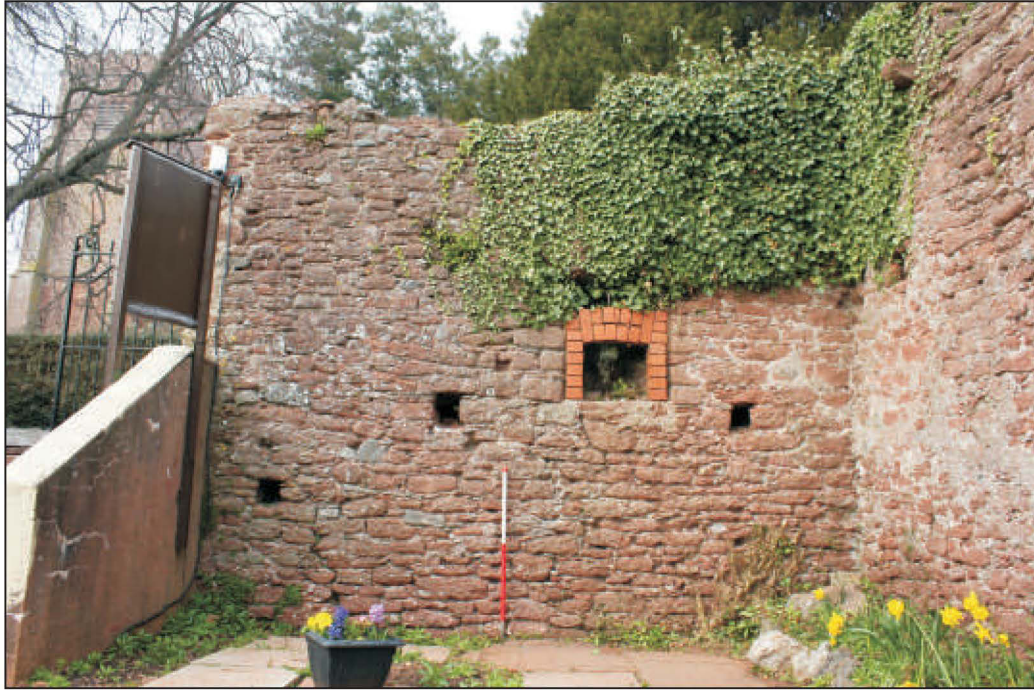
Plate 7: Wall F607, south internal elevation, viewed from the south. 1m scale.

To the east of the entrance to the parish hall the masonry continues (as F607) for a further 4.40m before it turns to the south and forms the east boundary of the palace. The wall contains a low-level putlog and a further pair of higher level putlogs that flank a splayed looped opening. On the inner face, the lintel has been removed, but its position is discernable through a rectangular socket. Above this there is a relieving arch, into which two shallow sockets associated with the roof of a later building have been added. The opening below had been partially infilled with an arched brick opening (610); this was removed during the consolidation works. To the east of the opening, at the corner of the wall is a shallow socket that also extends into the north-south return. At the top of the wall are further putlog holes, a corbel, and a blocked opening that may represent an infilled merlon. The top of the wall has been consolidated (604), and material associated with these repairs infills the possible merlon.

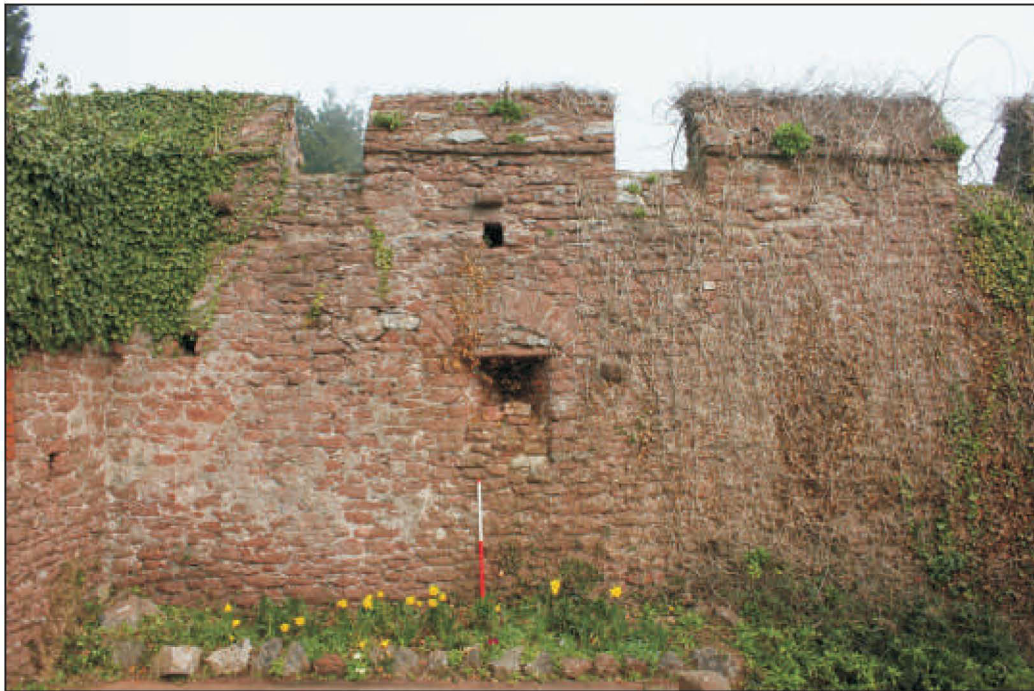
Plate 8: Wall F607, east internal elevation, viewed from the west. 1m scale.

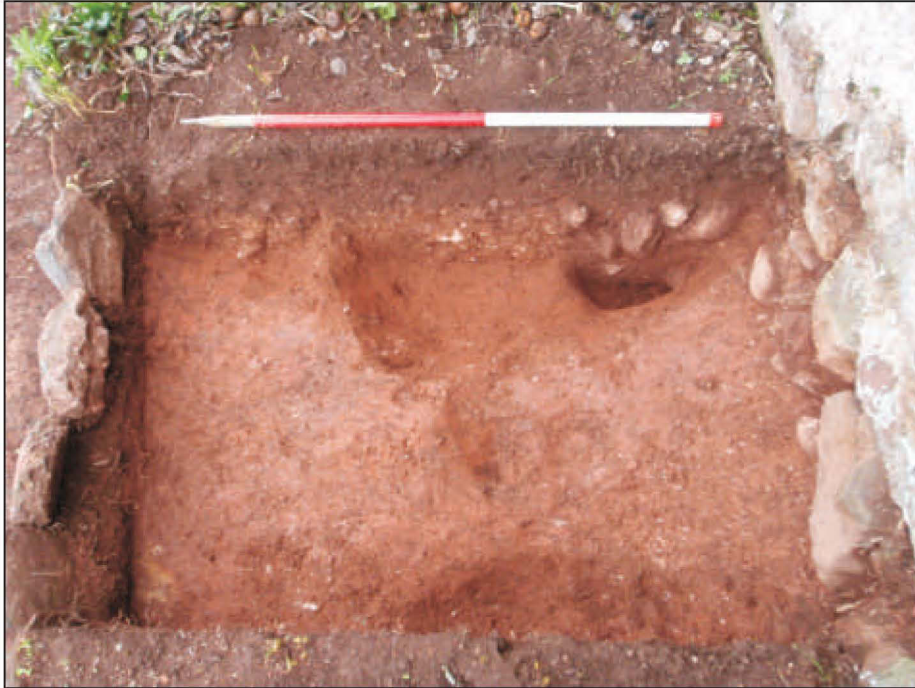
Plate 9: Test pit 1 showing features F102, F104, F106 and F108, viewed from the east. 1m scale.

A series of small pits (F108, F106 and F102), partially exposed within the test pit, had been cut into Layer 112. Their fills (109, 107 and 103 respectively) contained crushed breccia and lime mortar. A single fish vertebrae was recovered from 103, and two sherds of 18th- or 19th-century grey stoneware were found within 109. The presence of construction or demolition debris within their fills may indicate that these pits were associated with the rebuilding of the palace wall to the west in the 19th century. A deeper pit (F104) had been excavated through pit F102. Finds from two of its fills included sherds of flower pots and a fragment of 19th- or 20th-century blue transfer-printed industrial china. The pit was sealed by modern garden soils (100 and 101).

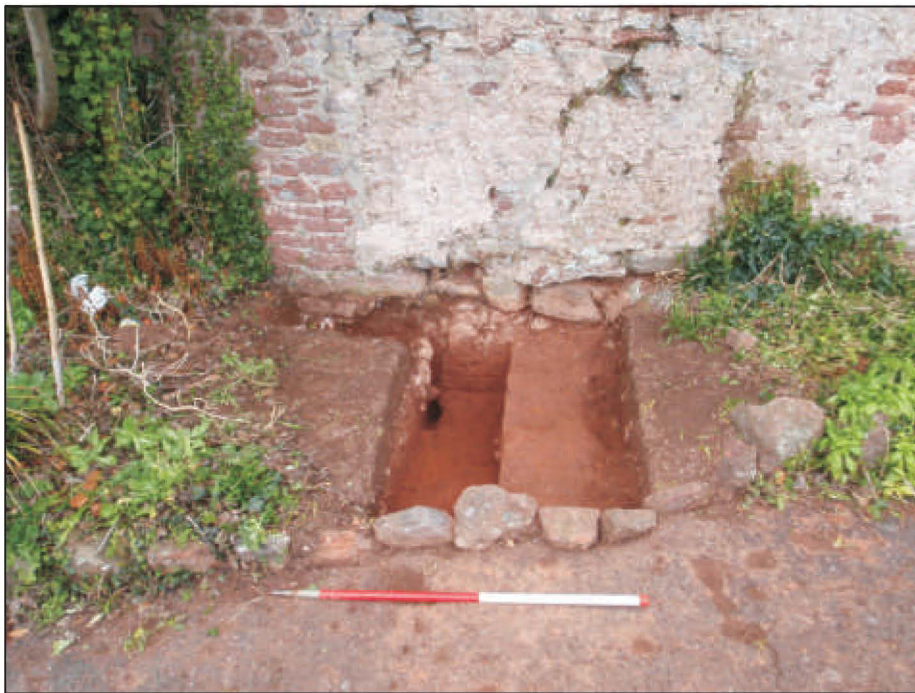
Plate 10: Test pit 1, post-excitation view showing footings 114 of wall F600 and 19th-century infilling to left, viewed from the south. 1m scale.

This pit was located at the west end of the main length of medieval fabric (including F600). The wall footings (114) comprise unfaced clay-bonded sub-angular mixed limestone and breccia with rare water-worn stones. It had been constructed onto (or into) a friable light red sandy clay containing occasional mortar fragments and flecks (112). This deposit was a redeposited subsoil, possibly a levelling layer. It overlaid a thin friable mid-red sandy-loam with rare mortar fragments (113). This is possibly a buried soil and overlaid the natural subsoil (116).
