THE HELE ARMS, MARKET STREET, PLYMPTON,  
PLYMOUTH

Results of historic building recording

Plymouth City Council planning reference 12-00135-FUL  
(conditions 18 and 19)

Document No: ACD645/2/1

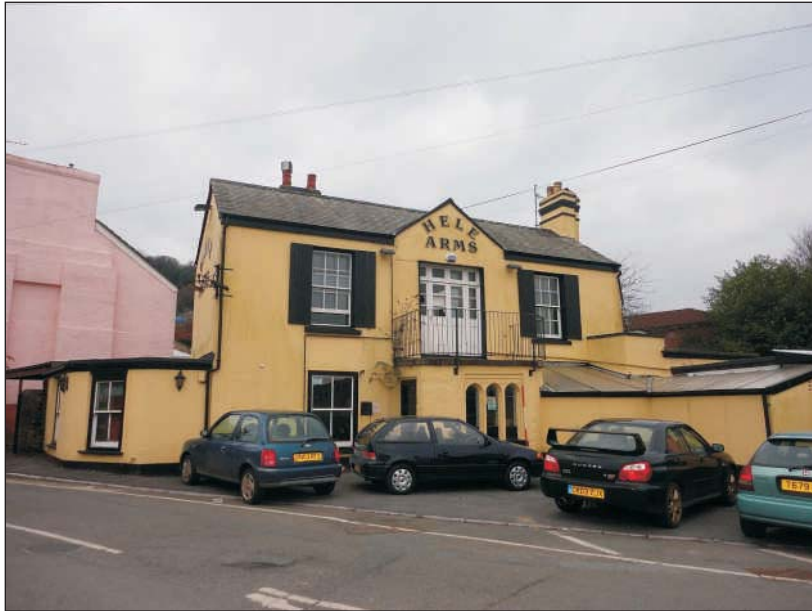
Plate 1: General view of the façade from Market Street, looking south. 2m scale

The nucleus of the buildings appears to be the two-storey rectangular block which forms the main building of the pub and occupies the eastern part of the site (Plate 1). The rest of the complex consists of low, single-storey ranges of outbuildings, perhaps replacing the skittle alleys and other facilities mentioned in the sale notice of 1855. Part of the façade is concealed by later walling intended to create covered passages to connect the main building with a latrine block, which was erected in the forecourt of the building in the late 19th-century and presumably drained into the adjacent stream. This structure may originally have been freestanding and may have incorporated an open air urinal.

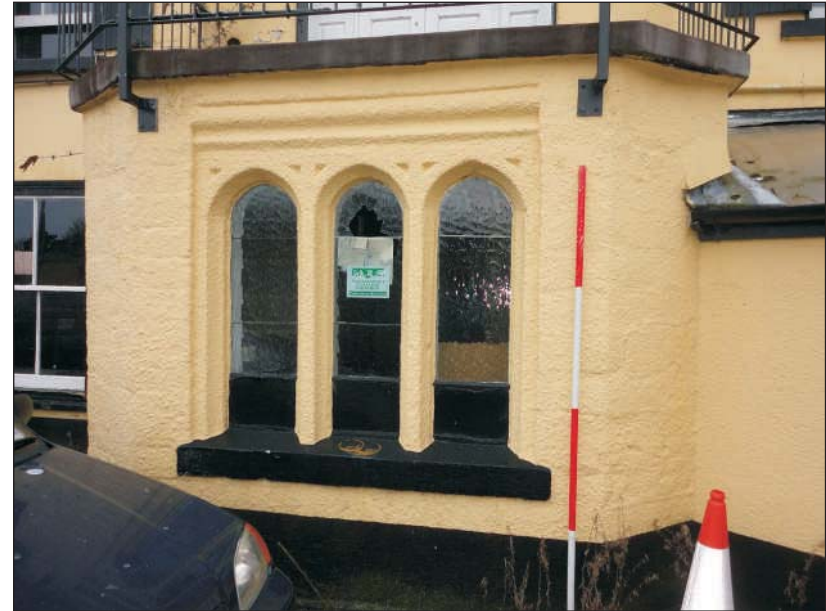
Plate 2: Detail of the reused late-medieval bay window built into the porch. 2m scale

The porch is of great archaeological interest, since it appears to have been adapted from a late-medieval oriel or bay window (Plate 2). There is no evidence that this is *in situ*, and it is most likely that it was brought from elsewhere and reassembled on this site. The window has canted sides with simple square-headed doorways to east and west. It is uncertain whether or not these doorways replace side lights to the window, or whether it was formerly of shallower projection without side lights. The canted jambs are constructed of ashlar masonry quite different from that of the rest of the building, while the central three-light window has monolithic dressings forming three tall, slightly pointed uncusped lights with indented spandrels and

external chamfers. Above the window is a wave-moulding, perhaps part of a longer string course or drip-moulding over the window. Internally the mullions are unusually square, without rebates for shutters (Plate 3). The massive scale of the mullions may, of course result from the use of an intractable material, such as granite. The window is thickly encrusted with layers of paint, but these layers peel off surprisingly easily. The dating and original form of the window (which may have been altered, for example by the trimming off of cusps to simplify reglazing) could only be established firmly with the removal of all of this paintwork. There seems no reason to doubt that this is indeed the remains of a late-medieval oriel window, reused in this position to give some architectural distinction to the entrance to the pub. It is highly unlikely that this window dates from the 13th century, as has been suggested in the Heritage Statement (Le Page Architects, 2012, Section 2.2) and other authorities (such as Cynthia Gaskill-Brown; *ibid.*) Square-headed mullioned windows with monolithic dressings like this, especially in granite, are characteristic of high quality buildings of the 15th and early 16th centuries in the locality. 'The Prysten House', in central Plymouth, for example, features a similar shallow bay on two storeys over the main doorway, both with side lights and with wave-moulded string- or drip courses over, very like that of the window at Plympton. The most likely origin of this window is a lost, earlier building nearby, either part of the Priory ruins or perhaps a large, late-medieval house in the area.

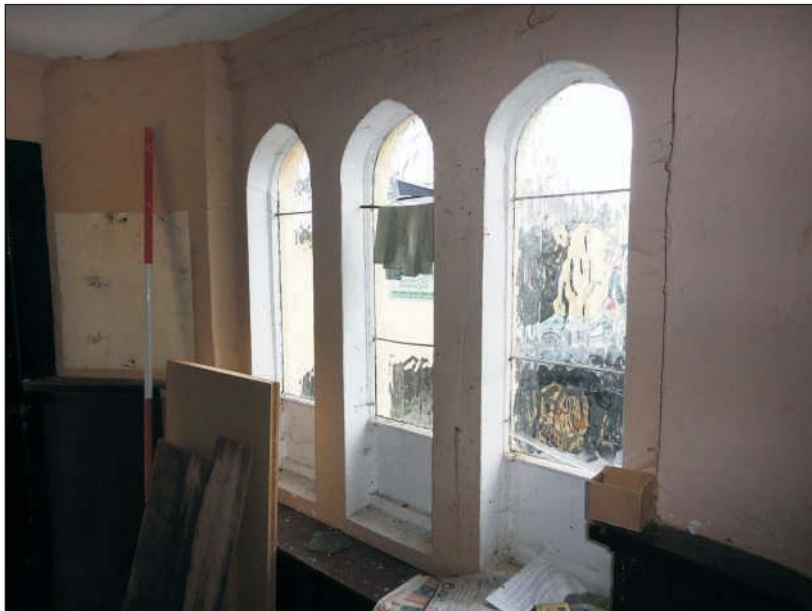
Plate 3: Detail of the window from the interior showing the thick, square mullions and the absence of rebates for shutters. 2m scale

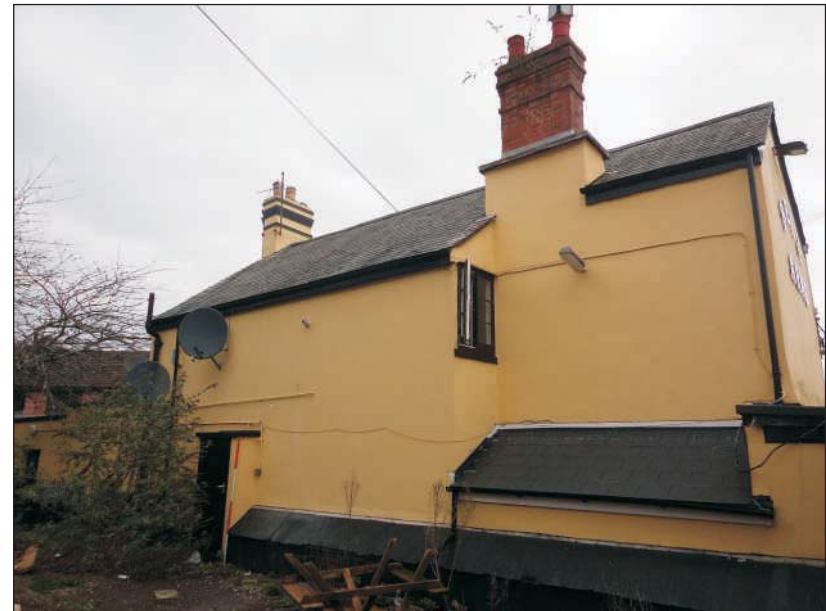
Plate 4: View of the rear elevation showing the presumed French drain running along the base of the wall. 2m scale

This elevation was formerly closely overshadowed by the neighbouring house to the south. It is extremely plain but contains some enigmatic features (Plate 4). Running all along the base of the wall is a broad, slate-capped feature of uncertain function. This is very probably a French drain constructed to minimise damp problems by isolating the building from the higher ground to the south west. The rear wall of the building is completely blind, except for two small doorways at ground-floor level. The upper part of this elevation is offset to the north at the eastern end, beyond which is a low lean-to roof covering the small, tunnel-like store behind the back wall of the main building. The central and western parts of the offset contain the staircase (lit by a casement window in the return wall of the offset) and a corridor which may have formerly communicated with the ancillary buildings to the west. The upper part, above the corridor is now bathrooms, but had a specific function related to the public house use, which will be discussed below.

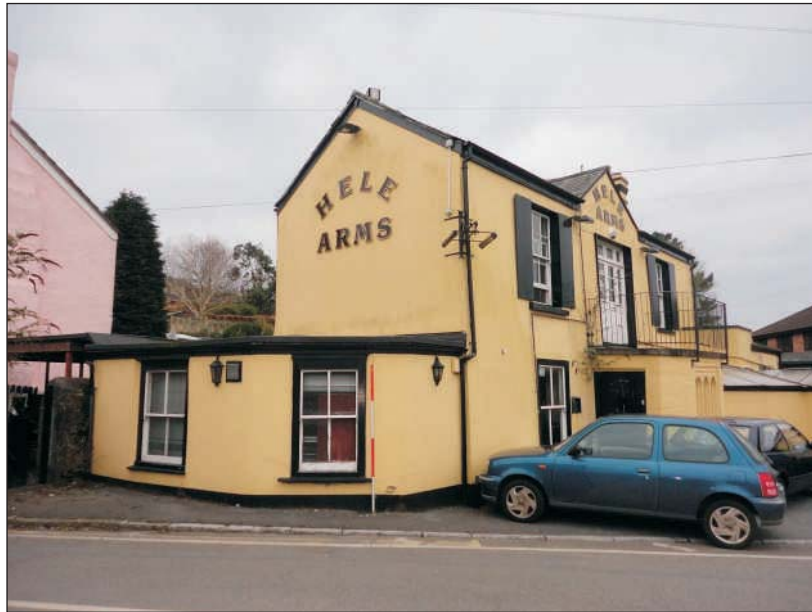
Plate 5: View of the eastern gable, with the low bar room projecting from it. 2m scale

The main building has a double-fronted façade, with a central entrance, under a low-pitched slate roof (Plate 5). These are all features typical of 18th or early 19th century domestic architecture rather than of earlier vernacular buildings in the region. The plan of the building is only one room deep, with but a narrow corridor-like space to the rear. This contains the staircase and a low, tunnel-like room within a very narrow lean-to structure extending alongside the northern boundary wall of the beer garden. The walls of the building are rendered and the masonry is not visible externally; however, where it has been stripped internally, through the removal of a dado or fixed bench seating, it shows as random rubble consisting of small, flat stones. Unfortunately this is painted with a black damp-proofing treatment and the mortars and geology were for the most part obscured.

Extending to the east of the main block is a low polygonal building with a flat roof and an angled corner to the street (Plate 5). Although this looks like an extension it appears on early maps of the site and must at least be of mid-19th-century date. The building is lit by two early 20th-century four-paned sash windows. It is probable

that one of these was formerly a doorway, since its jambs run down to floor level internally. This area may have formed one of the bars mentioned in the 1855 sale notice, with its own separate entrance from the street. Above roof level the eastern gable end of the building is blind, though there is evidence, internally, of a large window here with an arched head. There is no chimney stack in the end gable, instead, this is located against the rear wall of the building.

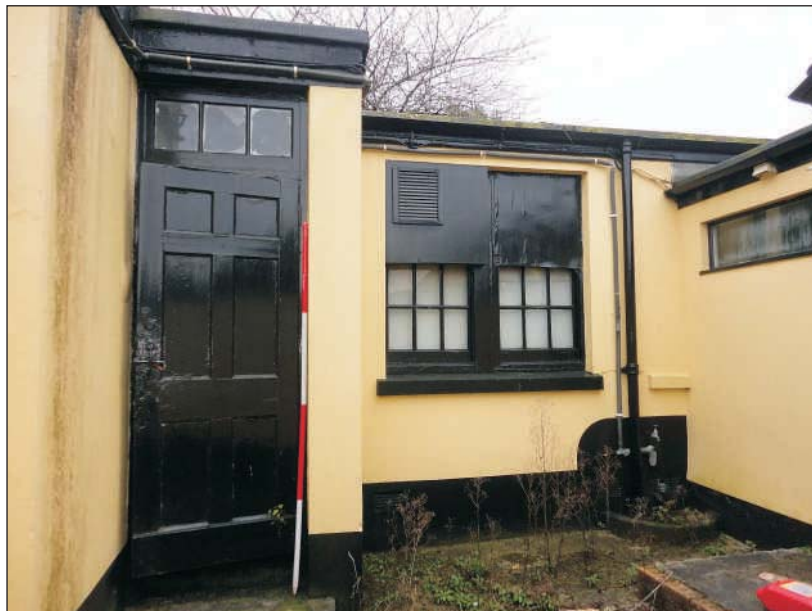
Plate 7: Detail of the 20th-century façade of the west wing, as rebuilt c.1930. 2m scale

The façade of this building facing northeast was more elaborate, despite looking onto the narrow court to the west of the presumed latrine block. This façade has rather elegant neo-Georgian detail, which suggests that it may have been entirely rebuilt in the early 20th century during a phase of improvement and enlargement of the pub facilities, perhaps c. 1930 or a little later (Plate 7). This façade included a large tripartite sash window with many-paned sashes, within a projecting bay now looking onto the covered passage to the ladies' toilets. A second window of paired sashes remains to the west, in a recessed part of the façade looking onto the courtyard. This part of the building was served by its own separate external doorway with a projecting porch containing a six-panelled door and glazed overlight, which may have provided an entrance to one of the bars or function suites. The doors and windows have all since been blocked and the orientation of the building is now away from the courtyard towards the beer garden behind. It is unlikely that much 19th-century fabric now survives in this building.

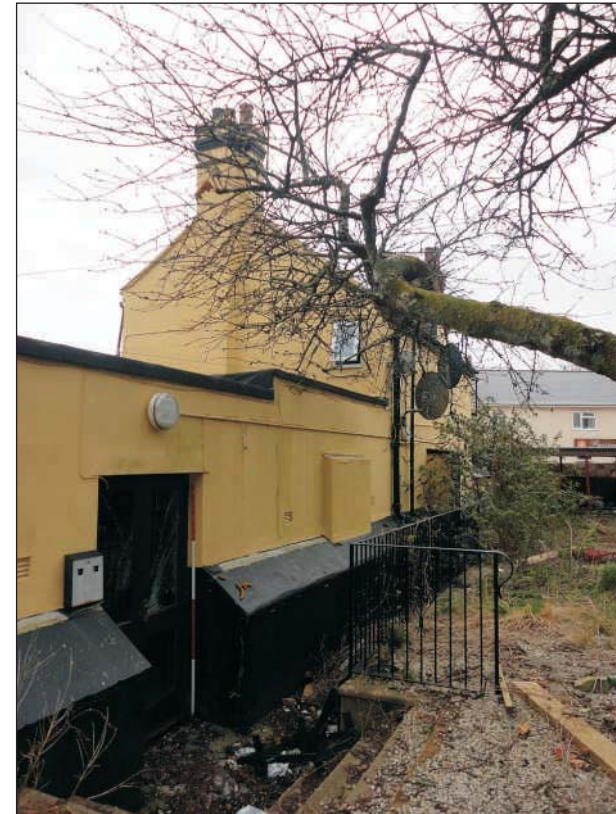
Plate 6: View of the western gable and the rear elevation of the west wing. 2m scale

The western gable end is now obscured by other buildings but rises clear of these above first-floor level (Plate 6). It has a large, T-shaped chimney stack, presumably serving three fireplaces: one on the ground floor and another on the first floor of the main building and a third fireplace backing onto these at ground-floor level within the lower buildings to the west. Both chimney stacks have attractive ornamental tops of corbelled brick.

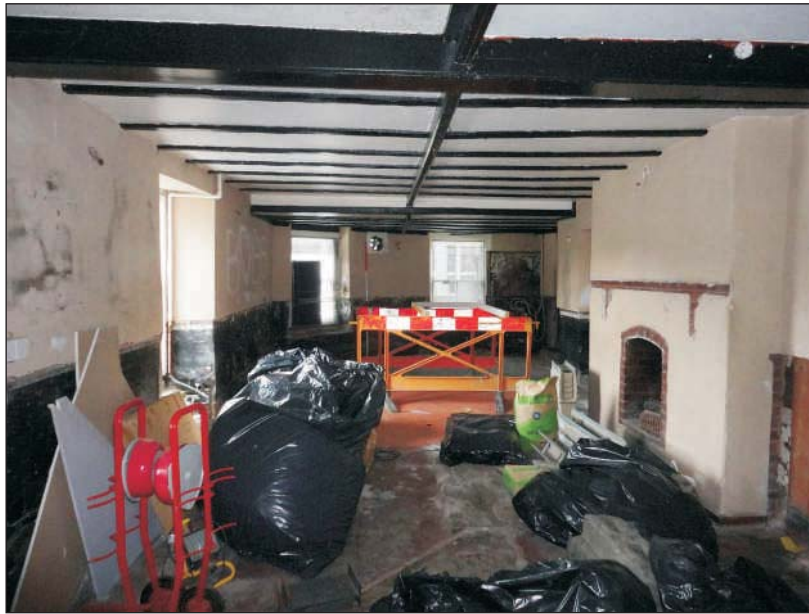
Plate 8: View of the interior of the main bar, looking east

The interior of the main building has been gutted to unite the whole of the ground floor into a single open space (Plate 8). This is likely to be a late 20th-century alteration since, until the last decades of the 20th century, it was the custom for public houses to be divided into separate, smaller areas, such as private parlours, 'public' and 'lounge' bars to cater for private drinking as well as for different social groups, classes and (to an extent) sexes. There is little visible evidence of the original layout of this part of the building. However it may have been divided into two bars by a central passage running across the building to meet the rear wall. The line of the passage is perhaps betrayed by beams in the ceiling, but these could well have been installed as part of the 'picturesque' olde-worlde beaméd make-over which the building appears to have suffered in the late 20th-century (as in so many pub interiors), and the beams are not wholly to be trusted. The presumed line of the passage, for example, does not link the front door to the doorway in the rear wall communicating with the staircase and, from this, we may postulate either that the passage turned in a dog-leg to the west or that it ended in a blank wall. The position of the staircase, which would appear to be contemporary with the building, would preclude a blocked doorway in this position. The door communicating with the staircase retains a fragment of a partially glazed screen incorporating a doorway and side-lights fitted with coloured glass panes and panels with exaggerated raised fielding (Plate 9). This feature is probably also of primary date. The door, which probably had margin lights and glory stars reflecting this detail, has been removed.

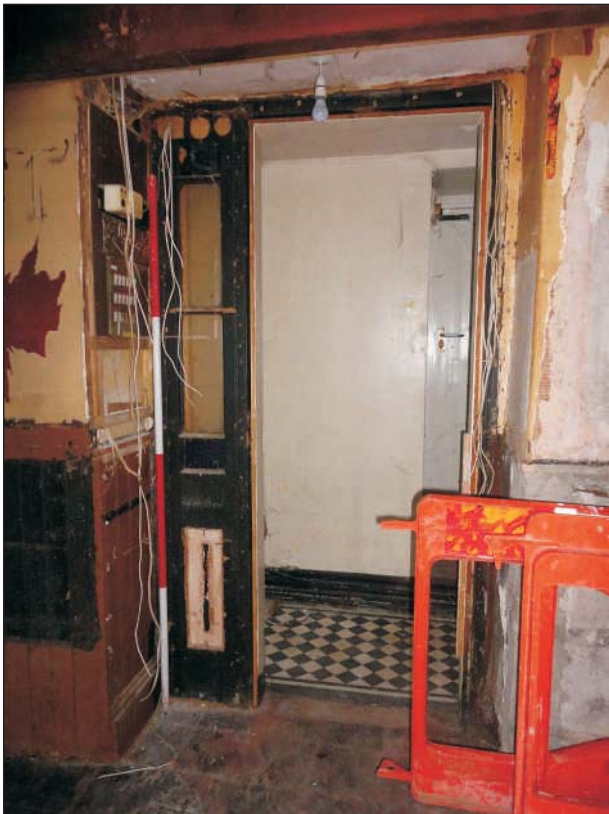
Plate 9: The remains of a glazed screen separating the corridor and staircase from the main bar. 2m scale

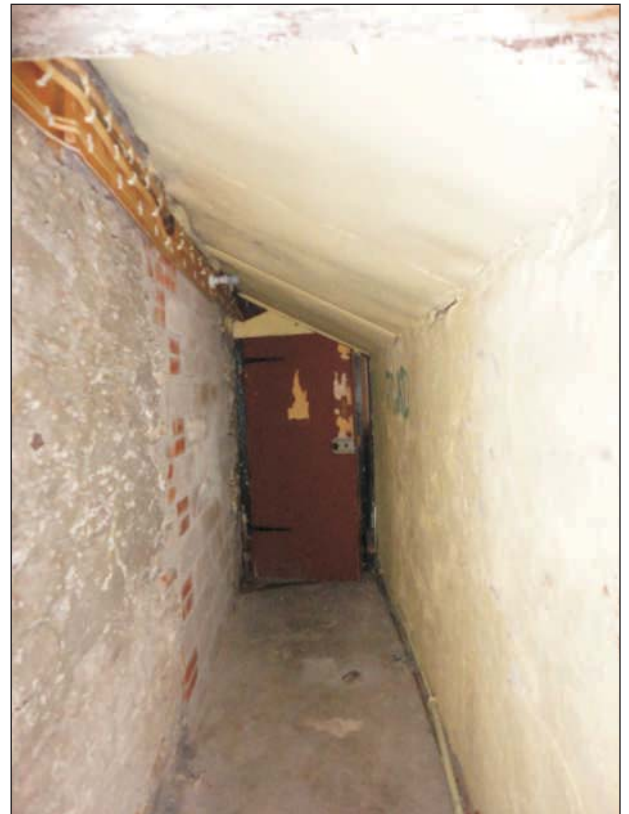
Plate 10: The curious, tunnel-like room in the rear lean-to, looking east

The eastern room was heated by a fireplace in its rear wall, alongside which was a doorway communicating with the narrow tunnel-like store beneath the staircase (Plate 10). Although it is a very narrow space, this might have been used as a cellar for the storage of more valuable victuals such as port, sherry or brandy, and it is thus possible that these rooms were set aside for the more high-spending customers. The room was originally divided by a wall from the polygonal room

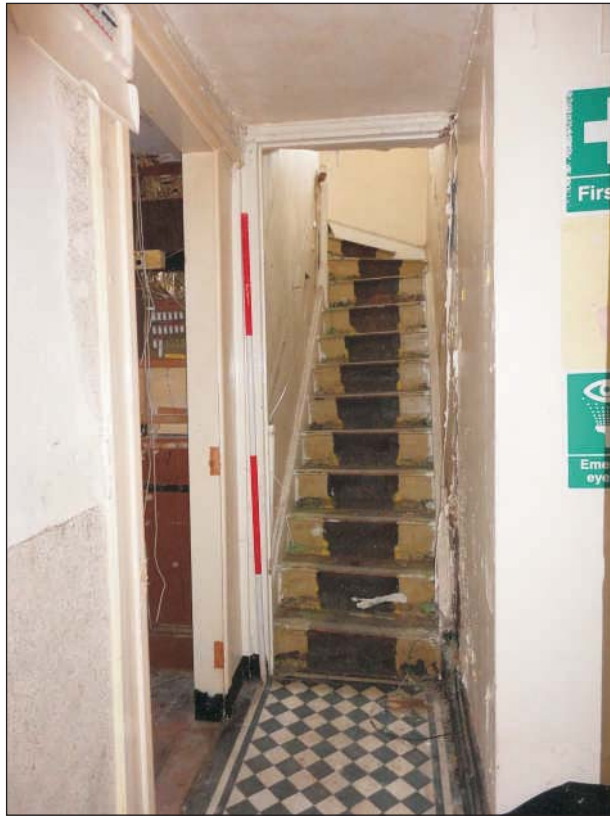
Plate 11: View of the corridor and staircase to the upstairs function rooms. 2m scale

The room is approached by the staircase at the rear of the house, which rises within a very narrow space enclosed by solid walls but which, nevertheless, was provided with a balustrade featuring turned typically mid 19th-century newels and a moulded handrail, now unfortunately much damaged (Plate 11). At the summit of the staircase, in the rear wall a doorway opened onto a large room, the original dimensions of which match those given in the sale notice. The room has since been divided into separate bedrooms but originally extended through the western two thirds of the first floor and for the full depth of the building. In its south-western wall was a wide alcove, forming part of the room and arranged centrally to it, with a domed ceiling contrived below the eaves (Plate 12). This has been converted into a bathroom, but it is divided from the room only by a thin modern partition, and it must originally have been an open alcove. This was probably provided for musicians to stand or sit in during functions, or perhaps, for the table and dais used at public meetings.

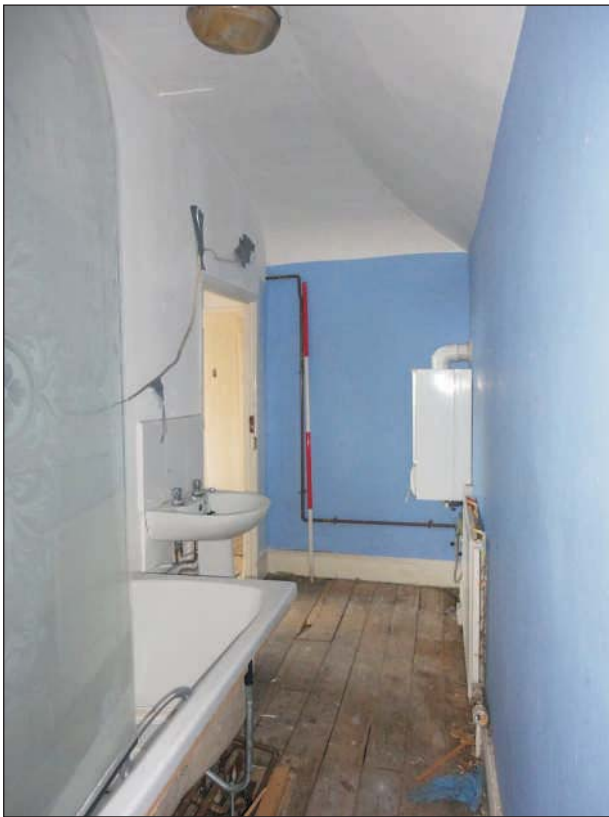
Plate 12: The alcove off the main function room, looking east, showing the domed ceiling and arched opening to the room, infilled by a modern partition. 2m scale

The room was heated by a fireplace in its western wall, now blocked, and was well ventilated by large windows. Part of the ceiling of the room, within the wide window opening onto the balcony, was domed upwards into the roof space. This part of the ceiling has deep coved cornices roughly 0.5m tall, now concealed by a lower suspended ceiling, but decorated with reeded plaster ribs and also, possibly an embossed wallpaper. It was not possible to ascertain whether or not there was a central ceiling rose for the suspension of a chandelier, or any other decorative plasterwork, but it is most likely that this area formed the dance floor and was thus distinguished architecturally from the areas set apart for the musicians and the spectators.

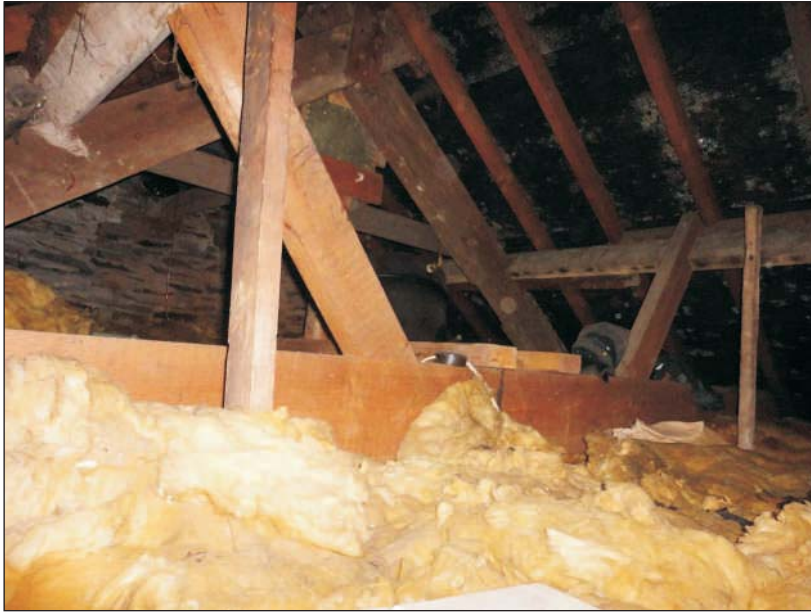
Plate 14: View within the roof, looking west, showing one of the primary trusses

The roof of the building could not be accessed for detailed inspection, but a small inspection hatch allowed it to be photographed remotely. The raised, coved ceiling of the central part of the building prevented a clear view to the east, but the lower ceiling of the western part of the room allowed views of the roof structure over this part of the building (Plate 14).

The roof is supported by tie-beam or 'A'-frame trusses with very low collars, the lower parts of the principal rafters being concealed by modern insulation material. The principal rafters are halved and crossed at the apex to cradle the ridge tree. A short timber nailed to the apex provided additional bearing for the ridge tree, which does not survive. The purlins appear to have been disturbed, since they bear the marks of the rafters on their undersides, but these timbers originally appear to have been trenched into and staggered over the backs of the principals in each bay. The coved ceiling of the central bay is supported on short, curved timbers (Plate 15) apparently resting on the tie beam of the second truss from the west, suggesting that there may be as many as five bays in total. The roof has been rebuilt in the 20th century and, as far as can be ascertained, new common rafters have replaced the originals, resting on reused purlins derived from the original structure.

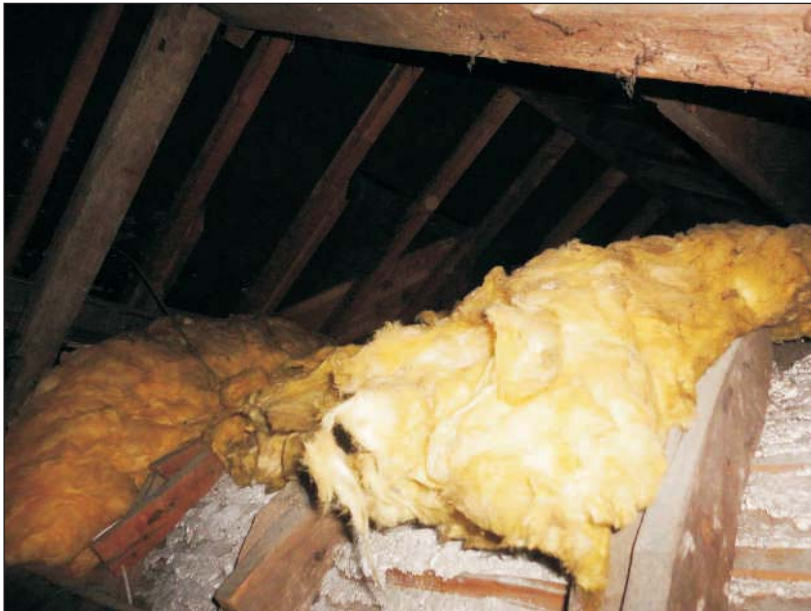
Plate 15: View within the roof, looking east, showing the domed structure over the central bay rising within the roof space

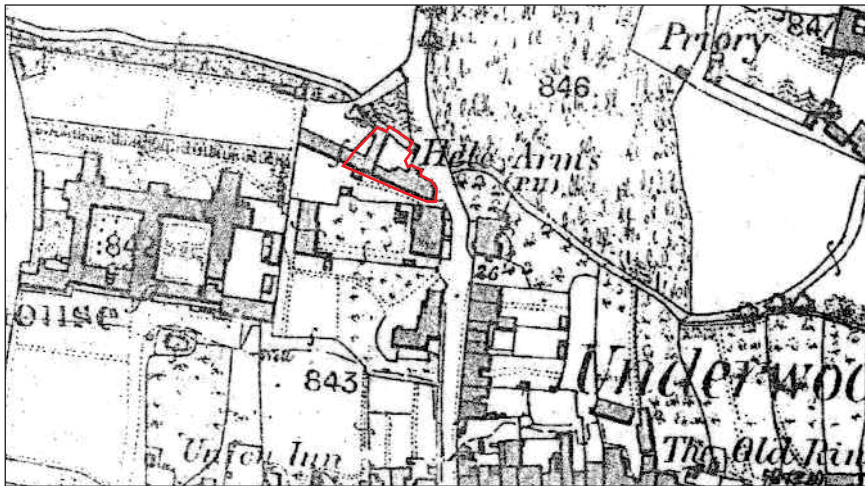
Map 2: Extract from the Ordnance Survey map, 1867
