# ROYAL WILLIAM YARD, WESTERN KING STAIRCASE, STONEHOUSE, PLYMOUTH

Results of historic building recording and archaeological  
watching brief

Planning ref. Plymouth City Council 10/02094/FUL (Condition 3)

Document No: ACD609/2/0

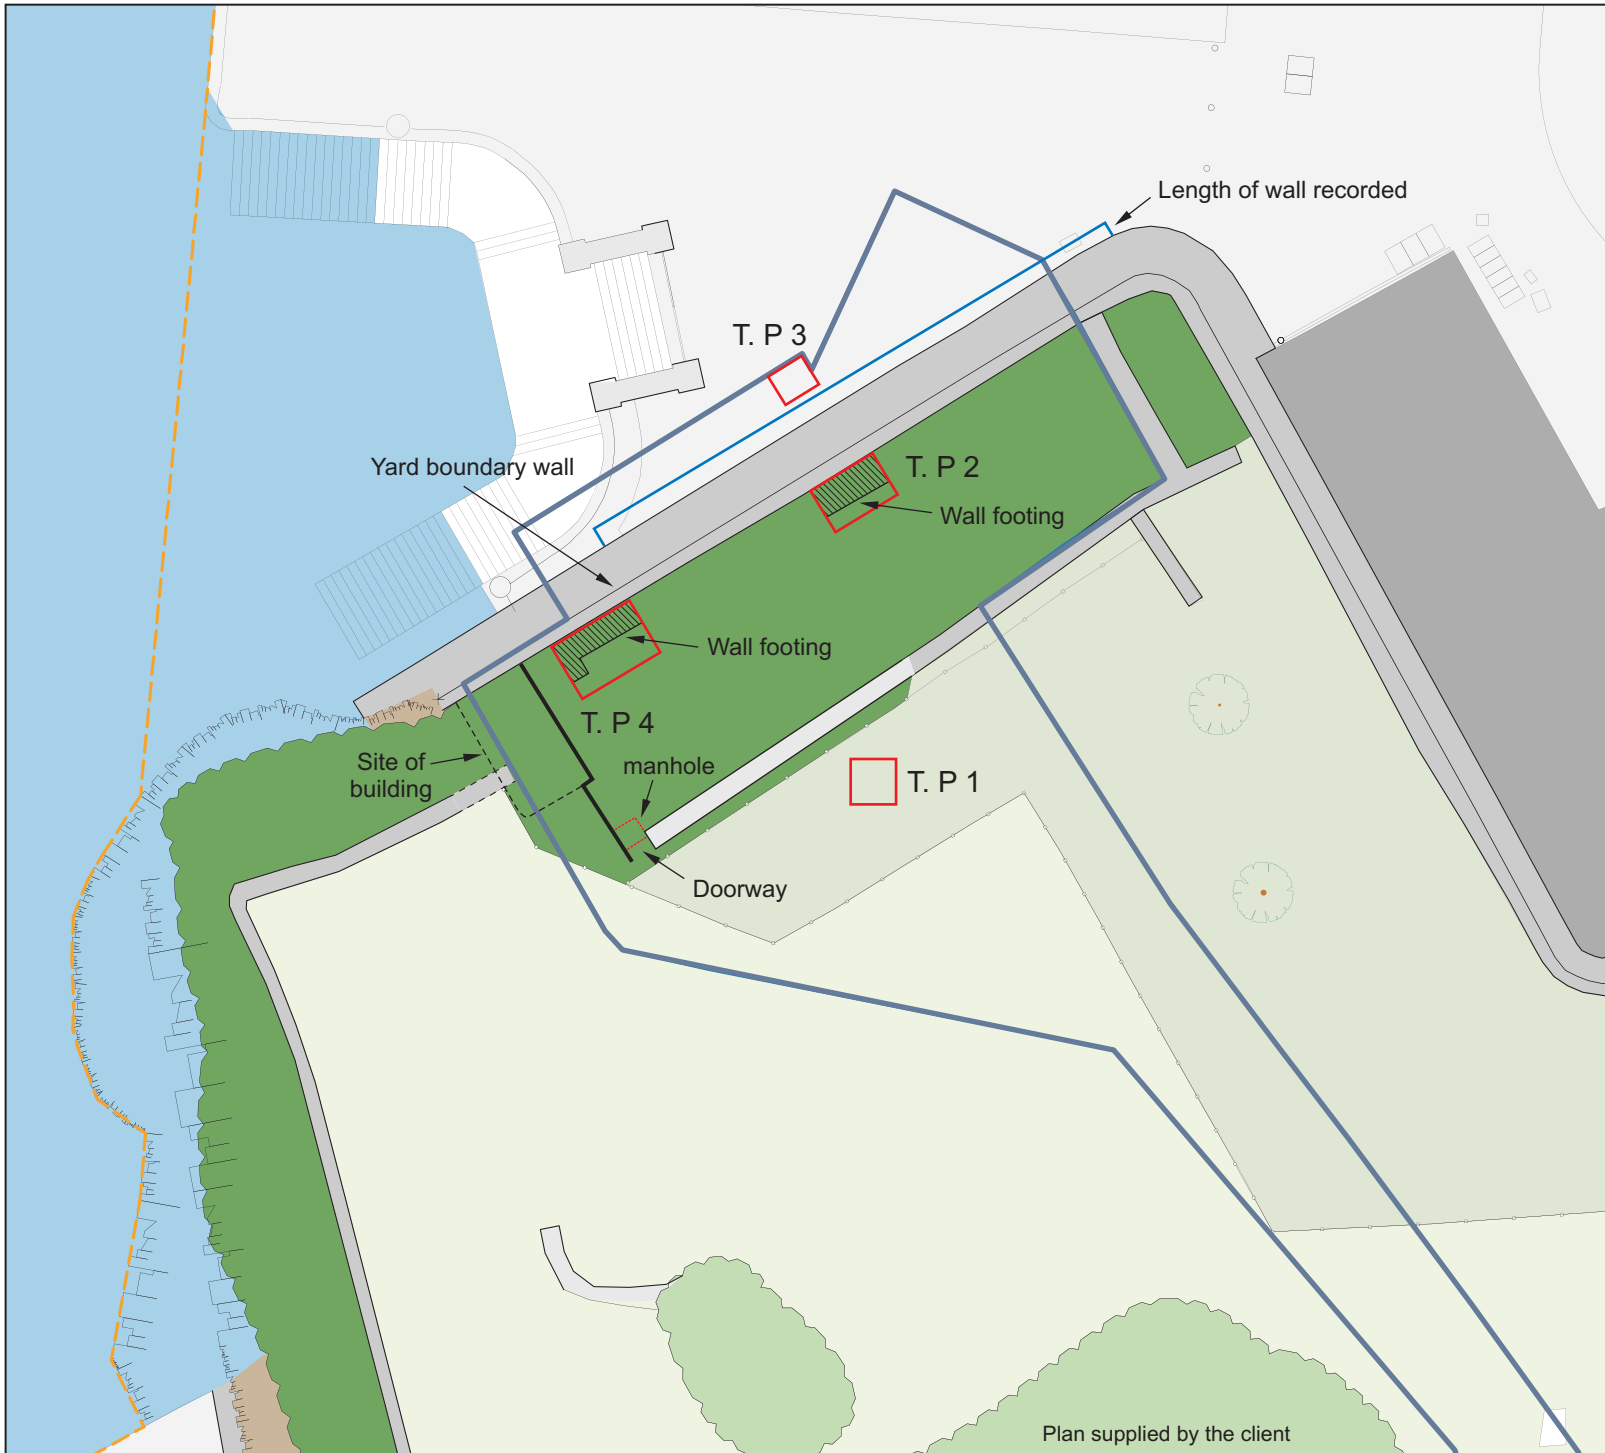
TITLE  
**Fig. 2: Location of observations**

- Test Pits 1-4
- Site area

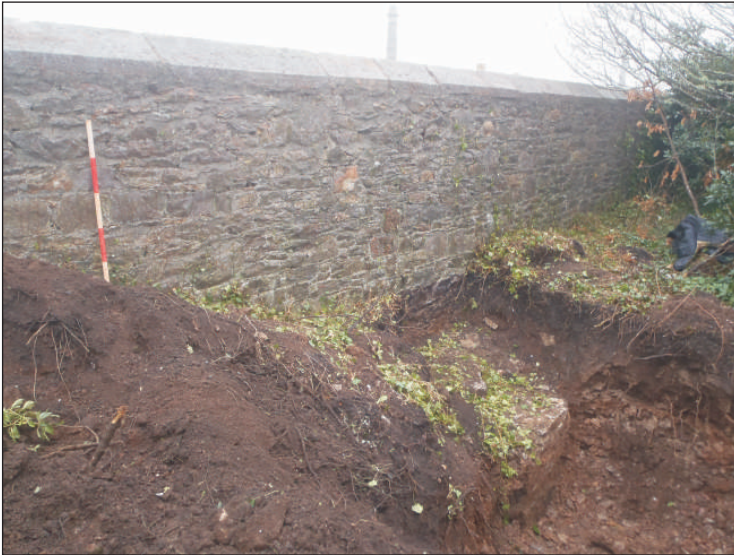
Plate 1: Test Pit 4 showing the yard boundary wall (2) and its projecting footings, viewed from the southwest. 1m scale.

This test pit was located adjacent to the Yard wall on Western King and measured 3m long by 2m wide by 3m deep. The only deposit exposed (12) comprised a friable mid reddish-brown silty-loam containing dumps of sub-angular limestone and granite fragments. This deposit was of 19th-century date and had been backfilled over the top of the Yard wall.

At a depth of 0.4m from the surface wider footings that stepped out 2m beyond the base of the parapet were exposed. In the southern end of the test pit further masonry projecting from the footings, and forming a buttress, was partly uncovered. Inspection of historic maps (Passmore 2010, Figs 4 and 5) appears to indicate that here, a natural scarp turned west from the Hamoaze to form the northern side of Western King. This thicker masonry was therefore probably required to support the end of the retaining wall where less stable rock was present, and at ground level it terminated at the sea wall around the waterfront of the Yard. The masonry is roughly coursed, although the stone was more irregularly laid towards the base of the exposed wall.

- 7.1 A record of the Yard boundary wall was prepared prior to works commencing. No significant new observations were made. The masonry exposed in test pit 4 provides details of the engineering required at this location. Previous observations to the southeast (see section 2.5 above) have demonstrated that the boundary wall had little or no foundations. Here, substantial masonry was constructed behind the northern elevation, and must have been required due to its position on the waterfront and the nature of the topography of the hillside behind.

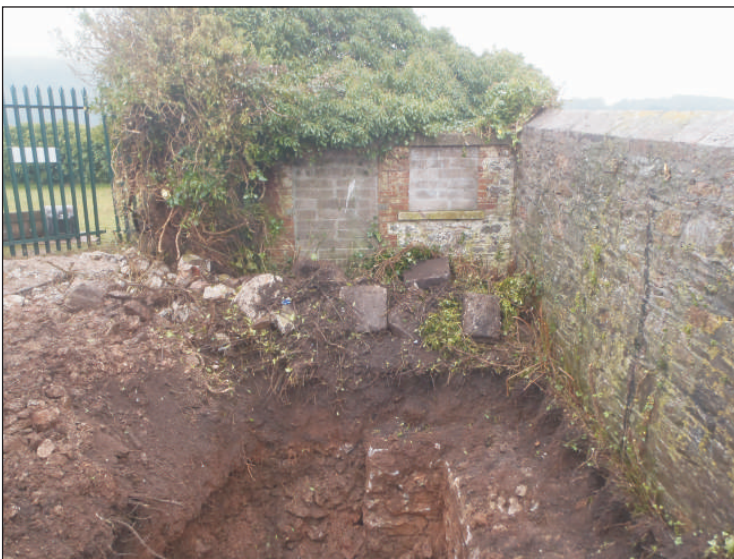
Plate 2: Test pit 4 showing the footings of the yard wall, with the northern part of upstanding wall 1 in the background, viewed from the east.

This wall (1) is attached to the southwest end of the Yard wall, and encloses an area of approximately 21m by 7m. It is constructed of irregularly-laid limestone measuring c. 200mm x 200mm x 140. The east and south walls survive to full height whereas the west wall was in part only eight courses high, and was capped with dressed granite blocks measuring c. 500mm x 500mm x 140mm. The north end of this west wall stepped into the east and this delineates the position of a former building on its west side. It incorporates a blocked doorway and window opening, both of which have brick jambs. This building is depicted on 19th-century Ordnance Survey maps (Passmore 2010, figs 5 and 6). The wall is abutted by a later (?20th-century) wall defining the edge of the higher ground at the northwest end of Western King.

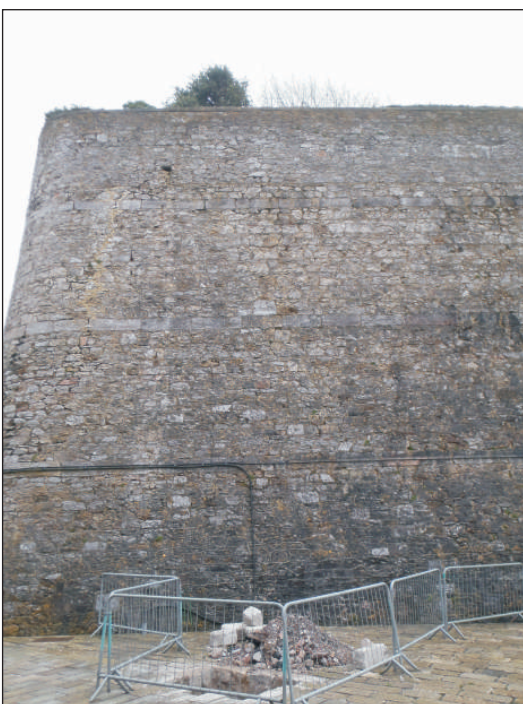
Plate 3: The interior elevation of the yard boundary wall, viewed from the north.

The wall is constructed of roughly coursed limestone blocks measuring from 100m x 80mm to 700mm x 200mm in size, bonded in a cream-buff sandy lime mortar with gravel inclusions. The northern face is broken up by three string courses comprising dressed blocks of limestone, each measuring up to 1.4m long by 300mm deep. The lower section of the wall has been partially repointed in cement render.

The wall is generally featureless. To the west of the staircase, in the upper section of the masonry is an iron bracket and two pulleys (see section 2.6 above). To the east of the staircase, in the middle section of masonry is a corroded iron bracket. Cables have been attached to the lower string course. There is a single square drainage hole towards the top of the wall, whilst further west is a vertical series of three circular drainage holes, inserted into the original masonry.

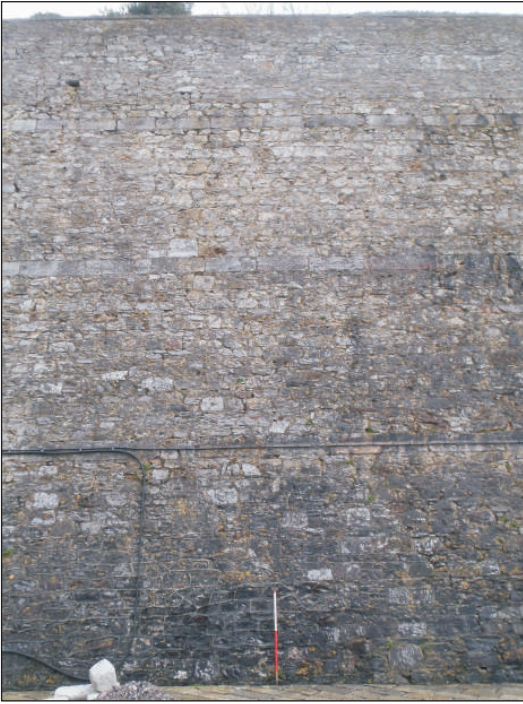
Plate 4: The interior elevation of the yard boundary wall, viewed from the north. 1m scale.

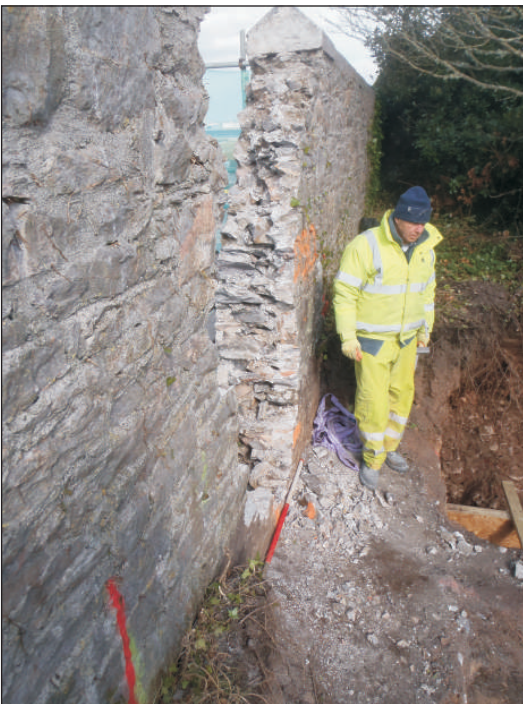
Plate 5: The parapet of the yard boundary wall during breaching, viewed from the southwest. 1m scale.

The parapet wall is 2.90m high by 400mm wide, and is constructed of coursed limestone on either face with a rubble limestone core. It is topped with chamfered granite capstones.

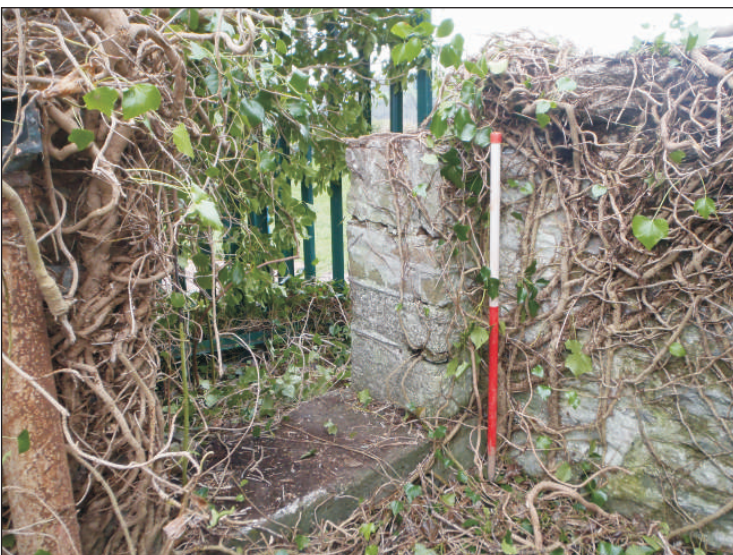
Plate 6: The doorway in the southwest corner of wall 1, viewed from the northeast. 1m scale.

In the southwestern corner of wall 1 is a doorway. This has a 200mm thick concrete threshold, and the lowest two courses of the jambs are granite blocks. Inside the doorway is a triangular concrete slab, containing a manhole, that is supported on at

least three courses of bricks. Adjacent to this structure are the remains of a cast-iron vent pipe.

- 7.3 The parts of wall 1 to be removed to as part of the works were recorded. The south part of this wall is known to have formed the rear of 19th-century battery. The area enclosed by the wall was entered via a doorway, but the use, if any, of this land is unknown. The west wall has been modified and reduced in height, and also partly utilised for a building attached to its west side.
