WEST QUAY, BRIDGWATER, SOMERSET

Results of an archaeological watching brief

Document No: ACD469/1/1

Date: May 2013

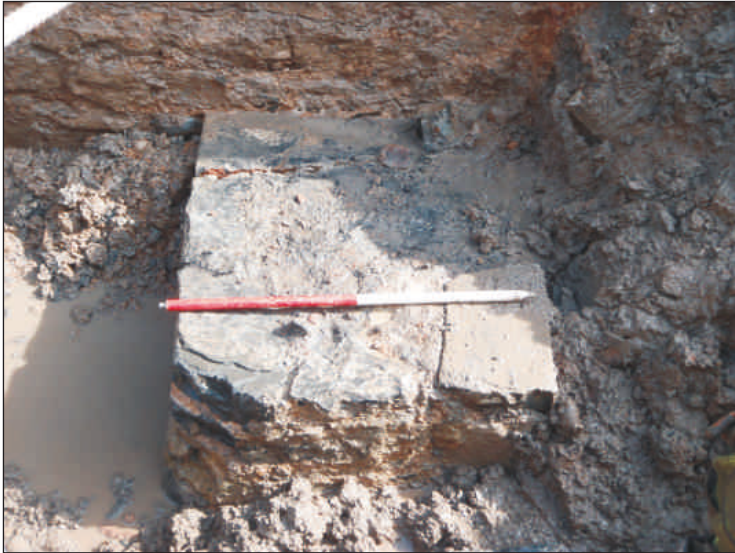
- 4.1** Two features were exposed within the base of the trench – a wall (1) and a surface (2). The wall was constructed of large blocks of blue lias bonded in hard pink mortar with lime inclusions (Plates 1-2). Four courses were visible, and the wall stood to a height of approx. 0.70m above the water level and adjacent surface (2). The contractor reported that it continued down for a further 0.50m. Clear faces were visible on its north, south and west sides. The north face was roughly aligned east-west, i.e. at right angles to the present quay wall, but was actually on a very slight northeast-southwest orientation. The upper surface was not flat, and it was clear that the upper section of the wall had been removed. The wall was partially overlaid by the present, collapsed quay wall.

Plate 1: Wall 1 after initial cleaning viewed from the west. 1m scale.

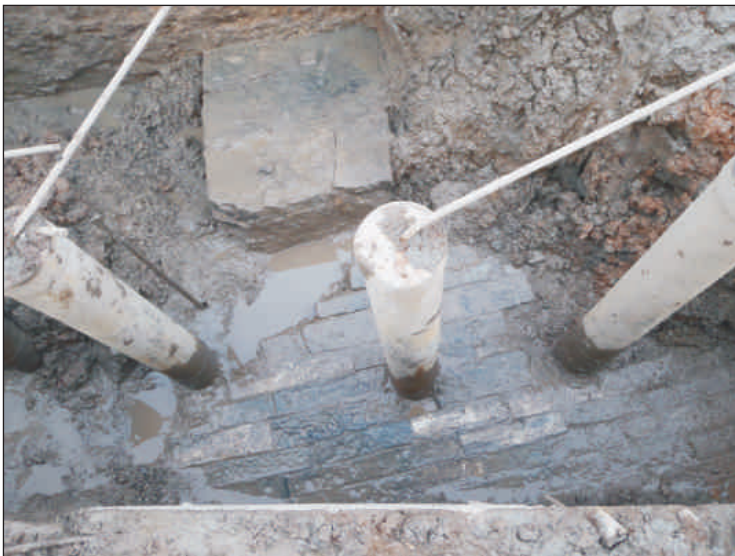
- 4.3** The relationship between wall 1 and surface 2 is unclear. There was a gap between the wall and the first row of setts. This may indicate that the wall had been constructed through an earlier surface, and that the gap represents the wall's construction trench. However, it is more likely that the two features are contemporary, and that the wall has rotated eastwards away from the surface, when the attached quay wall collapsed in 2011.

Plate 2: Wall 1 after further cleaning, viewed from the west, also showing surface 2.

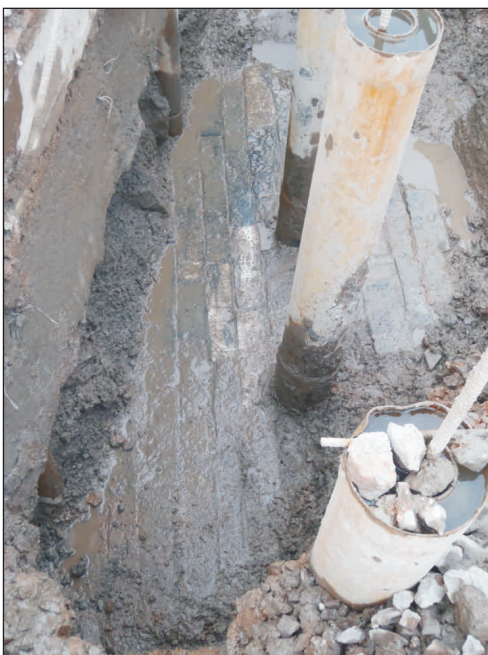
- 4.2** To the west of this wall, a surface (2) had been partially exposed (Plates 3-4). Its north side had been disturbed, probably by the present excavations and its southern extent also appeared to have been removed. The surface comprised lias setts laid in rows aligned north-south. The setts were 100-200mm wide and up to 1m long, and were bonded in a reddish-pink lime mortar. A total of 13 rows were uncovered, and the surface continued, or had continued, westwards under the sewer pipe. It appeared to slope downhill westwards away from wall 1.

Plate 3: Surface 2, viewed from the south.

- 5.2 Surface 2 may have been a tidal slip situated away from a quay wall under the present West Quay road or adjacent properties. Wall 1 appeared to have been an isolated pier of masonry, although it is possible further masonry is or was present under the quay wall. The visible masonry did not appear to define the eastern side of the probable slip, and it is possible that it formed part of an entrance to the structure.
- 5.3 The visible fabric at the rear of the quay wall is likely to be of later post-medieval date (presumably later 18th-century onwards) if wall 1 below dates to c. 1725. The main fabric (5) could be of early-mid 19th-century date and may form the core behind the front dressed face of the quay wall that had been constructed by 1887.

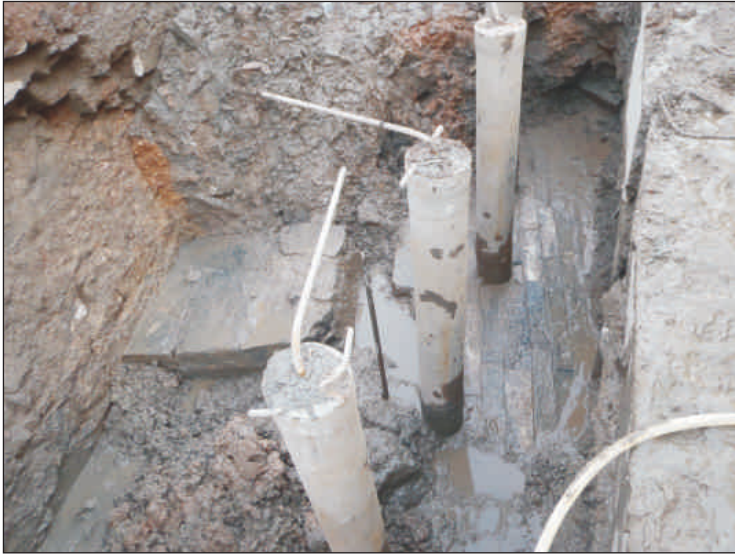
Plate 4: Surface 2,  
viewed from the north.

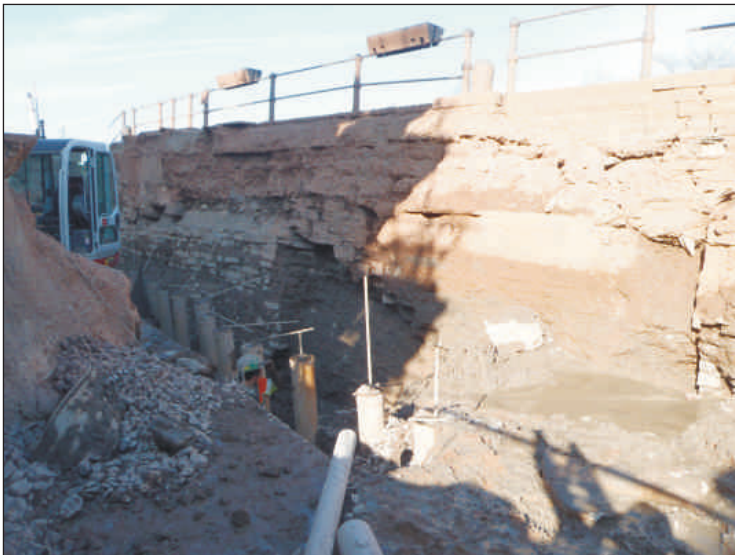
- 4.5** Within the working area several phases of masonry were identified in the collapsed quay wall (Plates 5-6). These all appeared to predate the present 19th-century quay wall parapet and streetscape. The earliest visible masonry was constructed of large lias blocks, and was orientated at a slightly different angle to the overlying rebuild (5). The later masonry (6) is in part stepped outwards (by c. 0.4m) from wall 4. It was built of well-laid coursed lias blocks bonded in pinky white mortar but was less well constructed than both walls 1 and 4. The southern section of this wall had been heavily repaired during the 20th century with concrete. The wall appeared to abut (or was perhaps abutted by) an east-west aligned wall (7) of which only the eastern stub survived. This wall appeared to be contemporary with the quay wall to the south, and where they joined was a section of angled masonry.

Plate 5: Wall 6 viewed  
from the southwest.

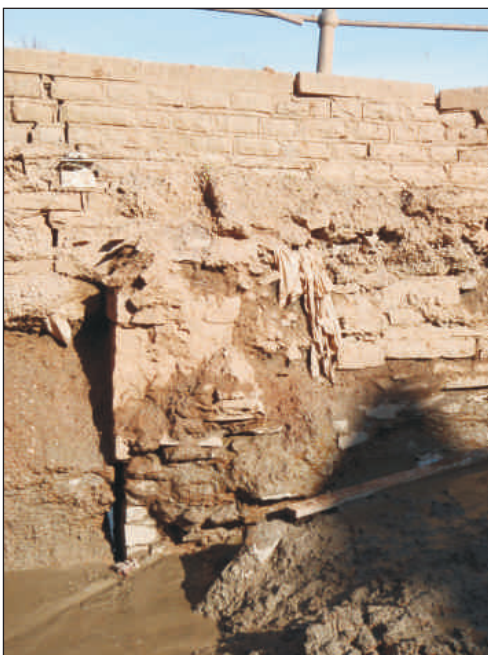
Plate 6: Wall 7 viewed from the west.
