Former Newton Abbot Hospital, Devon

Results of historic building recording

Document No: ACD441/3/0

Date: May 2013

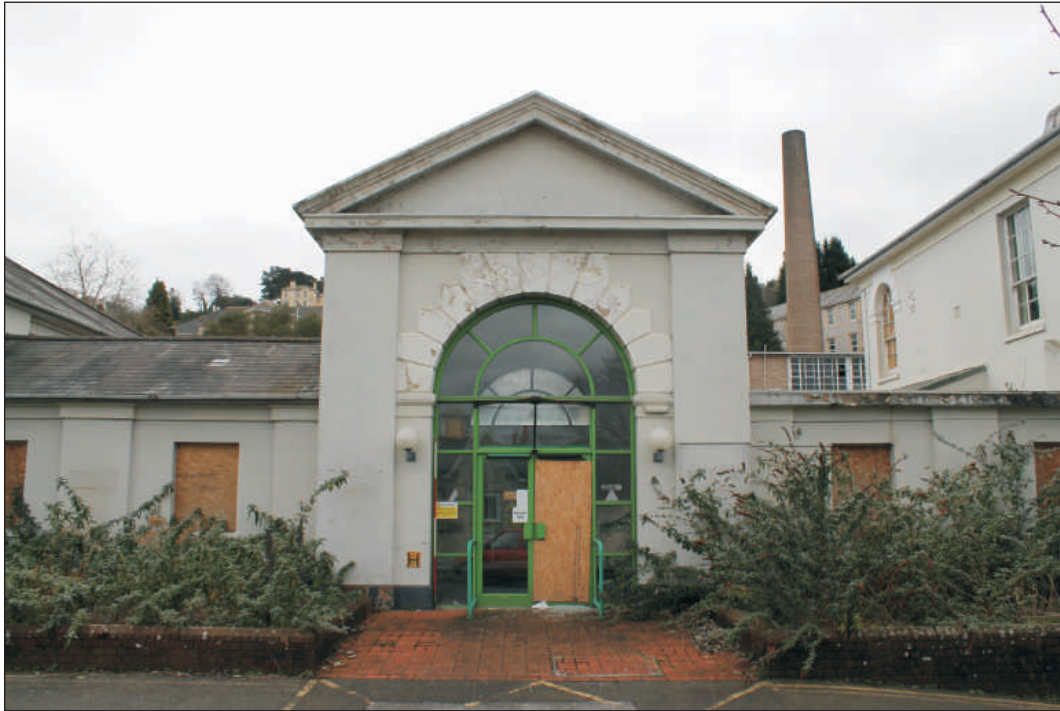
Plate 1: Building 1, former covered entranceway, viewed from the north. 2m scale

This building was the entrance block to the 19th-century workhouse, and would have housed administrative rooms either side of a central covered walkway. Typically, these would have included a boardroom and offices on one side and a chapel on the other side. It is mainly of one storey height, but the western block was heightened to two storeys in the late 19th-century. All the walls are of rubble construction with stucco rendering. The north front is dominated by a tall centrally-placed former carriageway, now converted to an entrance foyer, with a semi-circular arch in high-relief ashlar framed by plain pilasters supporting an entablature under a pediment. To either side of the carriageway, lower level bays extend to end blocks. Each block is of two bays with individual tall half-round windows to each bay. All are embellished with identical detailing to those of the carriageway block.

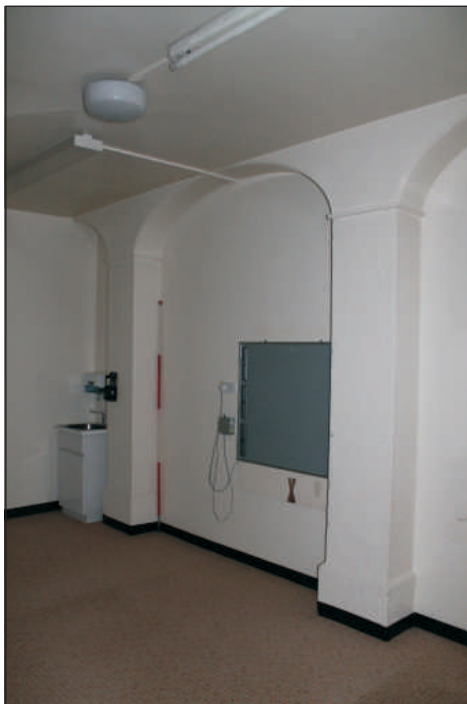
Plate 2: Building 1, former arcade in the boardroom, viewed from the southwest. 2m scale

The interior has been much altered and much of the original fabric is obscured by later partitions and suspended ceilings. However, the original floor plan can be deduced. Inside the western part of the building there was a primary group of three moderately sized-rooms, with a fourth smaller room projecting into the yard beyond. All were tall with some having either a primary or later phased source of heating from now blocked fireplaces within the long internal walls or singularly from a corner fireplace in the west room. With the exception of multi-paned large half-round windows mostly within the north and south elevations, very limited evidence of primary fixtures and fittings is apparent. A small number of later, early 20th-century windows, mainly large double-pane sash types, have been inserted into the primary wall fabric. Throughout, later internal openings relating to late 19th- and early 20th-century alterations have been either blocked up or reduced in height, many retaining flat mouldings or stop chamfered surrounds. Many of the square overlights to the doorways have been removed, but a peculiar timber trellis to one doorway remains replacing an original pane.

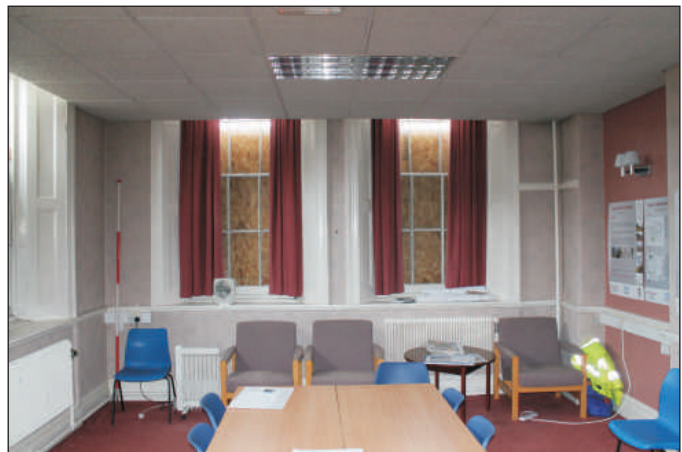
Plate 3: Building 2/F, receiving room, viewed from the west. 2m scale

The principal entrance is within the west elevation and is enclosed within a flat-roofed porch simply detailed with pilasters and a wide cornice. To each of the side walls (lighting the main original rooms) are single two-pane unhorned sash windows. Leading from the porch is a small reception area entered via an original 'Tudor'/basket arch door of four panels, two of which are glazed. The angled eastern wall of the south room reflects the alignment of an existing boundary wall associated with the 1830s workhouse.

The interior survives in good condition, but is to an extent obscured by partitions and suspended ceilings. Both main offices are furnished with skirting boards, moulded door frames, a dado rail, and panelling to the window reveals.

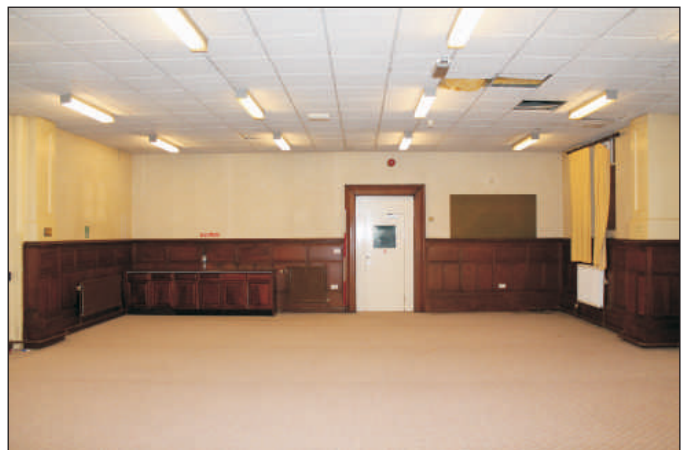
Plate 4: Building 2/F, boardroom, viewed from the east. 2m scale

At the heart of the building is the large Ella Rowcroft Room that is embellished with polished oak panelled walls and the recess in the north elevation. The ceiling is currently obscured by a modern suspended ceiling. However, a pair of plainly incised pilasters defines the north recess, and there is a second pair opposite on the south wall. The entablature of the pilasters continues as a circuit to the room upon which rise the ceiling ribs of a high coved ornamented ribbed ceiling, the ribs being formed into a geometric Jacobean 'square-within-a-square' design. The positions of fireplaces in most of the principal rooms can be identified, either from chimney stacks or the plan form of the rooms. In the Ella Rowcroft Room the panelling overlies the former fireplace.

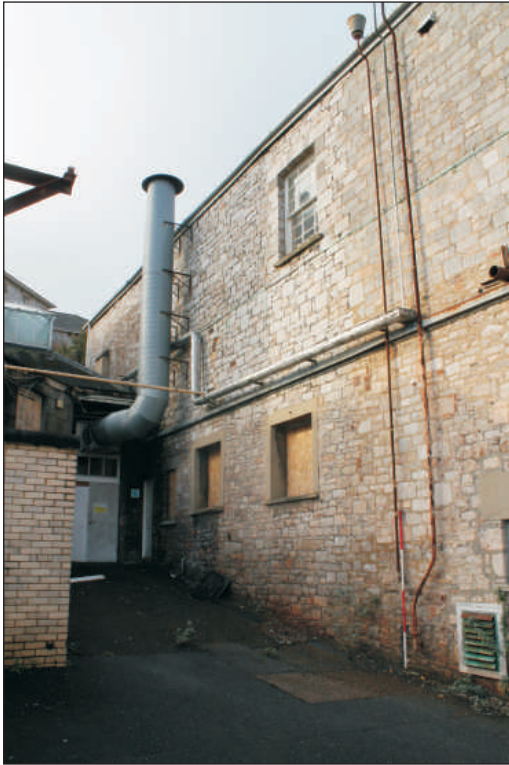
Plate 5: Building A showing northern extension, viewed from the northeast. 2m scale

This building formed part of a rear range of the 1830s workhouse. It was described in the assessment report as accommodation, but was probably actually used as a work room. A detailed description of the exterior was presented in the assessment report and no new observations were made.

The northern bay is an extension and internal access was not possible. The building was converted into a sewing and manufacturing room in 1984, and by 1994 had been reordered into toilets, showers and a store for use by kitchen staff and porters. No evidence survives for its original layout. The central part of the building has an arched ceiling supported on wide plain columns. In the northern part of the building there is a dado rail that is contemporary with the sash windows since it runs into the reveals; it also matches the carving on the window cills. In this area a high level cornice survives. There are two blocked fireplaces set into the eastern elevation.

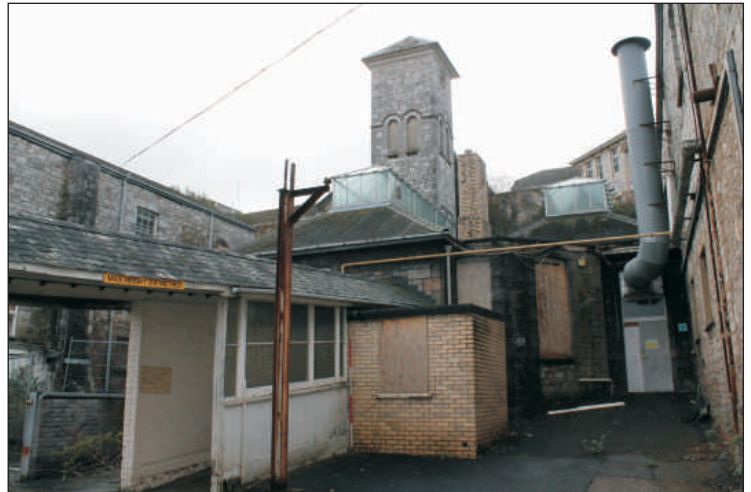
Plate 6: Building C, kitchen showing the walkway to the dining room, viewed from the south. 2m scale

This building is situated between buildings A and B and replaces an earlier rectangular building associated with the 1830s workhouse. It was constructed in c. 1897 and was last used as a kitchen. It may have had this function from the start since it is linked to the dining room (building E) to the north. Other than the dividing walls with buildings A and B – the former of which contains a chimney stack – there is no visible evidence that the original building was incorporated within the later structure.

Internally, the building has been thoroughly modernised and contains industrial kitchen equipment. However, elements of its historic use can be discerned. An original fireplace (with projecting brick stack) is present within a partition wall. Windows include original bottom opening (rather than sash) types, and the roof includes raised modern glass panels that may have replaced earlier louvres. The latter two features have similarities with the kitchen at the Tiverton workhouse (Passmore and Steinmetzer 2010, 6).

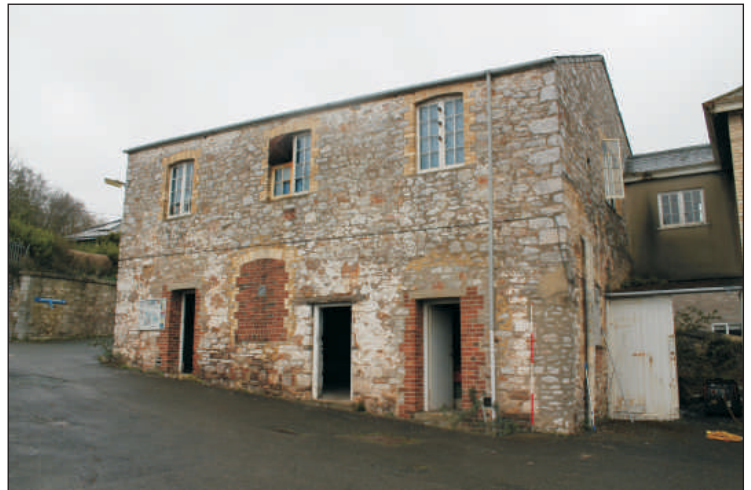
Plate 7: Building D, east elevation, viewed from the east. 2m scale

This was originally a detached, two-storey building associated with the workhouse and was located on the western boundary of its site. The description in the assessment report relates its architectural style to the primary workhouse buildings A and B. However, it is likely to be of later 19th-century date (but before 1889). The building was heightened sometime in the early 20th century and additionally reconfigured internally in the mid 20th century.

The form of the building originally appears to have been a tall, single-storey single room structure with a large opening within the gabled south elevation and a single entrance to the long eastern elevation, both with simple timber lintels. The building has been heightened to its present form during a subsequent phase of development which also includes the regular fenestration of the principal east elevation arranged around three windows to the first floor with two additional separate entrances to the ground floor, each serving newly-partitioned rooms. The open-plan first floor space is provided with windows/openings to both the north and south gables and a single doorway accessed via an external staircase at the southern end of the west elevation. Further access to the first floor includes an additional doorway leading into an enclosed walkway connecting building G. The window to the south gable has been reconfigured and extended in depth to form a loading bay matching in dimensions the primary opening directly below. Subsequent windows were added to the ground floor of the north, east and west elevations. Two have been blocked up and one reduced in height immediately during the post war period when a reinforced concrete ceiling was inserted, and the present brick partitions defining all three ground floor rooms added. Two of the entrances within the east elevation are reduced in size and their brick cambered heads and surrounds have been removed.

Internally, the walls are finished in white paint and the concrete first floor is exposed. The roof is supported on simple queen post trusses with struts and a narrow high-level collar, all fixed using bolted iron straps. There are few historic features or fixtures. There are several small recesses in the ground-floor walls, as well as vents, and some mid 20th-century electrical and water fittings are present.

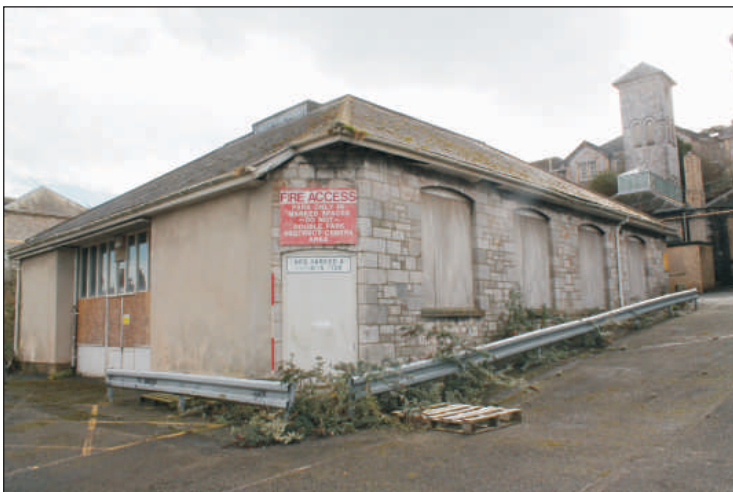
Plate 8: Building E, dining room showing its relationship to the kitchen, viewed from the northwest. 2m scale

This single-storey building is situated to the north of building C and connected to it by a walkway. The latter is constructed from a mixture of yellow brick and wooden frames with wood and glass panels as well as open sections. All are likely to date to the later 20th century. The building was constructed in c. 1897, and replaces the central hub buildings of the 1830s workhouse. It is constructed of limestone with four tall, shallow arch headed windows in its east and west elevations. These are divided into four by mullions and transoms. The six-pane upper lights are fixed whereas the larger windows below have horned sashes. In its north elevation is a large opening containing modern frosted glass panes.

The building was constructed as a dining room, and was latterly used as a store. The only surviving fitting is tongue-and-grooved panelling to the lower walls with a dado rail above. The room has a modern suspended ceiling concealing the original roof structure. This is hipped and formed from wooden trusses, 2-part trenched collars and trenched purlins, supported by iron or steel frames below. The interior of the roof is lined with lath and plaster.

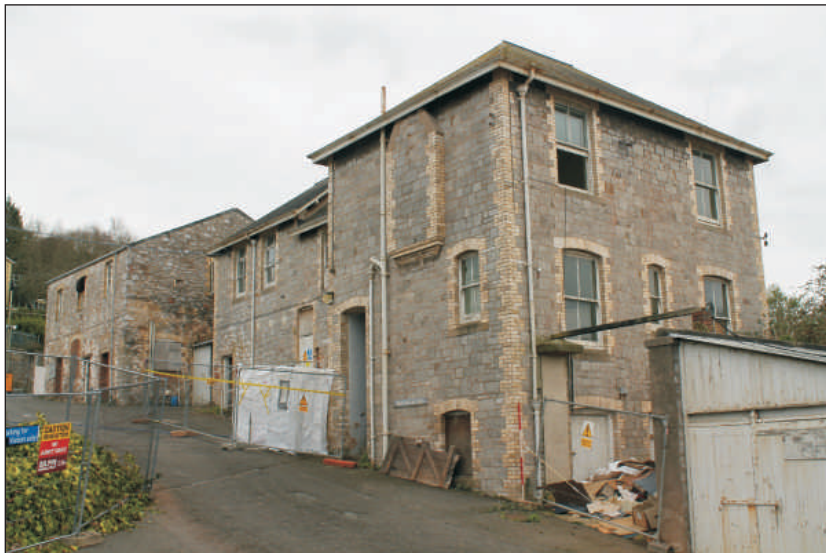
Plate 9: Building G, viewed from the northeast. 1m scale

This building is situated to the north of building D and had been constructed by 1905 (?in 1901). It is constructed of limestone with yellow brick quoins and dressings to the openings and chimney stack. It is mostly two storeyed but there is a half underground basement at the north end utilising the steeply sloping ground down to East Street. On its rear (west) elevations are projecting one- and two-storey extensions, constructed entirely of yellow brick. These had also been erected by 1905. The building contains offices on the upper floors and store in the basement. The upper floor rooms are lit by horned sash windows set within slightly arched-headed openings. Most have additional bottom-opening overlights above. The rear of the basement is lit by 14-pane fixed windows set above doorways.

Inside, all the rooms appear to have changed very little since their construction, although many fittings have been removed following closure of the hospital. The joinery is utilitarian in appearance with the majority of rooms have simple moulded skirting boards, picture rails and four-panelled doors. The original door furniture has also been retained with internal and cupboard doors having brass lock cases and oval keyplates with covers. The staircase is enclosed, but on the landing is a balustrade with thin square-profiled balusters, chamfered newel posts and a ramped handrail. The northern rooms were finished with fireplaces set within the east and west walls, all now blocked; at first-floor level the chimney stack on the east elevation projects out from the wall.

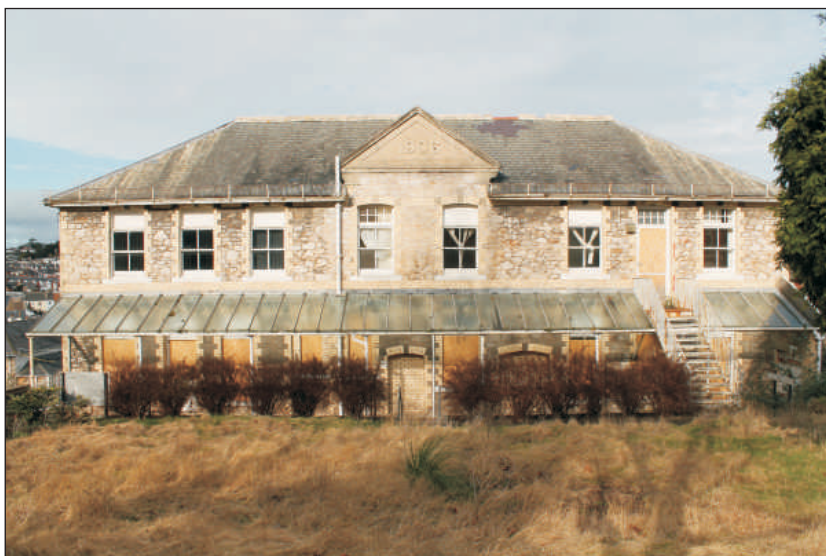
Plate 10: Building H, the rear principal elevation, viewed from the south. 2m scale

This two-storey building is located to the east of the workhouse and was built in 1906. It is constructed from rubble limestone with yellow brick quoins and dressings to the openings. The building faces south and is relatively plain, the façade being broken up by a series of tall window and door openings. The former contain hornless sashes with plain panels above that may represent replacements of original opening

windows (cf those in building G). There is a large central pediment containing a '1906' datestone. On the ground floor there is a veranda built upon narrow cast-iron columns. This would have faced a garden, and allowed patients to sit in the open air. The rear elevation has a series of three staggered wings, two of which contain sanitary blocks. The elevations are tied together with two courses of three rows of bricks forming string courses.

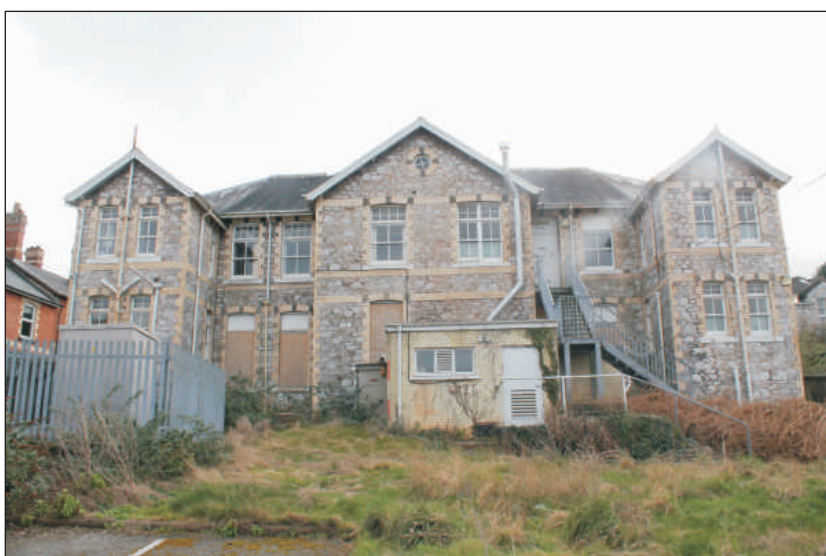
Plate 11: Building H, the rear elevation showing projecting wings, viewed from the north. 2m scale

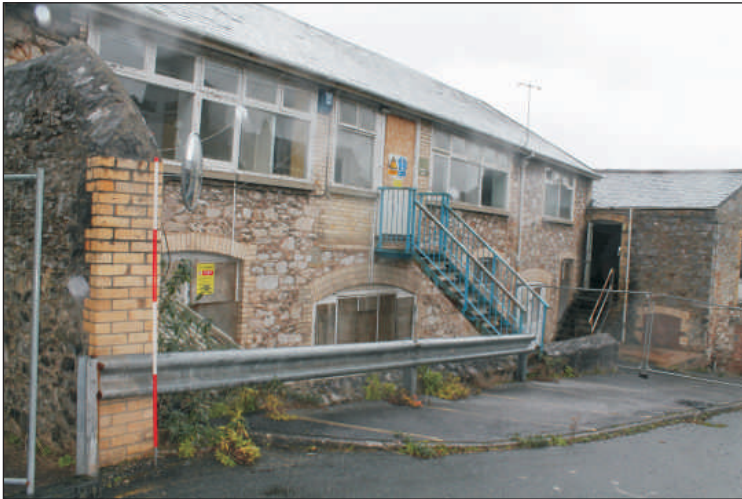
Plate 12: Building I, viewed from the southwest. 2m scale

This two-storey building is an extension to building D. It had been constructed by 1905 and was probably associated with the late 19th-century expansion of the workhouse and the construction of the associated infirmary in 1896-8. It is however, likely to be of a different (probably later) date than building G.

It is constructed of irregular coursed limestone with yellow brick dressings to the primary window and door openings on the south elevation. The first-floor windows are modern composite replacements. Both the ground and first floors are independently accessed, with the opening to the upper storey having been reduced in size from a larger double loading door-sized opening. Most of the openings on the north elevation have brick dressings, and are secondary additions, although some smaller window openings with yellow dressings may be primary. Other vertical areas of red brickwork are associated with former, inserted chimney stacks.

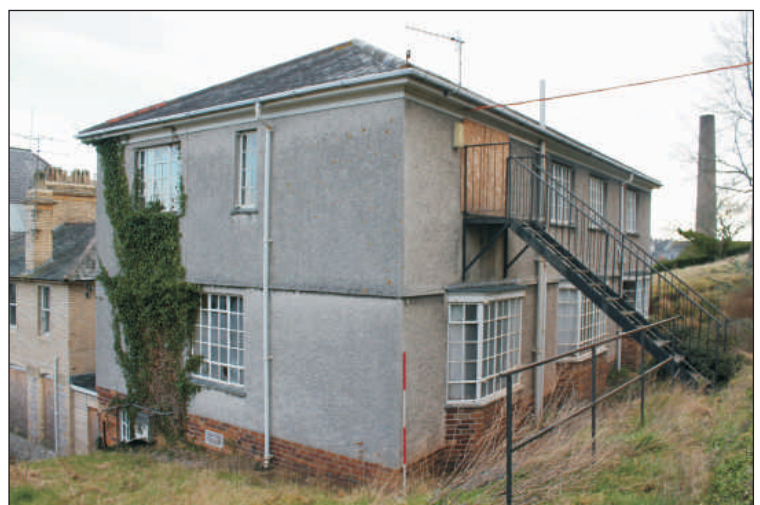
Plate 13: Building J, viewed from the southwest. 2m scale

This is a two-storey building over a semi-basement with a hipped roof positioned immediately south of the hospital (building L). It was constructed in 1937-8 as a purpose-built nurses' home. A foundation stone in the west elevation reads "WEBSTER MEMORIAL NURSES' HOME THIS STONE WAS LAID BY WILLIAM PROUDFOOT ESO. J.P. 20TH. JULY 1937." It principally has a stripped neo-Georgian appearance consisting of a partially rendered symmetrical main south elevation with three individual canted bay windows to the ground floor and four steel casements to the first floor. The aprons of the canted bays and the building's initial coursing have exposed brown brick. Within the north elevation is the principal entrance to the building, enclosed within a rudimentary corridor leading from the first-floor phase II extension of hospital building L. The first floor is marked by a full plat band overlain by render, and on the north elevation is a further plat band above the half basement. The building retains its original multi-paned critical windows throughout. The ceilings are lath and plaster.

The Interior is generally domestic in appearance consisting of a series of single bedrooms above a large communal sitting and a dining room. Some alterations have been made when the building was partially converted into offices. The majority of the rooms retain their fixtures and fittings such as skirting boards, picture rails (where fitted), door frames and cast-iron radiators. The fireplaces in the gable elevations have been blocked and the projecting chimney stacks removed. In the ground-floor corridor the parquet floor is exposed. The original stairs are plain in design with an enclosed plain string and continuous sweeping handrail rising in two flights to meet a centrally-placed landing.

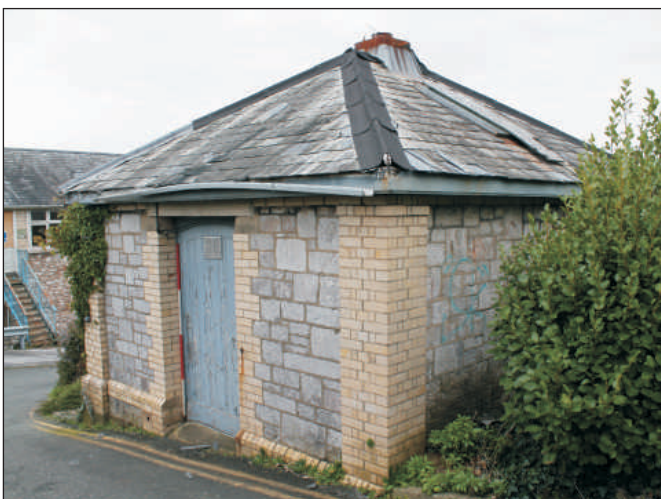
Plate 14: Building K, viewed from the southwest.
2m scale

This building is situated to the east of the hospital building L, and is probably of 1920s or 1930s date. It is constructed of coursed limestone with yellow brick piers at the corners. Yellow brick is also used for a low-level string course and for the door dressings in the west elevation. Other than this door there are no other significant openings. The roof is hipped and terminates in a shallow ridge into which a ventilator has been set. The slate roof is lined internally with boards and is supported on hip rafters and trenched purlins.

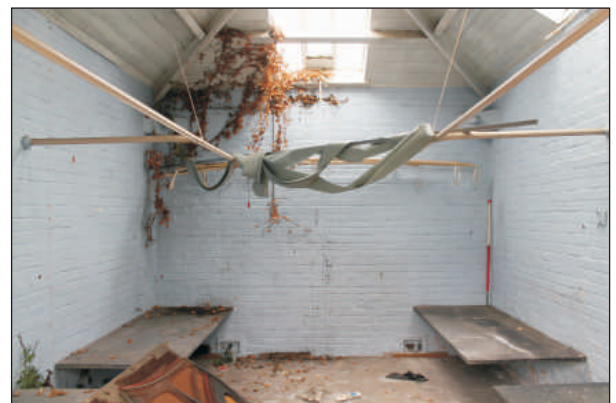
Plate 15: Building K, interior showing slate
slabs, viewed from the west. 1m scale

It was described as a boiler house in the assessment report but was actually constructed as a mortuary. The internal walls are painted blue, and the east and west elevations contain low-level vents. Set against the corners are four slate slabs for the storage of corpses. Above head-height aluminium tubes and thin rolled steel joists are set into the walls; screens were probably hung from these to provide privacy. The room has a tap, although the associated trough has been removed.

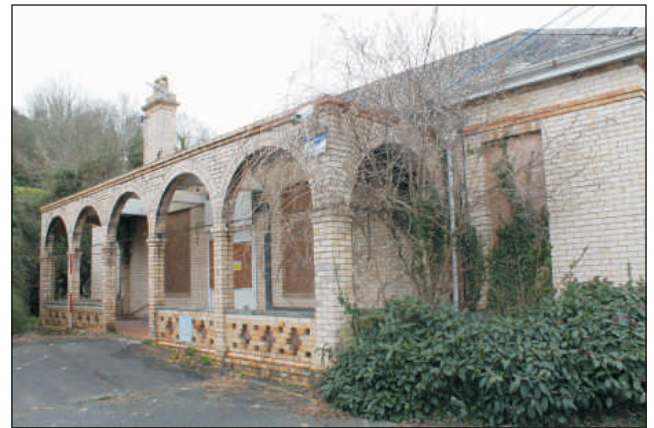
Plate 17: Building L, the east arcade of the 1927 extension, viewed from the northeast. 2m scale

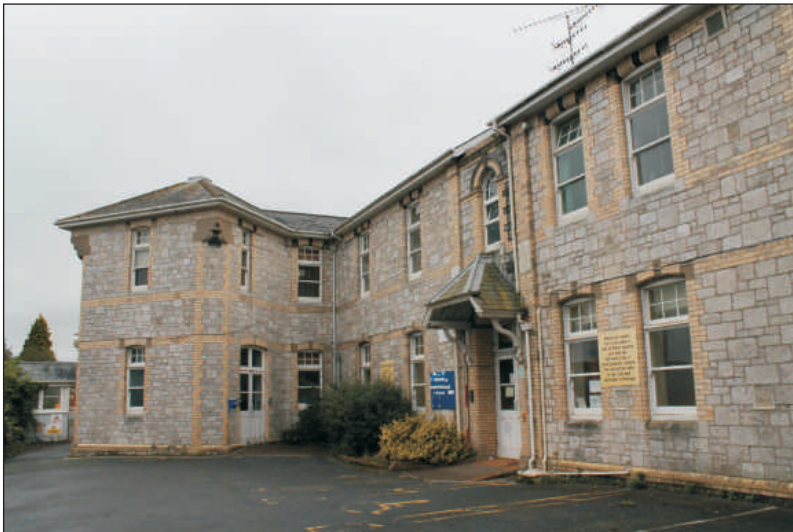
Plate 18: Building N, front elevation showing the sanitary tower, viewed from the northwest. 2m scale

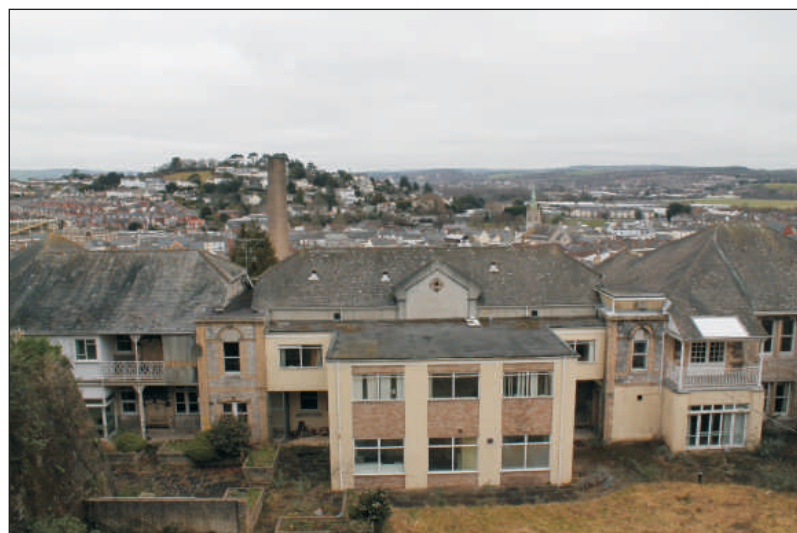
Plate 19: Buildings M and N, rear elevations showing remains of verandas, viewed from the south

The original asymmetrical form of the south elevation has been partly obscured by an amalgam of modern extensions, notably to both east and west pavilion blocks. The architectural detailing and opening types noted within the north elevation has been carried on through and applied to this elevation but here also includes an open pediment in each of the pavilions. At the centre of each pediment is a circular brick oculus bordered by a four keystone moulding. The building's central block incorporates a projecting sanitary tower of the form within the north elevation and an original small first-floor veranda. A ground-floor veranda of the same type was probably included in the primary design of the block but its open front has since been built in and amalgamated to create the present dining room. The first-floor veranda extends out from the elevation. Its roof is an extension of the main block's hipped roof and is supported by two slender iron corner columns. The iron balustrade is made up

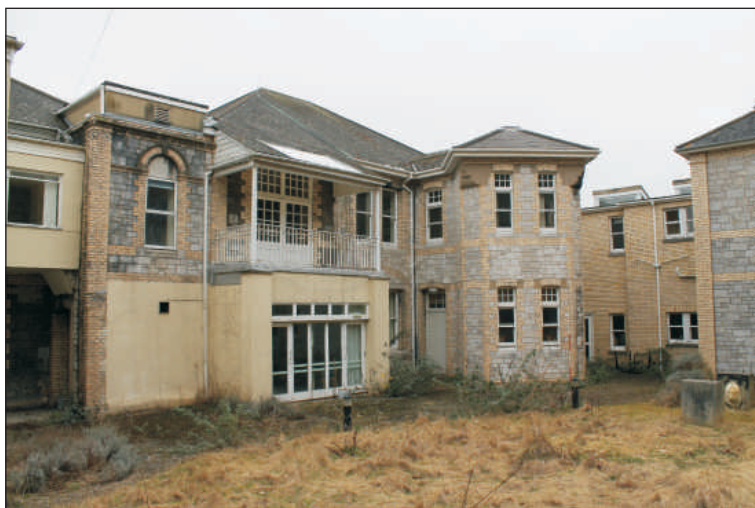
Plate 20: Building N, rear elevation showing later extensions and (to rear) link to building O, viewed from the southwest. 2m scale

of simple stick balusters grouped into fives all under a plain handrail. There is a large lean-to extension housing a kitchen, gym and laundry. The walls are wholly obscured, mostly by modern kitchen units and fittings, and the rear door is also a 20th-century replacement.

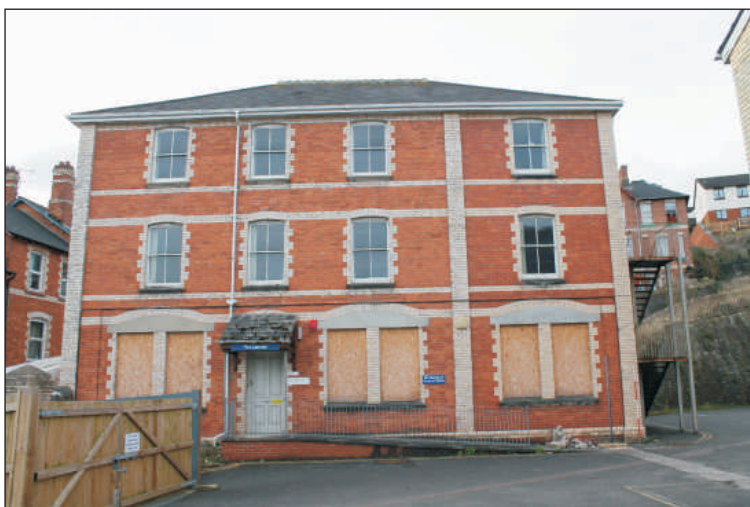
Plate 21: Building P, viewed from the north. 2m scale

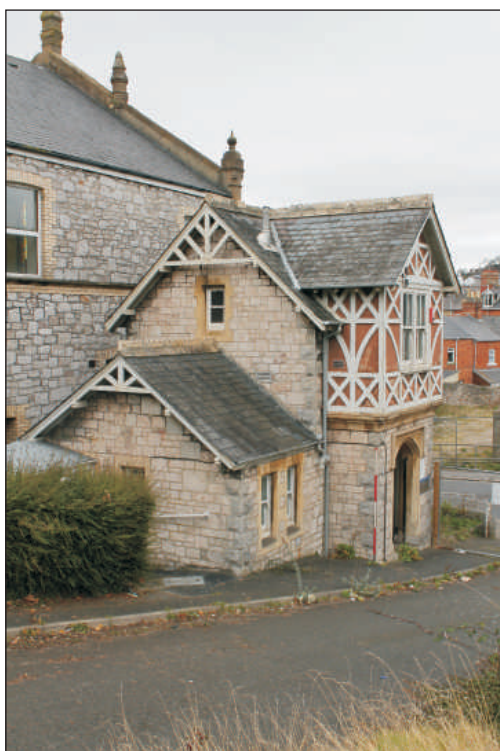
Plate 22: Building T, viewed from the southeast. 2m scale

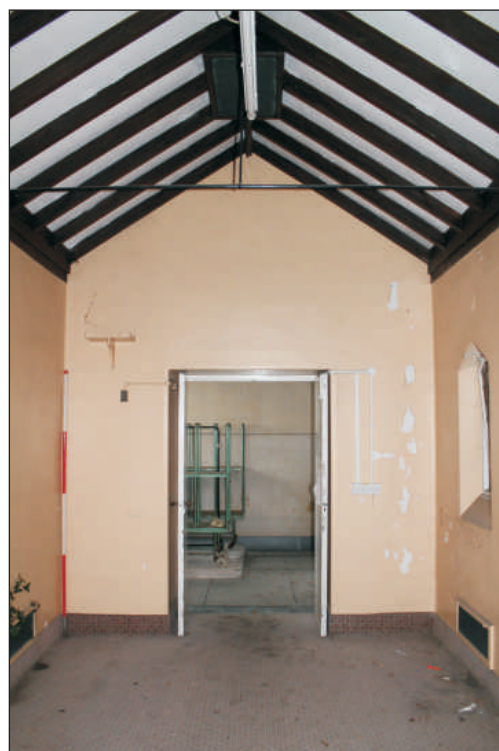
Plate 23: Building U, the chapel, viewed from the west. 2m scale
