Bicton College New Animal Care Building, Devon

Results of an archaeological watching brief

Planning ref. East Devon District Council 11/2808/MFUL

Document No: ACD481/2/0

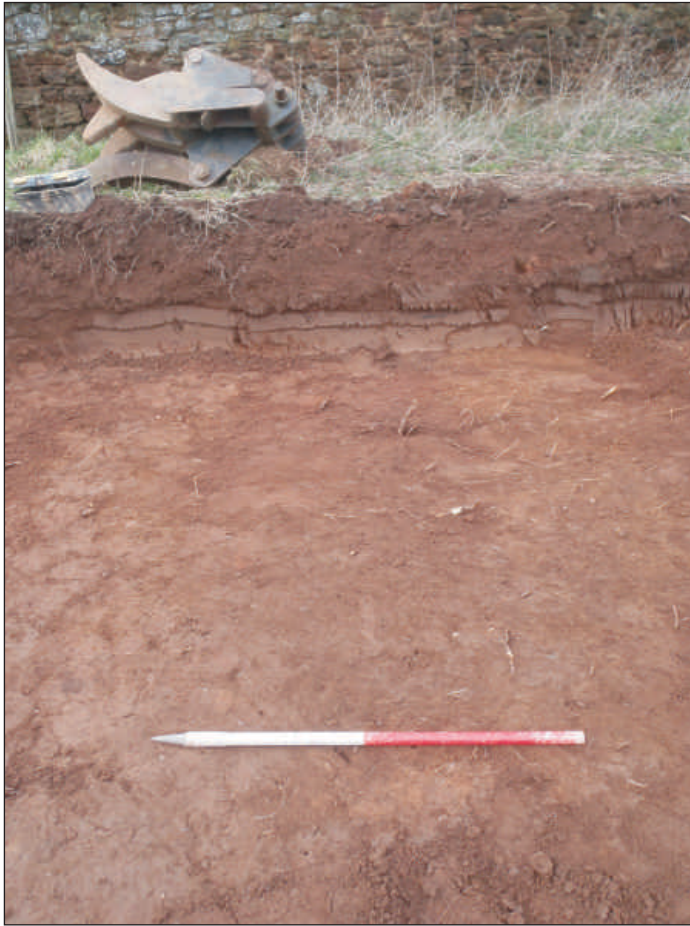
- 4.2 The area was heavily disturbed by tree roots and no convincing early archaeological features were exposed. A possible pit (F103), which was not excavated since it was present below the required formation level, was recorded (Plate 1). It measured 2.64m long by 1.54m wide and contained a fill of light grey-brown loose very sandy clay containing common small stones (109). Part of a flint multi-platform core fragment of possible late Neolithic or early Bronze Age date was recovered from the surface of this feature.

Plate 1: Possible pit F103, viewed from the east. 1m scale

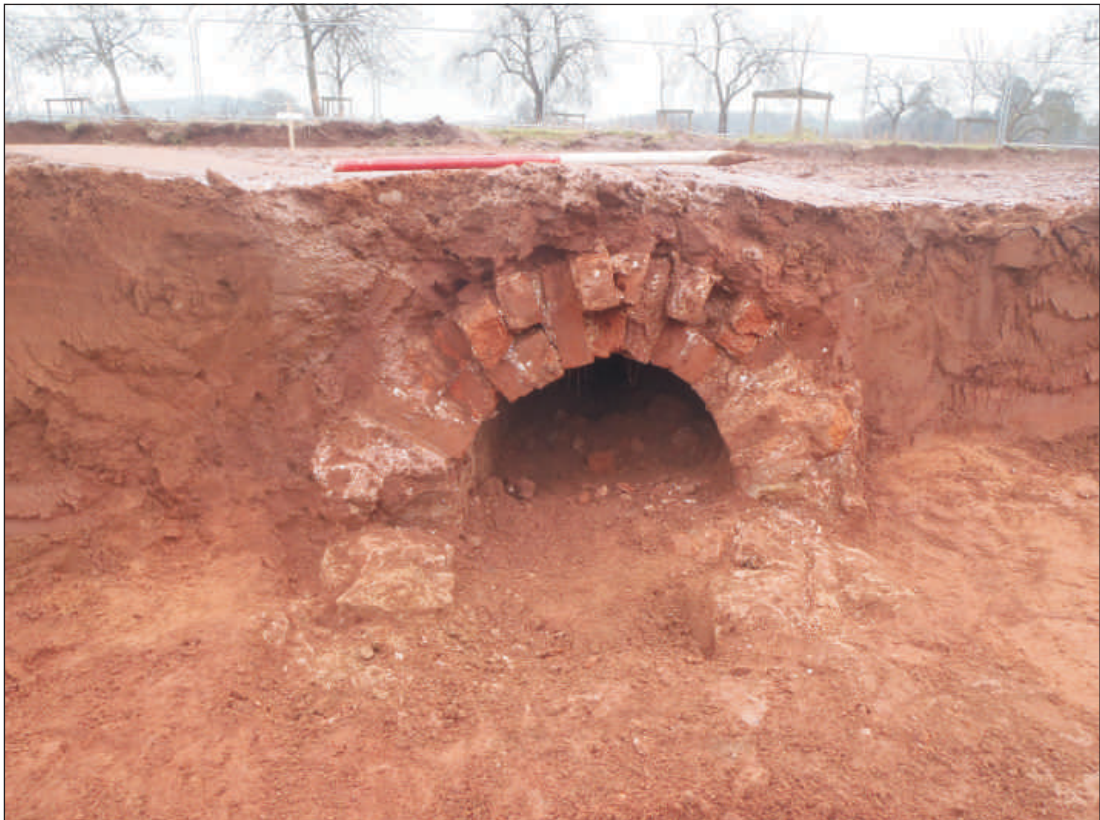
- 4.3 The only other feature exposed was a post-medieval culvert (F107). This was aligned northwest-southeast, and was located in the centre of the site (Plate 2). The culvert had been constructed in a 1.3m wide trench (F108) excavated through the subsoil and into the natural. The full depth of the feature was not exposed, and its interior had silted up. The culvert was constructed with vertical stone sidewalls and an arched capping of standard orange bricks laid in Flemish bond, all bonded in a hard pink lime mortar with large lime inclusions. The trench had been backfilled with yellow-red silty sand (106).

Plate 2: Culvert F107, viewed from the northwest. 1m scale

**6.2** The majority of the finds are of 19th- and 20th-century date, and are likely to have derived from the estate and been manured into the field. Of interest are the plant labels, since Bicton is renowned for its flower gardens and parkland. The culvert is likely to date to the early 19th-century alterations to the estate, and improvements to the agricultural land surrounding the park and gardens. The land to the east of the development site forms a small coombe, and the 1888 Ordnance Survey map depicts a stream with small ponds (Fig. 2). The culvert may therefore represent drainage associated with a former watercourse within this coombe.
