# STOKE CANON FLOOD DEFENCE SCHEME, EAST DEVON

Results of archaeological monitoring and recording

Document No: ACD479/2/0

Date: February 2014

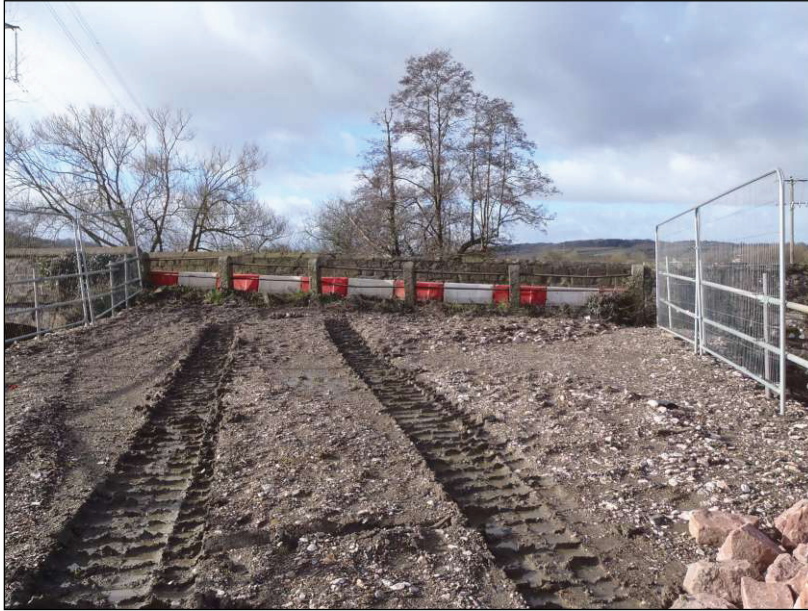
Plate 1: Stoke Canon Bridge, west parapet prior to removal of posts, viewed from the northeast

As part of the flood defence improvements, a section of the east side of the bridge was removed and replaced with a stone section of wall. At this location, the parapet had been replaced and consisted of granite pillars with iron slats. This and a section at the north end of the west side where the ground level had been reduced adjacent to the bridge were recorded. The results of the archaeological recording of these sections of the bridge is summarised in Table 1.

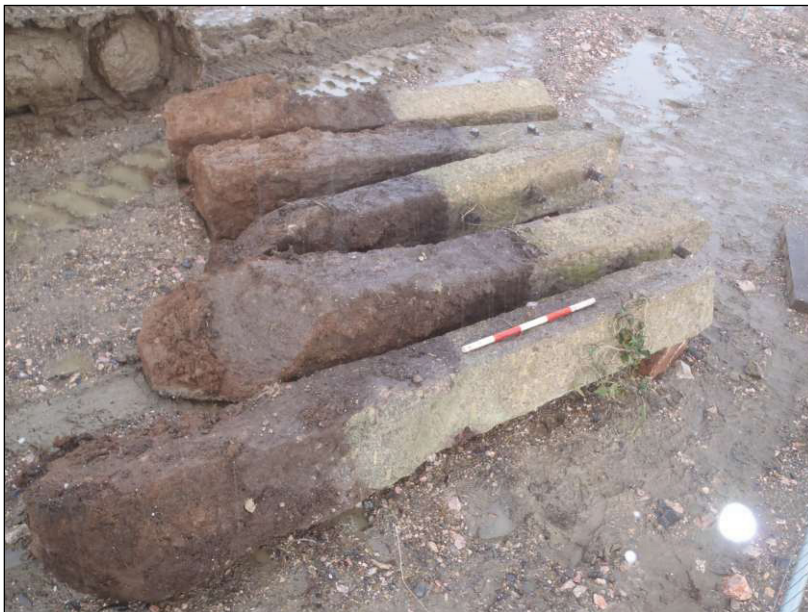
Plate 2: Stoke Canon Bridge, west parapet posts following removal. 1m scale

- 7.4** Repairs to the Stoke Canon Bridge were monitored and recorded. The granite pillars that formed part of the bridge parapet had probably been erected sometime during the late 19th or early 20th century, and are associated with the replacement of the earlier stone parapet. From their tooling it is clear that they had been dressed specifically for the bridge and were not reused.

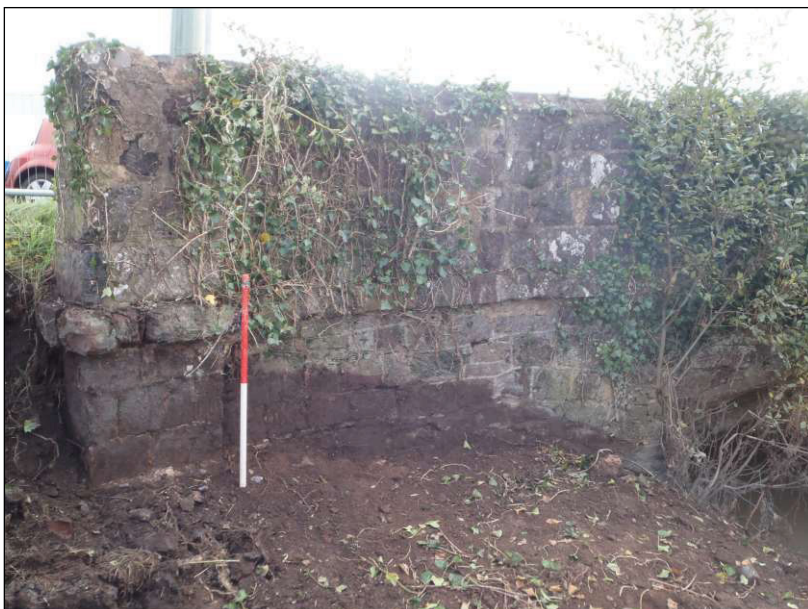
Plate 3: Stoke Canon Bridge, east parapet and end pier, viewed from the northwest. 1m scale

Context	Description
East side of bridge	
400	Parapet consisting mostly of rectangular or squared blocks of limestone, with sparse blocks of sandstone, Heavitree breccia and volcanic trap. The blocks are generally arranged in courses and average c. 0.3m long and 0.2m wide. They are bonded with lime mortar (401) and roughly pointed. Several areas of modern repair are evident.
401	Grey/off-white fine lime mortar used as bonding material for the parapet of the bridge.
402	Parapet capping consisting of limestone rectangular blocks with flat tops and bevelled edges. The blocks average 0.75m long and 0.3m wide. They are coursed in a line along the top of the bridge parapet and are bonded with lime mortar (401). Some have been replaced with concrete replicas.
403	Six granite pillars, rectangular in section with rounded heads, supporting iron railings (404). They stand 0.9m high above the ground surface and 0.3m wide.

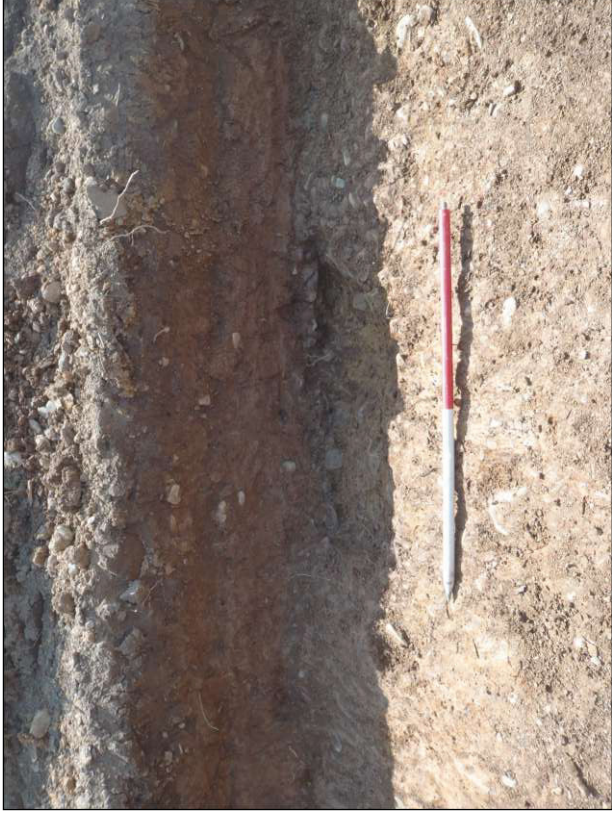
Plate 4: Plot 3, ditch F304, viewed from the northwest.  
1m scale

F304 was a 6.75m long ditch that measured 0.2m deep and had rounded terminals and moderately steeply sloping sides with a flat base. It was orientated northeast-southwest, parallel to the excavation, and continued under the eastern edge of the stripped area and was therefore of an unknown width. It contained a light grey-brown, stony, sandy clay fill (303) with iron-panning and common small-large sized rounded gravels, from which a fragment of worked flint was recovered.

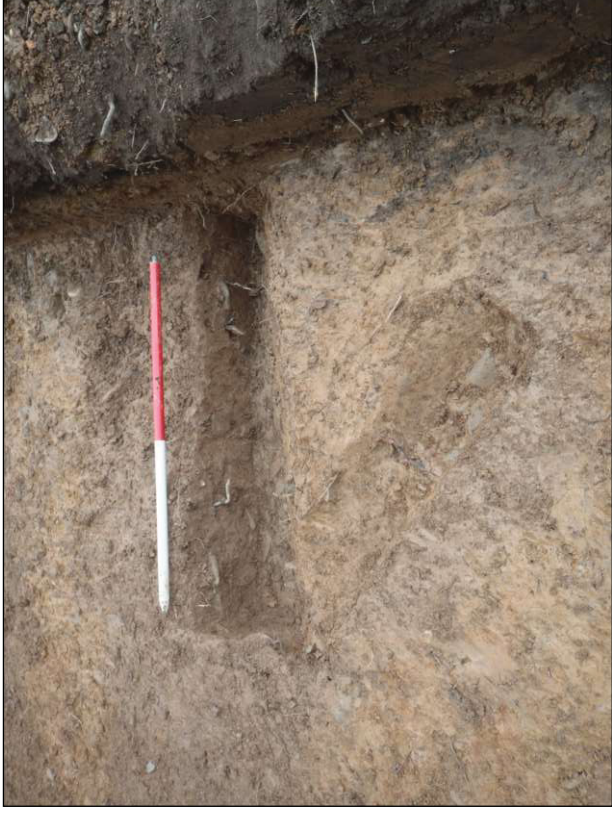
Plate 5: Plot 3, ditches F306 and F308, viewed from the southwest. 1m scale

F306 was a 2.6m long section of a linear ditch that was 0.85m wide and 0.42m deep. It continued beyond the east and west edges of the excavation. It had moderately steeply-sloping sides and a flat base. It contained a medium brown, stony, sandy clay fill (305), with common small-large sized rounded gravels, from which one fragment of worked flint and a piece of medieval ridge tile or roof furniture were recovered.

F306 was cut by a narrow, very shallow linear feature, F308, which was orientated northwest-southeast. It was 1.25m long, 0.35m wide by 0.05m deep and continued beyond the southeast edge of excavation. It contained a highly root disturbed, light red-brown, compact sandy clay fill (307) that contained common small rounded gravels.

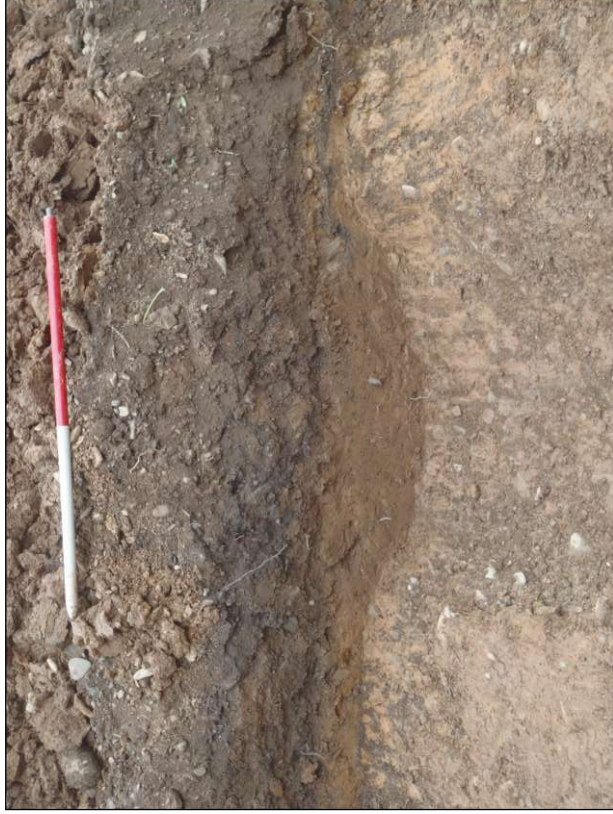
Plate 6: Plot 3, ditch F310, viewed from the southwest.  
1m scale

F310 was a 2.5m long section of linear ditch that continued beyond the northwest and southeast edges of the excavation. It had moderately steeply sloping edges and a concave base. It was 1.15m wide by 0.26m deep and contained a medium red-brown, compact, clay loam fill (309), with sparse small sized rounded gravels.

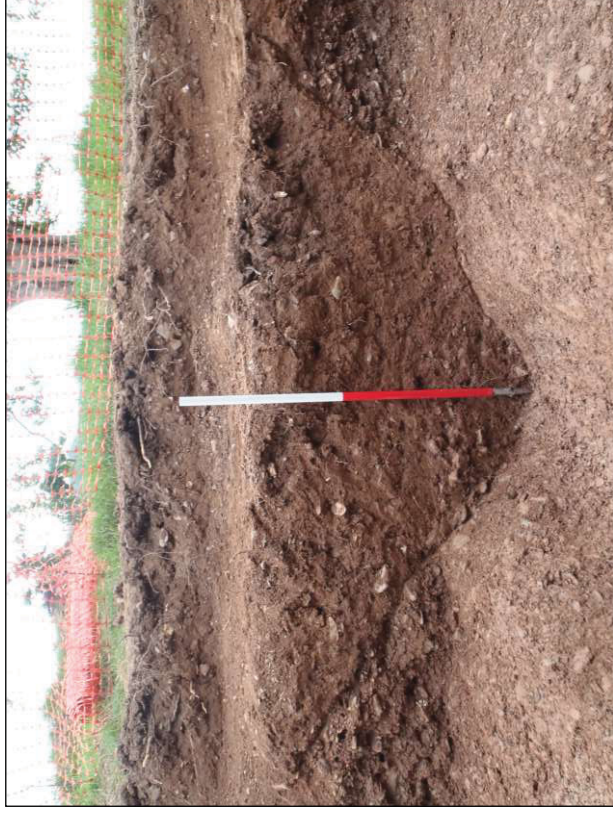
Plate 7: Plot 5, ditch F502, viewed from the northeast.  
1m scale

A single linear ditch was encountered within plot 5, F502. This was c .3m long, 1.5m wide and 0.91m deep, with moderately steeply-sloping edges and a flat base. The ditch contained a total of three fills: the upper fill (503) consisted of 0.6m of light

brown, firm sandy clay with common small-large rounded gravels, middle fill (504) was a 0.27m thick deposit of light brown, soft sandy clay and contained a single sherd of late medieval-early post-medieval pottery. The basal fill (505) consisted of 0.4m of grey-brown, loose sandy clay.
