HAVEN BANKS OUTDOOR EDUCATION CENTRE, EXETER

Results of an archaeological watching brief

Document No: ACD434/2/2

Date: July 2013

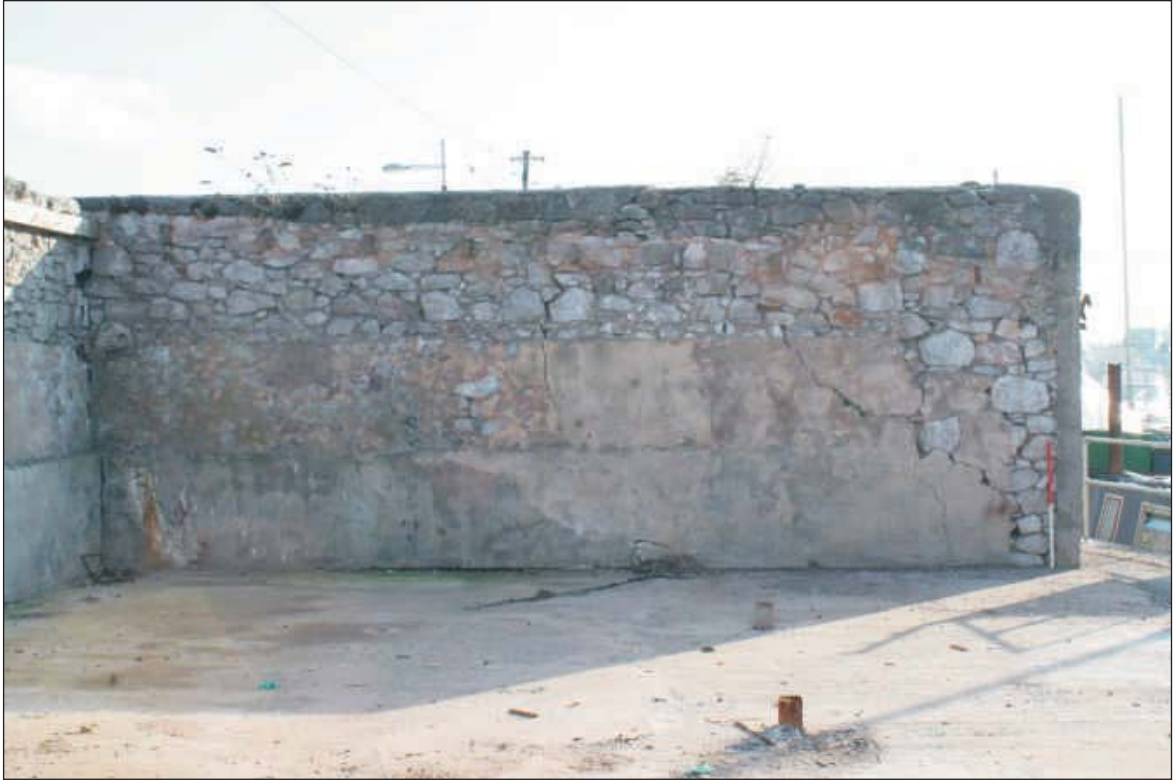
Plate 1: The southeast boundary wall, showing the truncated south end, viewed from the northwest (scale 1m)

The site is defined on its northeast and southeast sides by the limestone boundary wall that was built in 1831 to enclose the (then new) canal wharf (Fig. 2). The southeast length of wall forms one side of a passage between two wharves. Here the southwest end of the wall has been removed to create a walkway along the wharf frontage (Plate 1). The wall is 0.60m wide and is constructed from a mixture of rubble and faced limestone bonded in lime mortar. It stands to a height of 3m on its exterior face and 2m on its interior elevation. Where 20th-century buildings abutted the wall on its inner elevation, for example beside a former entrance (see below) it had been rendered, and scars of the walls and roofs are visible. The present entrance is an early 20th-century insertion that was been widened during the later 20th century. The jambs of the opening have been rebuilt (Plate 2). There are further openings at the northwest end of the wall and towards the northeast end. The latter is 3.8m wide and has been crudely blocked with limestone rubble bonded in concrete. This opening has dressed stone piers projecting from its south elevation (Plate 3). To the east of the present entrance the wall is supported on its inner face by two brick piers. The northernmost section of wall between the gateway opening and the warehouse has been rebuilt during the 20th century.

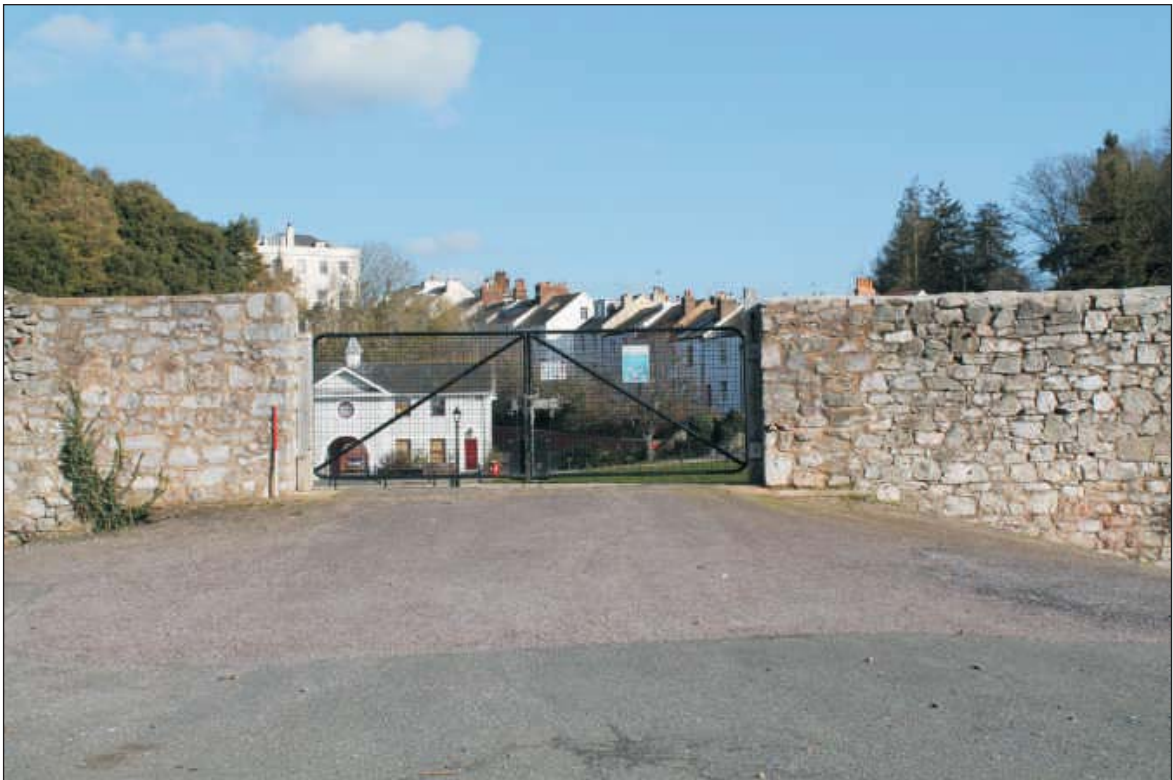
Plate 2: The current main entrance in the northeast boundary wall, viewed from the southwest (scale 1m)

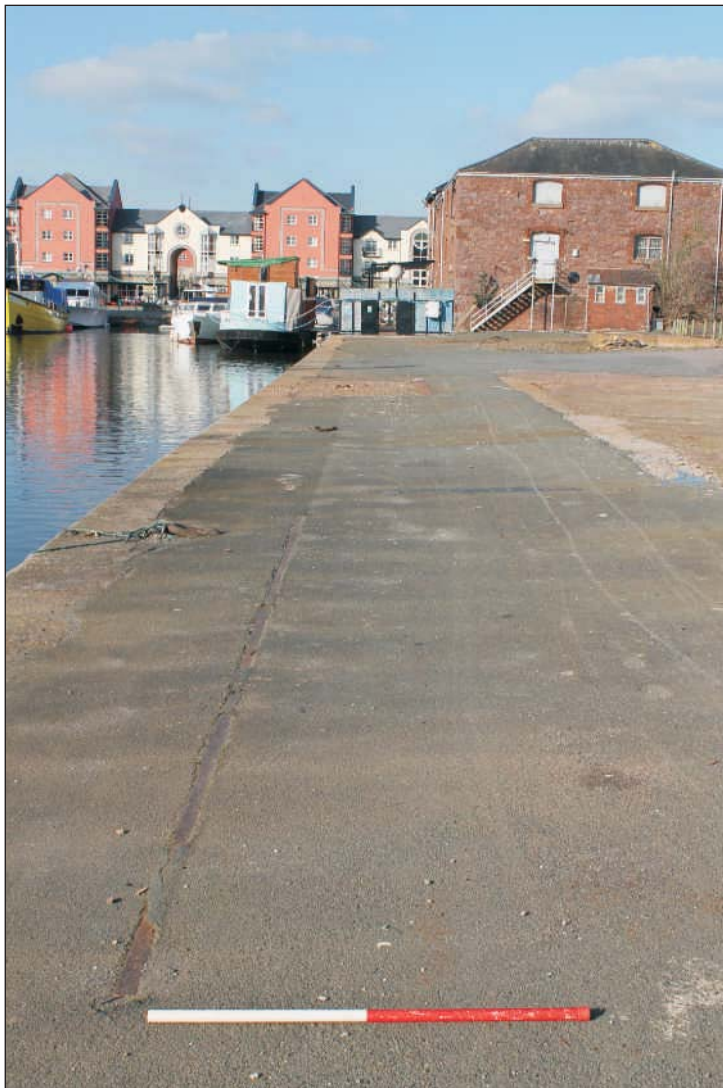
Plate 4: The front of the wharf, showing the siding rails, viewed from the southeast (scale 1m)

Prior to development the site was covered by tarmac and gravel as well as concrete forming the floors of former buildings. The only surviving structure is an early 20th-century brick lean-to attached to the gable elevation of the adjacent warehouse. It is constructed of red brick laid in stretcher bond, with discontinuous courses of yellow brick. There is a door with a blocked (?vent) opening in the southwest elevation and three narrow, high-level sash windows in the southeast elevation. It has a pitched corrugated iron sheet roof. The line of the buried railway siding could be discerned as raised lines in the tarmac surface (Plate 4).

The canal basin wall is constructed of coursed limestone blocks, with five courses being fully visible above water level. It is topped along the wharfside by granite capstones, some of which contain rebates for former iron ties as well as sawn off posts, presumably for former railings. The latter are unlikely to be original features. The extreme eastern end of the wall has been rebuilt in concrete and the capstones relaid. Behind the wall several large iron anchor points project emerge from the tarmac surface (Plate 4).

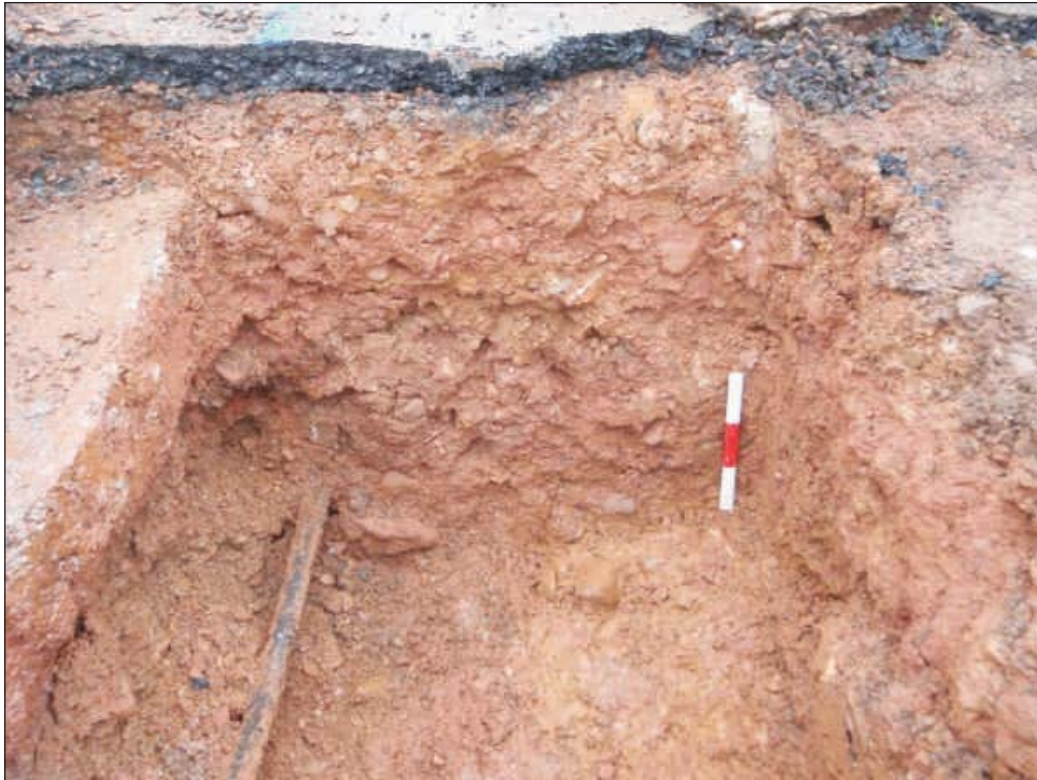
Plate 5: Deposits associated with the 19th-century wharf visible in the trial trench, viewed from the northwest (scale 0.30m)

At the southeast corner of the site, close the wharf frontage observations in a trial trench excavated to locate the existing electricity cable were made (Fig. 3a; Plate 5). At a depth of 0.86m from the surface waterworn gravels in light brown-yellow clayey sand (107) were exposed, which probably represent a natural alluvial deposit. This was overlain by a series of dumped deposits of gravelly clay-sand as well as gravels (102-106) that had been tipped behind the wharf wall. These were sealed by the present surface and its associated make-up (100 and 101). This same deposit sequence was observed throughout the new service behind the wharf, except that the upper dumped deposits 102 and 103 (and part of 104) had been removed and replaced with chippings (110) set within a wide trench (F117) when the railway siding was laid (see Plate 8).

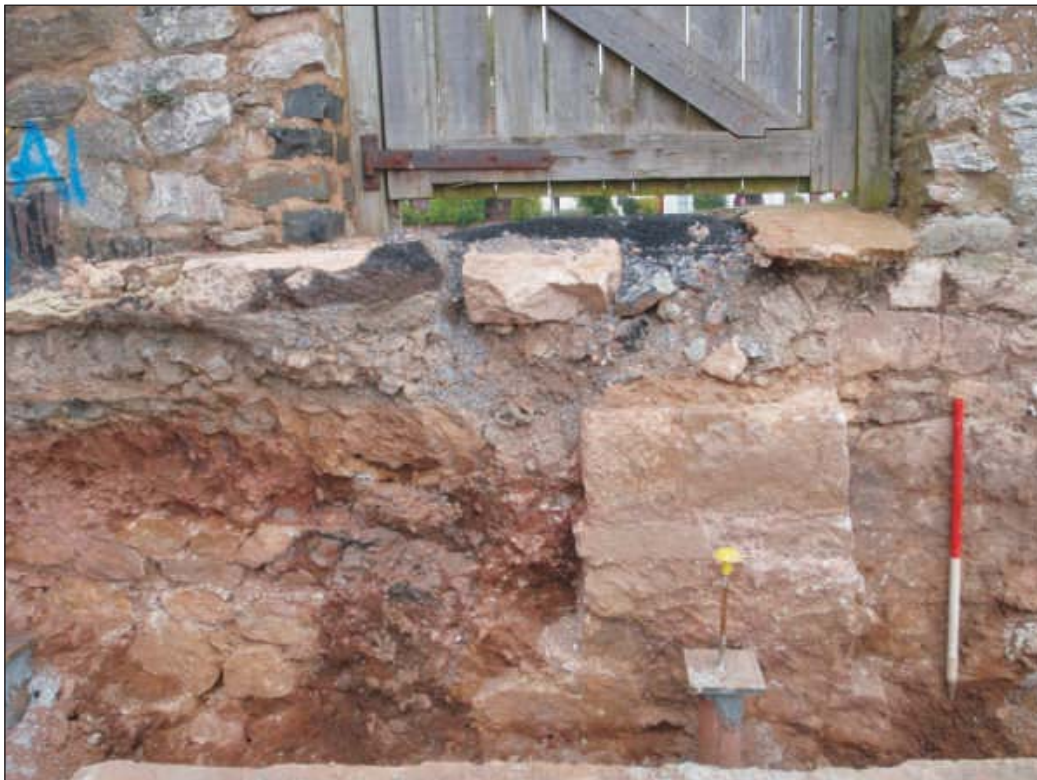
Plate 6: The masonry associated with the opening in the northeast boundary, viewed from the southwest (scale 1m)

In the northwest corner of the site a series of structures were recorded, both above ground and below ground (Fig. 4; Plate 6). The primary wharf boundary wall and associated footings (F147) survived to the south of the gateway, although the eastern jamb had been rebuilt (F139), as had the wall to the north of the present opening (F138). The lowest exposed course of the foundation appeared to be contemporary with a projecting footing of limestone masonry (F150) whereas the courses above appeared to abut F150. Masonry F150 measured up to 1.20m and its position coincides with a gate pier depicted on historic maps. The relationships between F147 and F150 appear to indicate that the foundations of the wall were constructed first and that the final positions of the openings (and associated gate piers) were made during the actual construction of the wall itself. A further length of masonry (F152) was present to the northwest of the wall. Unfortunately its relationship with the pier had been removed by the excavation of a trench for a wall tie. However, it is likely to represent the foundations of the 1831 boundary wall. Above wall F152 a layer of 19th-century levelling (151) survived. Deposits 148 and 149 also probably represent 19th-century levelling after the construction of wall F150. These were all sealed by 20th-century surfaces (142 and 143) and the foundations (140, 144-146) associated with the wall (F138) blocking and narrowing the former gateway.

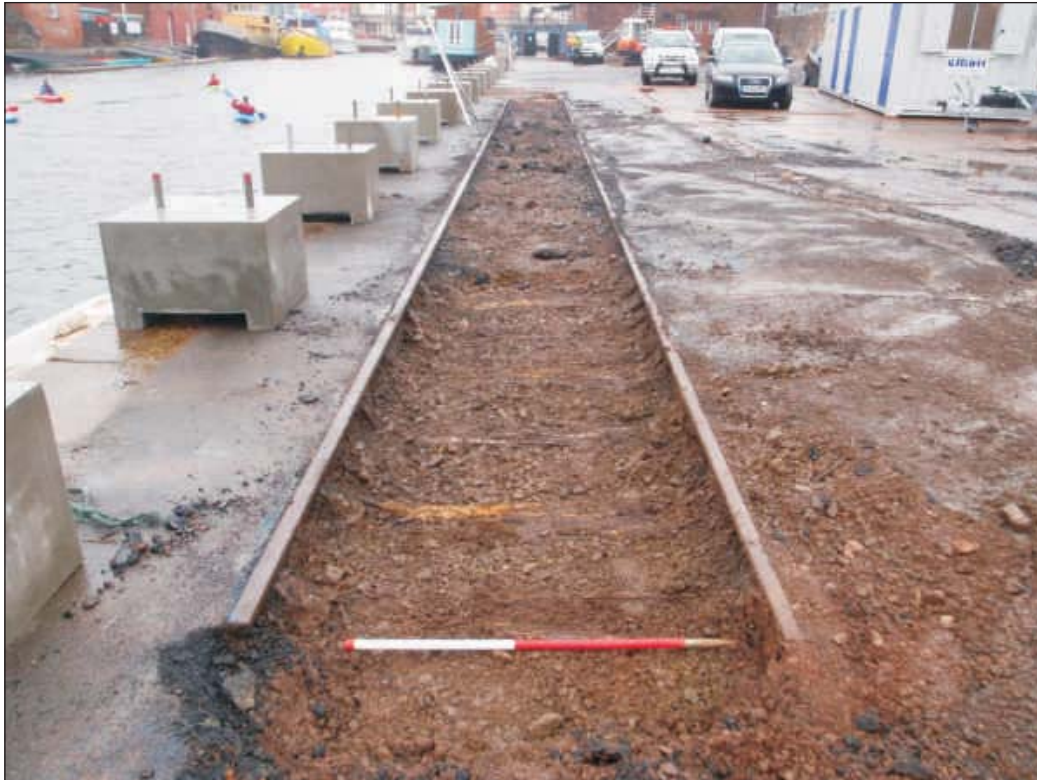
Plate 7: The exposed siding rails at the southern end of the site, viewed from the southeast (scale 1m)

The wharfside railway siding was exposed across its full surviving length. A 10.6m length of it had previously been removed at the southeast end of the site, presumably when the adjacent wharf wall was replaced. Two rails were present, spaced 1.44m apart, and were laid into wooden sleepers placed 0.52m apart (Plates 7-8). They had been laid to standard gauge dimensions, consistent with their late date – the siding was extended along the wharf probably in the 1920s.

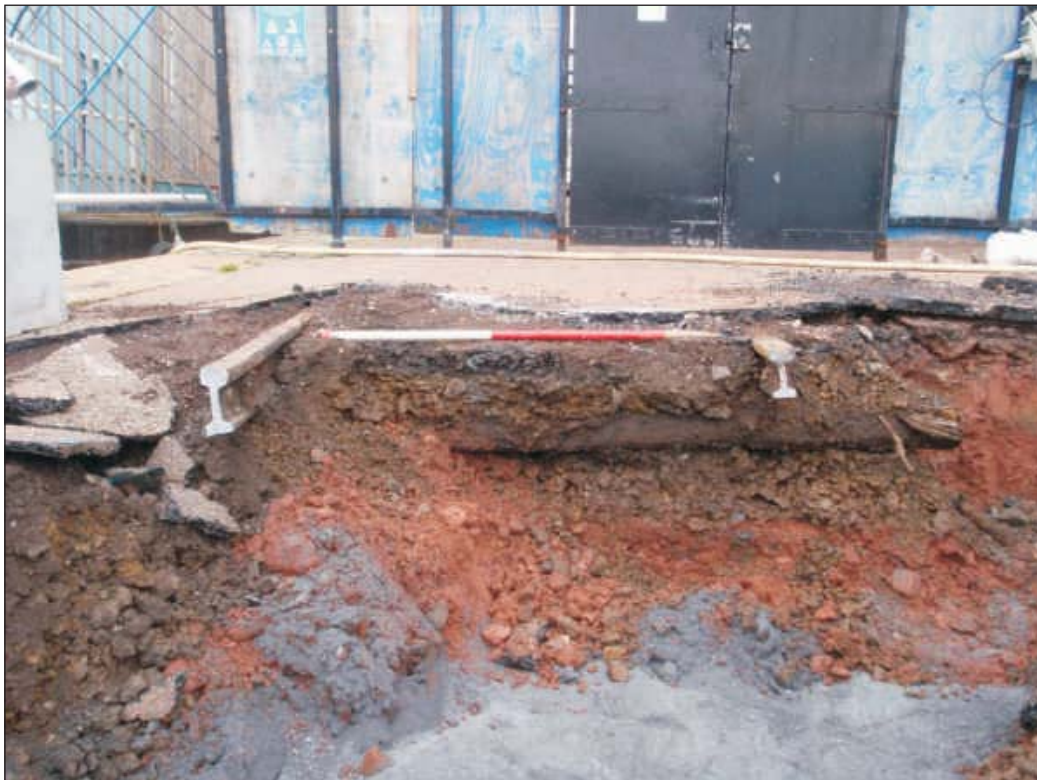
Plate 8: Section through the trench for the siding rails at the north end of the site, viewed from the southeast (scale 1m)
