LAND OFF ROWAN DRIVE, SEATON, DEVON

Results of an Archaeological Trench Evaluation

Planning Ref. East Devon District Council 13/1091/MOUT

Report No: ACD759/1/0

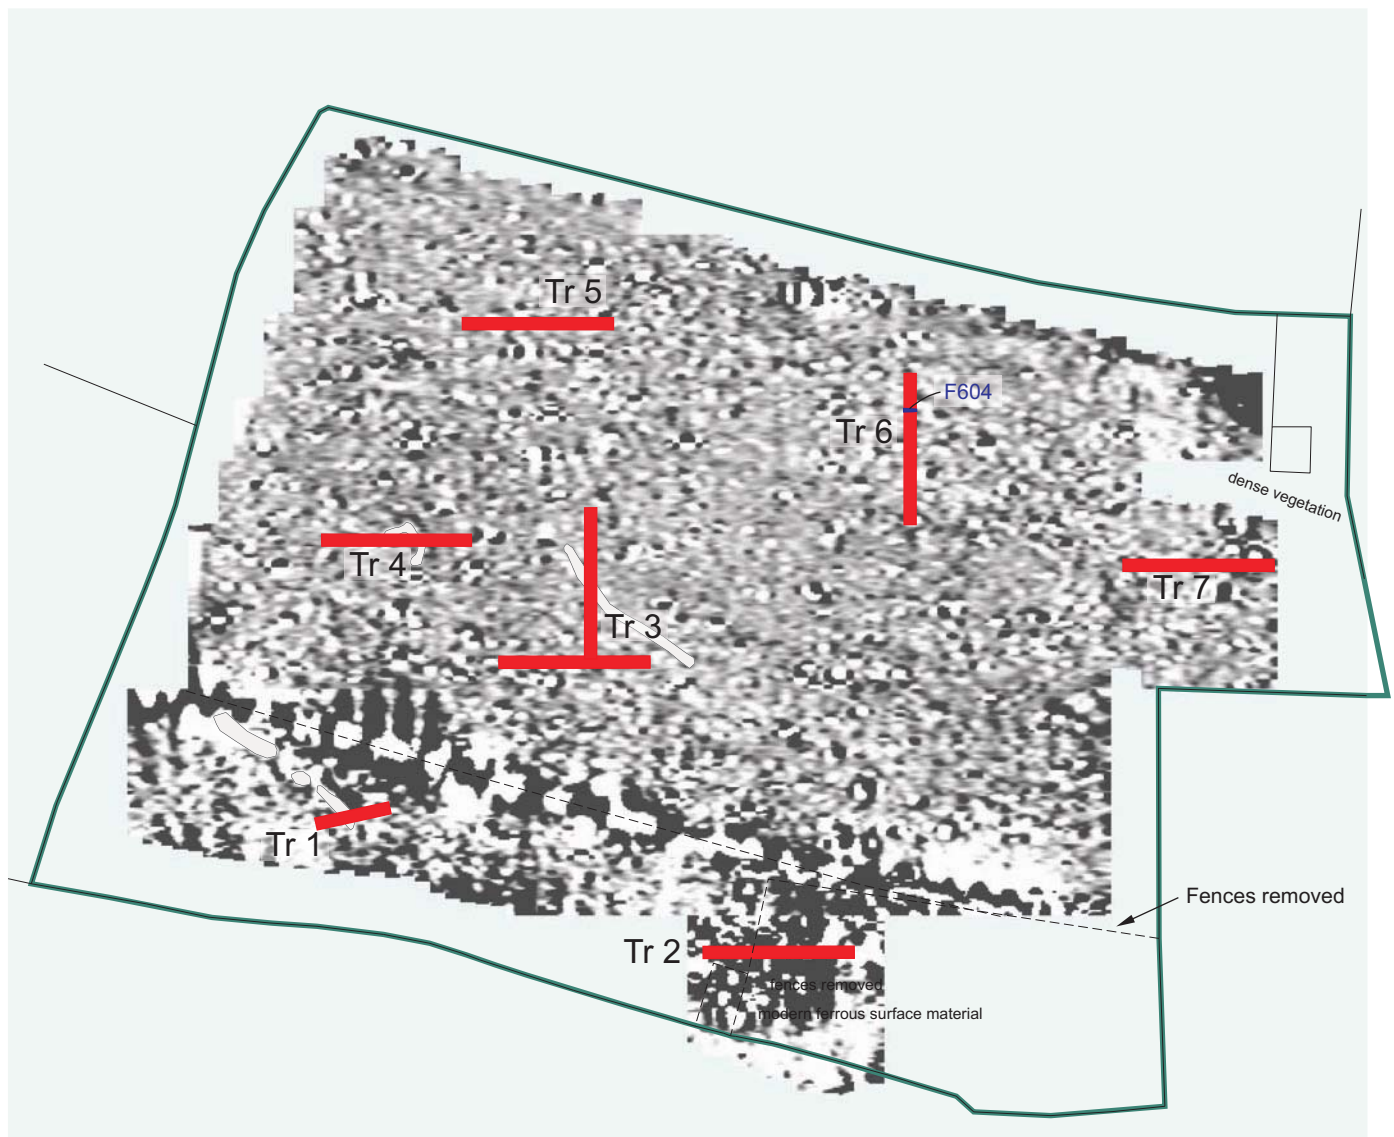
TITLE
 Fig. 2: Location of trenches and archaeological features identified

- Trial Trenches 1-7
- Archaeological feature F604
- Application boundary

- 4.1** The evaluation comprised the machine excavation of seven trenches totalling 135m in length, with each trench measuring 1.80m wide (Fig. 2). Trenches were positioned to target areas where anomalies were indicated by the geophysical survey and to provide sample coverage of areas where no anomalies had been identified. The removal of soil overburden was undertaken under the control and direction of the site archaeologist.
- 4.2** All features and deposits revealed were recorded using the standard AC archaeology pro-forma recording system, comprising written, graphic and photographic records, and in accordance with AC archaeology's *General Site Recording Manual, Version 2* (revised August 2012). Detailed sections or plans were produced at a scale of 1:20 or 1:50 as appropriate. All site levels relate to Ordnance Datum.

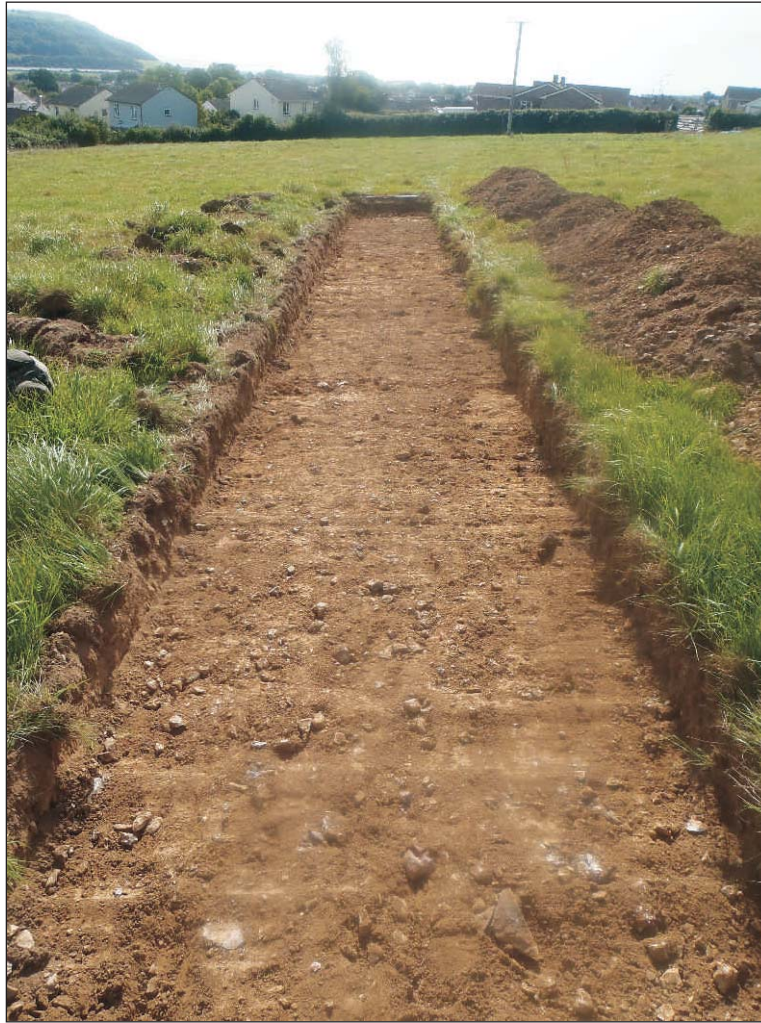
Trench 6 measured 20m in length and was aligned N-S. A linear feature (F604) was revealed towards the northern end of the trench.

Plate 1: General view of Trench 6, looking southeast

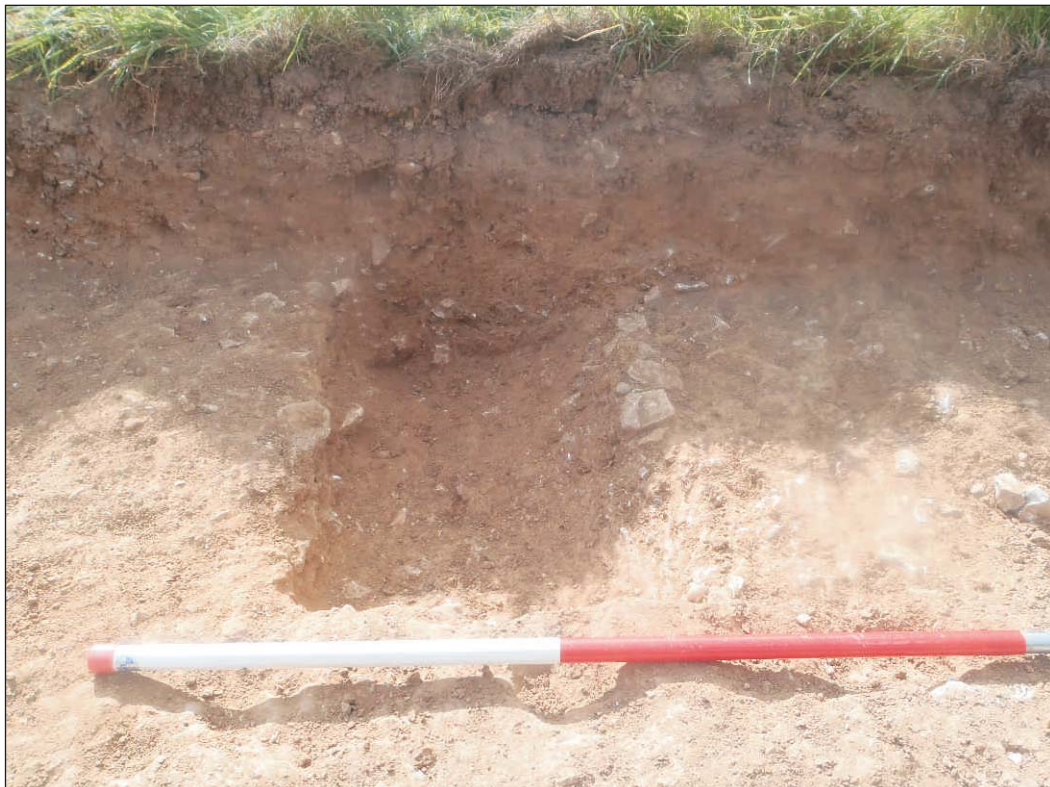
Linear gully F604 was northwest to southeast aligned and 0.50m wide by 0.19m deep. It had a U-shaped profile and was very shallow. It contained a single fill (603) consisting of a compacted silt. There were no finds and there remains the possibility that this was a natural feature.

Plate 2: East-facing section of ditch F604. Scale 1m

- 7.1 The evaluation has identified the presence of a single feature of possible archaeological interest on the site. The linear feature (F604) in Trench 6 may be regarded as of doubtful archaeological origin, but is similar to some of the features identified in previous archaeological work in the field to the northeast of the proposed development. Here, a network of ditches and gullies regarded as field drainage and boundary features of prehistoric to post-medieval date were recorded (Robinson and Valentin 2008).
