NORTH HILL, MINEHEAD, SOMERSET

Results of historic building recording

On behalf of:
The Exmoor National Park Authority

Document No: ACD711/1/1

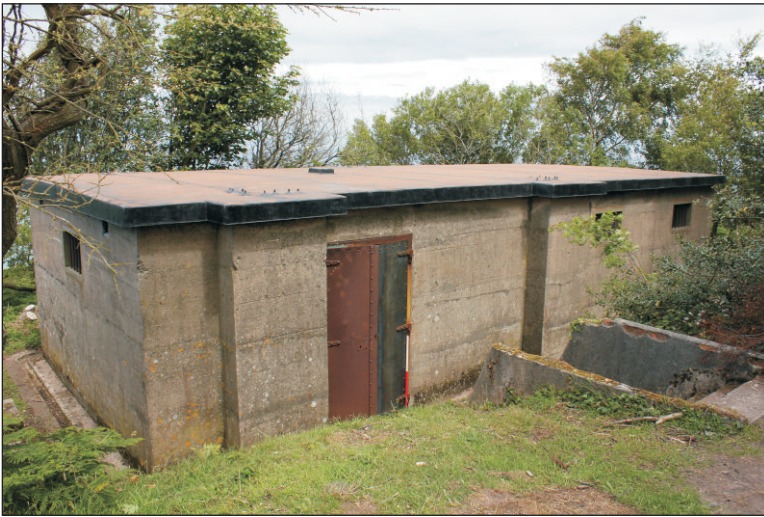
The building is constructed within a terrace dug up to 2m into the hillside (Plate 1). There is a flight of concrete-lined bricks set into the terrace on its southern side. The block is built of mass concrete that was poured within wooden shuttering, laid onto a concrete raft that extends beyond its elevations filling the terrace and creating a walkway. Within the raft is a shallow open drain that empties into gullies situated at the southwest, northeast and northwest corners. The walls incorporate eight integral buttresses – two each on the interior and exterior faces of both the north and south elevations. These supported the aerial array above the roof.

Plate 1: View of the TxRx block from the southwest, showing the building terrace with steps leading to the main entrance. 1m scale.

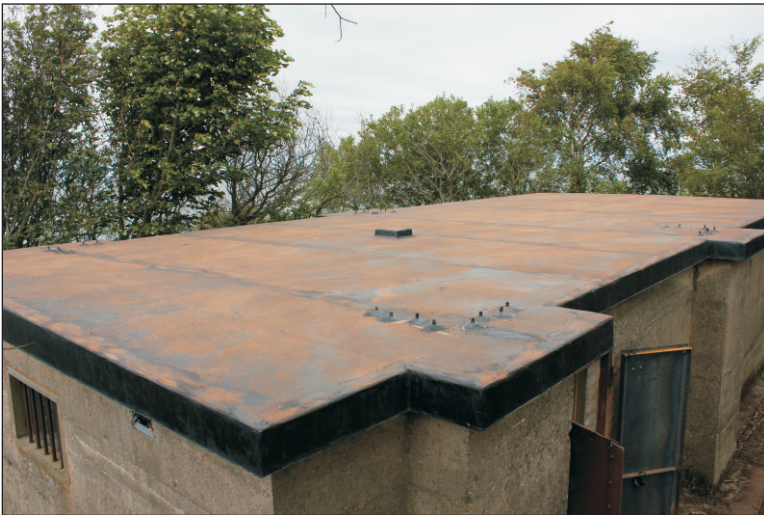
The roof itself is a slab of mass concrete covered with bitumen that has recently been replaced. The aerial array has been removed and only the bolts for supporting its lower structure survive, protruding from the roof (Plate 2). At Swansea, the static lower frame partially survives *in situ* (Plate 3). It is constructed of thin L-shaped steel pieces bolted together forming a truncated pyramid shape. At Rhossili Bay the TxRx block has been deliberately demolished, but a circular metal structure that appears to have been fixed to the lower frame (rather than being part of the upper turning array) survives (Plate 4). Access to the roof would have been via a ladder attached to the west elevation, now removed. The base of the ladder was attached to a three-step mounting block located away from the building. Attachment points for the ladder were observed on the mounting block and the side of the building.

Plate 2: The roof showing the bolts for the aerial array's lower frame, viewed from the southwest.

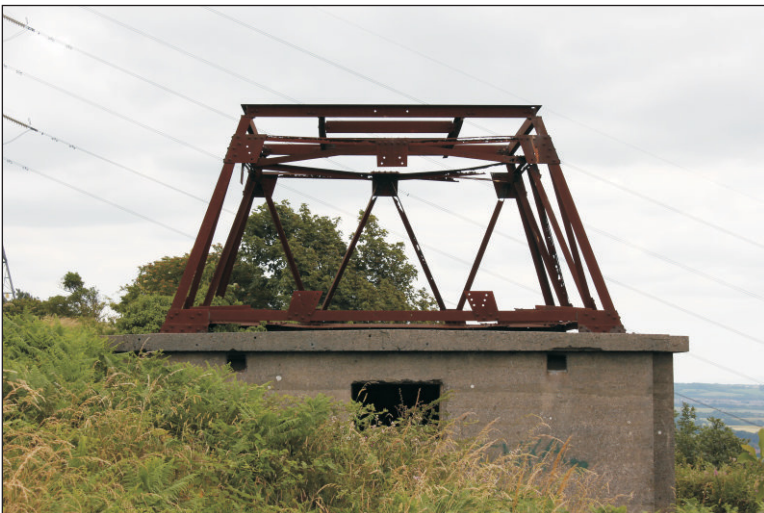
Plate 3: The aerial array at Swansea, viewed from the northwest.
Photo: Andrew Passmore.

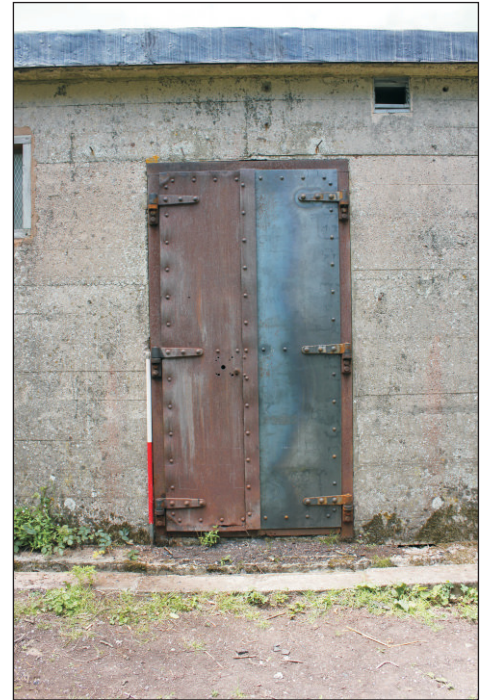
The building is divided into three rooms (from west to east, transmitter room, receiver room and telephone room), and there are double-width doorways in the south elevation into the transmitter room and in the east elevation into the telephone room. These both have steel outward-opening doors; one of each has been replaced as part of the present conservation programme. Above the doors are fittings for small canopies or hoods; this is clearer over the door in the east elevation where there is a scar and four protruding steel rods (Plate 5). These seem to represent attachments for a separate canopy, whereas at Oxwich Bay and Swansea shallow integral hoods were provided to deflect water away from the doors (Plate 6). As part of the post-war use of the building by the ENPA the openings have been narrowed using concrete blocks to accommodate standard-sized doors.

Plate 5: The doors in the eastern elevation showing the evidence for the hood above, viewed from the east. 1m scale.

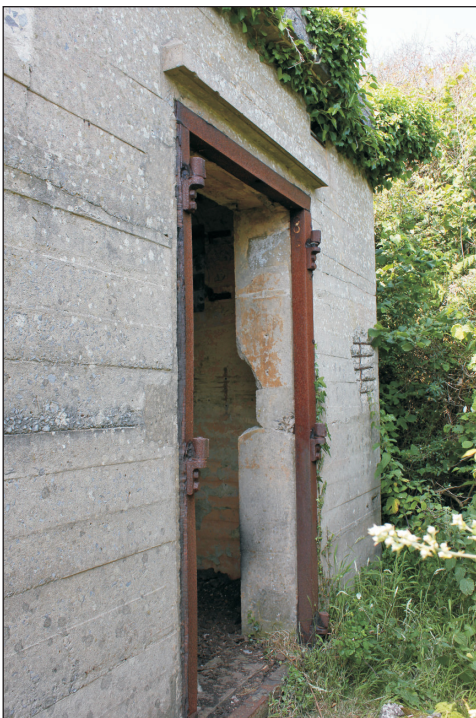
Plate 6: A doorway at Oxwich Bay showing the concrete hood, viewed from the southeast. Photo: Andrew Passmore.

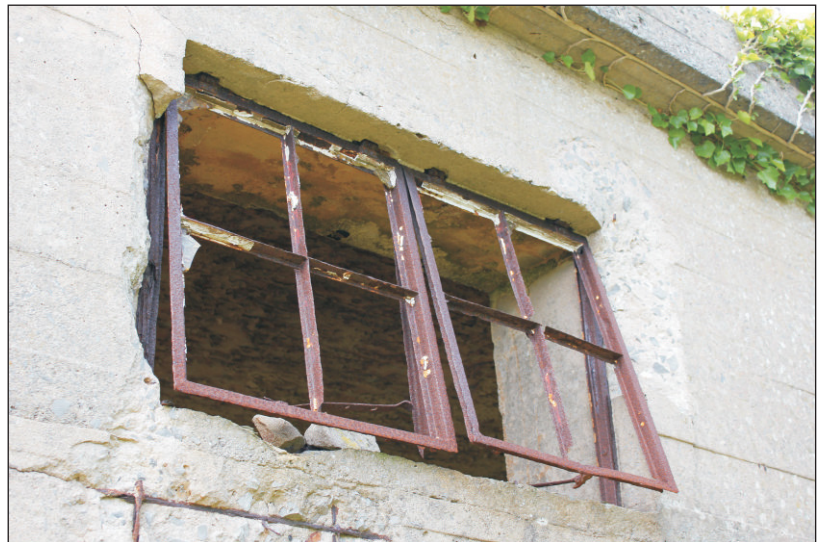
Plate 7: An original window frame at Oxwich Bay, viewed from the southeast. Photo: Andrew Passmore

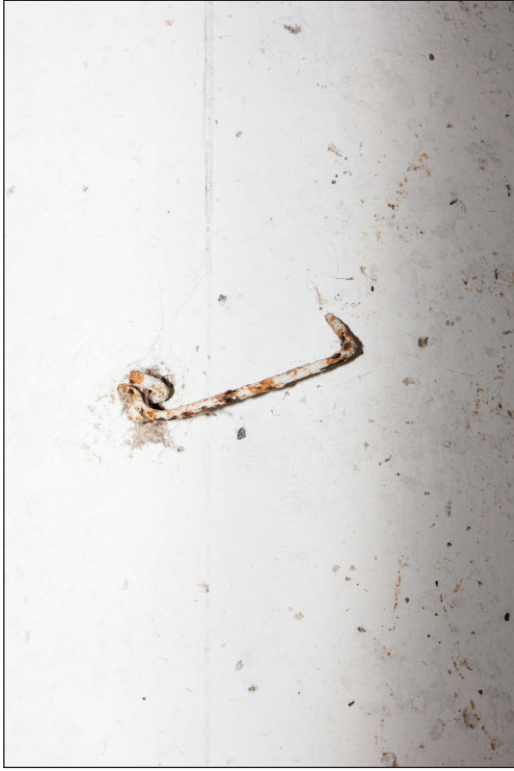
Natural light is provided by a series of high level windows; two in the south elevation lighting the receiver and telephone rooms, one in the east elevation lighting the telephone room, four in the north elevation lighting all three rooms, and one in the west elevation lighting the transmitter room. The present windows are post-war replacements comprising five metal security bars set into a wooden frame with leaded glass attached to the inner side of the frames. There is no evidence for the original fittings. However, at Oxwich Bay, some primary fittings survive and consist of metal frames holding a pair of top-opening two-over-two pane windows (Plate 7). Internally, the window opening incorporated pairs of steel security shutters, although at the time of the survey some had been removed for refurbishment and replacement. Each pair could be fixed in the closed position using vertical bolts on one shutter that slid into the window sill and a rotating latch on the other shutter. They could be secured in the open position using hooks attached to the wall; only one of the latter survives (Plate 8), although several brackets remain.

Plate 8: A securing hook for a window shutter, viewed from the south.

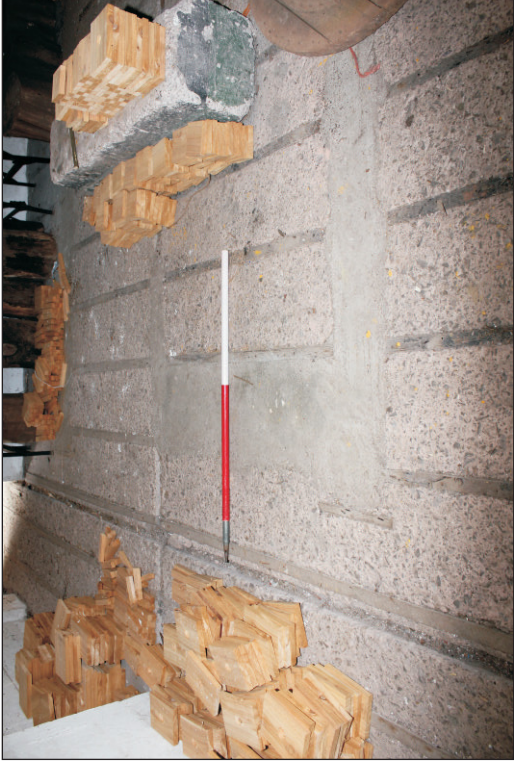
The floor is mass concrete and incorporates rows of wooden battens (not shown on Fig. 2) for the attachment of wooden floorboards and a linoleum floor (cf Hunt and Ainsworth 2006, 21-22). The floor also incorporates two groups of cable ducts, of different widths, now infilled with concrete (Plate 9). These conform to a standard layout as recorded at Craster (*ibid.*, 21, Fig. 9) and visible at Swansea.

Plate 9: The floor of the receiver room showing the battens for the floor joists and infilled cable ducts, viewed from the east. 1m scale.

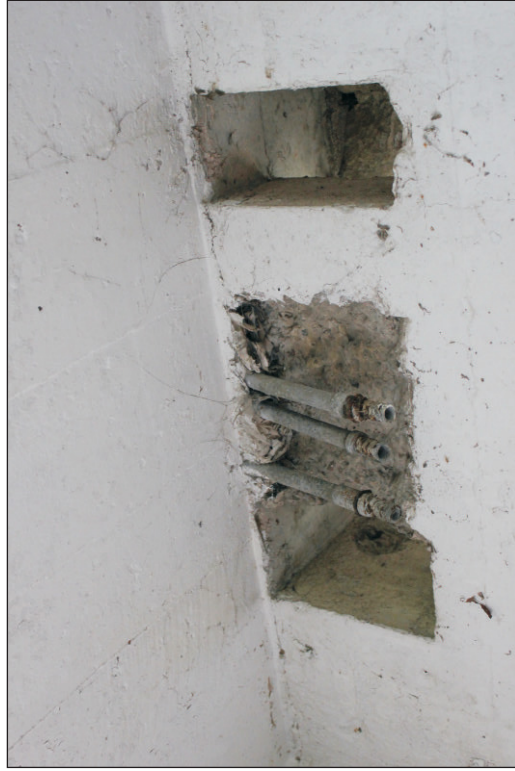
Electrical power entered the building from the northeast corner of the telephone room where there are the remains of five cable ducts (Plate 10). Some of these are, however, likely to be for phone cables. Cable ducts are incorporated into all the walls and where necessary into the ceiling, and terminate in metal plug socket boxes. A single possible light fitting survives in the telephone room.

Plate 10: The ducts in the telephone room, viewed from the southwest.

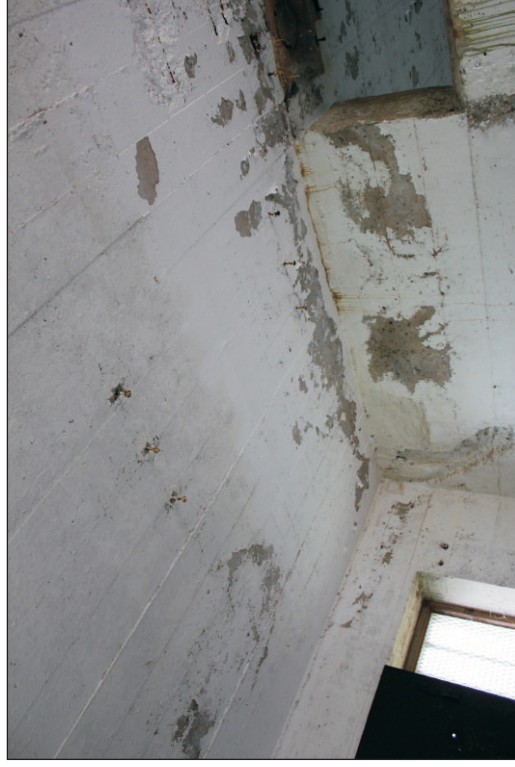
The centre of the aerial array was located over the dividing wall between the transmitter and receiver rooms. Here the wall has a hole for the turning mechanism above which is a circular opening in the ceiling. Transmitting and receiving cables to/from the aerial pass through crude cut-out channels in the dividing wall, and ducts partially survive below the ceiling. Fittings associated with the running gear are attached to the ceiling and comprise two rows of three nuts and bolts as well as two nuts and bolts and a C-shaped bracket in the transmitter room (Plate 11) and two rows of two nuts and bolts as well as two nuts and bolts and a C-shaped bracket in the receiver room (Plate 12).

Plate 11: The fixings on the ceiling of the transmitter room for the aerial array turning gear, viewed from the southwest.

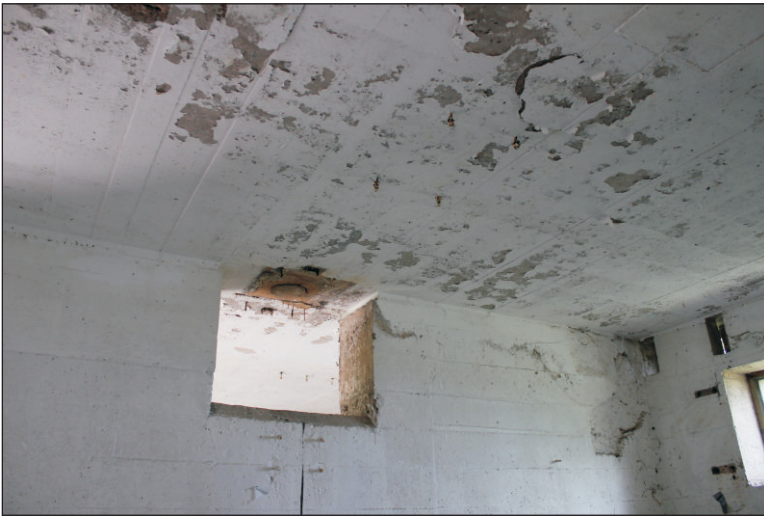
Plate 12: The fixings on the ceiling of the receiver room for the aerial array turning gear, viewed from the southeast.

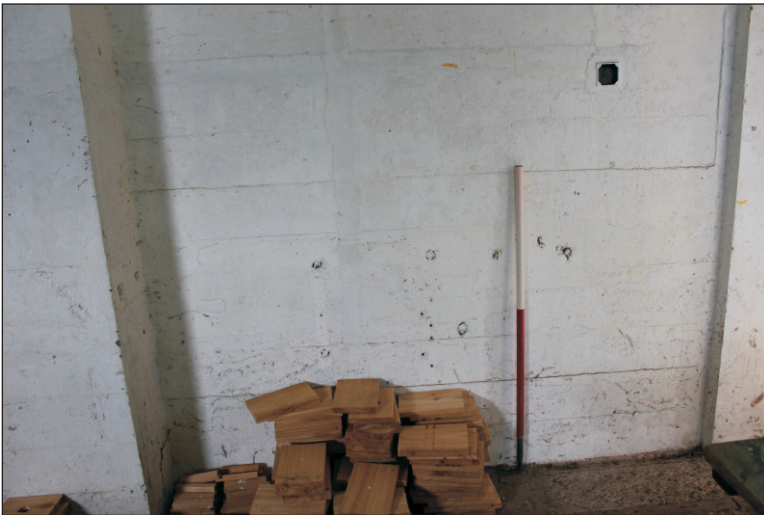
There are fittings for a shelf attached to the south wall between the buttress and the doorway into the transmitter room (Plate 13). Below this is a cable duct that may be associated with the former equipment on the shelf.

Plate 13: Evidence for the shelf on the south wall of the receiver room, viewed from the north. 1m scale.

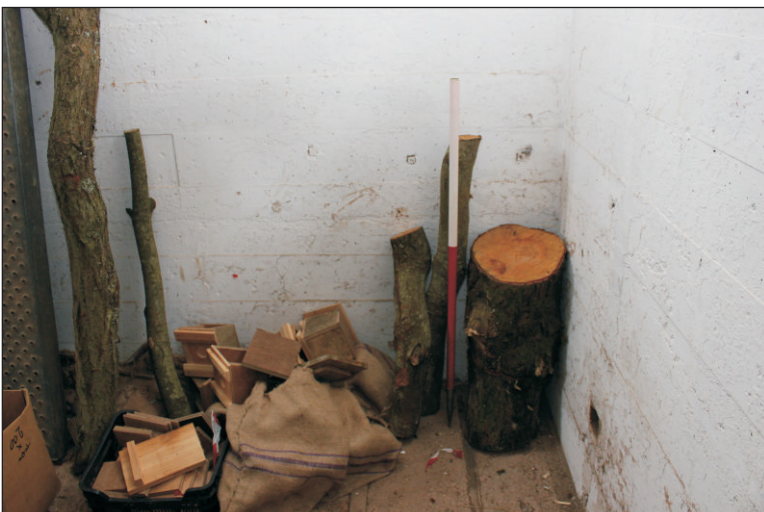
In the floor adjacent to both doorways are slight recesses finished in smooth concrete; one contains two iron fixings. Their function is unknown. There are fixtures for a shelf in the southeast corner.

Plate 14: Evidence for the shelf on the east wall of the telephone room, viewed from the west. 1m scale.
