SOUTH YEO, POUGHILL, DEVON

Results of historic building recording

Mid Devon District Council Planning Reference 12/01119/LBC

Document No: ACD735/2/0

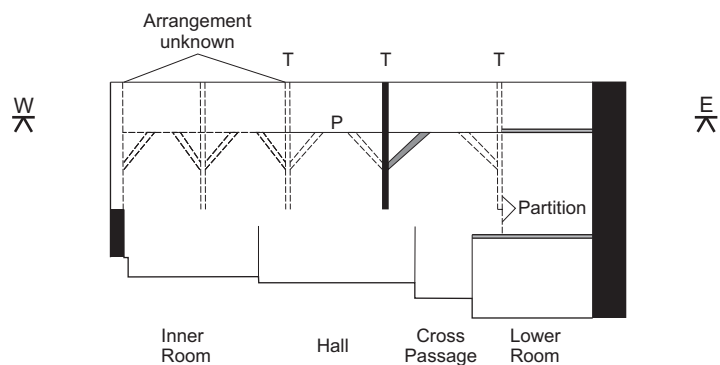
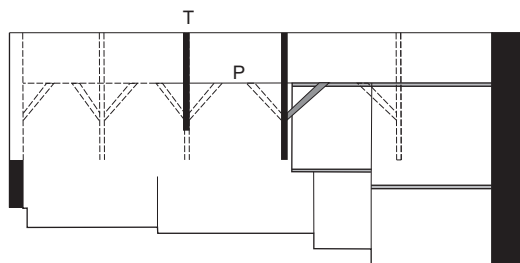
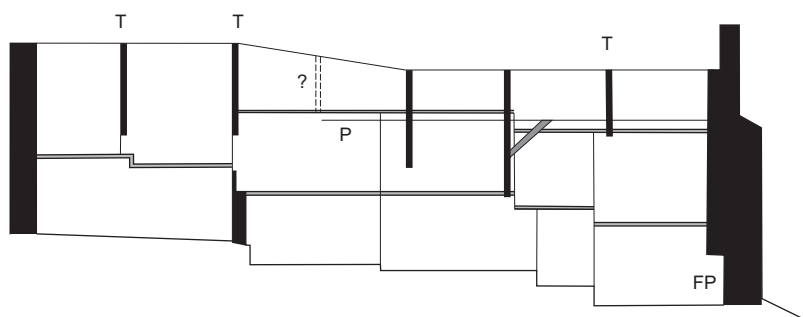
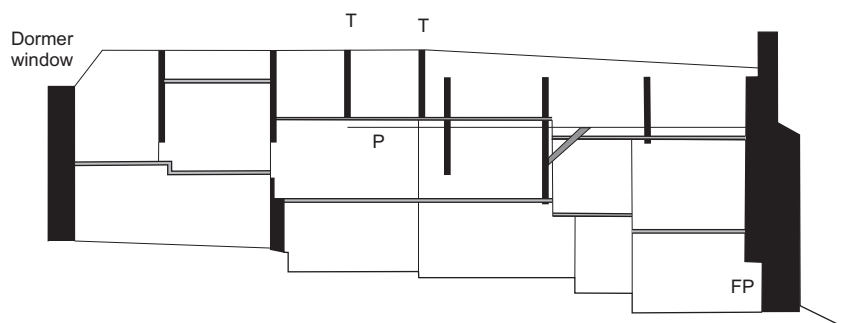
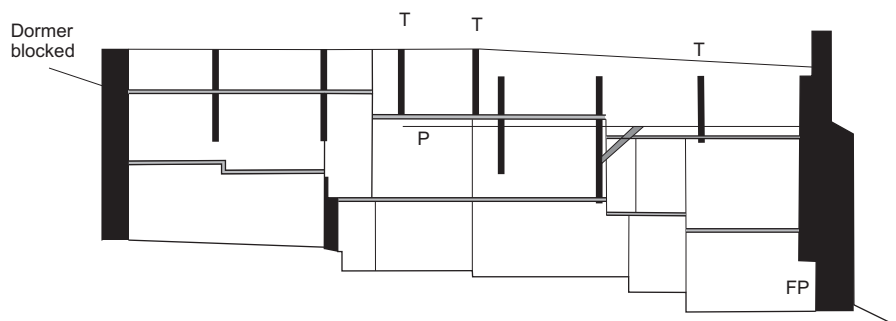
Fig. 2: Conjectural phased reconstruction of the farmhouse

- 5.1** South Yeo has origins as late a medieval three-room and cross passage house. This is put forward in the listed building entry, but the description is misleading in that the evidence for this is not described, and it only outlines the surviving fabric. This has been carried through in the recent *Design and Access and Planning Statement* where the origins as a smaller medieval house are suggested. It is clear from the details on the purlins that the house did include three rooms from the outset. The

first-floor arrangement can be partially understood. The smoke-blackening and the presence of wind braces indicate that the hall and cross passage were open to the roof and the former was heated by an open fire. The reduction in smoke-blackening over the lower room indicates that this was floored over from an early date. Given the later alterations, it is postulated that the lower room was ceiled from the outset with a narrow first-floor room over the eastern bay. Although the roof over the inner room has been removed, it is clear from the truss arrangement and the smoke-blackening of a replacement truss that the inner room was also open to the roof. The original thatch covering was smoke blackened, and some of this survives *in situ*.

- 5.2 During the 16th century minor changes were made to the building. First-floor accommodation was increased with the flooring over of the cross passage, and the room above supported on a jerry over the hall. Access to the first floor seems to have been from an enclosed stairwell or turret situated adjacent to the south elevation. This was lit by a window, now blocked whose opening is visible within a cupboard in the eastern bedroom. The remainder of the house remained unfloored, the evidence for this taking the form of a replacement truss situated towards the west end of the hall that is smoke-blackened. The smoke-blackened slates must date from this period, although it is not clear why, for a short period, the thatch was replaced.

- 5.3 Significant alterations to the house took place in the 17th century. An additional inner room (the present kitchen) was added with two first-floor rooms above. This extension was terraced into the hillside at a higher level than the rooms to the east, and correspondingly, this part of the building has a higher roof line that seems to have dropped down to meet the apex of the retained medieval roofline. The hall and inner room were floored over and accommodation provided above. The roof over the cross passage and lower room was partially replaced, although the medieval purlins were partly retained. The ceiling in these rooms was lowered to its present height. Given these alterations throughout the building, it is likely that the wind braces were removed at this time. The roof covering seems to have reverted back to thatch.

- 5.4 In the late 17th or 18th century further alterations were made to the roof. The west end of the medieval roof was replaced with new, taller trusses added to match the roofline to the west. This higher level seems to have been used across the remainder of the building, although there is no surviving evidence for this. A dormer window was inserted into the gable lighting the western room, whilst in the adjacent room a ceiling was added.

- 5.5 During the 20th century a new wing was added on the south side of the house, and corridors leading to it were added on both floors. The roof covering and supporting timbers were replaced, and new ceilings added over the western rooms and corridor. Here, the higher ceiling and the dormer window were removed. The eaves level was raised and existing 9presumably 17th-century) dormer windows converted into flush openings.

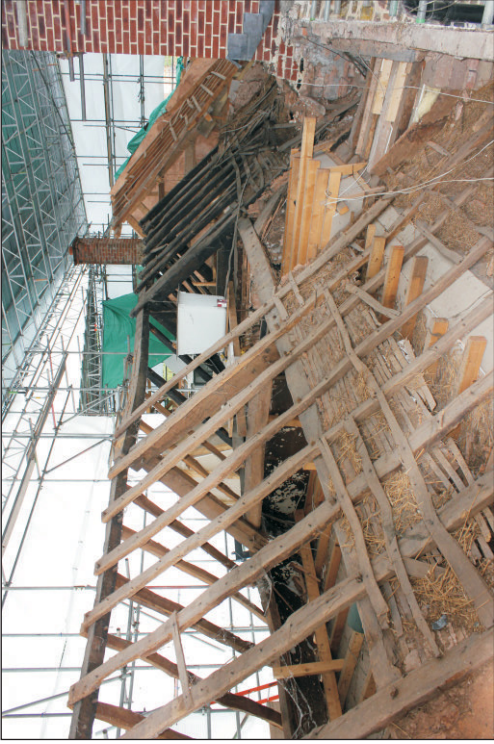
- 4.1** The overall roof structure comprises elements deriving from several phases of construction and alteration (Plate 1). These are described below in chronological order.

Plate 1: General view of the roof, viewed from the northeast.

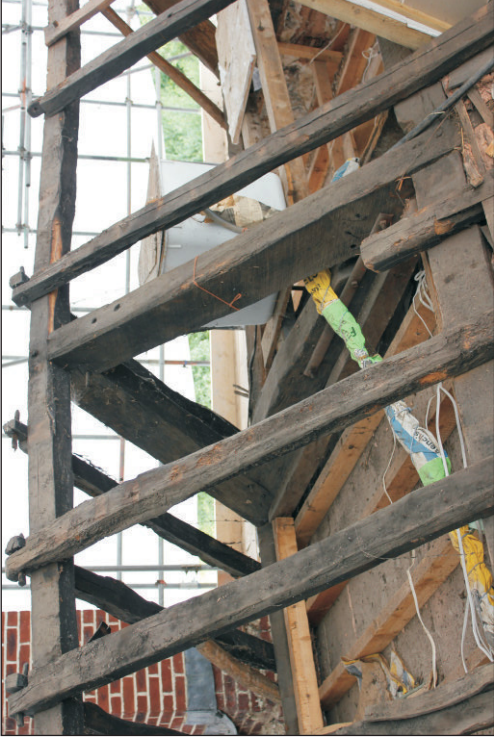
The oldest section of the roof is over the hall and cross passage where two and a half bays survive. The bays are divided by two trusses (of different designs) – one over the centre of the hall (Plate 2), and a second over the east end of the hall (Plate 3). The original ridge purlin displays evidence (in the form of a non-smoke-backed scar) for a third truss situated over the east end of the cross passage. The primary original truss is a jointed cruck and is partially exposed in the bedroom below. Here only one of the lower cruck blades survives. The truss has a halved high-level collar. This has been reinforced with the addition of an iron strap. The other early but secondary smoke-blackened truss has smaller dimensions than the primary truss and has a high-level socket and a chamfer on one side, indicating that it has been reused, possibly from a ceiling joist or screen. It has a collar above the present ceiling level, and a probable 18th-century halved nailed higher collar, presumably added to give extra support. It appears to be situated at the location of a primary truss, since there are scarfed joints on the side purlins at this location. (This is a common location on early roofs for the joints of purlins.)

Plate 2: The eastern truss in the medieval roof, also showing reused timber in partition beyond, viewed from the southwest.

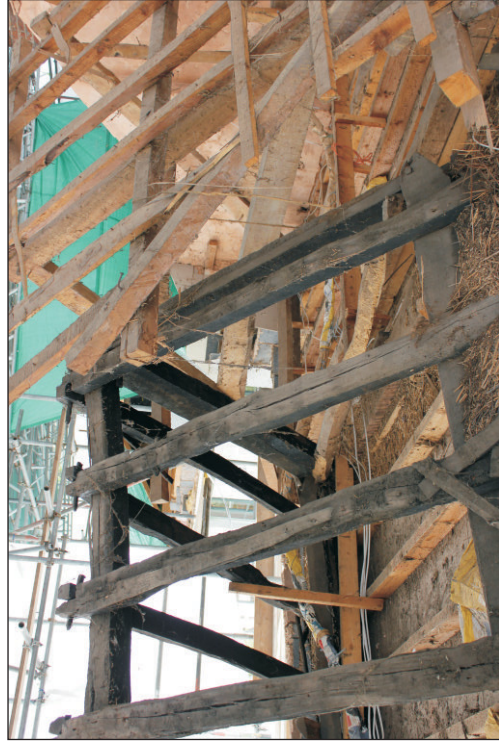
Plate 3: The replacement medieval truss in the primary roof structure, viewed from the northeast.

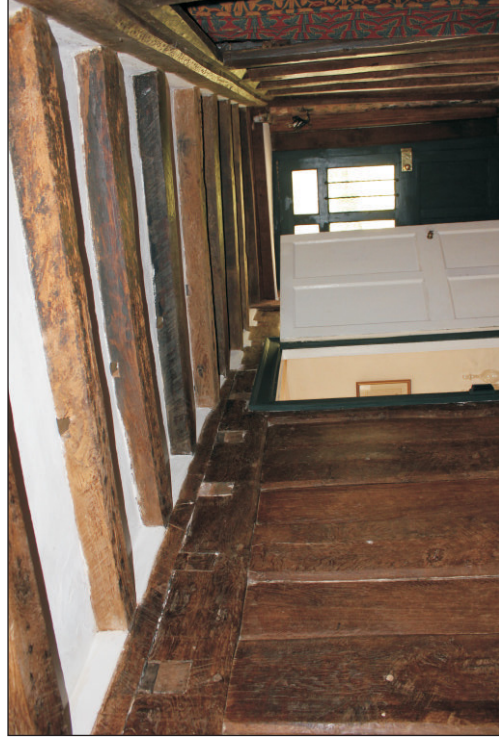
Plate 4: The cross passage showing the floor joists over the lower room in the screen to the left and later joists over the passage above the screens, viewed from the north.

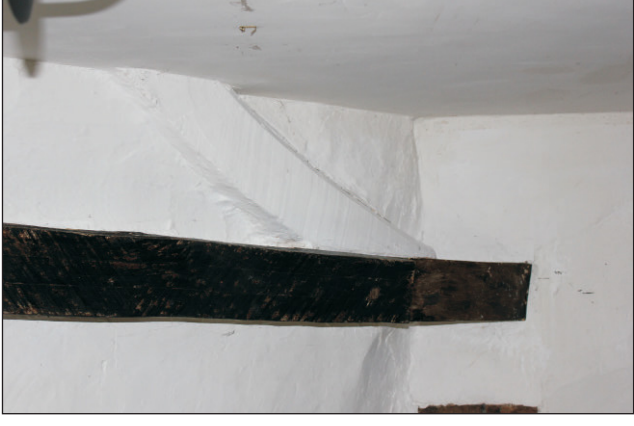
Over the hall and cross passage there was originally a series of straight wind braces set between the two rows of purlins; only one survives over the hall on the north pitch (Plate 6). Elsewhere, where not obscured, their positions were identifiable through the positions of pegholes in the purlins and mortice sockets in the jointed cruck.

Plate 6: The surviving windbrace, and adjacent primary jointed cruck truss, inside the bedroom, viewed from the south.

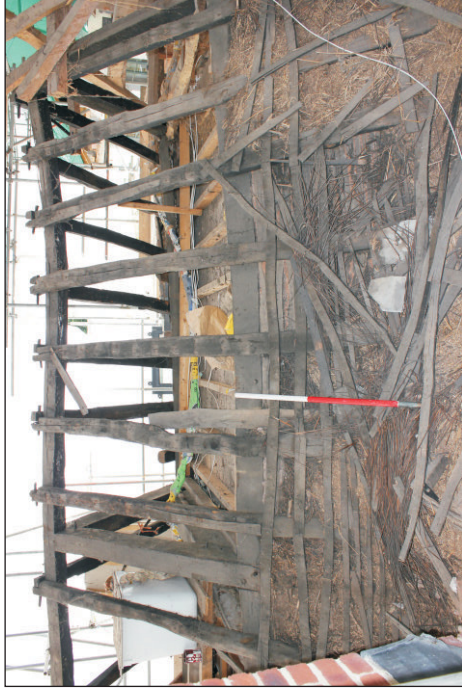
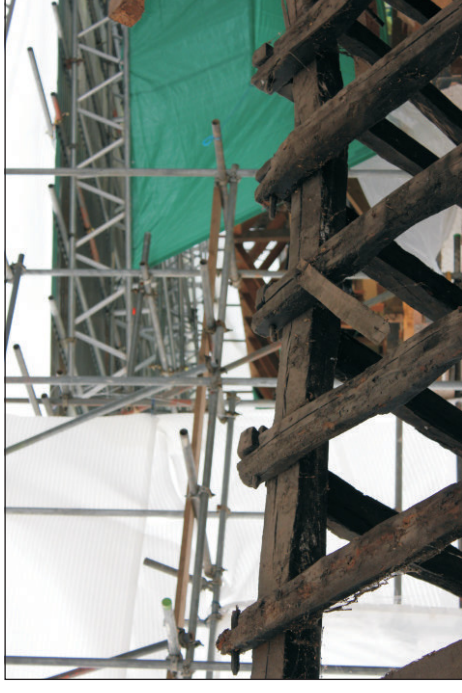
Smoke-blackened common rafters are pegged onto the side purlins and their apexes are halved and pegged over the top of the ridge purlin. A total of eight pairs survive; all others are attached with nails (Plates 7-8). These would have supported a thatched roof, and remains of smoke-blackened thatch survive around the roof space. These are being left *in situ*.

Plate 7: The medieval roof showing purlin with pegs for windbraces and the overlying common rafters, viewed from the north. 1m scale.

Plate 8: Close-up view of the medieval common rafters, viewed from the northeast.

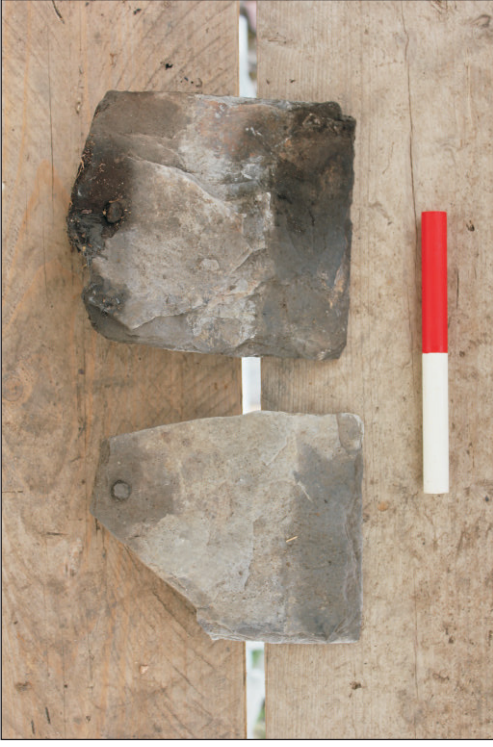
In addition, a group of five roof slates with surviving wooden nails (measuring 13mm^Ø by 62mm long) were also present here (Plate 9). Two slate types are present – a mid blue hard slate, and fine-grained but hard blue-light grey slate. The slates are of varying sizes from 202 x 186 x 10mm down to 199 x 168 x 11mm. These slates display evidence of smoke blackening on their inner faces.

Plate 9: Slates from the roof, top side. 0.20m scale.

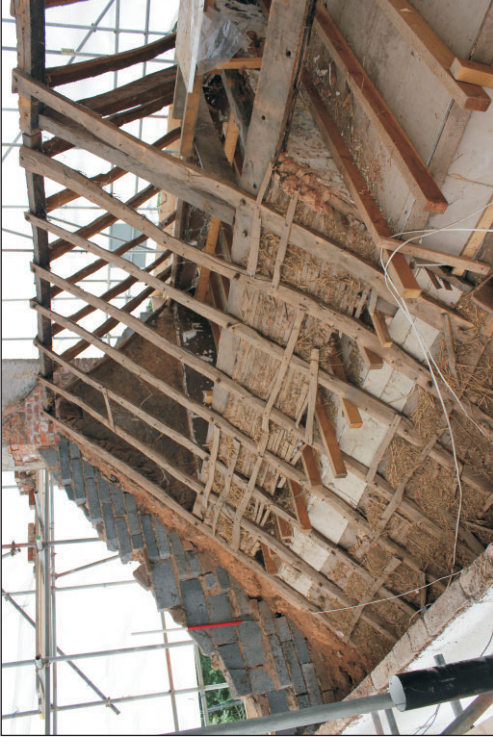
The lower room has a 17th-century roof constructed with the same ridge line as the primary structure (Plate 10). It is supported on a single truss positioned immediately west of the removed primary truss. It is of A-frame construction with a pegged lap-jointed collar and dovetail halving. The side purlins are retained from the primary roof, but the ridge piece has been replaced with a smaller timber. The former would have sat on a wooden corbel set into the gable. The common rafters are also 17th century and are pegged reusing the original peg holes in the purlins. These support nailed battens, presumably for a slate tiled roof. The primary ceiling of the first floor over the lower room was originally at a high level, under the collar, and comprised lath and plaster painted black. In the 17th century it was lowered to its present height.

Plate 10: The replacement roof over the lower room, viewed from the northwest. 1m scale.

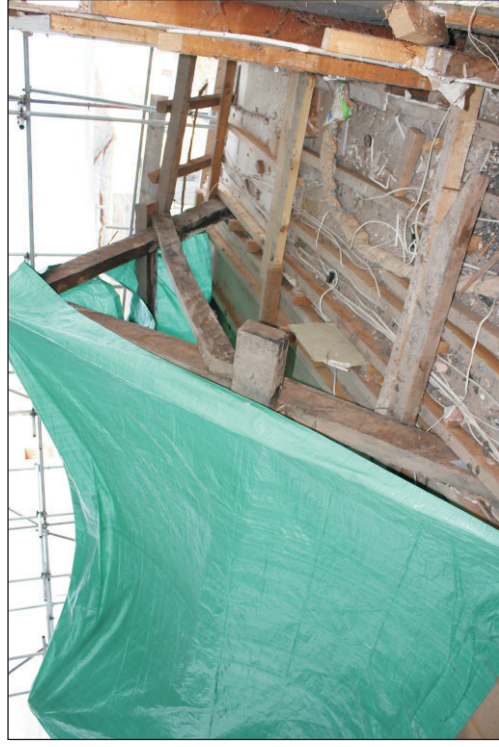
This roof was originally freestanding, but the purlins of the later roof over the hall extend onto the eastern truss. The east truss comprises an A-frame with an applied collar, all fixed with nails and pegs (Plate 11). It supported a lath and plaster partition (on its western side) that extended up to the collar beam. This has largely been removed but its position is visible as a scar. The western truss is a reused truss from the primary building, and comprises smoke-blackened rafters and collar (Plate 12). The south rafter rests on a narrow vertical post, but is not a jointed cruck in its original location. The remains of a lath and plaster partition survives on its western side, which indicates the current first-floor bedroom was formerly divided into two rooms. The trusses support a single row of large back purlins. The first-floor room below has a high modern ceiling, and any lower rows of purlins must have been removed during the 20th century. Trenches for purlins are visible in the exposed western truss within the bedroom, but these may be associated with the purlins of the original roof rather than the truss in its current location.

Plate 11: The eastern truss of the roof over the western extension, viewed from the southeast.

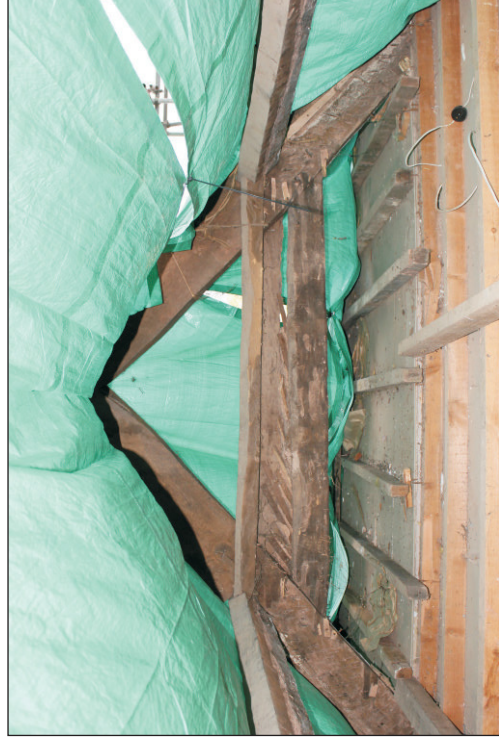
Plate 12: The reused medieval truss in the western extension, showing evidence for a partition, viewed from the east.

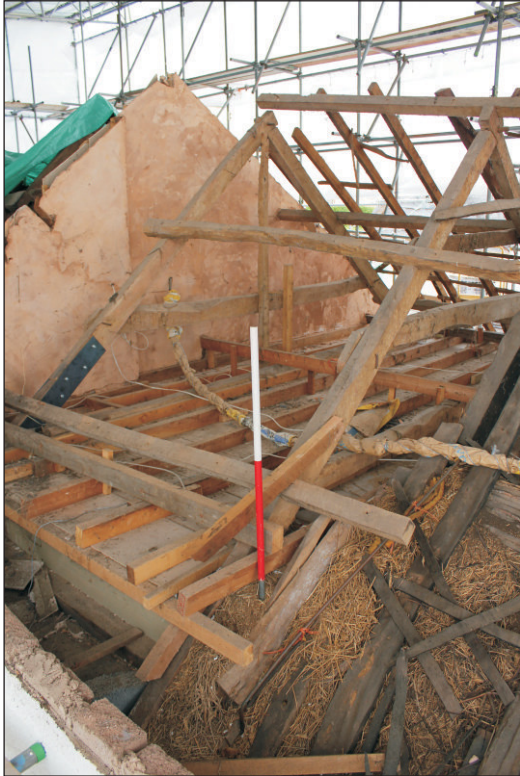
This is a replacement for the primary roof. It is set at a higher ridge level than, and therefore separate from, the roof over the hall to the east, and comprises two trusses that are set into cob that is greyer in colour than the walls to the east. This must reflect raising of the wall levels to facilitate the provision of first-floor accommodation and the associated higher roof. Its pitch is gentler than the earlier roofs. The trusses are A-frames with applied collars and apexes. The ridge is supported on an extended

mortice. The timbers are joined with both pegs and nails, giving a late 17th- or 18th-century date for its construction. The structure is precarious and elements must have been removed during the 20th century. There are two diagonal braces on its north pitch representing historic strengthening, and both horizontal and vertical braces as well as metal plates added during the 20th century. The eastern truss also has an additional high-level applied collar for additional support. The present first-floor ceiling is modern but just above this there are applied collars, which are probably associated with the historic ceiling that would have been roughly at the same as the present one. There are two rows of purlins that continue west through a modern partition wall dividing this roof from that of the inner room beyond. The lower pair sit on the back of the rafters, whereas the upper pair are treenched to sit in the rafters.

Plate 13: The replacement roof over the western end of the hall and the inner room, viewed from the southeast. 1m scale.

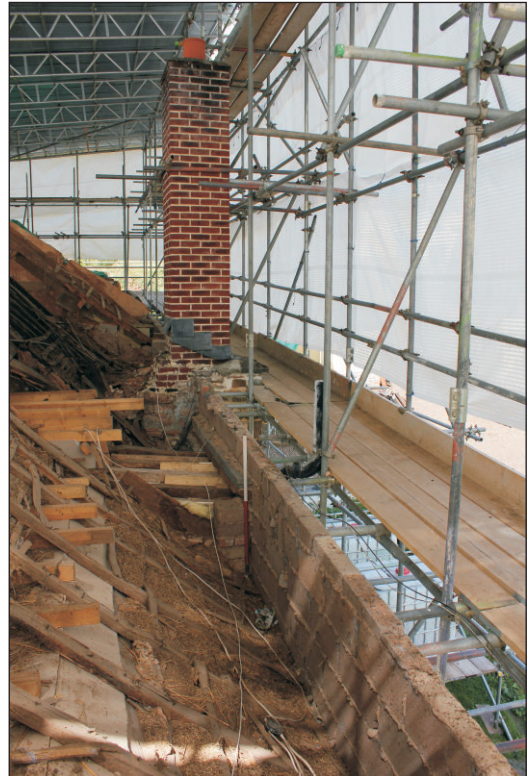
The building is constructed of local sandstone and pink-buff cob. As noted above, an area of greyer cob may represent a historic raising of the eaves level. The first-floor ceilings are modern and are associated with a further raising of the eaves. This has been achieved through the use of two skins of concrete blocks (and occasionally bricks and stones). The outer skin is rendered externally, whilst the inner skin supports the edges of the ceilings (Plate 14). The window reveals have also been rebuilt, with the opening changing from dormers to flush openings within the masonry. Some reused timbers have been incorporated within these features. In the west gable elevation, the concrete blocks also infill a central opening, a scar of which can also be seen at a high level within the bedroom. This probably represents the position of a former dormer window (Plate 15).

Plate 14: view of the northern pitch of the roof showing 20th-century raising of the eaves levels, viewed from the east. 1m scale.

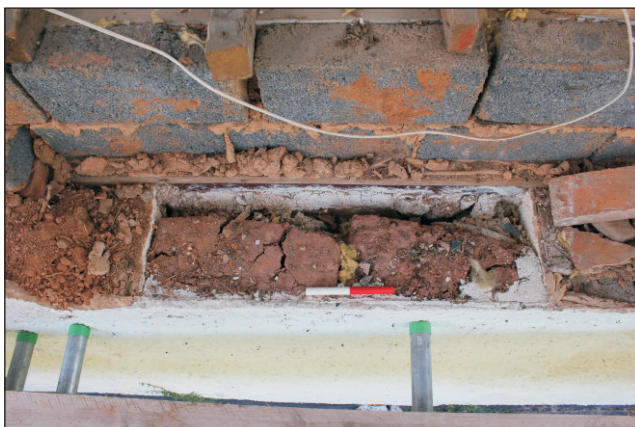
Plate 15: The infilled former window opening in the western elevation, viewed from the west. 0.20m scale.

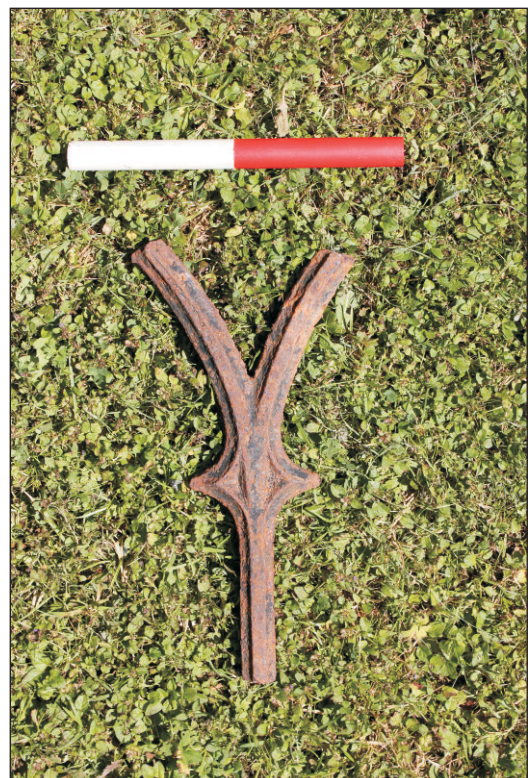
A small iron Y-shaped object, possibly a glazing bar, was found during removal of the roof. This has been retained by the owners (Plate 16).

Plate 16: The possible glazing bar, recovered from the roof. 0.20m scale.
