CREDITON LINK ROAD, WELLPARKS ROUNDABOUT TO LORDS MEADOW INDUSTRIAL ESTATE, CREDITON, DEVON

Results of an Archaeological Watching Brief

Report No: ACD704/1/0

Date: December 2013

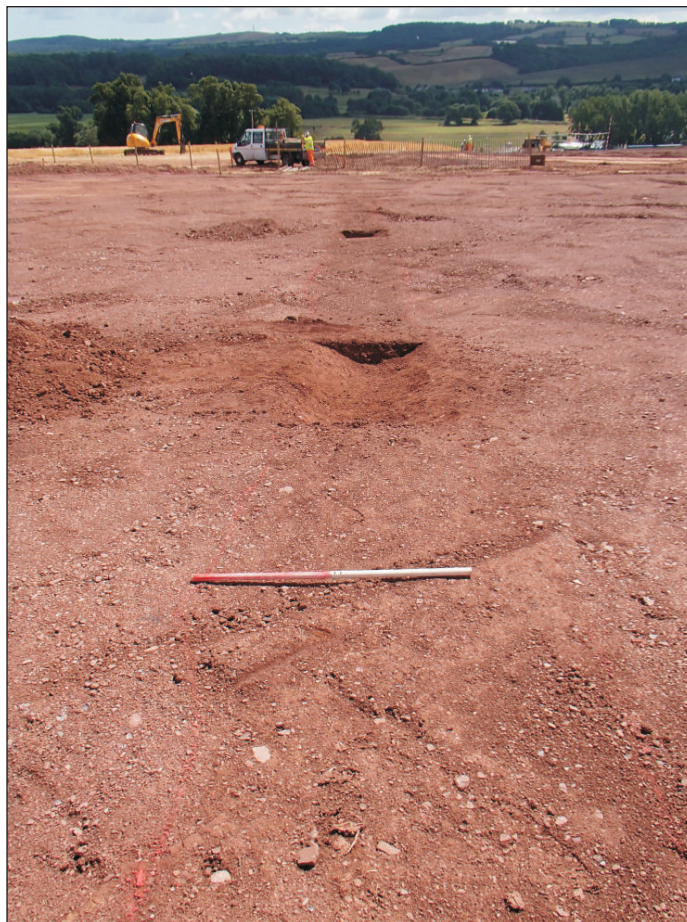
Plate 2: Ditch F113, view to SSE (scale 1m)

Each of the three archaeological features was plough-truncated and undated. The two ditch features may relate to former agricultural boundaries. Ditch F113 was not visible to the southwest of the field boundary flanking the public footpath and may indicated that it represents a former sub-division of the existing arrangement. The function of possible pit F107 was not established
