35 and 37 Stokes Croft, Bristol

Heritage Statement

Document No: ACD719/1/1

Date: August 2013

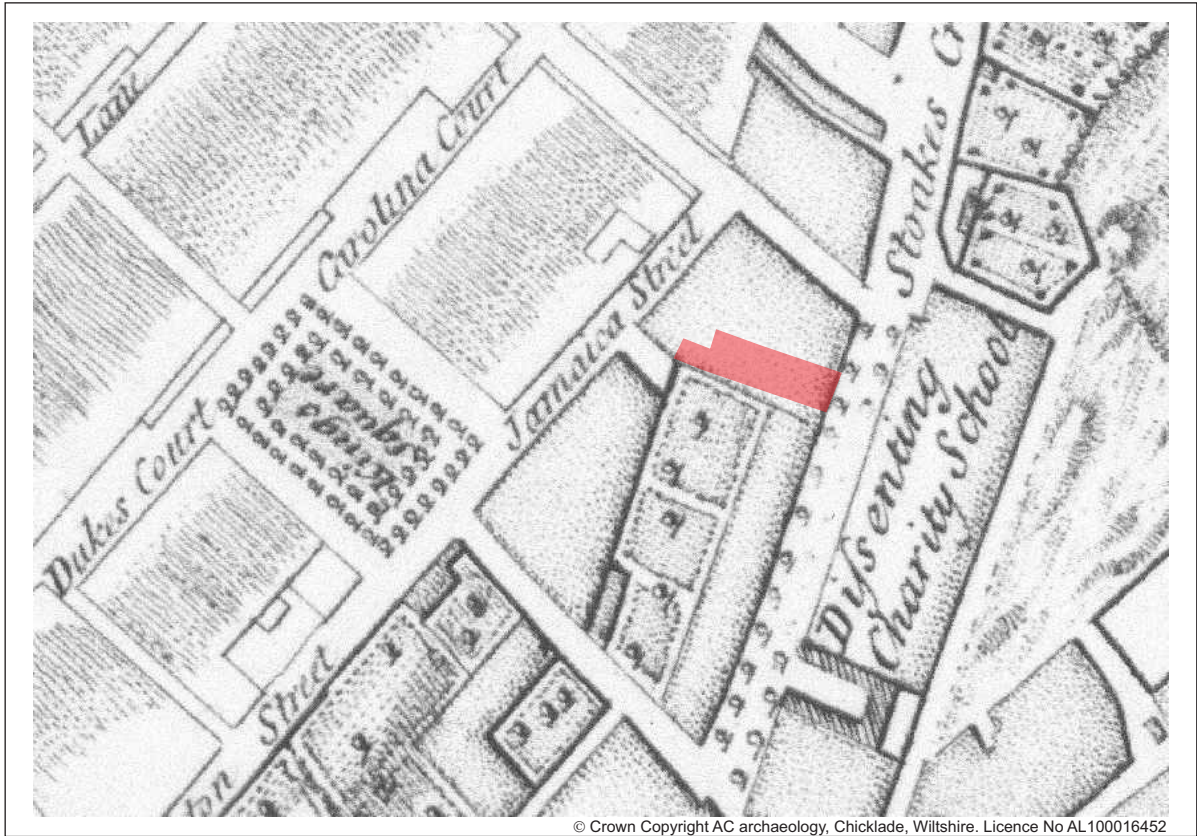
Fig. 2: Rocque's Map of 1750 showing the north-west side of Stokes Croft as a developed area

- 2.1 The site lies to the north of the historic walled city within an area of post-medieval urban development characterised by terraces of row houses arranged in formal grids of parallel streets and squares. Rocque's map of the area, dating from 1750 (Fig. 2), shows that many of these streets had already been laid out but that at that time they remained undeveloped. These streets include Kings Square (laid out in c. 1742 by George Tully), Dighton Street, Dukes Court, Carolina Court and 'Dove Coat Lane' later Dove Street. All these areas appear to be shown by Rocque as vacant ground. Stokes Croft, and Moon Street to the south east, lie on a different alignment and seems to be an earlier development. Rocque shows the block bounded by Stokes Croft, Hillgrove Street, Jamaica Street and King Square Avenue as fully developed, the densely built-up areas being represented by stippling.

- 6.2** These houses were clearly in existence by 1750, when the north western side of Stokes Croft appears as fully developed on Rocque's Map. It is typical of late 17th-, 18th- and early 19th-century speculative developments that, although there would be general agreement as to the form of the façades, the layout of the buildings and the alignment of the frontages, there might be considerable variation in detail and in the planning of the interiors. The surviving houses show some features typical of the period, including segmental-headed window openings with broad, flush-framed sash boxes and provincial Baroque detail in the rusticated piers and radiating, expanded voussoirs.

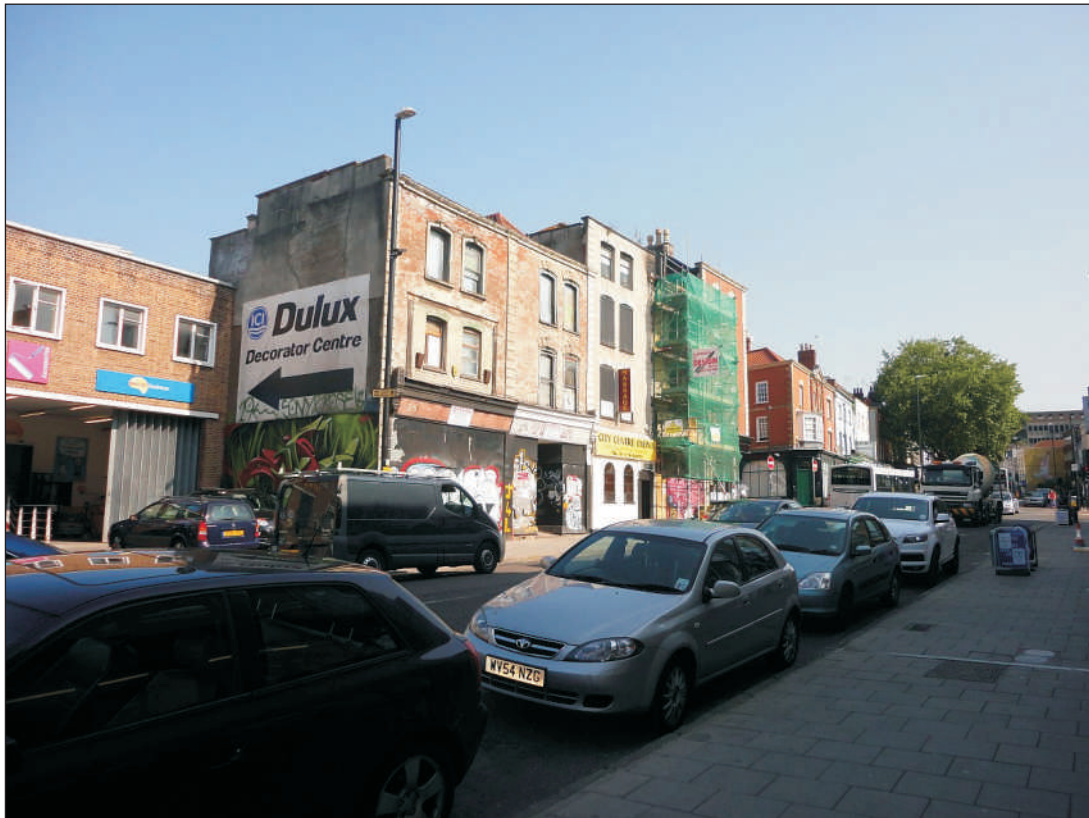
Plate 1: View of the surviving north end of the terrace showing it in its current urban context

- 2.6** Rebuilding of the area in the post war period set the building line to the south west of the properties well back from the original street frontage. It was probably anticipated that the surviving early buildings would in due course be entirely removed to widen the street. Five houses of the original terrace now remain: No 39 has been raised by an extra storey, probably early in its history, since the architectural detail is replicated. No. 41 survives at its original height, but is now in ruins following a fire and No. 43 (the corner house) has been either rebuilt in replica or refaced in modern brick. Beyond Hillgrove Street a short length of a comparable terrace remains, though here, rather than truncating the house plots in order to exploit the premises as commercial buildings, the shop fronts were extended over the areas to project from the frontages. These houses together represent an important fragment of the 18th-century streetscape of Stokes Croft (Plate 1).

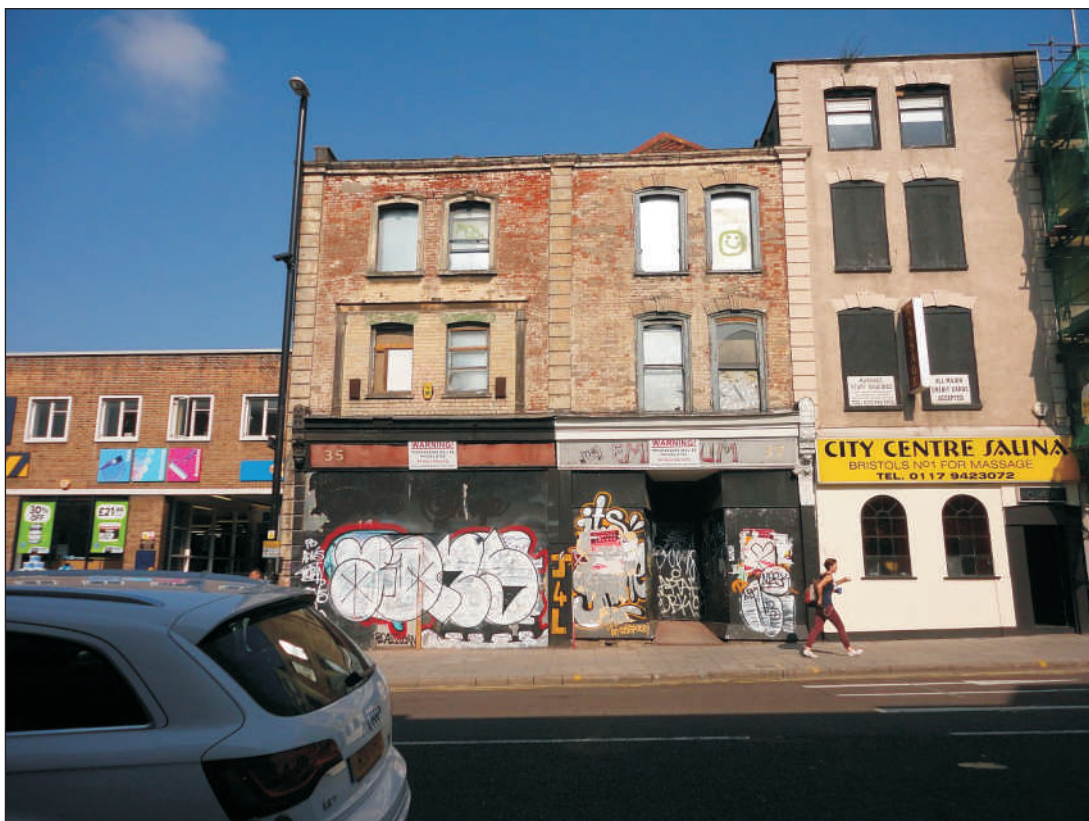
Plate 2: Details of the façades of the houses showing the offset windows in Nos 37 and 39 and typical architectural details

Both No. 35 and No. 37 originally had pairs of segmental-headed windows on each storey. No. 37 retains these intact, and also preserves its original, flush, timber sash boxes with broad architraves. These are set under segmental arched window heads with expanded radiating stone voussoirs in the manner characteristic of vernacular classical architecture in Bristol and northern Somerset (Plate 3). The existing sash windows are later replacements, with horns, probably of late 19th-century date and without window bars. The windows at No. 37 are offset to the north east of the façade, probably because it was meant to read as a pair with No. 39, next door. Here the windows are offset in the opposite direction, to the south west (Plate 2). It is probable that these two houses were built as a pair.

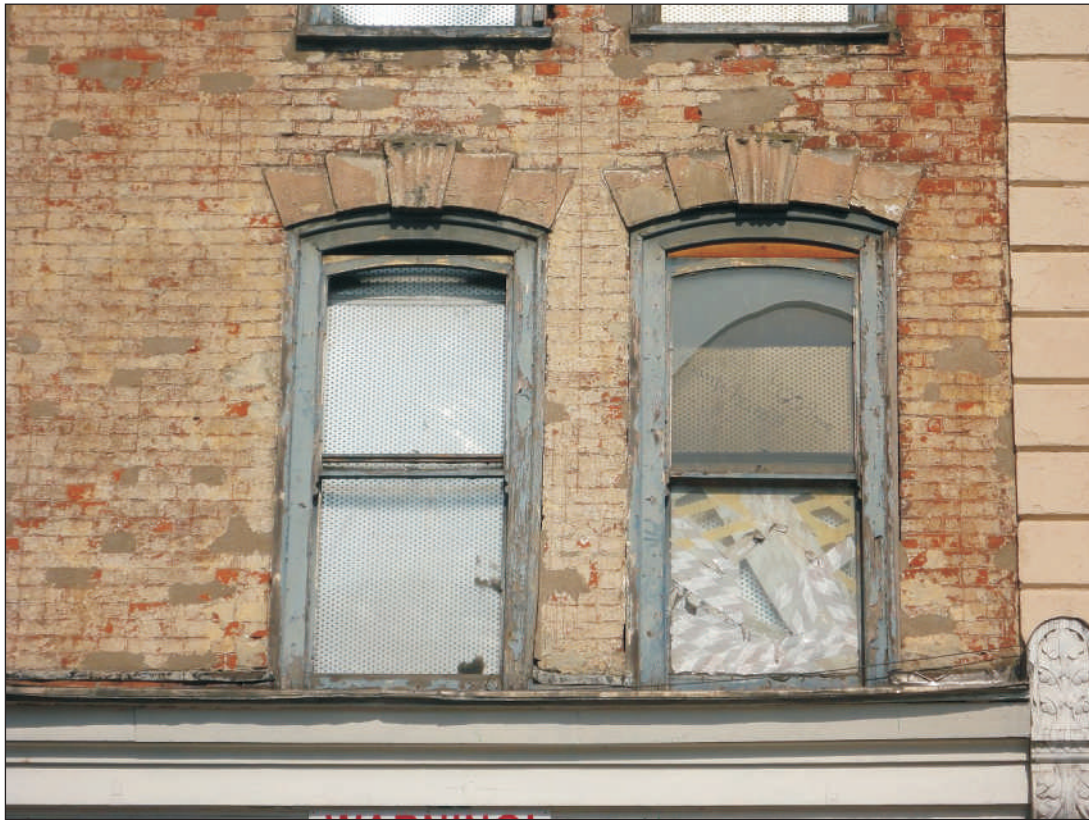
Plate 3: Segmental-headed windows with flush-framed sash boxes typical of the early-mid 18th century in the upper storey of No 37 Stokes Croft

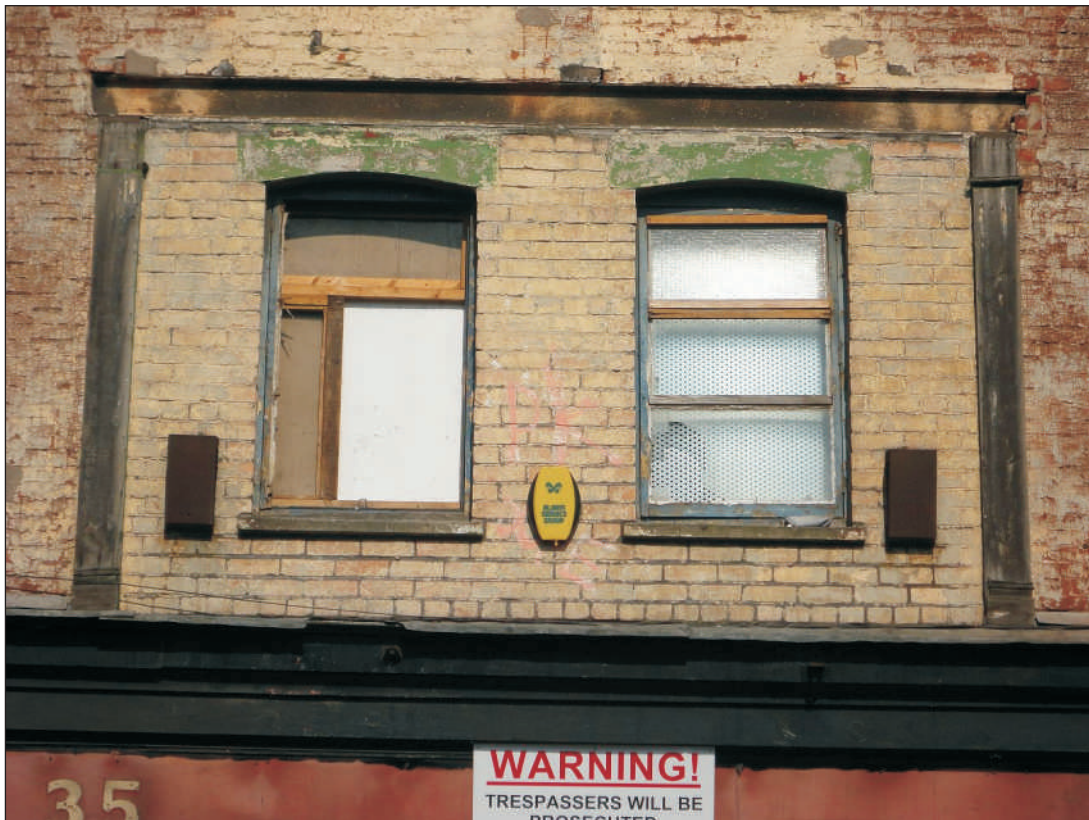
Plate 4: The remains of a late 19th-century first-floor display window at No. 35, blocked in the 20th century

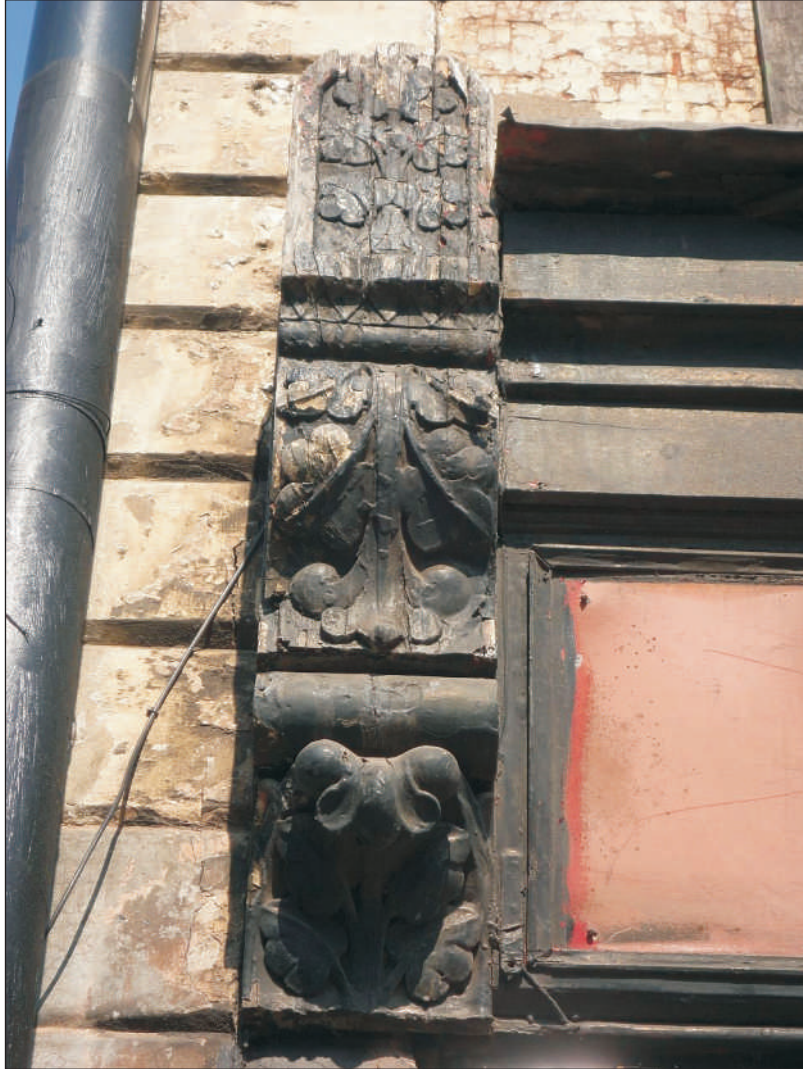
Plate 5: Detail of the ornamental corbel at the south-western side of the shop front, showing vigorous 19th-century foliage carving

Both shop fronts date from the late 19th century and are supported at each end by decorated corbels. No. 35 has two stages of corbelling decorated with bold, stylised foliage rising from the rusticated pier, supporting a domed acroterion carved with a floral spray in low relief (Plate 5). No. 37 has similar corbels, but these rise above a square pilaster with a boldly carved crocketed capital in Venetian Gothic or French Transitional style (Plate 6). Unfortunately one of the crockets has been truncated by the adjacent fascia of No. 39. There is no central corbel; despite the differing floor levels the two shop fronts are likely to have been renewed at the same time.

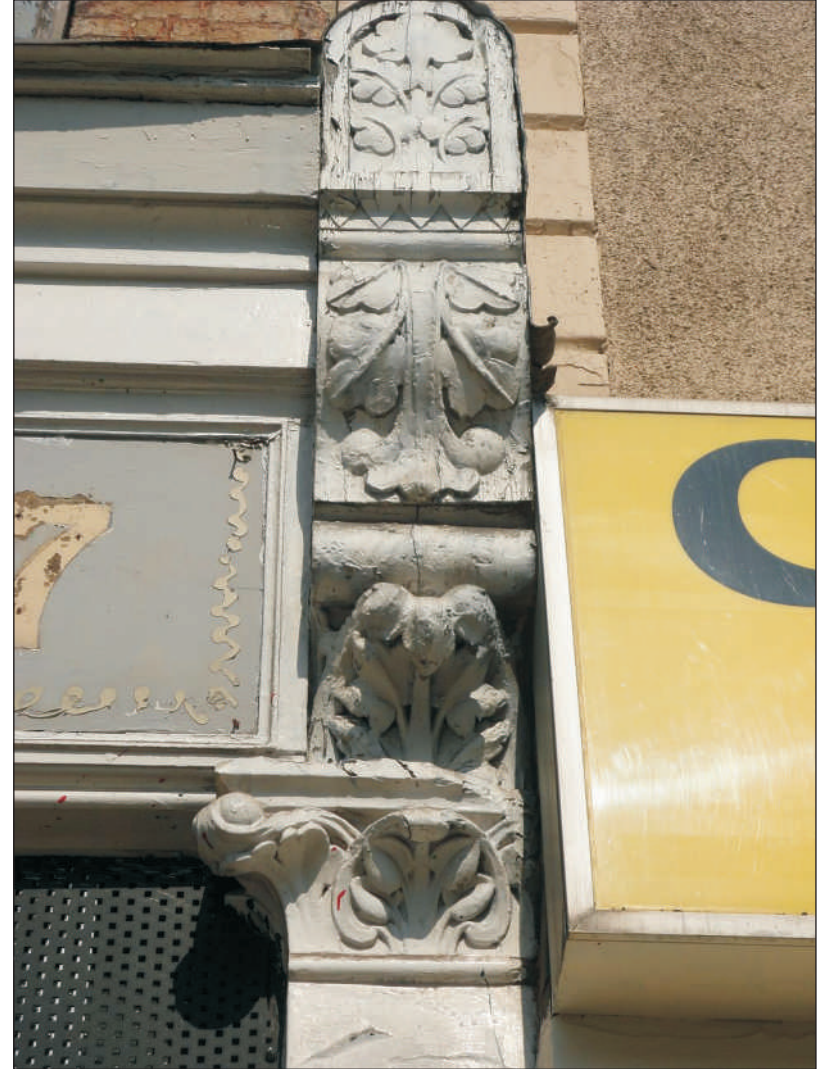
Plate 6: Detail of the ornamental corbel at the north-eastern side of the shop front, showing continental Gothic detail on the capital

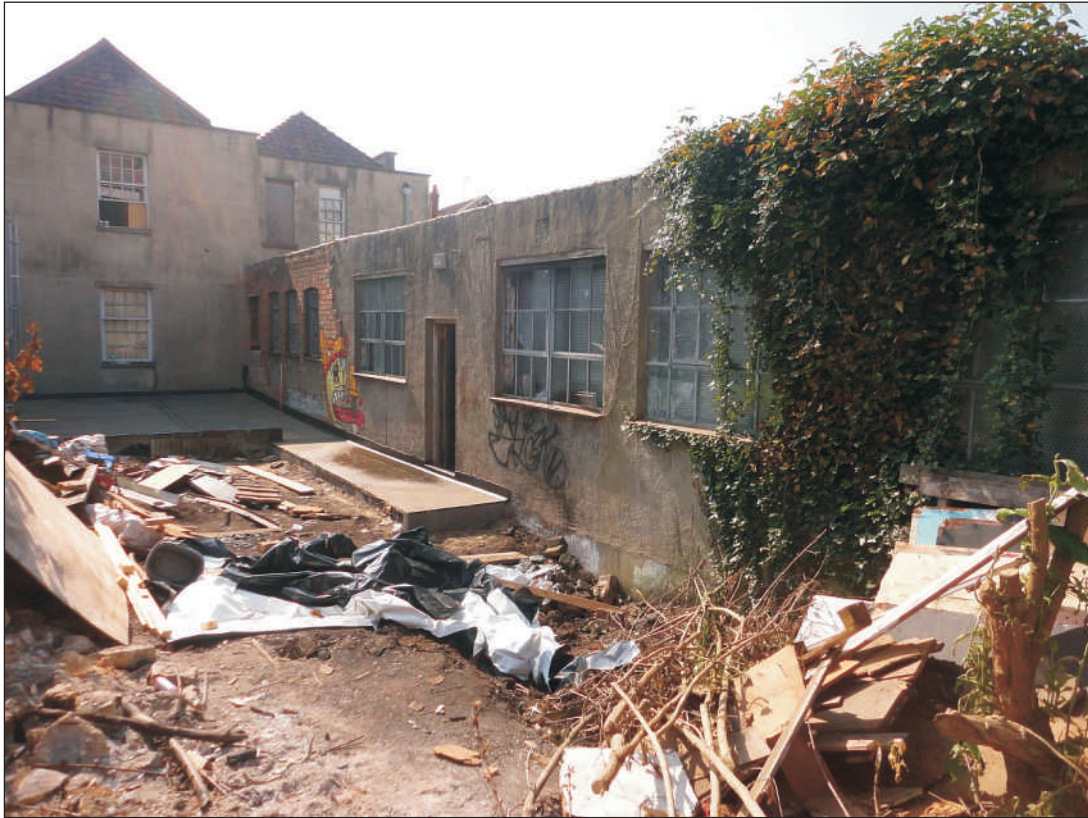
Plate 7: View of the rear of the buildings from the site of the proposed mews houses

The rear elevation of each house is very much simpler, of stone construction covered in render (Plate 7). The lower part of each rear façade is obscured by the rising ground and it is probable that there were originally deep areas or light wells separating the houses from the raised ground to the rear. These have since been roofed over or built over, so that the first-floor rooms are now at ground level on this side. No. 35 is obscured to second floor level; its rear elevation has a central sash window and a blocked window alongside this which may reflect the position of the original staircase, rising against the rear wall alongside the rear rooms. No. 37 has a plain rear elevation offset to north west of its neighbour, with a central sash window on each storey. The absence of an additional stair window alongside these may show that the plan of this house had a staircase set centrally, between the front and rear rooms. Both houses have low parapets concealing the hipped, pan-tiled roofs. All the existing sash windows are modern replicas.

The rear range of No. 35 survives and is a multi-phased structure, though not of early date. This seems to represent the truncated remains of the wing constructed for the hosiers and tailors in the 1890s, as rebuilt and re-roofed in the 1940s after bomb damage. The older part of the façade is constructed of late 19th-century orange bricks laid in English bond and features three large windows with segmental heads and a square-headed opening with a concrete lintel near the rear wall of the house (Plate 8). The windows were originally taller, with projecting window sills of stone which have been trimmed crudely off flush with the wall surface. The lower part of the openings has been blocked and metal-framed windows inserted. The upper storeys and roof were removed in the 1940s when the present mono-pitch corrugated asbestos roof was constructed. The north-western parts of the rear wing are also of 1940s date and probably of concrete construction, containing few visible features of archaeological interest (Plate 7).

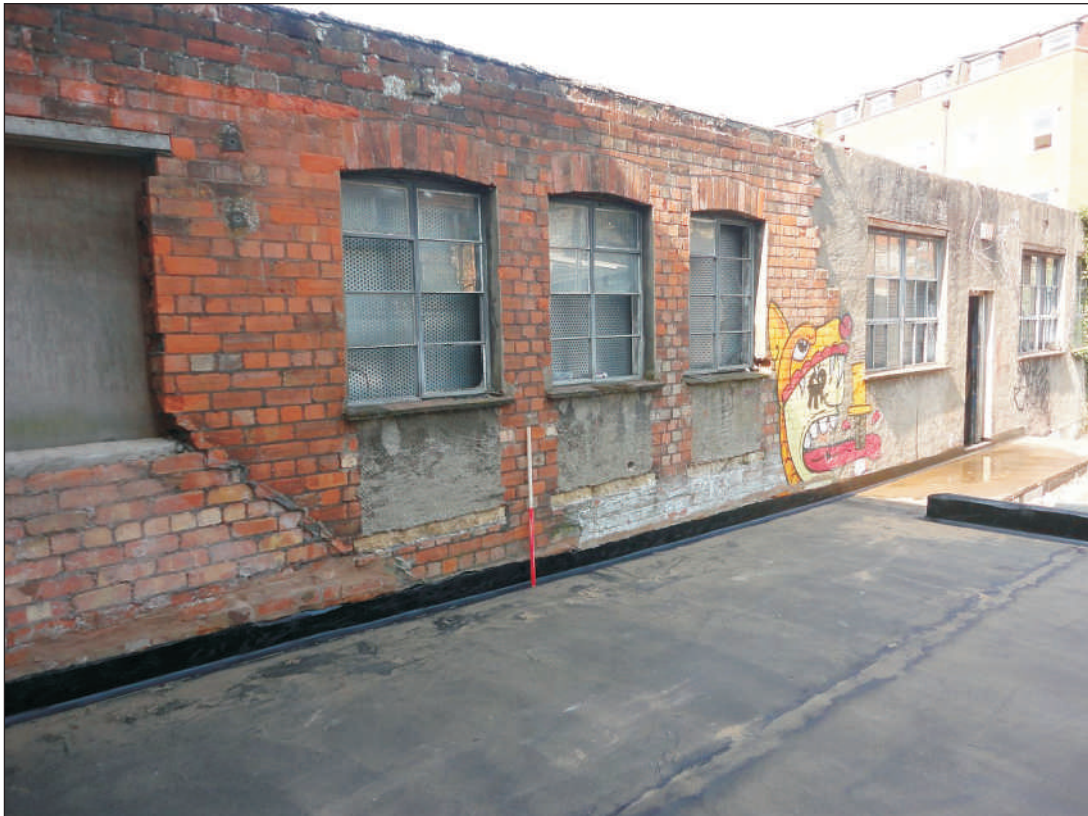
Plate 8: Detail of the surviving 19th-century work in the rear wing of No 35 Stokes Croft (scale 1m)

visible as a scar in the façade of the rear wing of No. 35 (Plate 8). From this a long, buried corridor runs underground along the front of that wing and then rises in a staircase to the former gardens. This was clearly not a part of the primary house and seems to have been added in the late 19th century, perhaps in place of a light well. Other parts of the building may survive below ground in the garden area.

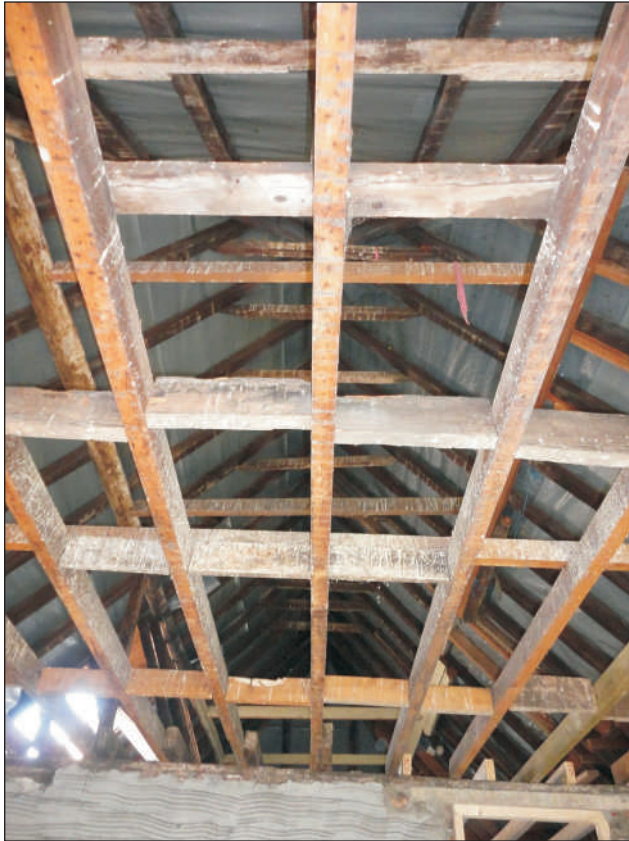
Plate 9: View of the 18th-century roof structure of No. 37 Stokes Croft showing traces of lath and plaster ceiling the attic rooms and (top) a chamfered trimmer for the original front dormer

The roof of No. 37 is a much older structure, though of very similar construction to the 20th-century roof of the adjacent house. It is supported by common rafter trusses resting on side purlins and rising to a plank ridge (Plate 9). The roof timbers are discoloured dark, are of narrow scantling and bear the marks of laths and plaster, showing that they were originally ceiled on the underside. The roof space of this house was clearly inhabited. Each common rafter couple is linked just below the apex by a short collar beam, which also shows evidence of ceiling and there are occasional additional ties at a lower level, presumably added after the attic storey was abandoned. At the centre of the building, over the stair compartment, the roof timbers on both sides of the roof are interrupted by blocked voids which must represent either skylights or dormer windows providing lighting for the central staircase. A further void is visible in the hipped front section of the roof. This is defined by a trimmer at top and bottom, the lower trimmer being chamfered away flush with the surface of a dwarf wall originally enclosing the eaves, the studwork for which survives in places. There must therefore have been a dormer window in the front elevation, looking over the parapet towards the street. No comparable feature is visible in the rear slope of the roof and it is presumed that the room here, though plastered, was unlit, and probably served as a box room or store. The character of the carpentry is so plain that it is difficult to date with any certainty; however, a roof of this type, without trusses or bay divisions would be consistent with a date in the mid 18th century or later. There is no evidence of an earlier roof form and it is considered likely that this is the primary roof of the house.

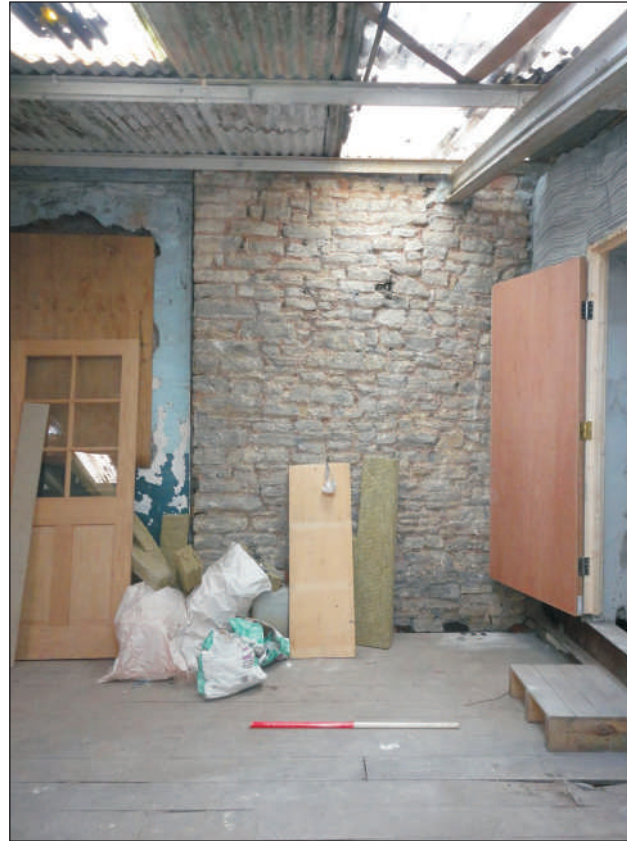
Plate 10: View within the rear wing showing the original rubble masonry of the side wall of No. 37 Stokes Croft (scale 1m)

The interiors of the rear wing are largely featureless but some evidence of the materials of construction are visible. At the south-eastern end of the wing the fabric of the side wall of No. 37 is visible, projecting 2.3m beyond the rear wall of No. 35. This wall is of buff limestone rubble bonded with a lime mortar and has well-constructed quoins (Plate 10). It seems likely that the original treatment of the walls to the rear of the house was bare masonry, facing bricks being employed on the front wall only. There is no evidence of any window openings in this wall. The rest of the rear wing consists of one very large room, filling most of the length of the wing, with a further (inaccessible room beyond) in the modern section of the wing (Plate 11). The south-western wall is almost certainly an early boundary wall, being largely constructed of soft orange/red bricks laid in a soft grey lime mortar. The bricks are without a regular bond and it is possible that this represents an 18th-century garden wall separating the properties. At the south-eastern end a further section of limestone rubble masonry may represent an extension or projection to the rear of either this, or the neighbouring house. There were no other features of historic interest visible in this part of the building, which appear to have been extensively rebuilt as a workshop in the mid 20th century.

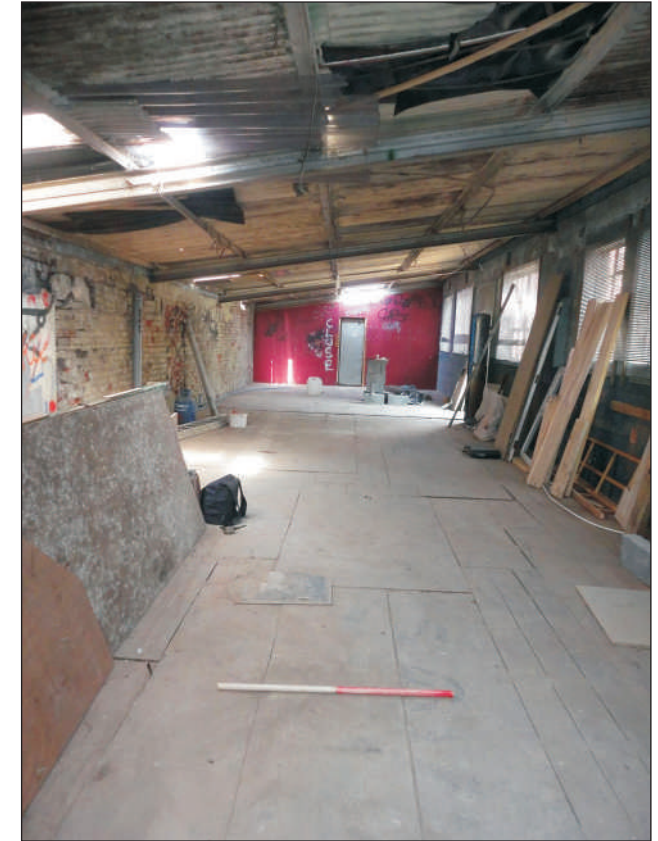
Plate 11: View of the rebuilt rear wing, repaired after the Blitz, showing the modern corrugated asbestos roof and the absence of visible historic fixtures and fittings (scale 1m)
