# GEEVOR MINE OUTFALL REPLACEMENT, ST JUST, CORNWALL

Geevor Mine: Scheduled Monument No. 32999;  
English Heritage Reference S60015

Results of an archaeological watching brief

Document No: ACD593/2/1

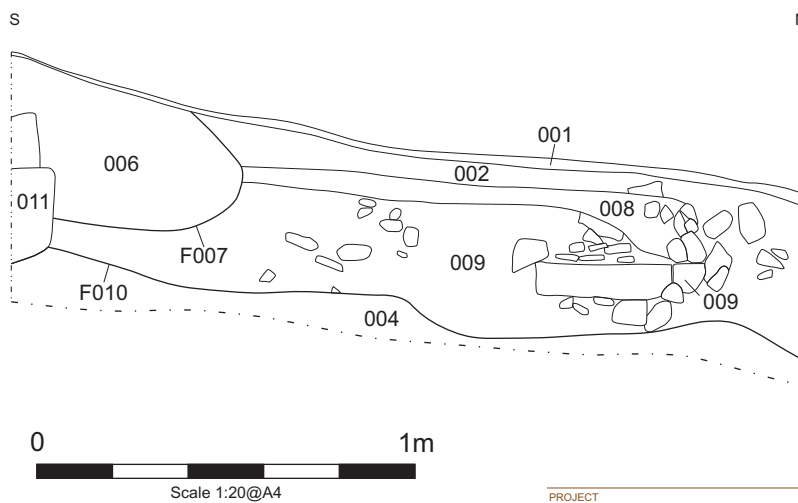
b) Section of F007 and F010

**6.2** The removal of the south side of the spoil heap revealed an area of hard standing which is probably the former location of a mine out-building of similar proportions to one still standing directly to the south (Plate 3). The hard standing was rather amorphous and was expected to be further revealed when the old pipe trench was cleared, but no further exposures were made. The original pipe was found to be present between 0.50m and 0.90m below an uneven surface of made-up ground (004) exposed beneath the spoil heap (Plate 4). The original pipe trench was cut into the made-up ground which contained much modern material including concrete and brick. The made-up ground and the back-fill of the pipe trench had been further disturbed by cuts (e.g. F006 and F010 in Fig. 3b), some of which may have been associated with previous repairs to the pipe.

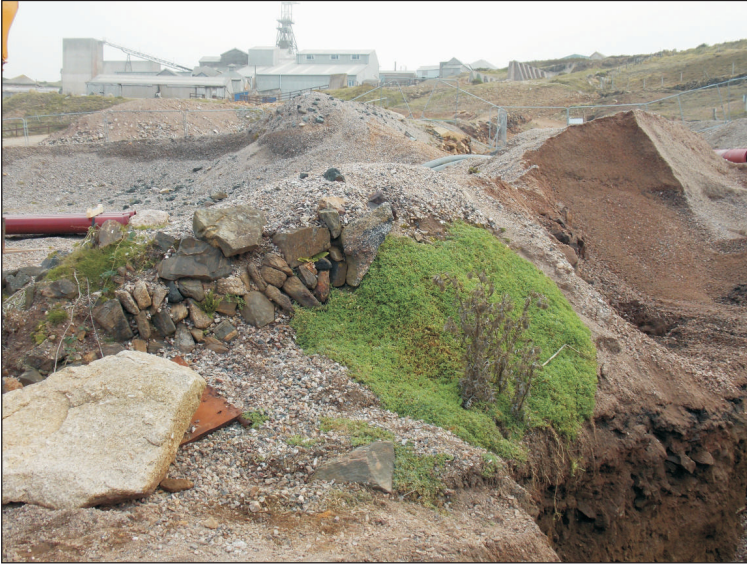
A former agricultural boundary wall which had been buried under the spoil heap was exposed during the groundworks but was left undamaged (Plate 1); this wall is marked on the 1st edition OS map (1886) and was part of a piecemeal field system defined by Cornish hedges of probable post-medieval date.

Plate 1: Field boundary wall exposed under the spoil heap, view from the northwest

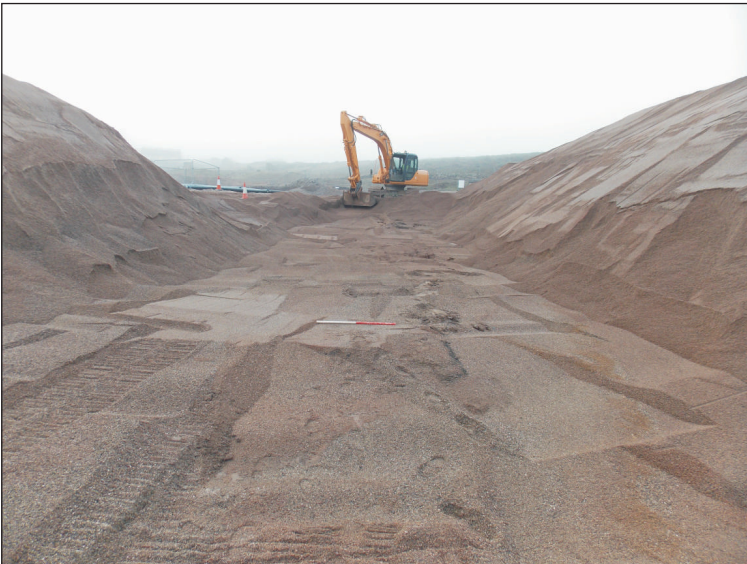
The groundworks required the temporary removal of a large area of a spoil heap in order to reveal the line of much of the outfall pipe within the area of the Scheduled Monument (Plate 2). The spoil removed was placed on the spoil heap to the west, outside of the scheduled area, before being returned to infill the void above the line of the outfall pipe. The original pipe was removed and replaced in the same trench. Excess material excavated from the pipe trench was incorporated into the gravel spoil heap and its location recorded.

Plate 2: Spoil heap temporarily removed, view from the north (scale 1m)

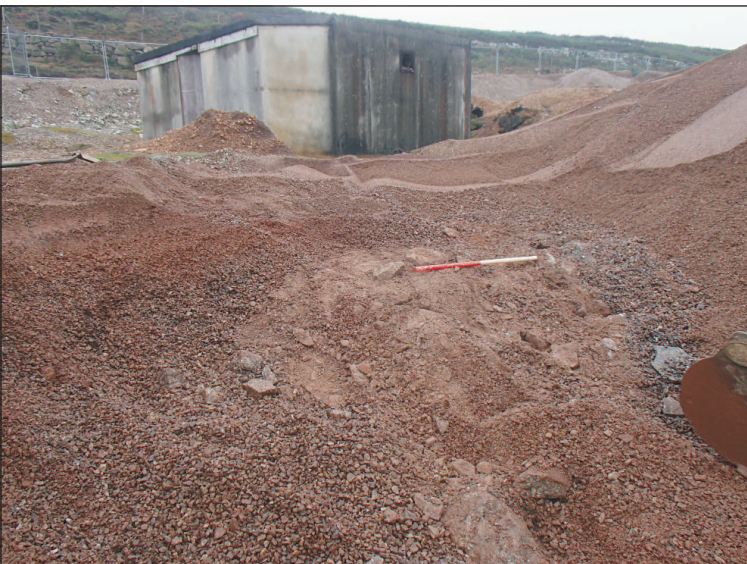
Plate 3: Area of hard standing beneath the spoil heap, view from the northeast (scale 1m)

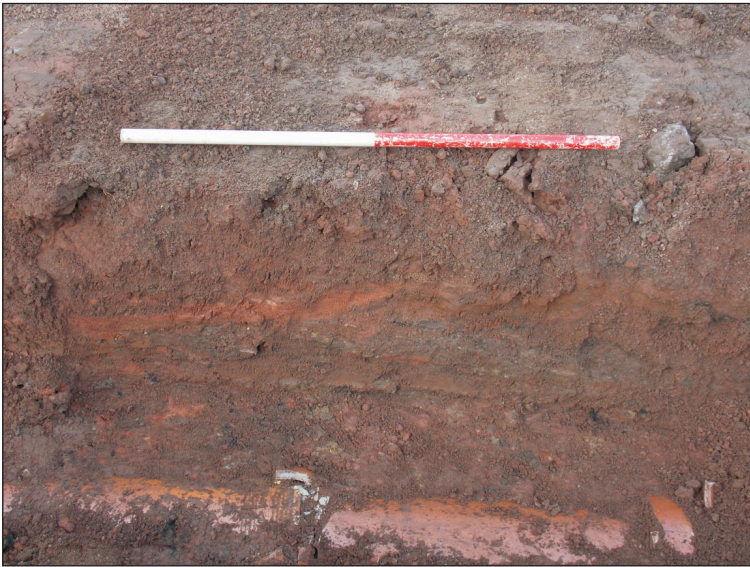
Plate 4: West-facing section of old pipe trench beneath the spoil heap (scale 1m)

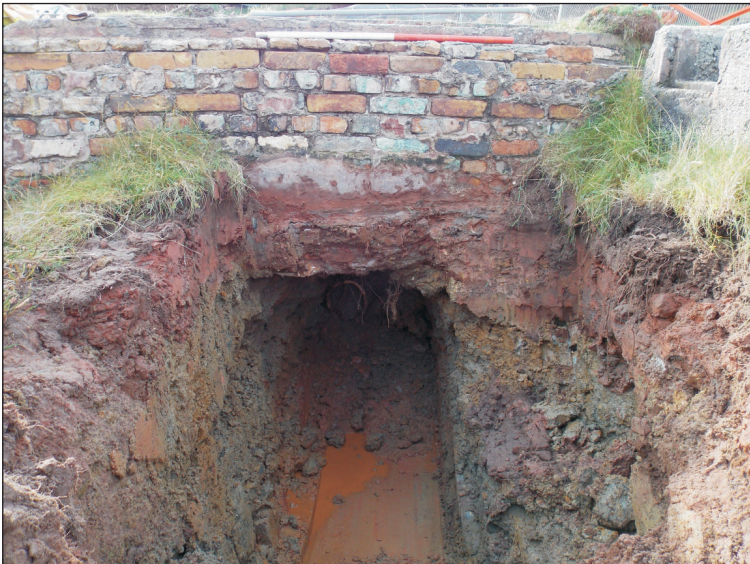
**6.3** A brick structure of unknown purpose was located to the east of and adjoining the former settling tanks and was found to have the original pipe running beneath it (Fig. 3a). Either side of the structure a test pit was dug to locate the original pipe trench and once located this was

Plate 5: Brick structure and pipe trench below, view from the north (scale 1m)

cleared so the new pipe could be pushed beneath the structure (Plate 5). There was no impact on the structure.

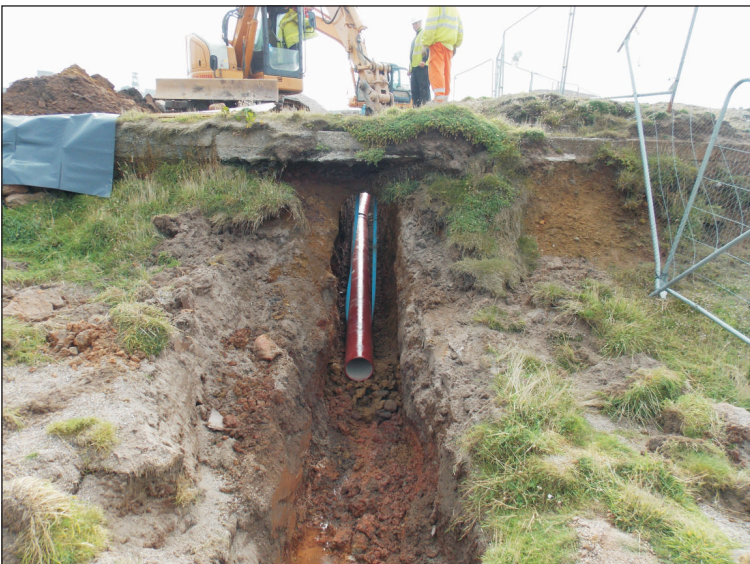
- 6.4 A concrete wall, which appeared to have some association with the settling tanks, also had the original pipe running beneath it. The pipe trench was excavated by machine on either side of the wall and the original pipe trench revealed by tunnelling allowing the new pipe to be pushed through without damaging the wall. The pipe trench beneath the wall was 2.80m deep and was backfilled with stone to underpin it (Plate 6). Only at this location, due to the depth of the trench, was the probable natural subsoil exposed consisting of dark red compact silty clay.

Plate 6: Concrete wall and pipe trench below, view from the north

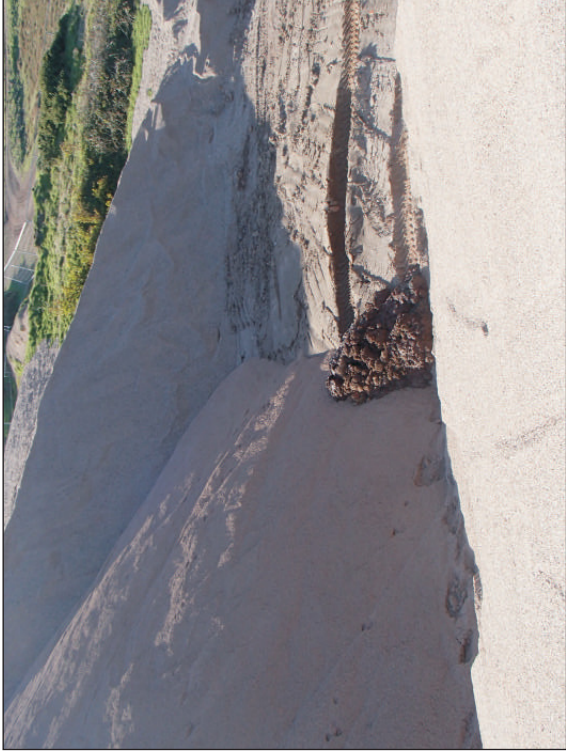
Plate 7: Location of excess spoil, view from the east

- 6.5 The base of the new pipe trench was backfilled with imported granular material creating excess spoil which, with large stones removed, was dumped at the base of the north side of the reinstated spoil heap taking in an area of approximately 20m by 7.50m (Plate 7).

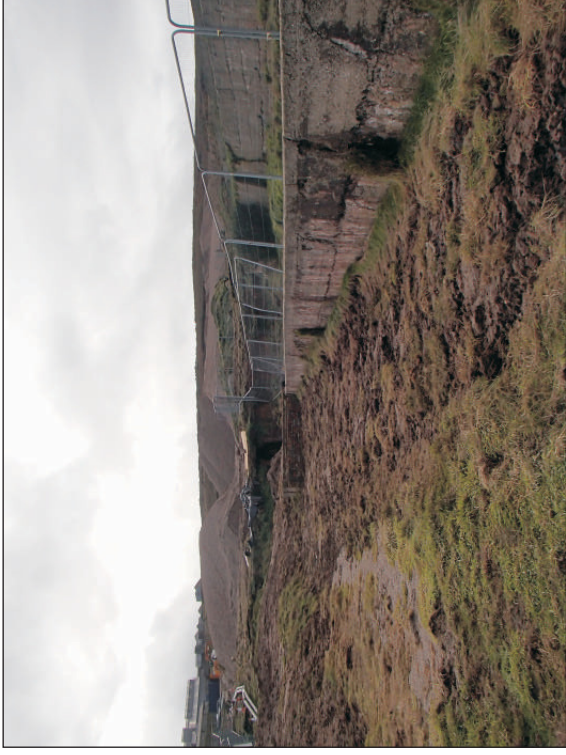
Plate 8: Backfilled and re-turfed pipe trench north of the brick structure

- 6.7 The pipe trench was backfilled and made good and the spoil heap was reinstated (Plates 8-10).
- 6.8 No finds were recovered during the watching brief.

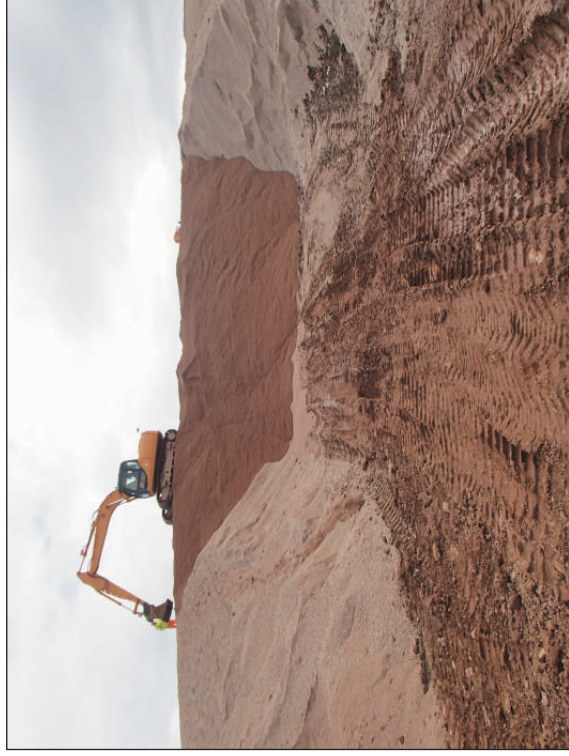
Plate 9: Reinstatement of the spoil heap, view from the north

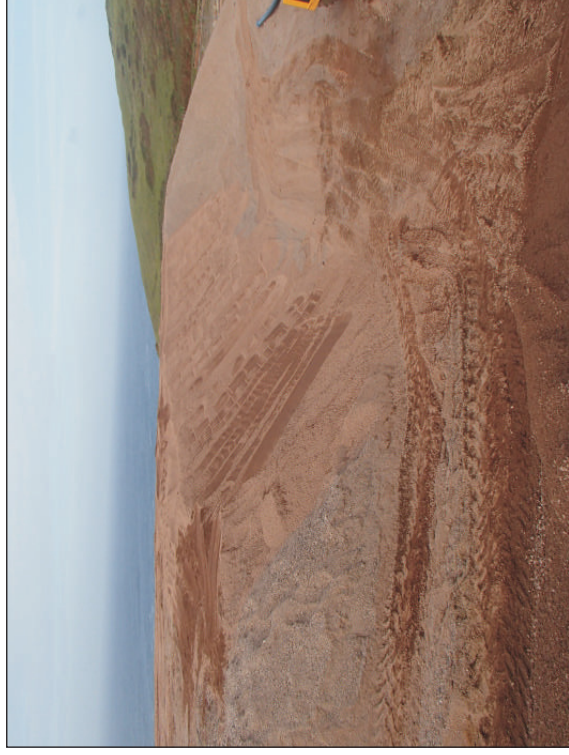
Plate 10: Reinstated spoil heap, view from the south
