# REGENT ARCADE, CHELTENHAM, GLOUCESTERHIRE

Results of monitoring and recording

Planning ref. Cheltenham Borough Council 10/1850/TIME

Document No: ACD45/2/0

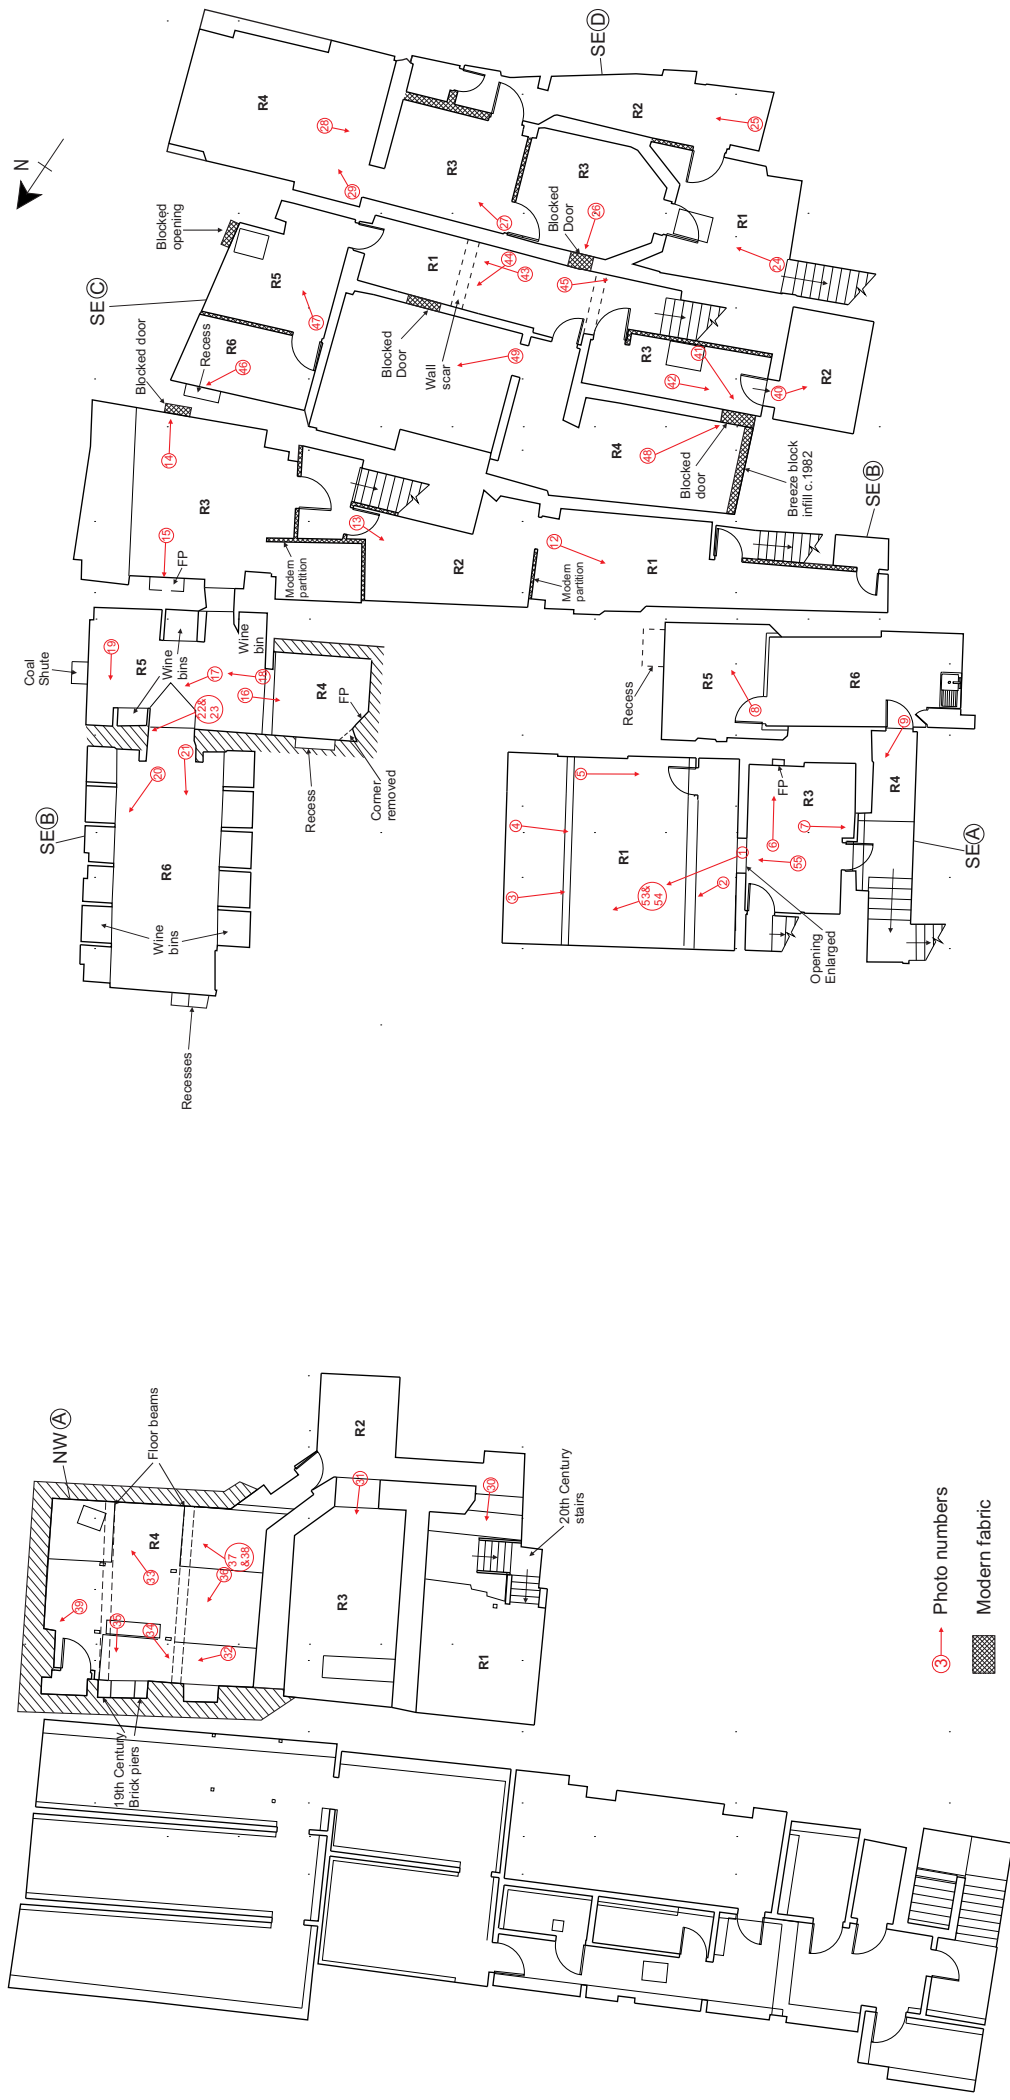
- 5.1** The plans provided by the client showed six groups of cellars. The northern group lay outside the development and no access was permitted. For the purposes of this project the remainder have been labelled NW cellars, and SE cellars, Areas A-D. They are constructed of brick laid in English Bond, some having low shallow brick vaulted ceilings with brick walls continuing upwards that would have supported the buildings above (Plate 1).

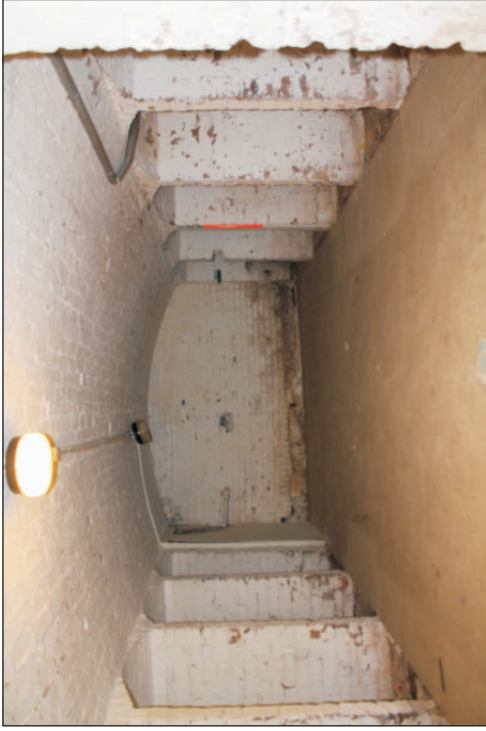
Plate 1: SE cellars, area B, room 6: vaulted ceiling and wine bins, viewed from the southeast (scale 1m)

- 7.3** Other than the ceilings, which were originally either arched brick vaults or supported on wooden beams, few architectural features were visible or survived. The most intact features were a series of wine bins in rooms 5 and 6 of the SE cellars, area B. Elsewhere, features included fireplaces, arched openings and in one room, the original stone and brick floor surfaces.

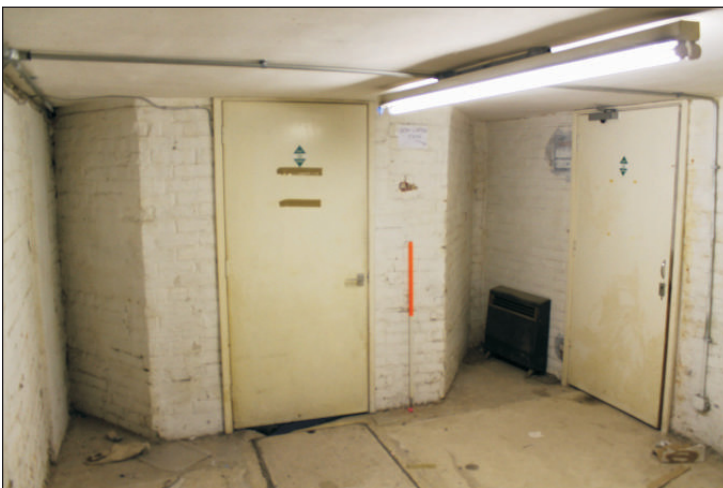
cellar to continue westward is not known. In room 1, at an unknown date, a north-south aligned wall had been removed. The only primary architectural feature was an arched recess within the north wall of room 6. In the north wall of room 5 was a low blocked opening adjacent to which was a cast-iron plate in the floor. Their functions are not known. In rooms 2 and 5 cast-iron drainpipes passed through the ceiling to the floor.

Plate 6: SE cellars, area C,  
room 1 showing the splayed wall  
of room 3, viewed from the west  
(scale 1m)

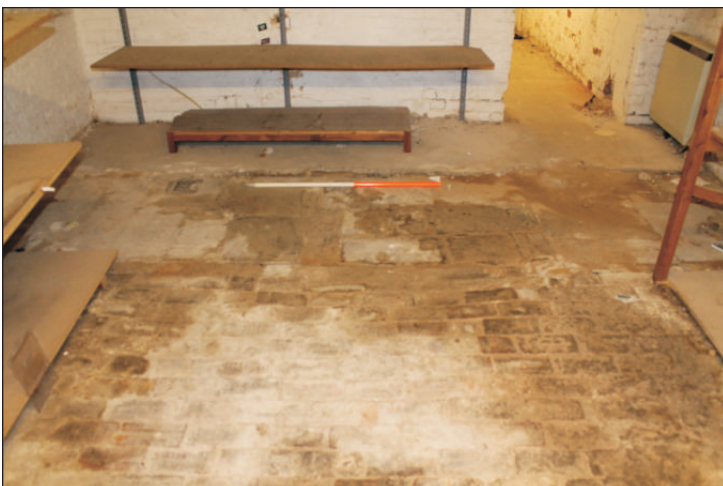
- 5.8** Area D of the SW cellars comprised a row of four rooms. They were entered from a staircase at the rear of the building in room 1. Room 3 had angled corners to its west elevation (Plate 5). The significance of this is not known, although since its western end could be bypassed (through room 2), it may have had a specialised function such as a cold store. In room 4 the primary brick and flagstone floor was exposed (Plate 7); otherwise the floors were all concrete. No other primary architectural features survived.

Plate 7: SE cellars, area C,  
room 4: brick and flagstone floor,  
viewed from the northeast  
(scale 1m)
