OLD MATFORD, WONFORD STREET, EXETER

Results of an archaeological trench evaluation

Document No: ACD821/1/1

Date: January 2014

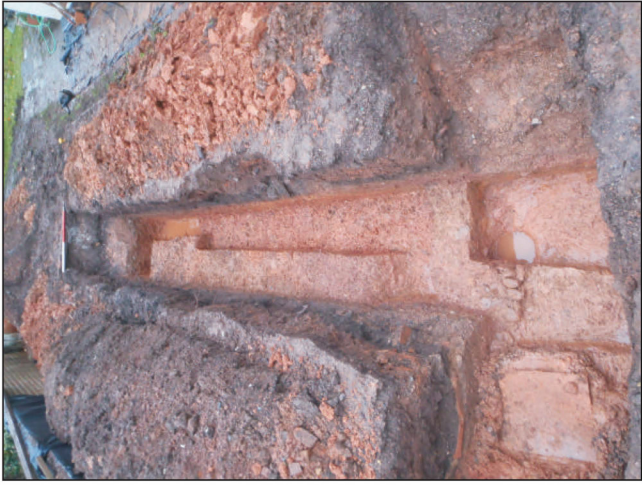
Plate 1: Trench 1, post-excavation photograph, viewed from the northeast (scale 1m)

- 4.1** A single T-shaped trench was excavated within a raised garden southeast of the house, the only area available for evaluation within the footprint of the proposed development. Its arms measured 7.5m and 3.55m long by 1m wide. The results of the evaluation are summarised below and fuller context descriptions are presented in Appendix 1.

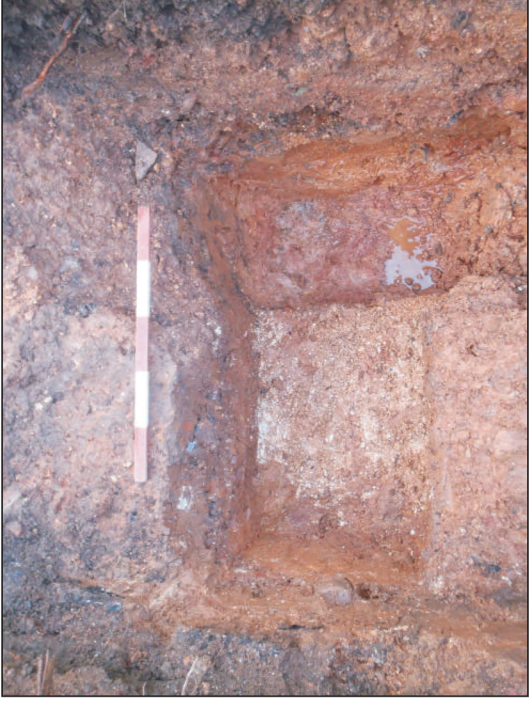
Plate 2: Construction trench F118 showing mortar bedding 117, viewed from the northeast (scale 0.50m)

- 4.3** At the southwest end of the trench a northwest-southeast aligned trench (F118) had been cut very slightly (20mm) into the natural subsoil. It contained the remains of a very fragmentary foundation of a breccia wall bonded with very coarse white/grey sandy lime mortar (117). To the northeast of the wall a thin (60mm) layer of clay (121) was present overlying the natural, which might represent the remains of a trampled earth floor.

6.1 The evaluation has uncovered evidence for an early structure southeast of the present house. Although it had been almost entirely removed when demolished, a foundation trench was identified (F118) along with what may be an associated interior earth floor (121). The level of the surface was around 1m below the present courtyard level and threshold of the door into the southeast wing of the house. The position of the foundation trench ties in with Richard Parker's inferred location for the rear wall of a southeast range. The depth of the exposed floor level below the present house, along with the consistent level of the floor and the underlying natural subsoil indicates that the structure contained a semi-basement as put forward by Richard Parker. The possible earth floor may indicate that the basement was used for storage or other service activities, and that high-quality domestic accommodation would have been present on the north side of the building. This interpretation is backed up by the lack of high quality finds from overlying demolition deposits that clearly included debris and building material from the former range.

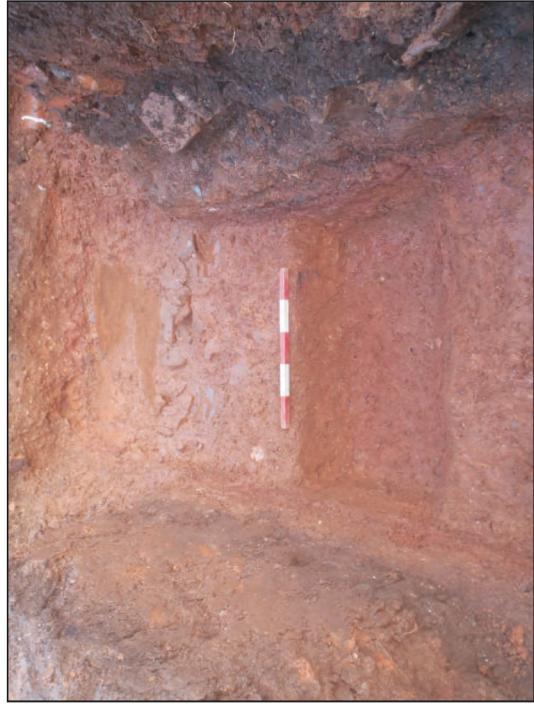
Plate 3: Edge of feature F122 in the foreground within drain F108 behind the scale, viewed from the southwest (scale 0.50m)

- 4.5** The levelling deposits were sealed by a thin layer of a buried garden soil (104). At the northern end of the trench, 104 had been truncated by a large feature (F122) that extended down into the natural subsoil. It was only partially exposed, and its function

is unclear, but may be associated with 19th-century landscaping. It contained fills (111, 115, 125, and 114) of fairly sterile gravels and clays with rare demolition debris. A small linear feature (F108), filled with compact clays (107 and 106), had been cut into 111. It was only partially exposed within the trench, and its function is unknown. Layer 115 was truncated by a northeast-southwest aligned drain (F113) comprising layers of cobbles bedded in clay (112).

6.3 The overlying deposits and features were all dated to the 19th and 20th centuries. No obvious function can be put forward for the large feature (F122) at the north end of the trench. However, a plausible context is landscaping associated with the construction of the garage to the northeast in the late 19th century, perhaps in 1888 (*ibid.*, 11-12). The overlying brick surface (103) may be of the same date. The later deposits (100-102) are of 20-century date and the raised garden in which they are found was probably created when the southeast part of the site was redeveloped as a church and the present brick boundary wall constructed.

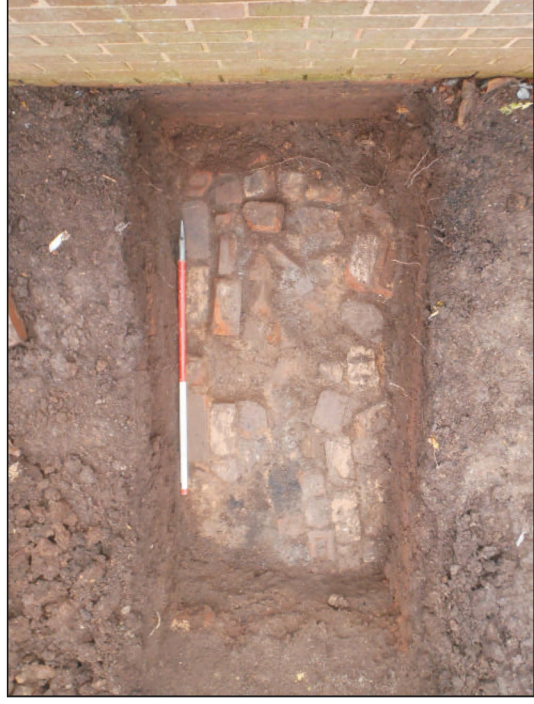
Plate 4: Surface 103 partially exposed, viewed from the southwest (scale 1m)

4.6 Feature F122 was sealed by surface (F103) that was present throughout the trench. It comprised laid bricks as well as tiles, roughly dressed breccia, and moulded concrete blocks, and was exposed at the same level as the courtyard surface and garage to the north (and the landscaped grounds of the adjacent church to the southeast). The surface was sealed by up to 0.60m of soils containing building debris (102 and 101) and the present garden soil (100). In the northern arm of the trench two modern drains were partially exposed; one ran alongside the northern edge of the raised garden, aligned northeast-southwest, but was exposed at a level below the present courtyard surface. The other was aligned roughly north-south and was exposed at the same level.
