EAGLE YARD, TUDOR STREET, EXETER

Results of for desk-based assessment, historic building appraisal
and archaeological monitoring and recording

Document No: ACD817/2/1

Date: April 2014

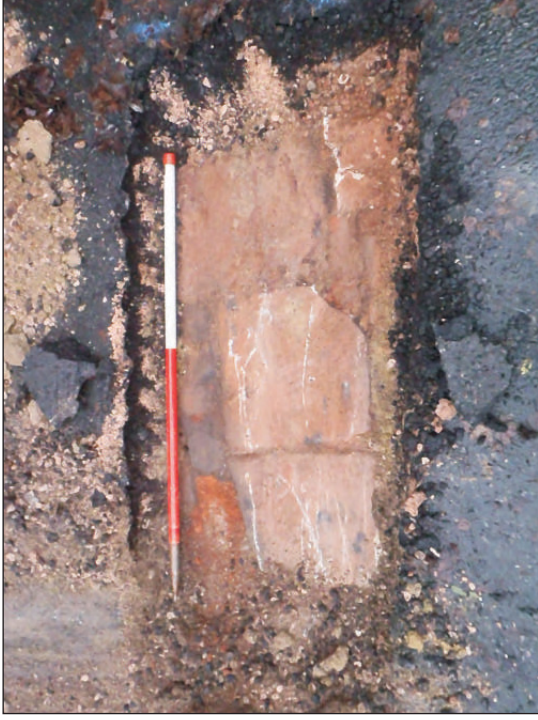
Plate 2: Test Pit 1, stone and brick floor surface (101) (scale 1m)

The machine excavation of seven geotechnical test pits in the yard was observed. The general sequence consisted of modern tarmac and hardcore underlain by a surface of brick or brick and stone. Below this were a series of made ground deposits to a depth of 1.60m-1.90m deep. The upper deposits to approximately 1.2m below ground surface (approximately 7.92 to 8.41m aOD) contained modern and post-medieval artefacts; below this the deposits were cleaner, but

still contained varying quantities of demolition type material (slate, lime mortar, ceramic building material (CBM) etc.). Only Test Pit 5 did not have a brick or brick and stone surface below the tarmac and, though consisting of made up deposits, was generally much cleaner than the deposits in the other test pits. Test Pits 4 and 7 contained further archaeological deposits and are described below; full context descriptions are presented in Appendix 1. The finds are described in Section 6 below.

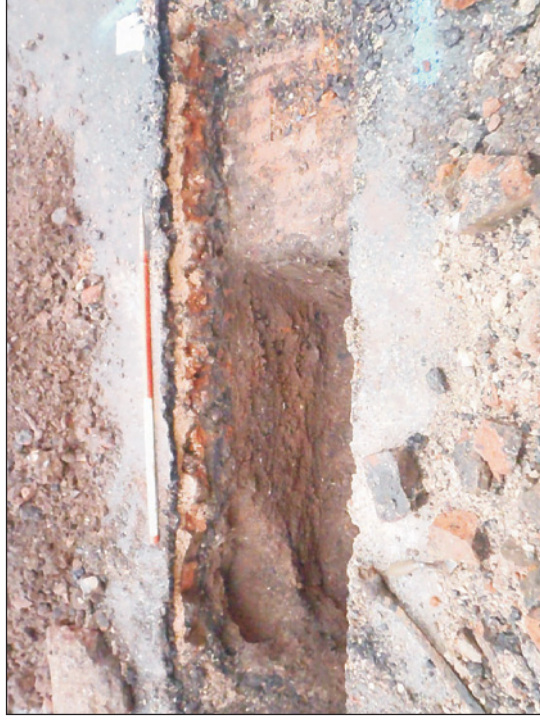
Plate 3: Test Pit 4, northwest-facing section. Void on left is where large breccia stone of structure F404 has been displaced (scale 1m)

Test Pit 4 was located in the northern corner of the yard and measured 2.40 by 1.80m and was excavated to a depth of c. 2.40m. Directly below the surface, modern tarmac and hardcore (400) and a single course brick floor (401) was a deposit, measuring 100mm deep, of very dark brown to black compact clayey sand with frequent charcoal and CBM (402). This sat on top of a solid brick footing (F403), constructed of a single course of stretcher bond, which was left *in situ* and not further investigated. At the opposite end of the trench a single course of breccia stone bonded with lime mortar appears to be the corner of a structure (F404). The relationship between F404 and deposit (405) which was 160mm deep and consisted of dark brown sandy clay with moderate mortar, CBM and slate fragments was not clear. Features F404 and F403 were exposed at around 9.25m aOD. Both F404 and deposit (405) were above a thin deposit (406) consisting of moderately compact mid reddish brown sandy clay with moderate frequent mortar and CBM fragments. Below this were two made ground deposits (407 and 408) above the alluvial natural (409). Deposit (407) was 600mm deep and consisted of mid brown sandy clay with moderate CBM, slate and mortar fragments. Deposit (408) was 700mm deep and consisted of soft dark brown sandy clay with sparse CBM and animal bone fragments.

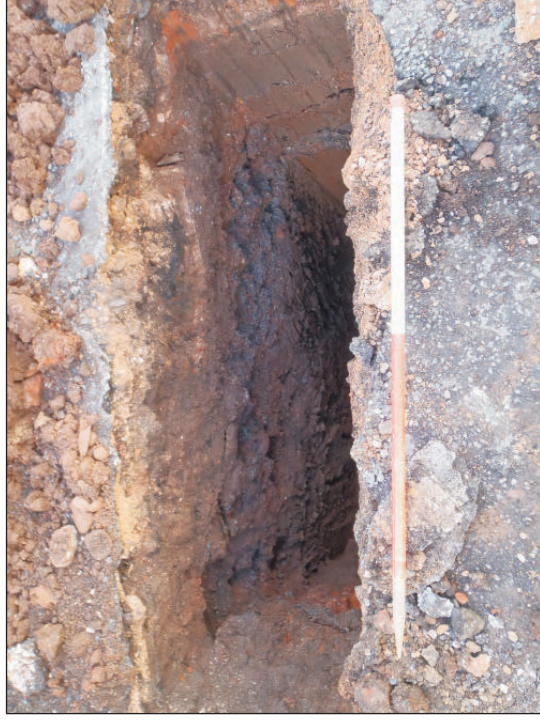
Plate 4: Test Pit 7, east-facing section (scale 1m)

Test Pit 7 was located centrally in the yard and measured 2.60 by 0.85m and was excavated to a depth of c. 3.30m. Directly below the modern tarmac and hardcore (700) and a brick and stone floor (701) was a made ground deposit (702), measuring 580mm deep, consisting of mid red brown silty sand with abundant mortar flecks and moderate CBM. This sat on top of deposit (703), exposed at a height of 8.51m aOD, which was 600mm deep and comprised abundant CBM, slate and degraded breccia stone. This appeared to share some of the characteristics of structure F404 in Trench 4, but was at a slightly lower level. Below this was a made ground deposit (704) which was 1m deep and consisted of mid brown alluvial clay with sparse charcoal and sparse small slate and animal bone fragments. This overlaid natural (705).

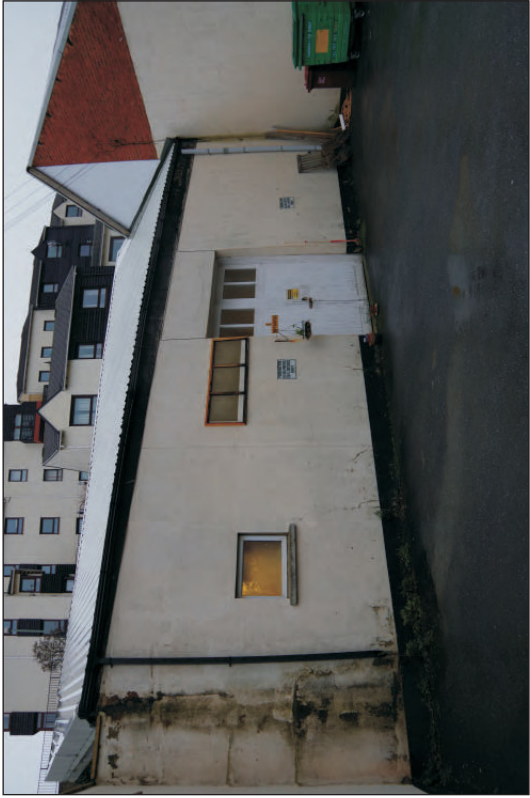
Plate 5: Building 1, southwest elevation (scale 1m)

It has a gabled roof with a corrugated metal covering. The northeast wall is terraced into the hillside. The southwest elevation is rendered and has a modern UPVC window and double wooden doors with windows above. Part of the northwest elevation is visible and is exposed brickwork. There are several phases of masonry visible. The main brickwork is laid in an irregular bond with light grey sandy hard cement mortar, which is truncated in the centre by what appears to be a blocked chimney stack. This has brickwork laid in an irregular bond with a light grey hard cement mortar. Below this masonry is an area of brickwork laid in English bond with a dark grey hard sandy cement mortar. At its base, two layers of brick are visible that form a flattened arch over the Higher Leat. This masonry is later than that above, and appears to be a rebuild, perhaps of a former collapsed arch or being associated with modern changes to the roof of the culverted leat during later 20th-century alterations to the building. The top of the elevation is rebuilt in English bond brickwork with a light pinkish mortar, and supports the modern pitched roof.

The interior has modern finishes, with a concrete floor and block work walls. There is no visible evidence of the leat or any original fixtures or fittings that may relate to industrial activity. It is mainly open plan with three small offices. There is no evidence for an historic upper floor.

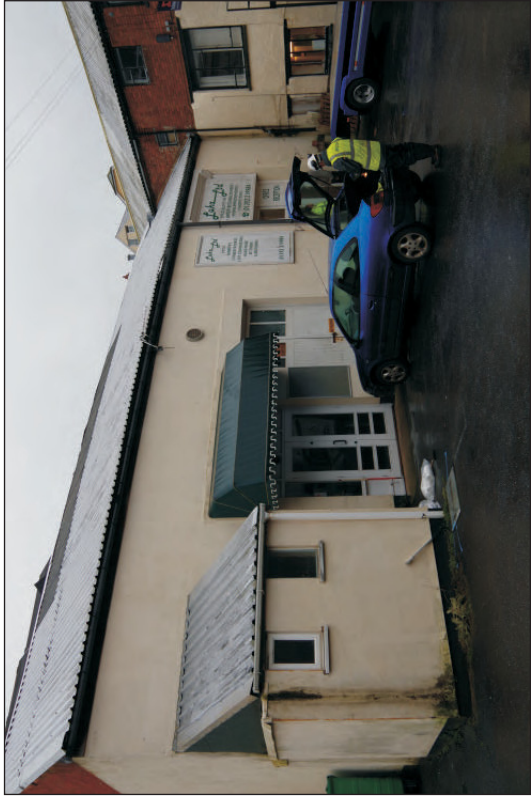
Plate 7: Building 2, southwest elevation (scale 1m)

The present arrangement includes a building over the Higher Leat as well as rooms with a range to the northeast of Building 3. It has a gabled roof with a corrugated metal finish. Building 1 joins on the northwest side and Building 3 on the southeast side. The northeast wall is terraced into the hillside, although the gable at the eastern end is clad in corrugated iron. All but half of the northwest-facing gabled wall is rendered. This part is built in stretcher bond with occasional headers. On the southwest-facing elevation there are three sets of modern wooden doors with glass windows. Attached to this wall is a small modern lean-to with a pitched roof.

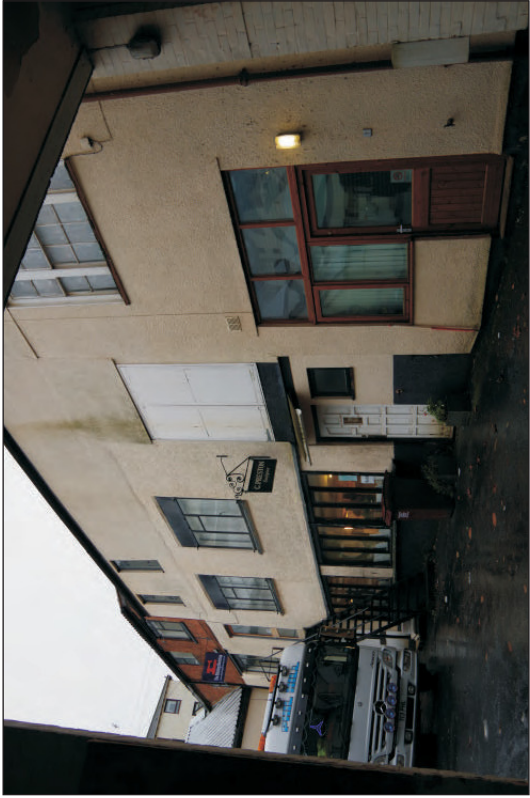
Plate 9: Building 3, northwest elevation (scale 1m)

It has a gabled roof on two levels. The part to the northeast is covered with corrugated metal and the part to the southwest has slates with two skylights. All but the top half of the northeast end of the wall is rendered. This part is built in Flemish bond. The part to the southwest is obscured by modern finishes, but may be timber framed. There are four windows on the second floor. The landowner reports that two of these were salvaged from the pub on the Countess Wear roundabout in Exeter. There are four windows on the first floor (one of which has hornless sashes), a door accessed via an external staircase and a wooden loading door. There are four windows and three doors on the ground floor. All of these are modern.

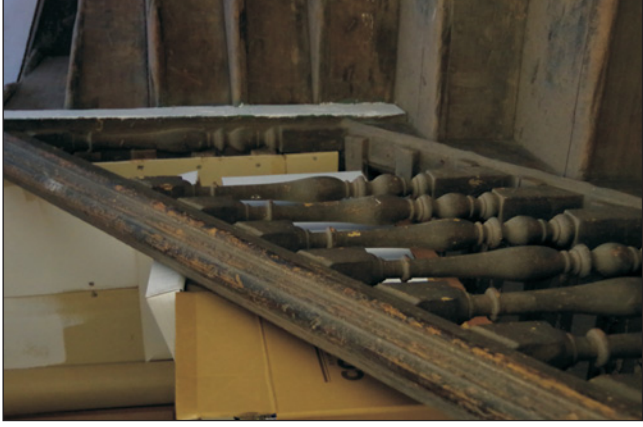
Plate 10: Building 3,
detail of staircase

The ground floor of the building is open plan. On the first floor it is divided with the part to the northeast being accessed via an external staircase and then the second floor is accessed via an internal staircase. Access to the first and second floors in the area to the southwest is via an internal staircase from the ground floor. There are mainly modern finishes in this building. There are some areas of painted brickwork. There are many horizontal and vertical wooden beams visible that support floors and there are some rafters supporting the roof visible on the second floor, the majority of these appear to be original. There is a small staircase leading from the first to the second floor in the southwest area of the building. This has turned balusters that date to the mid-late 18th century. Half way up the stairs is a wooden bracket with fittings for a door. There is no evidence of any other original fixtures or fittings.

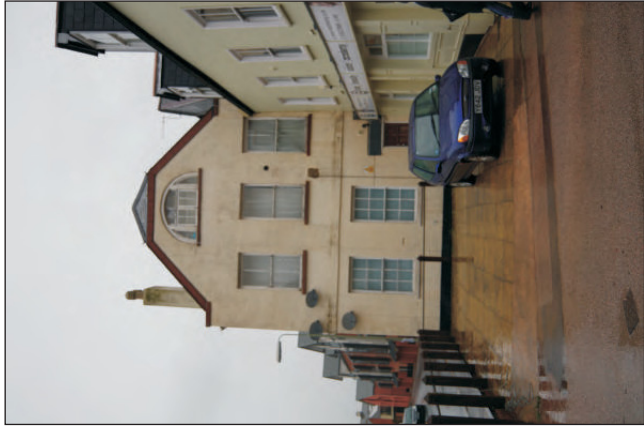
Plate 11: Building 4,
southeast elevation

Building 4 is also known as 'Eagle House'. It lies outside the development site but forms part of the same structure as Building 3 and is therefore described for completeness of the record. It has a gabled slate roof, with a slight hip at the top of the southeast elevation. The southwest facing elevation is rendered and incorporates the opening for the yard. There is a doorway with a modern door to the southeast of the opening to the yard. Above this are three windows, the one to the northwest is a sash window of nine panes, the two to the southeast are sash windows of six over six panes. There are two dormer windows in the roof with sash windows of two over two panes. There is a chimney stack on the southeast side of the roof. The southeast-facing elevation is rendered. On the ground floor it incorporates two sash windows of six over six panes with a doorway with modern door. There are three sash windows of two over two panes on the first floor and a semi-circular window on the second floor. It was not possible to view the inside of this building.

The evidence of OS mapping indicates that Building 4 was heavily modified in the 1950s or 1960s when the arch was significantly enlarged.

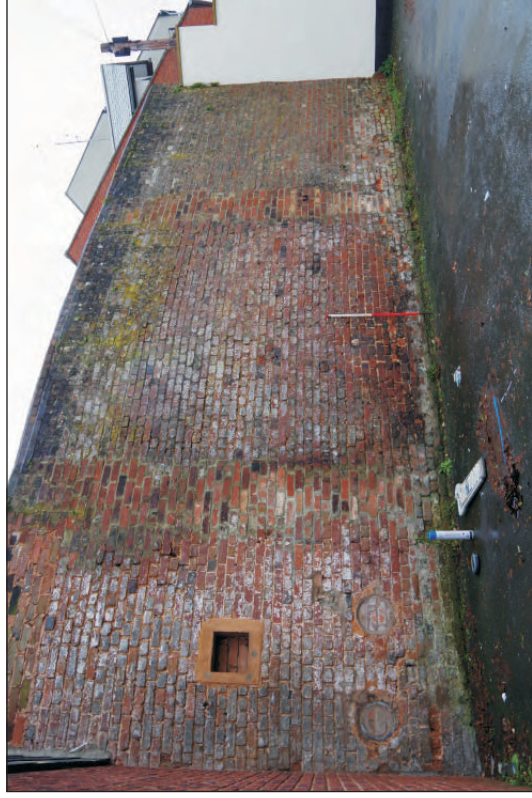
Plate 12: Wall on the west side of the yard (scale 1m)

The masonry of the west boundary wall is mainly brick laid in English bond with light pinkish white lime mortar or a later light orange pink cement mortar. At its southeast end it incorporates a square modern vent intrusion with two circular pipes below; all are blocked. The top seven courses of the wall here has been repaired in stretcher bond. The wall is punctuated by two vertical scars, equidistant from its ends. These do not continue to the base of the wall. The features, which are probably infilled chimney stacks are blocked in brick laid in stretcher bond with yellow grey hard cement.

At the northeast end it joins the rendered northwest wall. Photographic evidence (Passmore *et al* 2009, fig. 10b) shows that in 2005 this was a bare brick wall of a similar height to the west yard wall. Since then it has been reduced by stepping and rendered on both sides.
