# THE KITCHEN AND DINING ROOM AT LADYSMITH INFANT AND NURSERY SCHOOL, EXETER

Results of historic building recording

Document No: ACD800/2/1

Date: March 2014

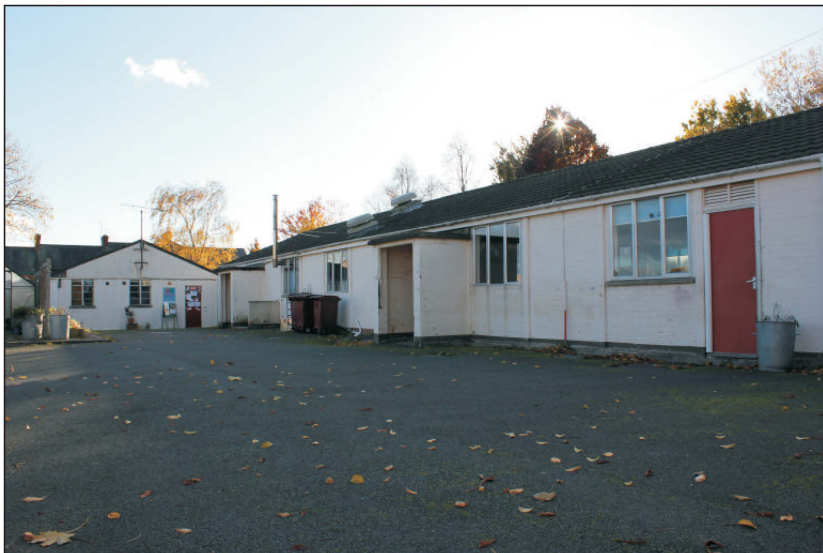
Plate 1: The kitchen and dining room, viewed from the northwest. 1m scale.

The kitchen and dining room are situated towards the rear of the school on raised ground above the main school buildings. They are formed from four attached horsa buildings – a long north range with a boiler room at its north end connected by a corridor to 3 shorter rooms at its south end (Plates 1-3). The latter comprise two medium length buildings flanking a shorter central room at the end of the corridor. The ground slopes down to the south and they are terraced into the hillside and constructed onto concrete raft foundations that are partially exposed above the adjacent ground level. A possible contemporary building was situated to the east of the northern range, but it has been demolished and its position is currently utilised as kitchen gardens. On its east and south side the kitchen and dining room are surrounded by hardstanding, whilst on the other sides are gardens.

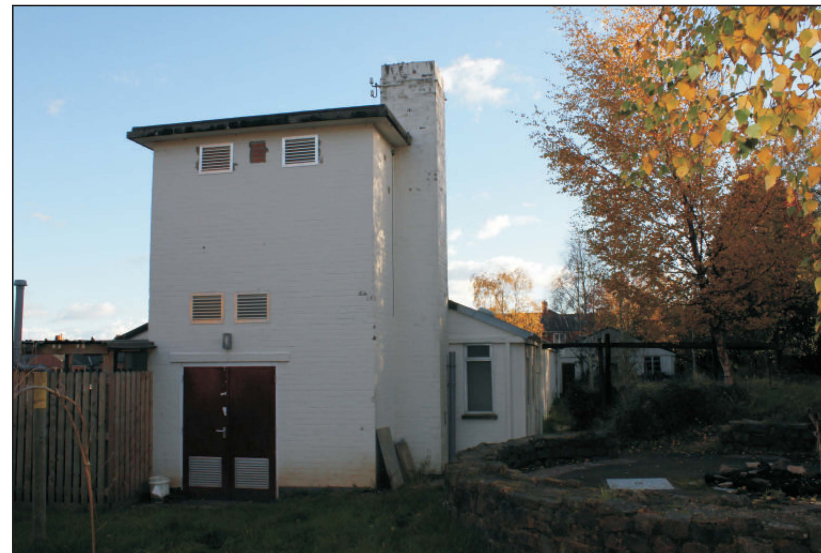
Plate 2: The kitchen and dining room viewed from the northwest showing the boiler room in the foreground.

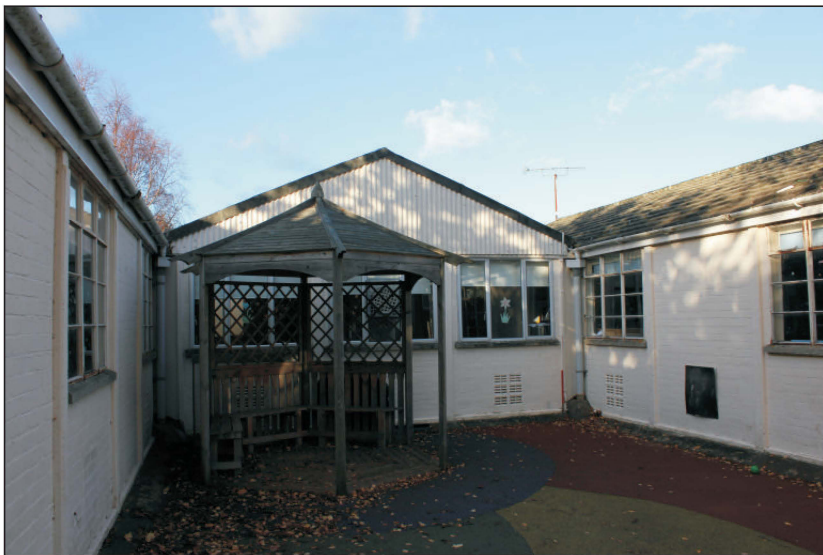
Plate 3: The south end of the kitchen and dining room, viewed from the south. 1m scale.

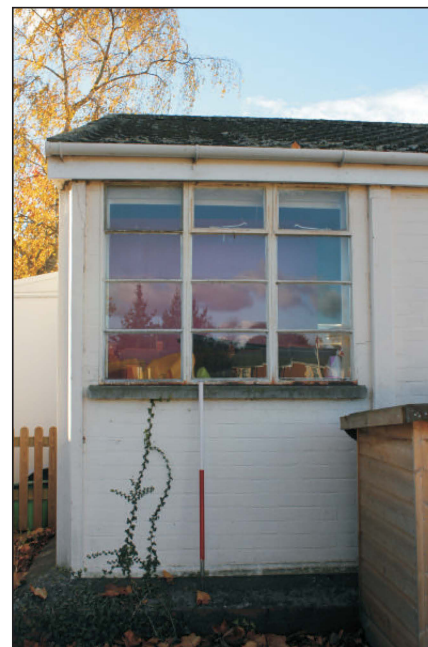
The original windows in the side elevations are 3 over 3 panes in metal frames with the upper two rows top opening (Plate 4), whilst those in the gable elevations are 4 over 2 panes with the upper row again top opening (Plate 5). The latter were clearly a 'localised' design since they are set within panels with chamfered wall plates designed to take the wider windows. Under several of the windows are groups of 6 vents – there is no pattern to their locations.

Plate 4: A bay in the east elevation of the south range, east room showing typical details and a window, viewed from the east. 1m scale.

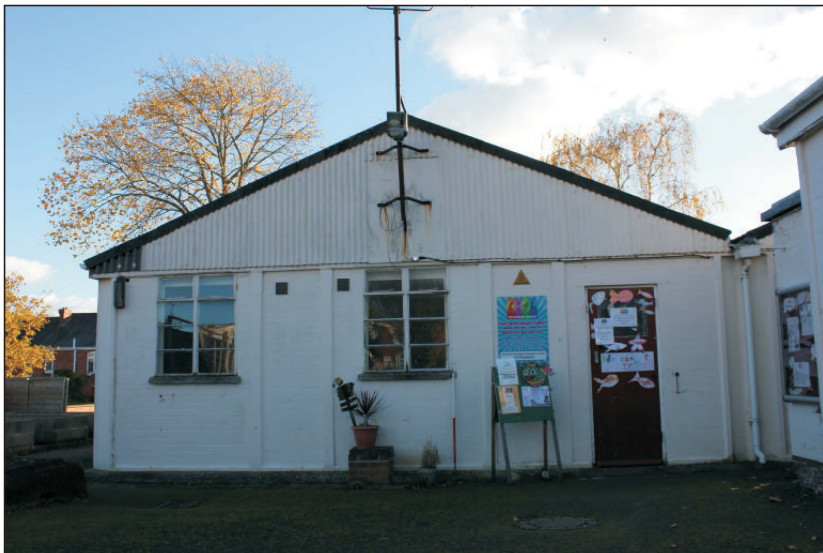
Plate 5: The north gable elevation of the south range, east room, showing window types, viewed from the north. 1m scale.

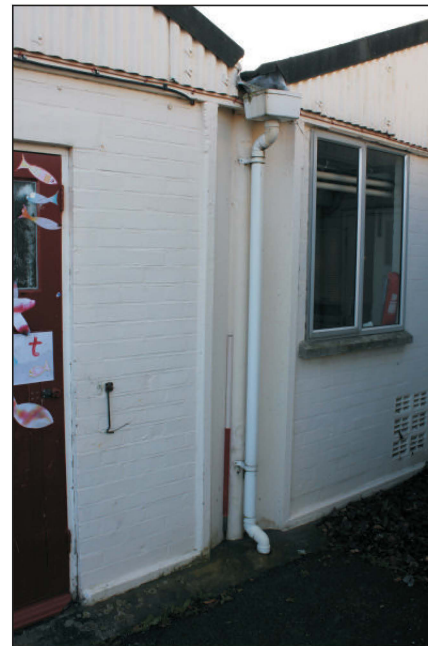
The pitched gables are clad in asbestos sheets and incorporate two vents. The end corners of each building are formed from curved concrete posts. Where the three southern buildings join each other, pairs of these posts are joined together (Plate 6).

Plate 6: Detail of the join between two huts, viewed from the northeast. 1m scale.

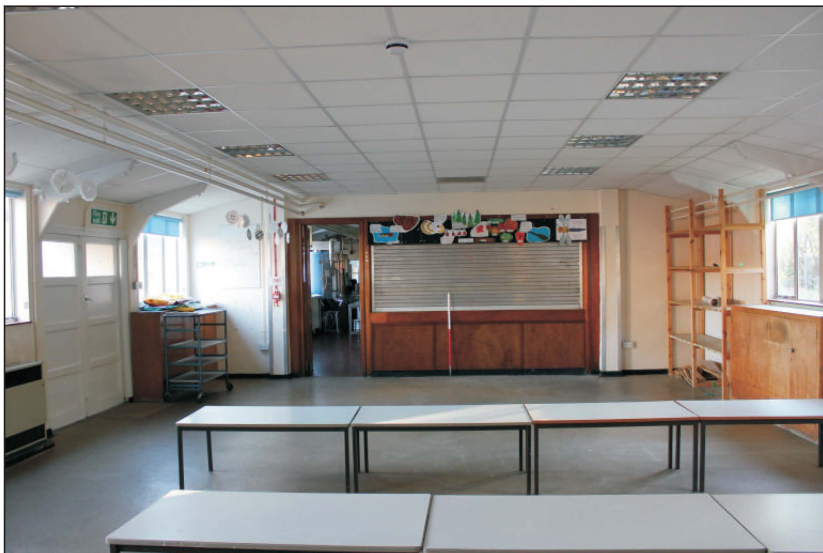
The range is currently used as a dining room and kitchen, with a service partition dividing these areas. At the north end is a boiler room that contains a modern gas boiler. In the dining room, the floor is covered in linoleum whilst the roof structure is obscured by a false ceiling (Plate 7). The room has heaters placed on concrete plinths. In addition to the modern gas pipes there is some of the original pipework and other fittings associated with the heat source from the boiler room survive.

Plate 7: The interior of the dining room in the north range showing inserted partition, viewed from the north. 1m scale.

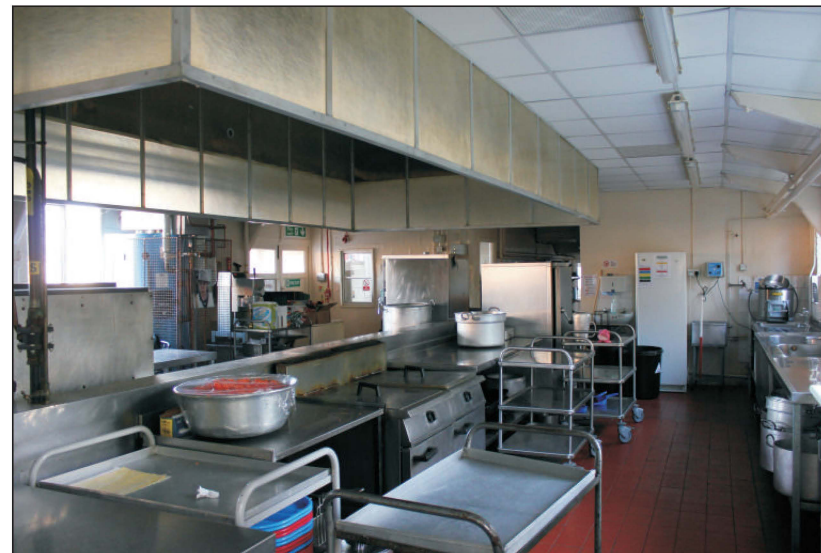
The kitchen has been fitted out (in the late 20th century) with industrial kitchen equipment and worktops, and gas supplies to the ovens (Plate 8). The walls are mostly painted brickwork with ceramic tiles used above the worktops. This material is also used for the floor covering. The room has a suspended ceiling that incorporates a large central extractor unit. The roof structure above must have been altered here, although there is no sign of this externally. In the west elevation there is a group of four high-level vents.

Plate 8: The kitchen in the north range showing the inserted walls at the south end, viewed from the northwest. 1m scale.

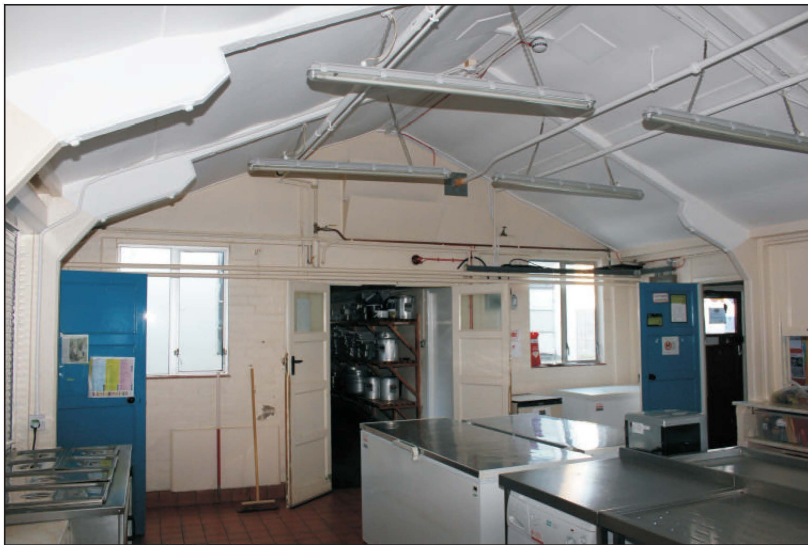
This room is a kitchen/food storage and preparation area (Plate 10). The partition walls with east and west rooms incorporate large serving hatches set between the trusses. In the east wall two primary wooden sliding hatches survive, whereas in the west wall they have been replaced by roller blinds (Plates 11 and 12). To the north of these hatches there are doorways into the adjacent rooms, retaining their original 4-panel doors. Below the hatches, and the windows in the south elevation, there are brick bench piers that now support laminated wooden shelves and worktops (Plate 12). Some have been removed to allow the fitting of modern storage facilities, such as fridges.

The room is open to the ceiling where the roof structure is exposed. The inside face of vertical trusses (visible on the outside of the building) are angled internally, in part reflecting the pitch of the roof. Bolted to these are rafters (Plates 10 and 11). The internal edges of both these elements are chamfered. The ceiling is set between these rafters, and comprises (?asbestos) boards. In the centre of the ceiling there is a pair of blocked openings within the boards. The outer covering is ceramic tiles that are almost certainly of late 20th-century date. This material has also been used to cover the other huts. The original cast-iron downpipes survive, although the gutters have been replaced in plastic.

Plate 10: The kitchen in the south range, central room, viewed from the south. 1m scale.

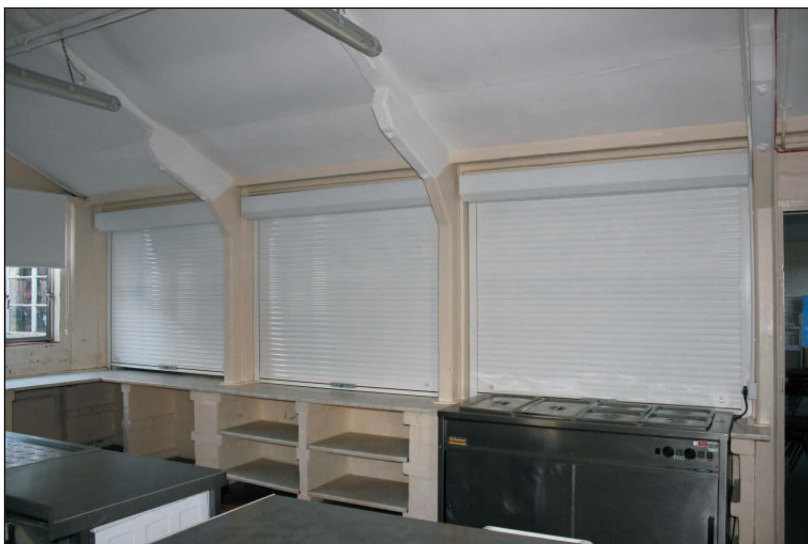
Plate 11: The shutters in the west wall of the south range, central room showing work top below, viewed from the northeast.

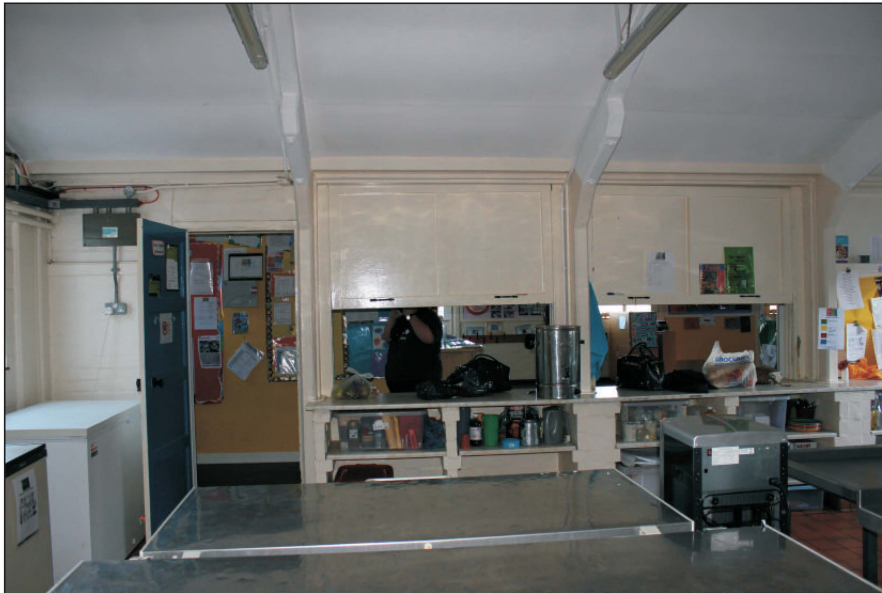
Plate 12: The serving hatches in the east wall of the south range, central room, viewed from the west.

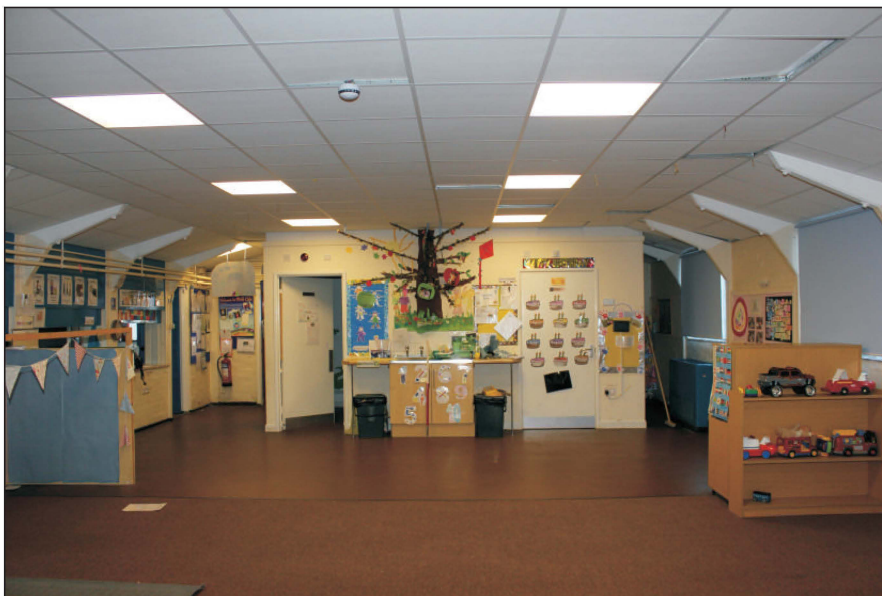
This part of the building is currently used as a 'fish' pre-school room, and originally had an open plan layout (Plate 13). There is a doorway in the north elevation leading to a short corridor. The east side of the corridor is formed from the wall of an inserted block of lavatories. At the north end is a fire exit with an external porch. Either side of the door is a pair of inserted storage cupboards. The interior has flooring of carpet and linoleum, and a suspended ceiling. The walls are mostly painted brickwork, partially covered in noticeboards. The only other fixtures are heaters placed on concrete plinths.

Plate 13: The south range, east room showing the interior, viewed from the south. 1m scale.
