BARN AT HIGHER TRENANT FARM, ST NEOT, CORNWALL

Results of historic building recording

Document No: ACD864/2/0

Date: March 2014

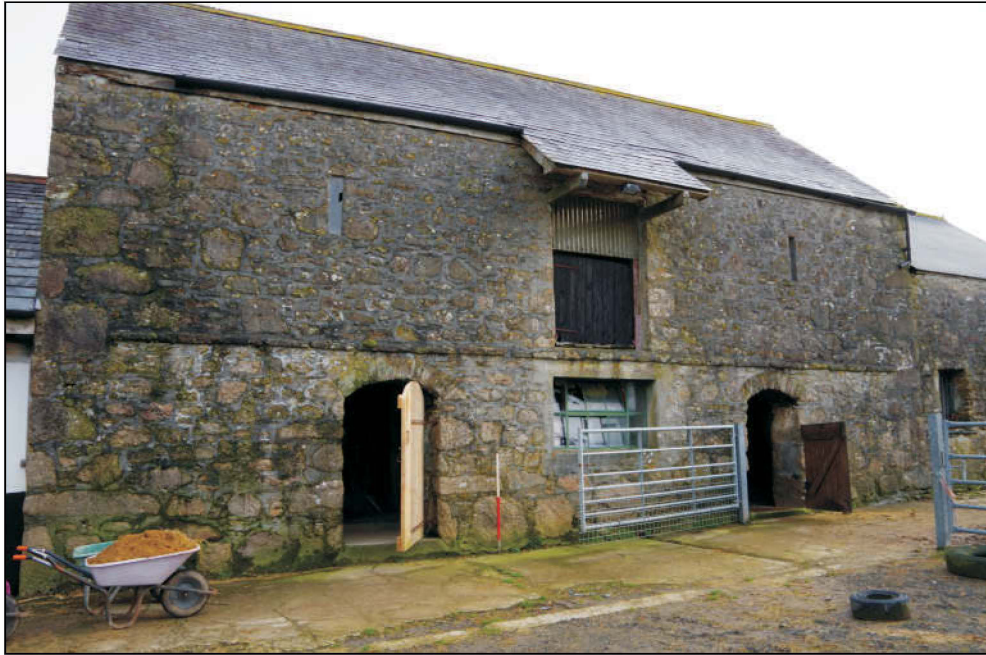
Plate 1: Room B, viewed from the south. 1m scale.

Room B is constructed from subangular granite blocks up to 0.80m long bonded with a hard grey-white cement mortar. Larger granite blocks have been used for quoins and around windows, as well as for the basal courses of the wall. The masonry continues as the north gable above the roofs of rooms A and C. Here, the blocks used are generally smaller and are laid in a more irregular manner.

There is a simple plat band between the ground and first floors. On the ground floor there are two doorways with wooden doors and shallow stone arches above. Between them is a later window opening with a concrete lintel. The reveals and any new masonry around the opening are obscured by a concrete render finish. On the first floor are two small rectangular, glazed slit ventilation openings and a central doorway. This has a wooden lintel and frame, filled with a low wooden door with 18th-century style strap hinges and a corrugated asbestos sheet above. The roofline continues down over the doorway as a porch supported on wooden beams

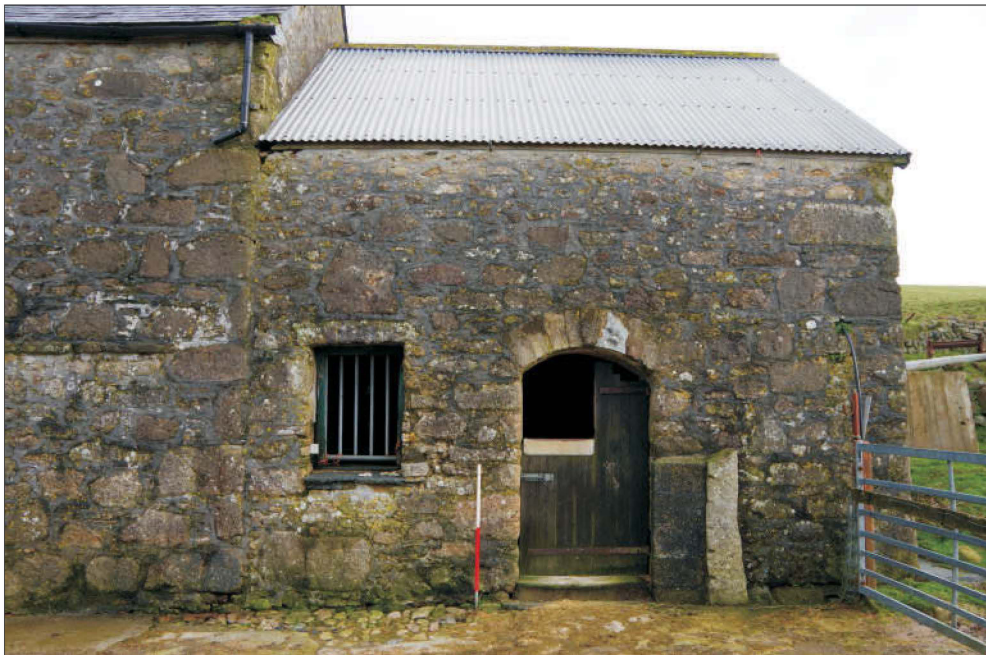
Plate 2: Room C, viewed from the south. 1m scale.

Room C is constructed from subangular granite blocks up to 0.80m long bonded with a hard grey-white cement mortar. Larger granite blocks have been used for quoins on the east corner and around the doorway. On the ground floor is a window opening with a granite lintel and slate sill. There are a few repairs around the opening. There is also a doorway with a stone arch defined by voussoirs and a prominent keystone, all made from a vesicular stone. Abutting the east side of the doorway is a tower of concrete blocks and a tall piece of granite (displaying feature and tare splitting marks), both which look like they have been used as gate posts. The present gate is to the east of these, and gives access to a field to the northeast of the farm.

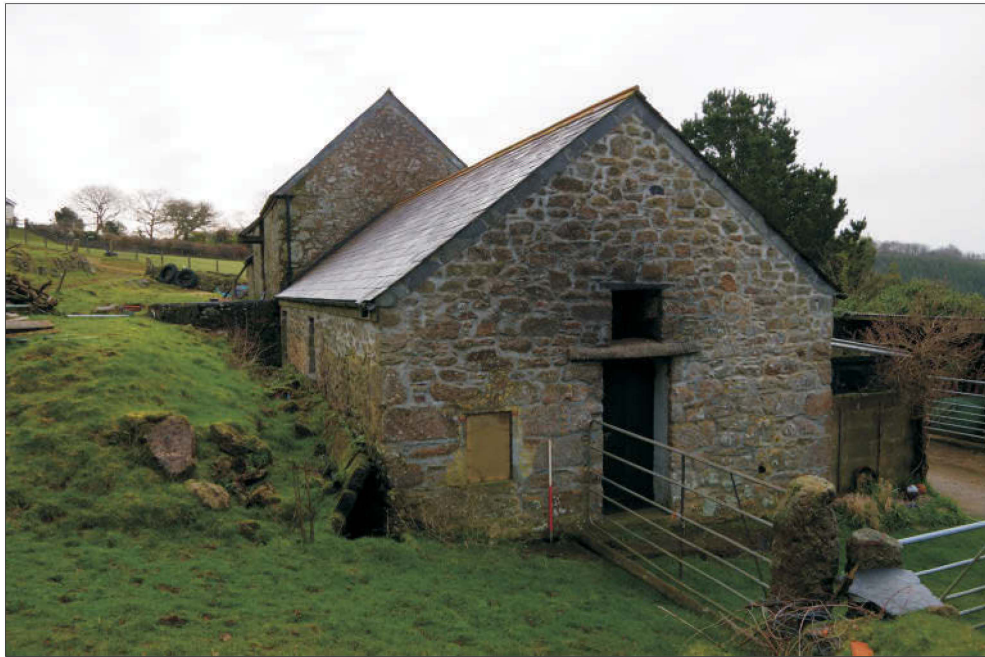
Plate 3: Room A, west elevation, also showing collapsed retaining wall on north side of building, viewed from the northwest. 1m scale.

The masonry continues from the south elevation of room A, but here incorporates occasional pieces of slate within the mortar joints. On the ground floor there is a central door opening with a wooden door, jambs around the opening and a granite lintel. This has a square first-floor opening above it with a wooden lintel. One of the jambs is reused, and incorporates a rectangular rebate. There is a later ground-floor opening to the north of the central opening; this has a concrete lintel with brick and cement used to form the opening. The stonework above and around the first-floor opening is blackened, which is due to smoke. The building has been heightened and this has been constructed in the same style as the lower part of the wall with granite bonded in hard light grey-white cement mortar. The scar of the original roof line is clearest on the north side. At the base of the wall there is a ceramic land drain encased in sloping concrete that incorporates a flat step up to the door.

A retaining wall to the north of this room has collapsed and material is slumped against the lower part of the wall.

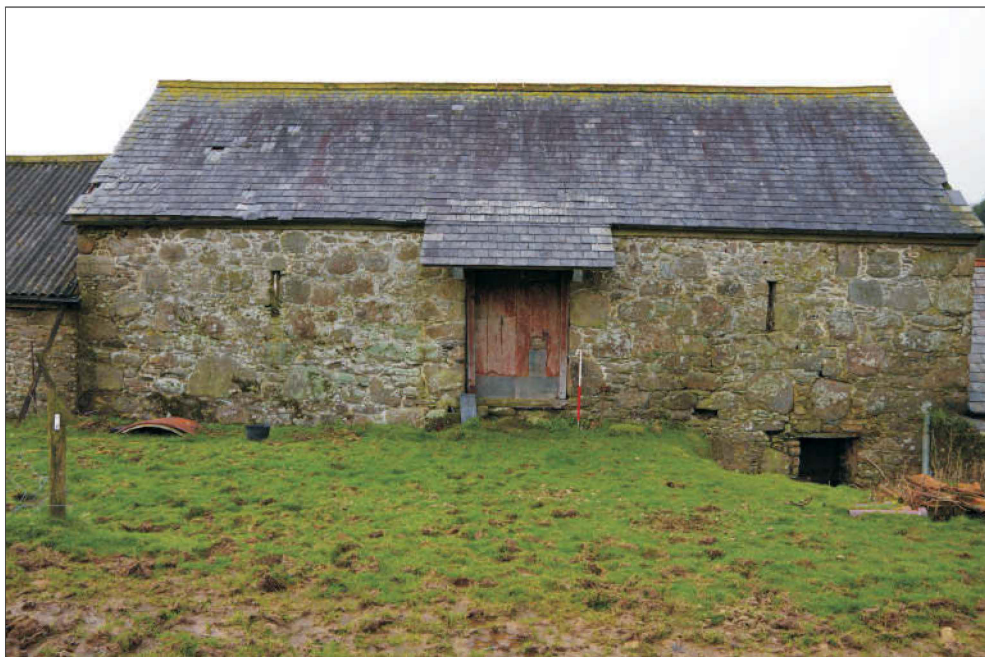
Plate 4: Room B, north elevation, viewed from the north. 1m scale.

The masonry of room B is the same as described in the north elevation, except it has no plat band. On the ground floor there is a doorway with a wooden lintel at the west end, with two ventilation slits to the east of this. These have been blocked, and are only visible internally.

The building has been terraced into the hillside, which is retained by a wall constructed up to the first-floor level. Outside the doorway the gap between the building and hillside opens out into an open structure. This is partially defined by a further retaining wall that abuts the main building. On the first floor there are a central doorway and two small ventilation slits. The doorway has a wooden frame, door and lintel, and is accessed over the gap behind the building via a step. It also has a small porch, supported on wooden beams, covered in slates continuing the pitch of the main roof above.

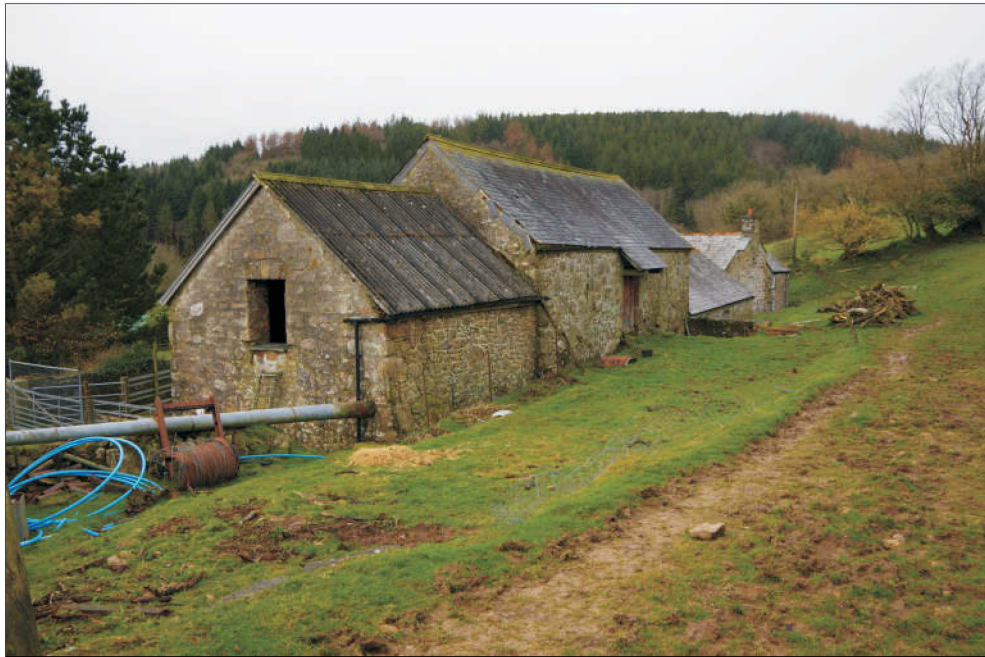
Plate. 5 The building viewed from the northeast, showing the rear elevation and the east elevation of room C.

This elevation, forming the gable of room C, is the same masonry as described in the south elevation. On the first floor is a door opening with a wooden door and slate sill. It has a stone arch defined by voussoirs and a prominent keystone, all made from a vesicular stone. On the wall below this at ground floor level is a projecting stone. This may have formed part of a set of steps or support for a ladder to access the first-floor opening. There are two bolts in the wall on the ground floor to hold a door that would have given access to the area between the north elevation and the retaining wall. The roof is modern, and the top of the gable was repaired when the roof was replaced.

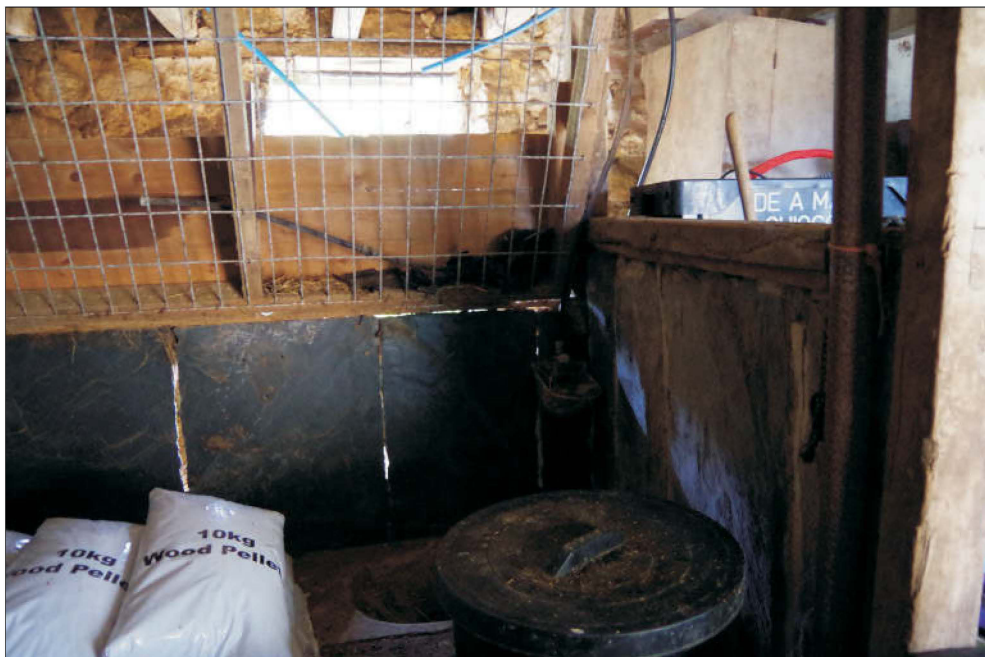
Plate 6: The interior of room B showing the slate stalls, viewed from the south.

The ground floor is divided into two parts – a main area to the west and a smaller area to the east. The two areas are divided by a concrete wall with a metal grille on top with a gate for access at its south end. The floor is concrete. It has a lower drain along the south side containing grooves, which had been infilled on the east side of the building. The lower parts of the walls have been rendered in cement. The central part of the main room contains animal stalls. The partition walls of these have been built using large pieces of slate and wooden beams. There is a feeding passage along the north side. The smaller area to the east functioned as a separate animal pen.

The first floor is supported on wooden joists and has been reinforced by the addition of two large horizontal steel I-beams that have been inserted against the south wall and along the in the central axis. These in turn are supported on steel posts. In the south elevation are two protruding stone blocks. These have blocks of wood on top and now support the metal beam. They may have originally supported a lower floor, or more likely an internal beam that supported the floor joists at their present height. Attached to the ceiling is a galvanised water pipe associated with the cattle stalls below.

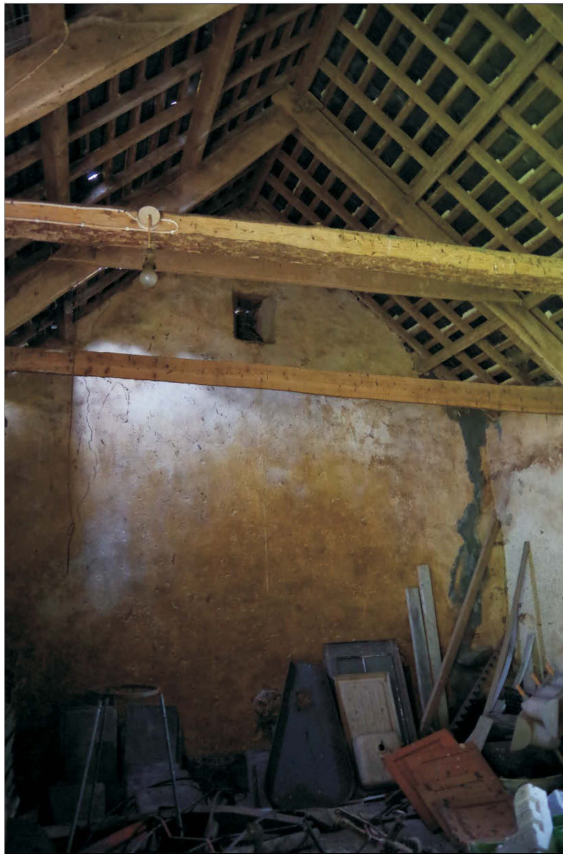
Plate 7: The first floor of room B showing the roof structure, viewed from the southeast.

The first floor spans the length of the room, and is open to the roof. It has wooden floorboards. The walls are covered with lime plaster and there are no visible original fixtures or fittings. There are small, high level rectangular blocked ventilation openings in the gable end walls which were not visible externally. The roof is formed from principal rafters lapped and pegged at their apex, with pegged curved collars and nailed straight tie beams. Additional nuts and bolts have been added to the

collars. Not all of the collars survive; some trusses display pegholes for removed timbers. One set of the trusses displayed carpenters marks in the form of "II" at the joints. The purlins sit on the back of the principal rafters and support the common rafters that hold the slates.

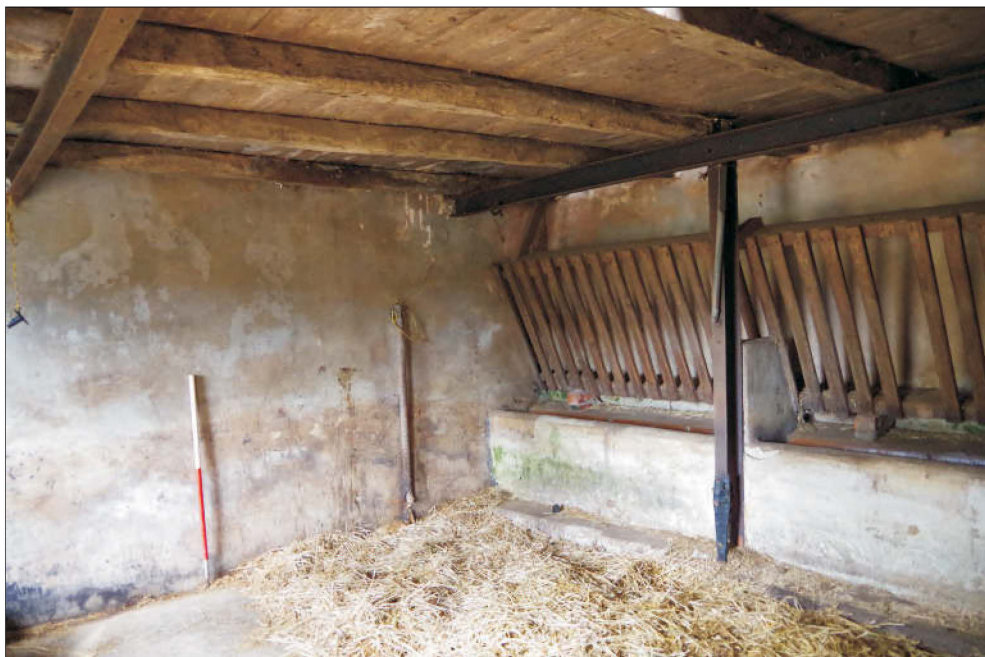
Plate 8: The interior of room C showing the modern fittings, viewed from the southeast. 1m scale.

The ground floor was latterly used to house livestock. It has a ceramic and concrete feeding trough with a manger above along the north wall, and a concrete floor. The first floor is supported on wooden joists as well as two horizontal steel I-beams that have been inserted close to the south and north walls. The latter is supported on a metal post. It was not safe to access the first floor, so this was not investigated.
