ROUGEMONT HOUSE, EXETER

Results of historic building recording and archaeological monitoring

Exeter City Council planning reference 13/4184/03, condition 5

Document No: ACD818/2/1

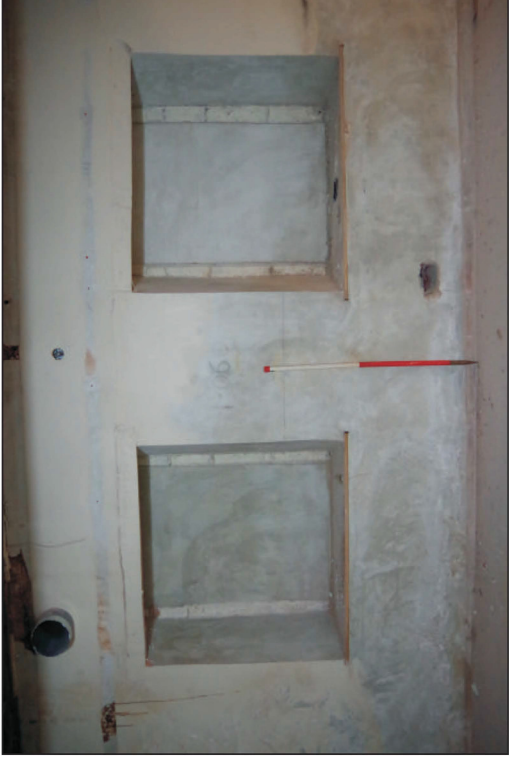
Plate 2: Basement (B3), blocked windows of primary phase west-facing wall (scale 1m)

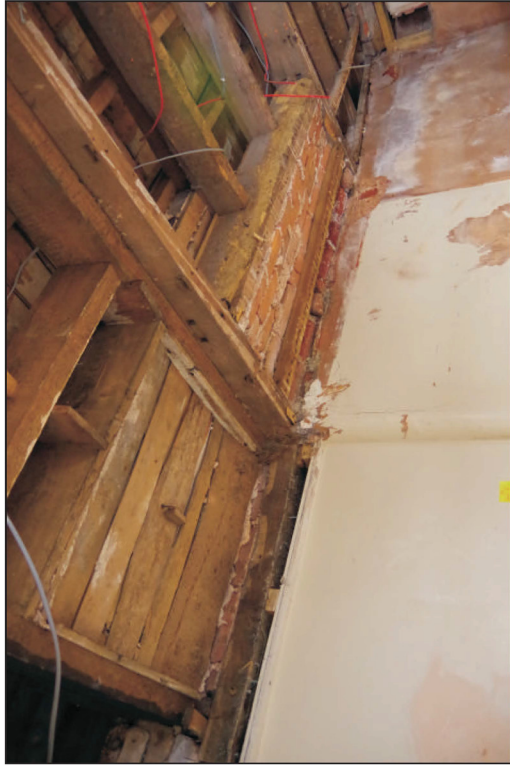
Plate 3: Basement (B4), ceiling with ?hatch and brick fireplace base

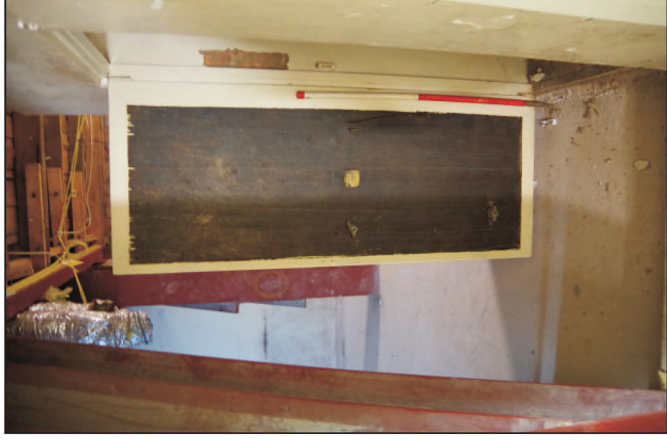
A strongroom (B5) is constructed of brick walls with a vaulted brick roof, and retains its original metal door.

Plate 4: Basement, door to Strongroom B5 (scale 1m)

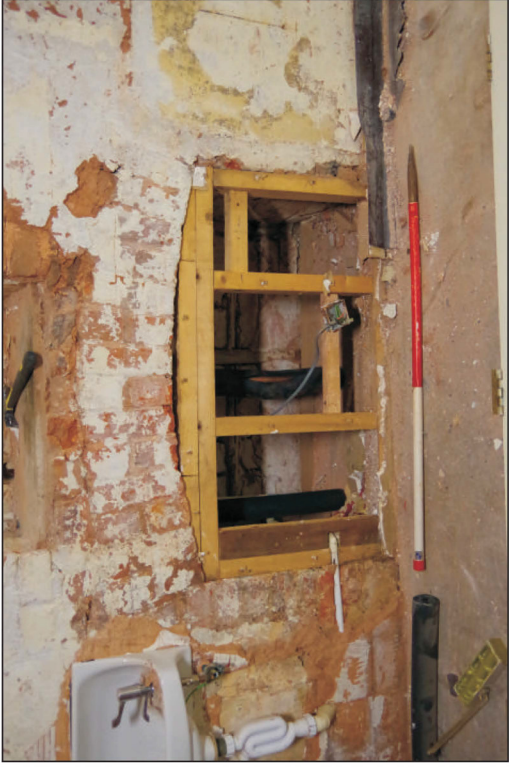
Room B9 has had its partition walls removed, the joists and bridging beam supporting the upper floor are exposed and there is evidence of modern repairs. In the centre of the east wall is a rectangular recess for the previously-suspected blocked window from the primary building, and matching the position of that converted to a door between rooms B8 and B10. Directly below the blocked window is a brick-arched recess not previously seen and of unknown purpose, but may be related to access to the sub-basement Room B12 below. Exposed masonry in the north wall revealed a mix of brick and sub angular Heavitree breccia blocks bonded with a hard reddish white mortar. This crude construction may indicate that this wall was not designed to be visible externally. Two small recesses with brick arches in the north wall are of unknown purpose and the suspected fireplace was not visible.

Plate 5: Basement, arched recess, east wall of Room B9 (scale 1m)

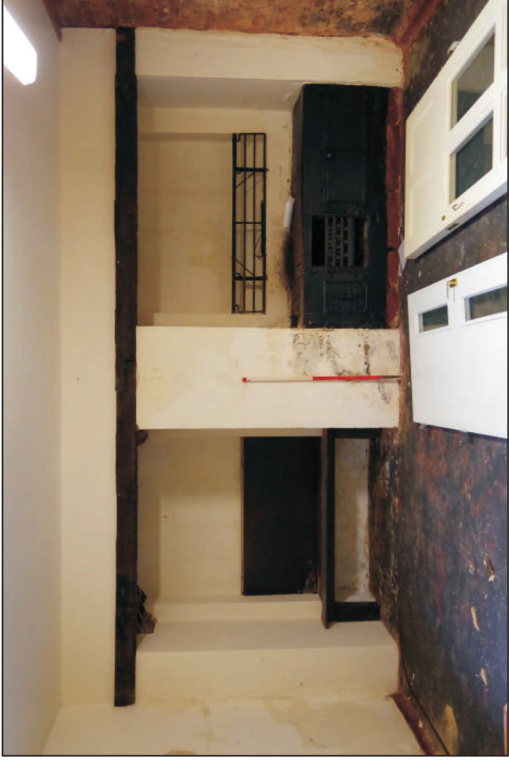
Room B10 was formed by the extension of the primary building to the east in the early 19th century. It has a concrete floor and plaster ceiling. In the north wall are two doorways, one contains double wooden doors with glass windows which is modern. The east wall contains a large sash window, the central part is formed of 12 panes and has two smaller windows on each side of 4 panes. The south wall contains two squared recesses linked by a single wooden lintel – one, a former fireplace now containing a fixed wooden bench, and the other a cooking range with a concealed brick arch above containing a flue cavity.

Plate 6: Basement, fireplace and range, south wall of Room B10 (scale 1m)

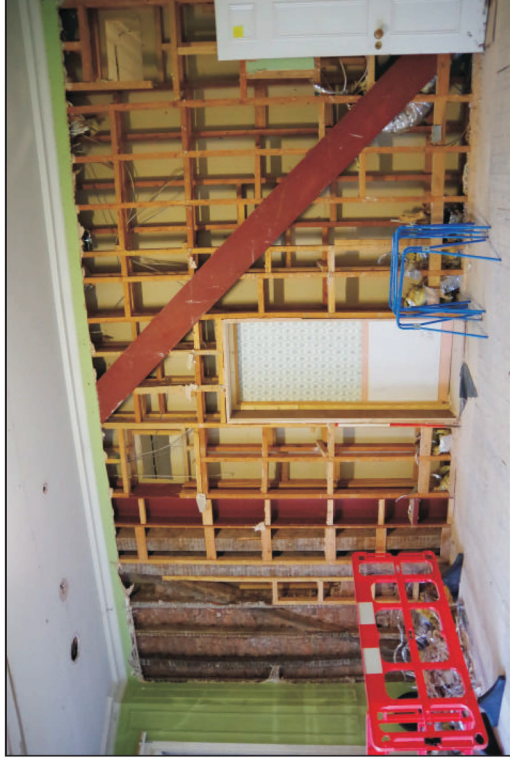
Room G1. The previously blocked fireplace in the south wall has been opened and has a wooden fire surround and stone hearth. The north wall was exposed and the partition wall of the primary building has been largely removed and replaced by structural steel framework which had been boxed in by modern work. This probably dates to 1987. At the west end the timber framing and brick noggin bonded with hard pinkish white mortar of the early 19th century extension overlooking the garden had been retained. In the east wall is a central arched opening through to room G4 with doors either side of it, with that to the right providing access to the servants' stairs.

Plate 8: Ground floor, north wall of Room G1 (scale 1m)

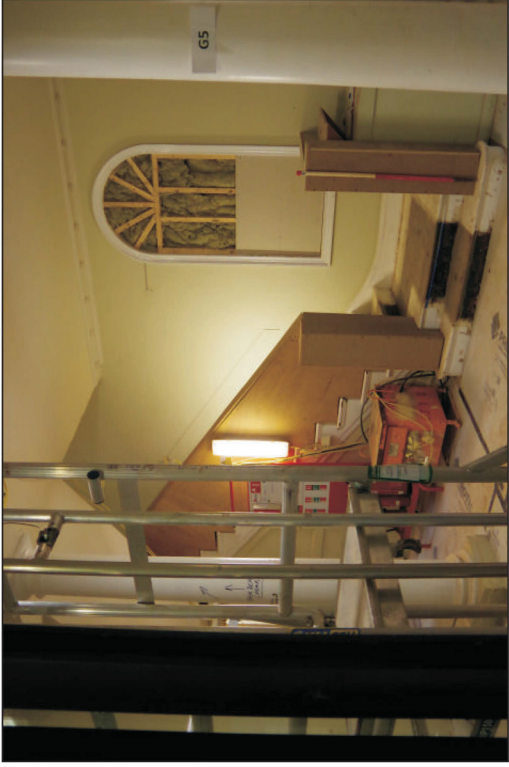
The Entrance Hall, G5, has a modern glass lobby inserted by the main doorway. In the south wall the blocked window shared with Room G4 has a wooden moulded frame.

Plate 9: Ground floor, south wall of Entrance Hall G5 (scale 1m)

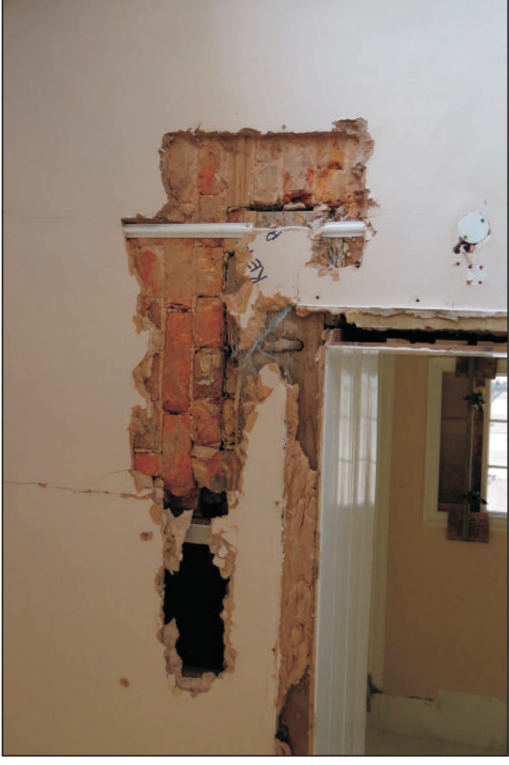
Room F5. A large squared doorway has been cut in the east wall, presumably the site of a former window, during the early 19th century extension. A small section of brickwork bonded by a hard pinkish white mortar from the primary building was visible, along with the end of the inserted wooden lintel. The external side, the west wall of Room F8, showed brickwork with very fine joints and a hard pink grey mortar, presumably indicating that this wall was expected to be seen at this level.

Plate 10: First floor, east wall of Room F5, primary building brickwork (scale 1m)

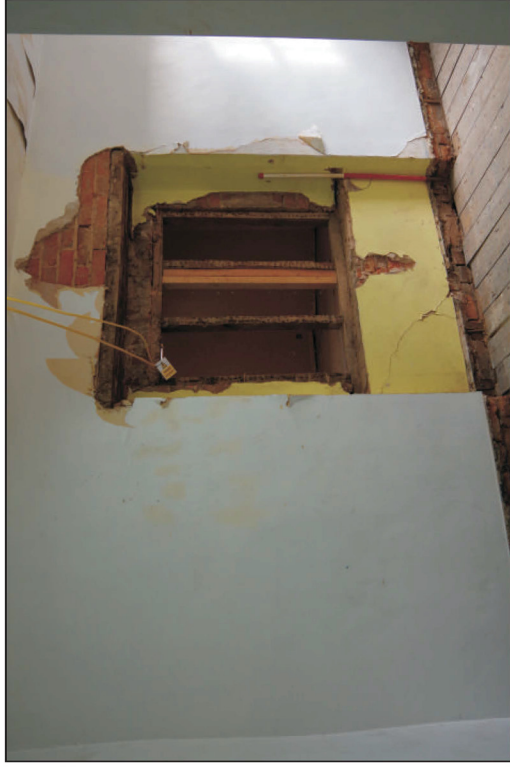
Room S6. In the east wall an original window opening for the primary building has been exposed with good quality brickwork around it bonded in a hard pinkish white mortar. (A small area of this, including a rubbed brick lintel, was also exposed on the opposite side in Room S9.) It is possible that the window recorded in room F5 below room F6 forms part of the same opening. The floor level of the neighbouring room (S9) is c. 0.5m higher than that of Room S6, showing that the proportions of the rooms of the extension were greater than the original building.

Plate 11: Second floor, east wall of Room S6, primary building window (scale 1m)

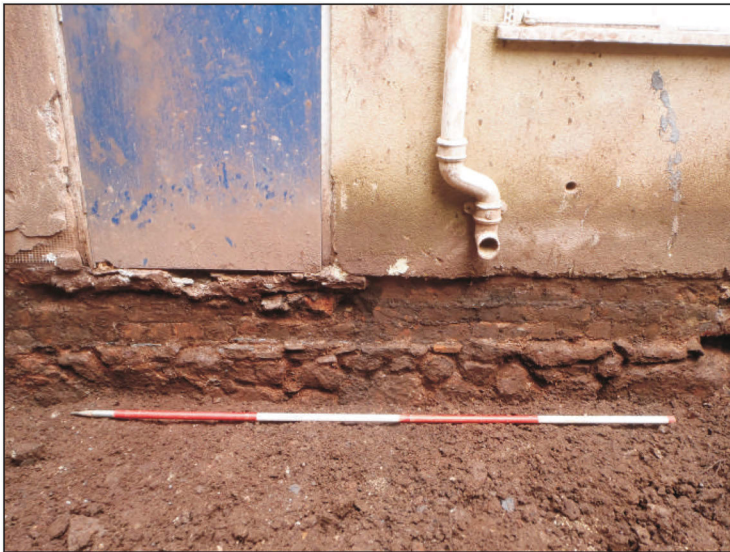
The south wall of Rougemont House (primary phase) was constructed in a foundation cut F110. The cut was not fully excavated although it was linear in plan (following the wall of the house) with a sharp upper break of slope and vertical sides. The foundations (F108) consisted of a series irregularly bonded and shaped sandstone, trap and breccia blocks (measuring 120x100x100mm–460x200x250mm) topped with smaller trap blocks (c. 100x100x100mm), river cobbles (c. 120mm) and pieces of slate and tile. The larger blocks formed the lower part of the exposed foundations whilst the smaller blocks, slate and tile were used to create a level horizontal base for the construction of the brick wall F109 (see below). These foundations were not fully exposed and extended below the extent of excavation. The backfill of the foundation cut (111) consisted of a dark purplish brown sandy clay with moderately sorted sub-angular gravels with frequent CBM, slate and mortar fragments, and finds of post-medieval pottery and clay tobacco pipe. The foundations appear to be dipping towards the west with an extra course of brick masonry being exposed before the foundations were truncated below the doorway to Room B3 by modern services. The lower courses of the southern wall F109, exposed by damage to the render during removal of modern yard surfaces, are bricks (210x110x70mm) laid in English bond, bedded in a yellowish sandy lime mortar.

Plate 13: South wall foundations F108 and F109, view from the south (scale 2m)

8.2 The foundations of the primary phase of the southern wall of Rougemont House F108 were also exposed. These appear to be getting deeper in an E-W direction (falling from 48.10-48.03m aOD). The similarity in height of F108 to F104, 112 and 113 (48.00m aOD, 47.98m aOD and 47.96m aOD respectively) indicate that these features may be a continuation of the foundation levels below the chimney breast.

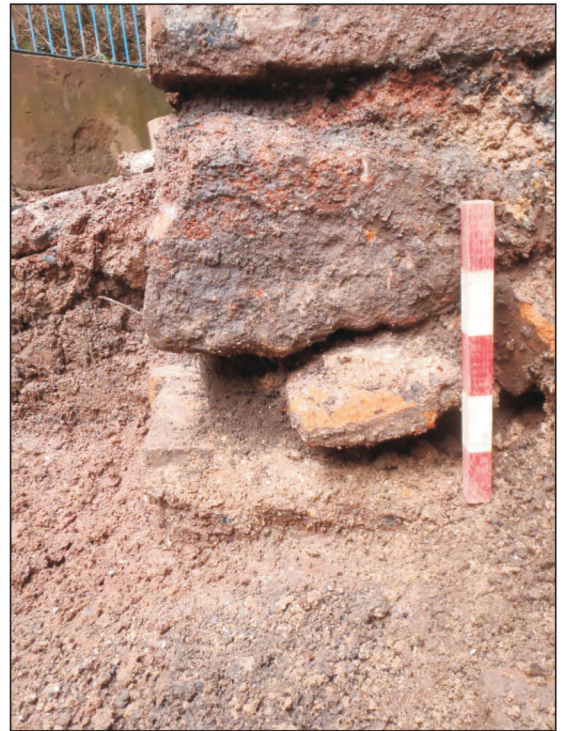
To the west of this two horizontal courses of squared breccia blocks F106 (measuring c. 600x240x210mm) bonded with a brownish grey sandy lime mortar were recorded on the outside wall of Room B3. This section of wall projected south from the main south wall of the building by 0.40m. In association with these blocks a deposit of dark grey to black sandy clay loam (105) was recorded. Remnants of this deposit covered the southern face of F106 and infilled a gap below this. Removal of a section of deposit (105) showed it was in-filling a series of voids below F106 and overlying further structures beneath. It was not possible to remove (105) completely as this would have involved undermining the upstanding structure of the house. Partial removal of (105) revealed that F106 was sat on a layer of irregular sandstone blocks (F116) 0.03-0.07m thick, bonded with a greyish white sandy mortar. F106 projected out from F116 in a southerly direction by approximately 0.25m. F116 in turn lay on a fragment of tile bedded onto a mortared surface 112. The southern edge of 112 was parallel with the southern edge of F106. The join between F116 and 112 was not complete and more voids existed between them. Investigation of these voids revealed traces of a soot like material on the underside of F116. Also recorded in this were other fragmentary structural remains. Surface 104 consisted of remnants of a brick surface bonded with a sandy lime mortar. Above 104 another fragment of tile 114 was recorded. Approximately 1m east of this a small fragment of brick surface (113), very similar to 104, was recorded.

Plate 14: Detail of the relationship between F106, 112, F116 and 105, view from the south (scale 0.25m)

8.2 Features F106 and F116 are likely to relate to a chimney stack. Inside room B3 (Allan *et al.* 2010) opposite the point where these features were recorded a blocked fireplace is postulated. In the rooms on the floors above this there are a series of blocked fireplaces. The presence of deposit 105 on the southern face of F106 and infilling a series of voids beneath hint at the presence of some sort of flue system (possibly linked to the courtyard by a grate) aimed to increase the draw of the fireplace inside. It is likely that this system was allowed to clog up after the removal of the internal fireplaces. The breccia blocks previously interpreted as foundations for the primary phase of Rougemont House (Smith 2013) are actually F106.

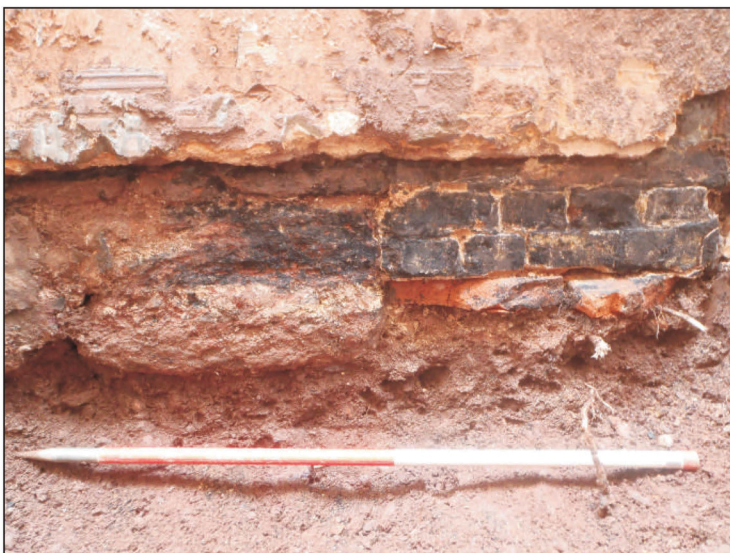
On the southern edge of the kitchen yard the reduction of levels exposed the foundation of the southern boundary wall of the property. The foundations of the wall were not as deep as those of the house and were fully exposed by excavation. The foundation course F100 consisted of a single course of roughly shaped breccia and limestone blocks (measuring 0.50x0.40m – 0.38x0.40m) bonded in a yellowish white

sandy mortar. Adjacent to this foundation course at the western end of the boundary was a remnant of tiled floor surface 102. The tiles measured c. 0.05m in thickness and were bedded in a yellowish white sandy mortar. The tiles were not complete and it was therefore not possible to measure their other dimensions. Above F100 and 102 was F103, the south boundary wall of the site. The wall has many phases to it which were not investigated in detail and are largely obscured by modern render. The small portion exposed at the western end consisted of bricks laid in horizontal courses with an irregular bond in a yellowish white sandy mortar. To the east of this, F103 was constructed of sub-angular trap cobbles (c.0.20m across). The brick section of F103, the upper surface of F102 and the upper half of the foundation course F100 showed signs of soot blackening.

At a distance of approximately 1.0m east, beneath the east end of F100, structure F117 consisting of breccia blocks (0.40x0.40x0.40m - 0.40x0.20x0.20m) with a regular bonding in horizontal courses bedded in white grey sandy mortar was recorded beneath F103. F117 followed the line of the south boundary wall before turning N-S and extending below the southern pier of the brick archway separating the east and west halves of the kitchen yard. It was not fully exposed and extended beneath the extent of excavation. The lower courses of the northern pier on the opposite side of the arch were also exposed. These courses consisted of bricks of the same size and laid in English bonding as observed in F109 although it was not possible to view the relationship with this the south wall of the house as it was obscured by modern render and concrete. A brick culvert (measuring c. 0.45m in diameter) was recorded running across the kitchen yard at a height of c. 48m aOD. The culvert appeared to emerge from below the modern NW-SE concrete boundary wall running NE-SW before turning to a more E-W direction. It had been truncated by the installation of modern services at its eastern end.

Plate 15: Foundation course F100 with soot blackening, view from the north (scale 1m)

8.3 Breccia masonry structure F117 (48.00 – 48.22m aOD) observed below the foundation of the southern boundary wall F100 may relate to glasshouses located to

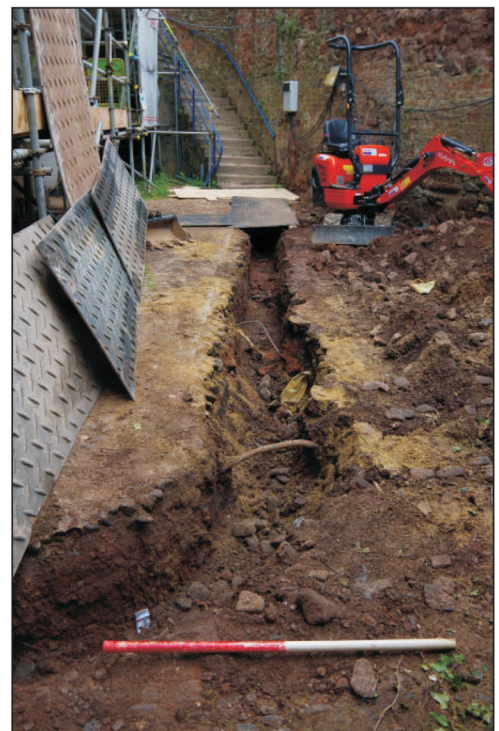
A trench for services approximately 0.4m wide and 0.5m deep was excavated in the eastern half of the southern yard area and continuing through the eastern yard. The surface consisted of a single layer of cobbles set in a dark purple brown sandy silt. Below this, where not already disturbed by modern services, deposit (101) was revealed. There were no features or earlier ditch fills exposed, and no finds were recovered.

Plate 16: View of the east yard service trench, view from the south (scale 1m)
