GRANBY HOUSE, ST JOHN'S ROAD, BEDMINSTER, BRISTOL

Historic Environment Assessment

Bristol City Council Planning Ref. 14/00307/F

Document No: ACD865/1/2

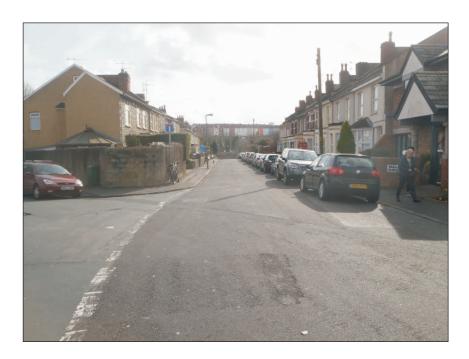
Plate 1: View towards the southeast end of St John's Road

- **6.3** In the area surrounding the site the key views and landmarks identified in the *Bedminster Conservation Area Character Appraisal* (December 2013) were assessed in relation to the development site. The most pertinent of the key views are those identified up and down St John's Road (identified in Plates 1 and 2). These plates also highlight the importance of maintaining the current sandstone and brick perimeter wall of the former Granby House as part of the development and in keeping with the character area. The local dominant landmark is the Robinson Building. This former industrial building has recently been re-developed as apartments with the addition of two storeys. The building, and the additional storeys, can be seen at the top of St John's Road on Plate 2. The Robinson Building can also be seen in the background (to the right) of Plate 5.

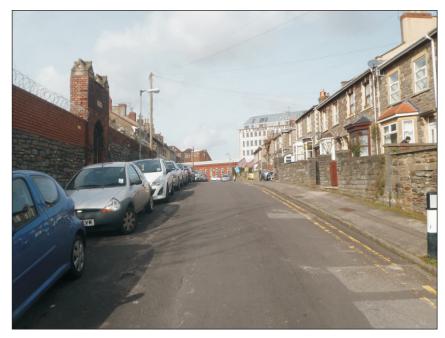
Plate 2: View from the southeast end of St John's Road

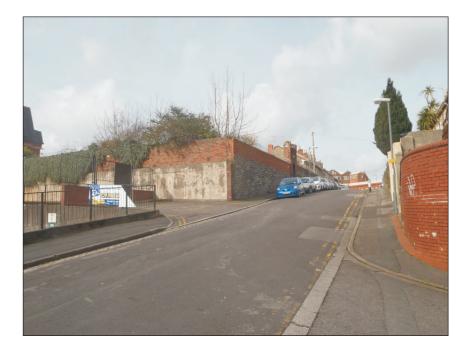
Plate 3: View of the site from the southeast end of St John's Road, looking west-northwest

is roughly square in shape, approximately 44 x 38m, with a further strip (40 x 12m) extending from the northwest corner. It was only possible to view the site of the development from the perimeter. From here it was apparent that the site, outside of the footprint of the demolished Granby House, has the potential to contain buried archaeological deposits. In particular, the strip behind the rear gardens of St John's Road has no recorded evidence of use other than as a field and garden. In this area part of a stone wall (see Plate 5, middle foreground) stands in front of a modern brick wall, and is on the line of the eastern wall of the Rev. Watson's garden strip identified in the Smythe Estate Plan of 1827. A peculiar feature is the side wall of No. 56 St John's Road where it faces on to the site. This wall is rendered except for a section of toothing bricks, paired and end on, rising to the height of the base of the gable; it is not known to what wall or building these toothing bricks may have been connected. It appears to be associated with the earlier, former outbuildings along this boundary of Granby House, but if they are, then it is odd that no other structural remains can be seen on this elevation.

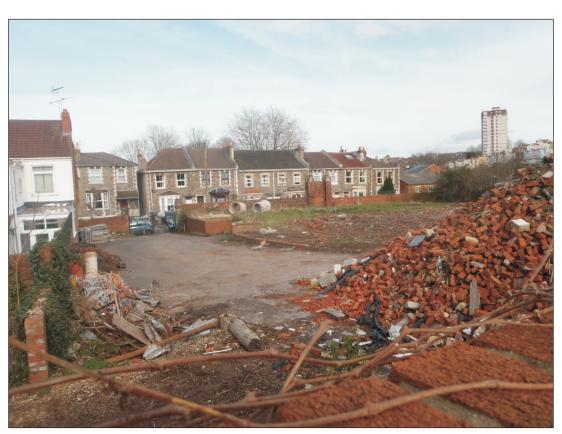
Plate 4: View of the main part of the site, looking east

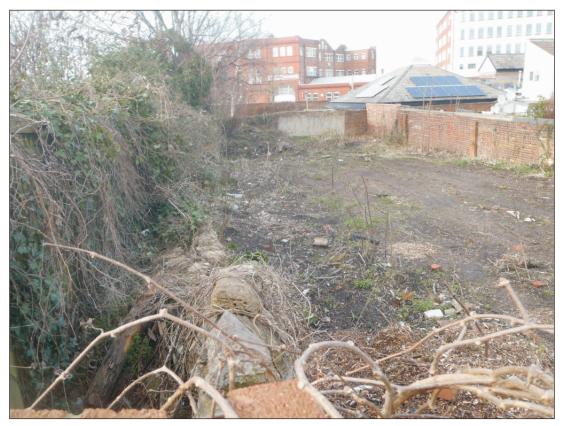
Plate 5: View of the plot behind St. John's Road, looking northwest

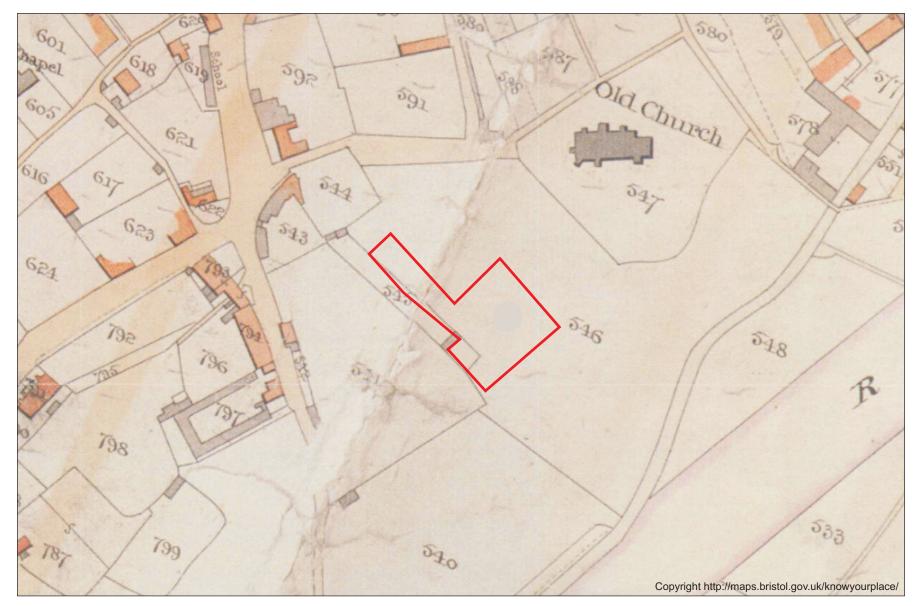
Map 1: Extract from the Bedminster Tithe Map, 1841

5.5 The site was shown as still located in the large irregular bounded field (numbered 546). Adjoining the field to the northeast was the enclosure (547) incorporating the site of Bedminster Church here marked 'Old Church'. Just beyond the Malago river the railway was now present, which continues in use today. The strip of land (545) now has small buildings associated with it; they are coloured grey indicating that they were not dwellings. The one closest to the site had been built with its long axis along the line of the northwest boundary of the sub-square paddock, previously labelled a garden. The apportionment listing for these and the neighbouring plots are listed in Table 2 below. As in the Smyth Estate map of 1827, the Rev. Watson remained the landowner and the strip remained a garden, although now divided by an outhouse of some description and the large irregular field appeared unchanged and in pasture.

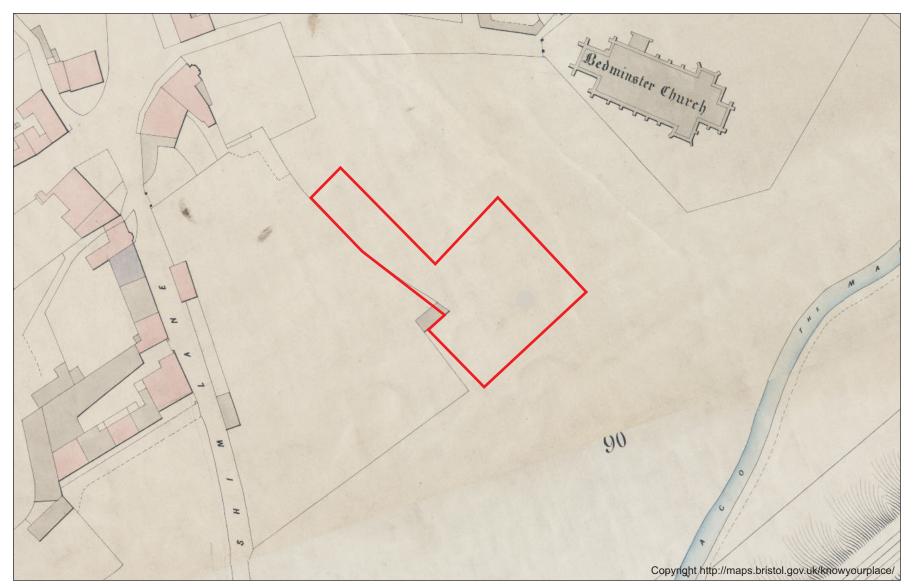
Map 2: Extract from the Ashmead Map, 1855

5.6 The large irregular bounded field had become larger due to the removal of the boundary to the field located to the southwest. Other boundaries removed included the northeast and southeast bounds of the sub-square paddock and the western boundary of the strip, which had become incorporated into the adjacent field. This had left the out-building within the field to the west. The church was once again marked 'Bedminster Church'.

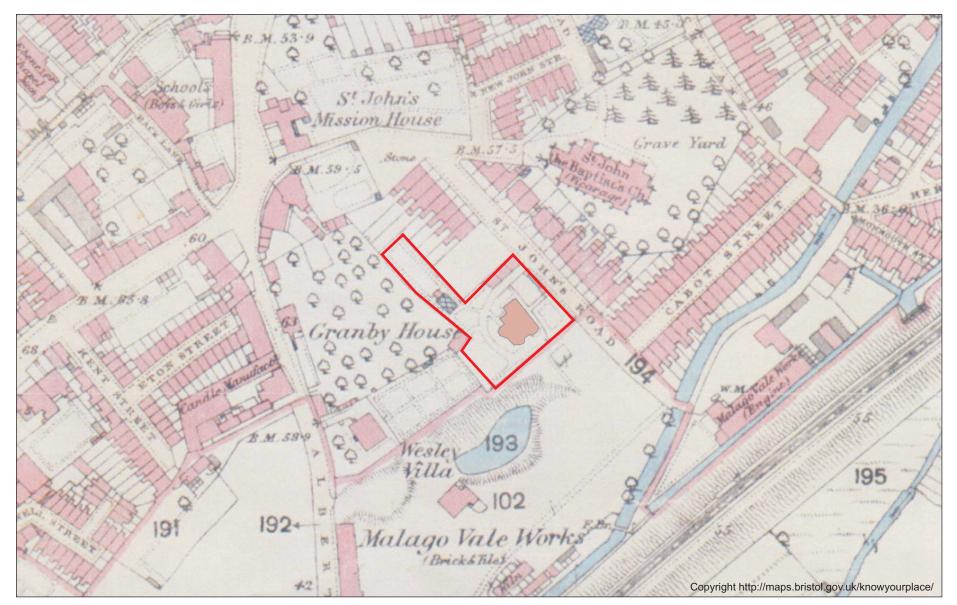
Map 3: Extract from the First Edition Ordnance Survey, 1880s

5.8 On the first edition Ordnance Survey (OS) map details of the grounds of Granby House were presented showing a drive, outhouses and a greenhouse. The vacant plot between Granby House and the terrace on the west side of St John's road remained. However, the rear gardens of terraces 42-48 had been shortened to allow an extension of the Granby House gardens to create what appears to be a garden with a greenhouse at the southern end of this long and narrow plot. The west side of this plot continued to follow the eastern line of the strip of the former garden belonging to Rev. Watson. The building at the southern end of the former garden still remained, but it is not clear if this is part of the Granby House property or belonging to an adjacent property; the latter is likely. In the grounds of Granby House the long thin building remained, and was adjacent to the carriage drive entrance on to St John's Road. It was shown divided into three equal-sized parts and was perhaps a coach house and stables. To the south of the drive entrance a path was marked which approaches the position of the pedestrian arched doorway on to St John's Road. Between these two entrances three very small buildings or structures were illustrated for the first time and perhaps related to formal gardens on this side of the house. A further path was marked through the perimeter wall on the south, presumably giving access direct to the works in the valley. To the west, separated by a boundary, were the formal gardens of Wesley Villa. The area to the south had been industrialised with a clay pit and kilns for brick and tile manufacture belonging to the Malago Vale Works. Bedminster Church was now labelled St. John the Baptist's Ch (Vicarage).

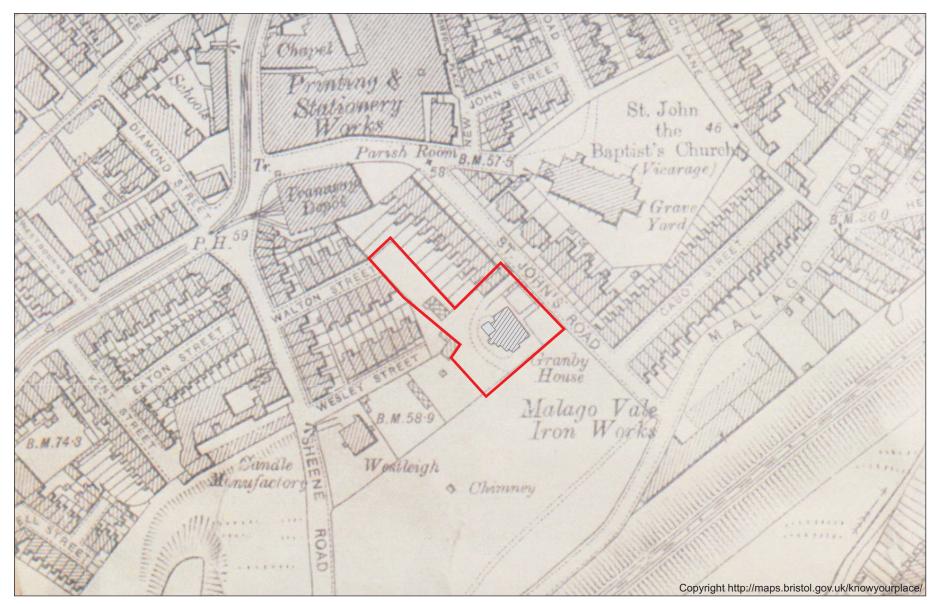
Map 4: Extract from the Second Edition Ordnance Survey, 1900s

5.10 The empty plot on the west side of St John's Road had now been filled with the extension of the terraces with four more houses (nos 50-56). The end of the rear gardens of these matched their neighbours and maintained the long garden plot extension of Granby House to their rear. A conservatory has been added to the northwest corner of Granby House. The grounds appeared to be less formal, or at least less detail was provided. The small garden buildings adjacent to St John's Road have been extended to line the south side of the carriage drive. On the west side the garden had been extended to take in part of the gardens of the former Wesley Villa, now in a severely reduced plot and named Westleigh. The works to the south of the site are now labelled Malago Vale Iron Works.
