101 BAMPTON STREET, TIVERTON, DEVON

Results of historic building recording

Condition 3 of Mid Devon District Council planning reference  
12/00129/LBC

Document No: ACD915/2/0

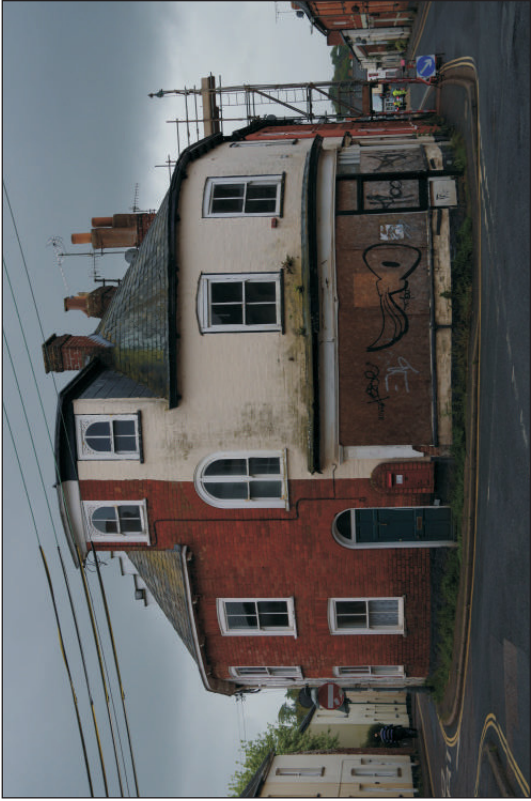
Plate 1: The property, along with no. 102, viewed from the north.

The property, along with no. 102 Bampton Street, forms a pair of houses with a rounded end at the junction of Bampton Street and Barrington Street (Plates 1 and 2). In the centre of the rounded end is a VR letterbox made by Smith and Hawkes, Birmingham. This is set within a circular brick arch, and within a projecting surround of bullnose bricks. The majority of the two houses are brick built, laid in Flemish bond, but with the lower courses constructed of sub rectangular stonework laid in rough courses and painted black (no. 102) and black and white (no. 101). The remainder of the façade of no. 101 is painted white.

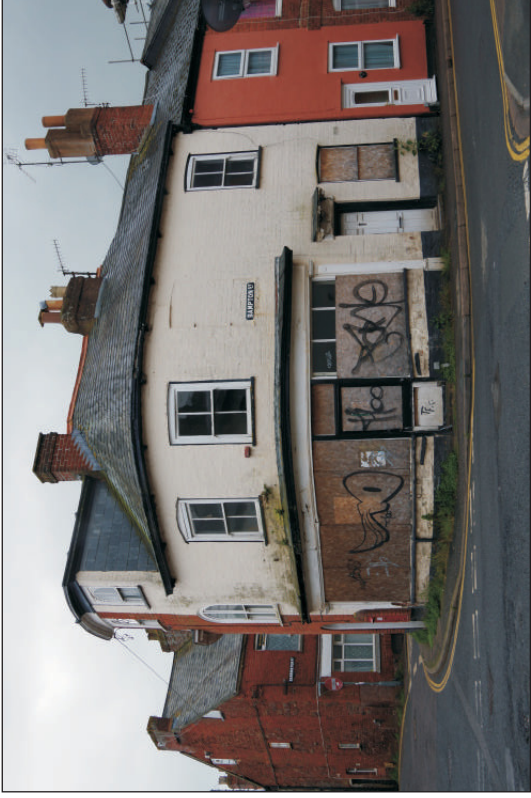
Plate 2: The property, viewed from the northwest.

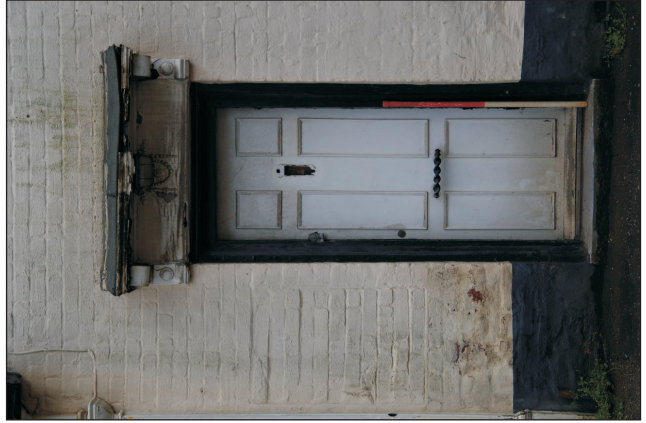
Plate 3: The door showing the blocked window opening to the left, viewed from the west. 1m scale.

There is a former shop on the ground floor of no. 101. The shop window has outer pilasters constructed of brick on volcanic trap (or Thorverton stone) plinths finished in wood with a garland of beads design. It incorporates a half-glazed door with an overlight and one 6-light window to the left and a 3-light window to the right. To the right of this is a wooden panelled door below a small porch supported on brackets. These are decorated with roses, whilst the lintel has the same garland of beads design as the shop front (Plate 3). Between this door and the shop front is a blocked opening, infilled with bricks. To the right of the door is a 4-pane sash window.

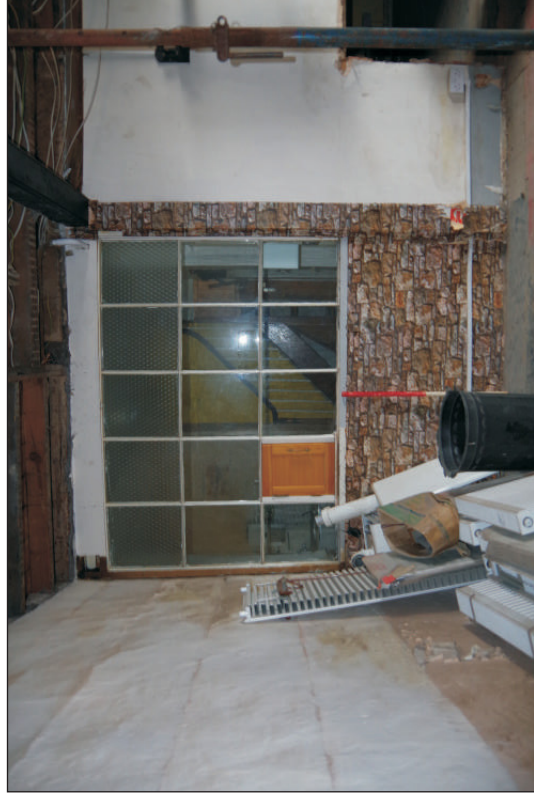
Plate 4: The partition between the shop and the kitchen, viewed from the north. 1m scale.

- 7.5** Limited evidence for later changes to the shop was noted. These comprised the creation of a glazed partition between the shop and the kitchen, and the insertion of a hatch in this partition, and another in the wall to the west.

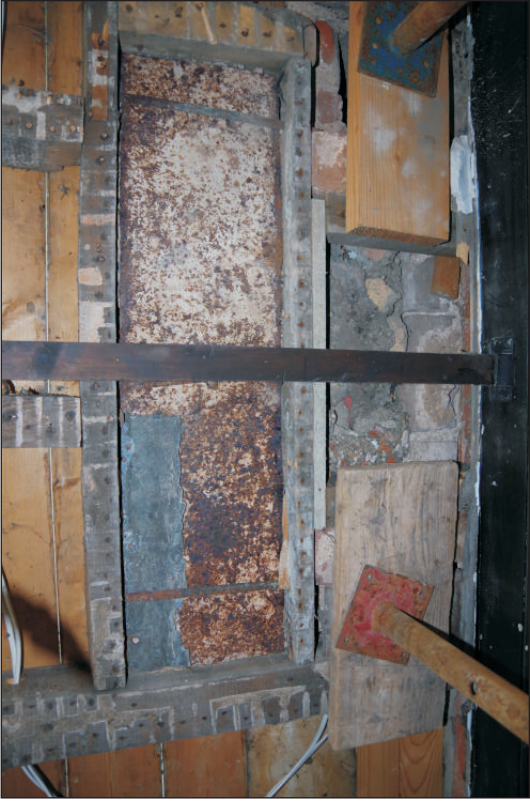
The lath and plaster has been removed from the ceiling, exposing the wooden joists supporting floorboards above. There is a fire hearth visible in the centre of the ceiling. The base of the brick stack is exposed along with part of the slate hearth, covered with an iron plate (Plate 5). The ceiling in the southeast corner is different to the rest and has a trimmer with adjacent joists and floorboards do not line up with the others in the ceiling (Plate 6). This represents the position of a former staircase.

Plate 5: The base of the first-floor hearth looking up from the shop, viewed from the east.

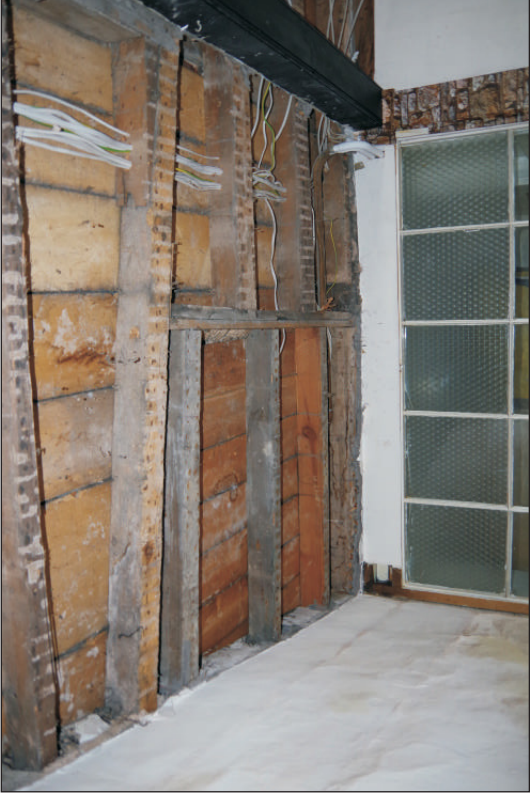
Plate 6: The joist arrangement showing the location of the former stairs, viewed from the north.

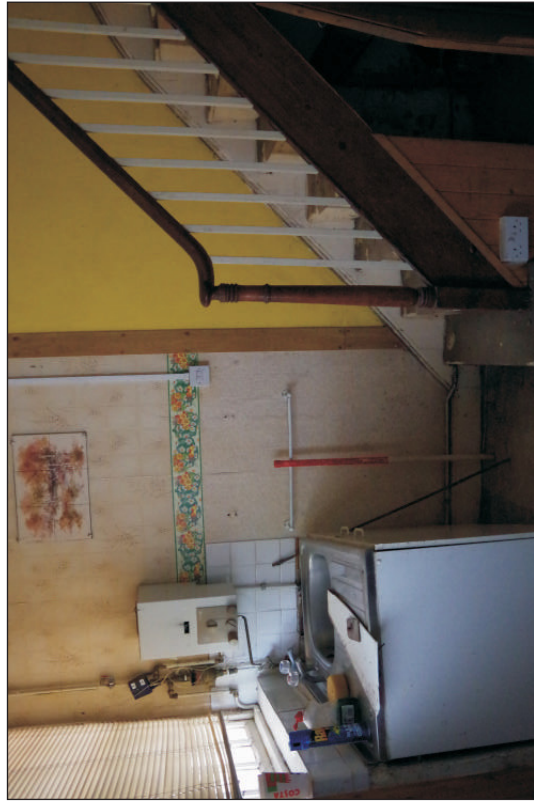
This room is plastered, though there is some brickwork exposed at the base of the east wall. It has a concrete floor. The ceiling is intact, although a small patch of lath and plaster is exposed. The room contains a wooden open-string staircase to the first floor set against the south wall (Plate 7). It has slender stick balusters and a turned newel post with a ramped handrail. Below the stairs are cupboards. In the west wall is a tall fireplace. It is now open and tiled, with the stack blocked but incorporating a vent (Plate 8). In the southeast corner of the room is a modern sink unit and hot water boiler.

Plate 7: The staircase in the kitchen, viewed from the east. 1m scale.

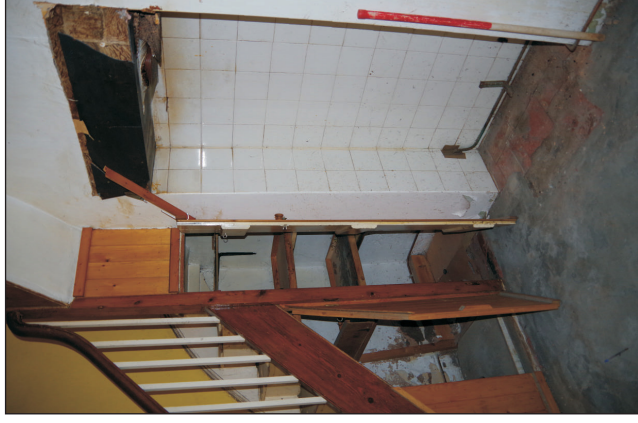
Plate 8: The fireplace in the kitchen, viewed from the southeast. 1m scale.

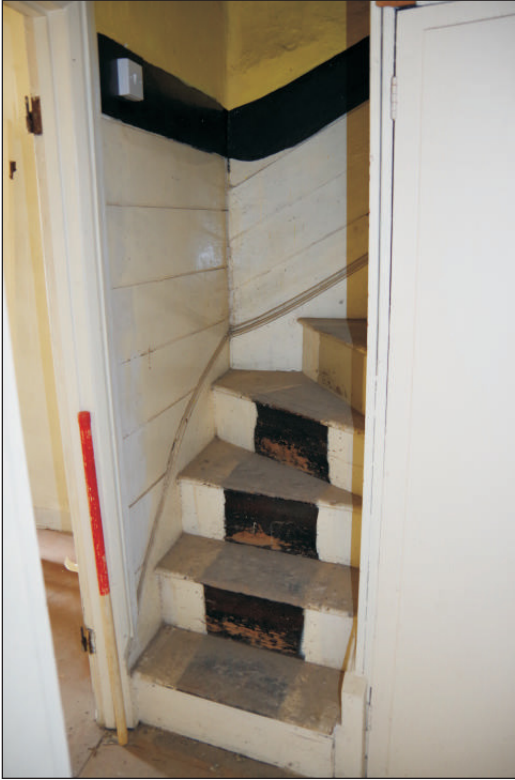
Plate 9: The stairs to the second floor, viewed from the southwest. 1m scale.

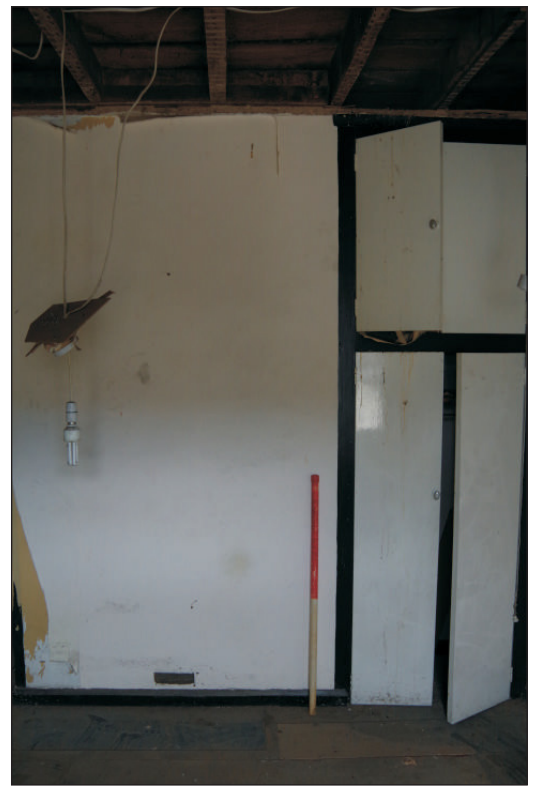
This room has plastered walls (except for a small patch of exposed brickwork in the south wall) and wooden floorboards, and is entered via a modern four panel door. The lath and plaster ceiling has been removed, exposing the beams above. The fireplace in the east wall has been completely boxed in, although the slate hearth is exposed, as is brickwork of the chimney breast just visible at the top of the wall. Adjacent to the fireplace are built-in cupboards (Plate 10).

Plate 10: The blocked fireplace and cupboards in bedroom 1, viewed from the west. 1m scale.

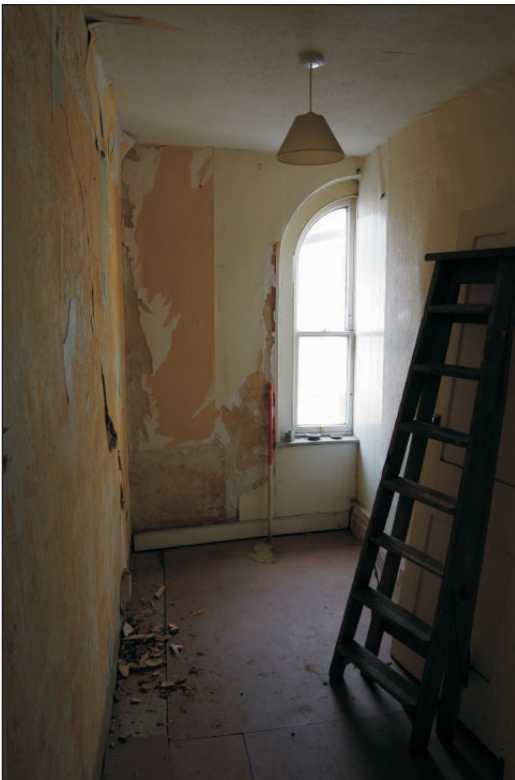
Other than some exposed brickwork and the wooden floorboards there are no fixtures or fittings or architectural features exposed. It is lit by the half-window shared with no. 102 (Plate 11).

Plate 11: The shared window in bedroom 2, viewed from the south. 1m scale.

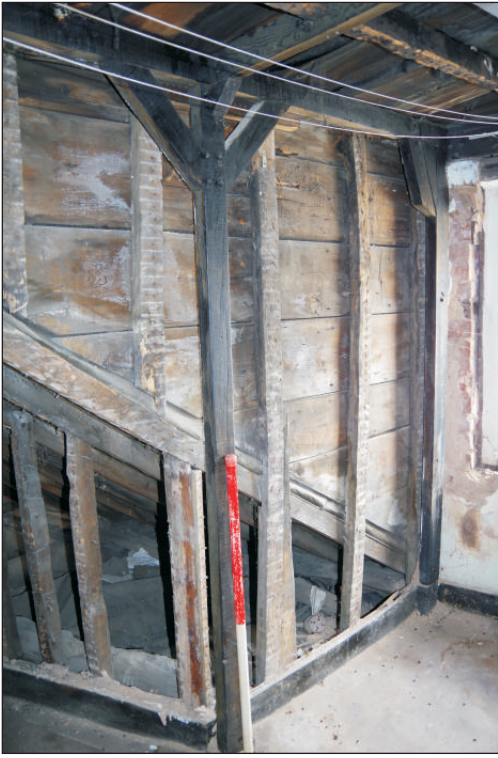
Some of the wooden beams have pegged joints, and do not display scars of lath and plaster, which indicates they are secondary supports (Plate 12). Some modern repairs with steel nuts and bolts were also noted. All of the timbers forming the roof are sawn softwood, and one displays scored marks such as "XIXII", which is probably associated with its importation (Plate 13).

Plate 12: The second floor stairwell showing secondary timbers, viewed from the southwest. 1m scale.

7.6 Within the roof space there was evidence of fire damage, however no damage was visible elsewhere in the building. Structural issues were noted within the roof space, and several phases of historic and modern repairs to the roof structure and partitions were noted.

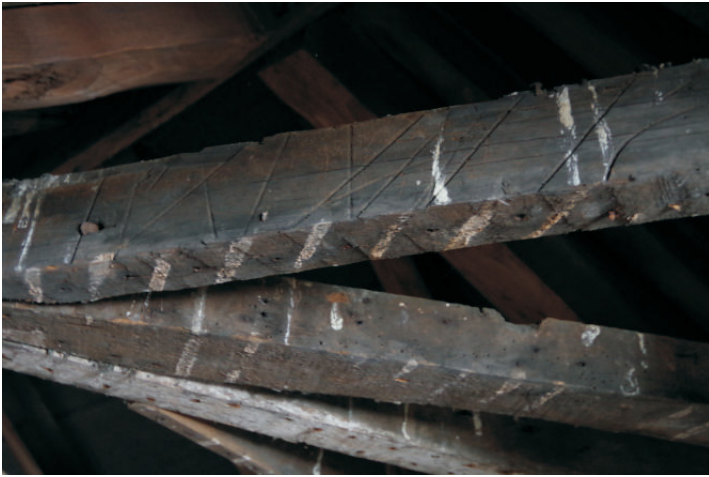
Plate 13: The markings on a roof timber, viewed from the north.

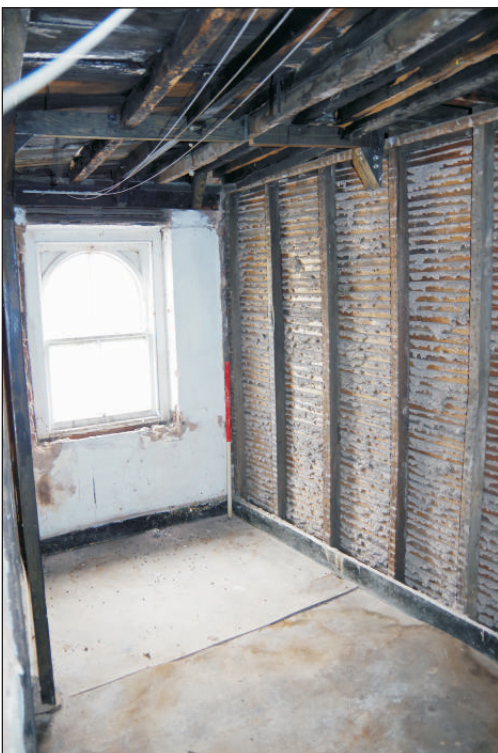
smoke blackened. In the area of the dormer window in the north wall, there is evidence of fire damage to the ceiling beams.

In addition to the front (northern) dormer window (Plate 14), there is a further dormer facing east lighting the rear of the room.

Plate 14: The second floor front dormer window, viewed from the south. 1m scale.
