TORRE ABBEY MEADOW FENCE, TORQUAY, TORBAY

Results of an archaeological watching brief

Scheduled Monument no. 24840: Torre Abbey

Document No: ACD916/2/0

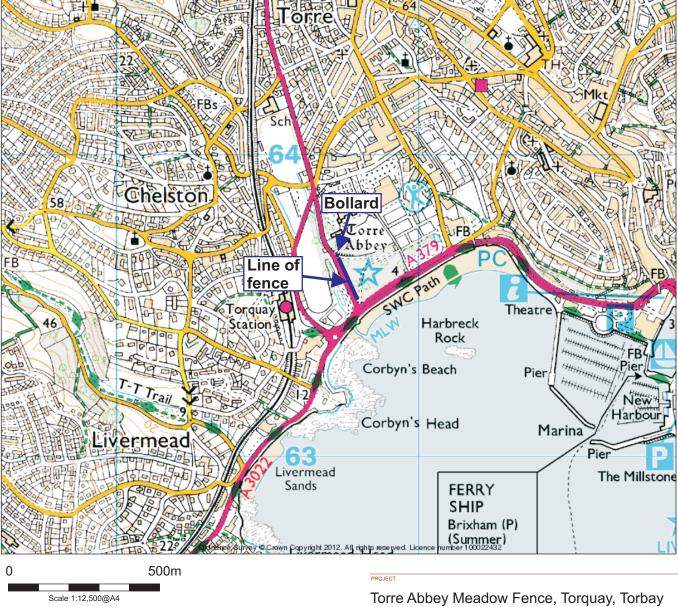
The location of the fence is adjacent to The King's Drive, along the western edge of Torre Abbey Meadow (Figure 1; Plates 1 and 2). This is within the outer precinct of the Abbey, situated between the upstanding buildings and the foreshore. The topography of the site is that it slopes gently down to the south-east towards the foreshore and lies at c.3-5m aOD. The underlying solid geology comprises inter-bedded Breccia and Sandstone of the Torbay Breccia Formation.

Fig. 1: Site location with location of fence line and bollard shown

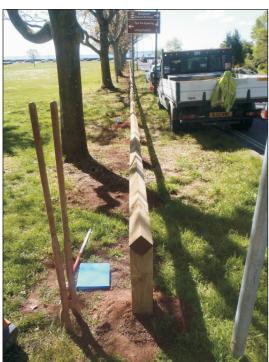
The watching brief consisted of the monitoring and recording of exposed deposits and/or artefacts during ground works associated with the construction of the post and rail fence. The groundworks consisted of the excavation of 105 fence post holes each measuring c. 350^3 and the excavation for the footing of one bollard located in the centre of the western end of raised footpath that runs to the south of the abbey grounds.

Plate 2: Finished post and rail fence

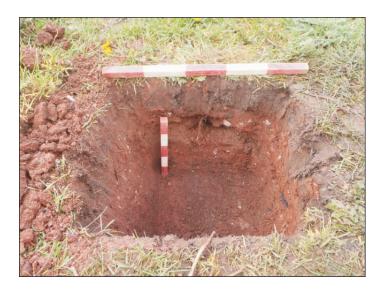
The excavations exposed a layer sequence (Plate 3) consisting of modern sandy clay loam topsoil (100) up to 0.15m thick overlying a series of relatively modern made ground deposits (101). Although quite varied these generally comprised red-brown to purple-brown sandy clays and sandy silty clays with varying amounts of subround to sub-angular poorly to moderately sorted gravels (>35mm). Mixed in with these deposits was a range of coarse components of modern date (brick, blue and white transfer printed china, stoneware pottery, plate glass and bottle glass, plastic, coal, tarmac, mortar and concrete fragments etc.), none of which was retained. In post-hole 67 two nickel-brass alloy threepenny bits dating from 1958 and 1960 were noted within (101).

Plate 3: Section through blank post-hole, showing made ground

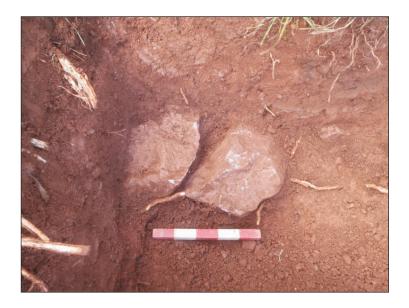
The post-holes were spaced at intervals of c.1.8m, and were excavated beginning at the south end of the fence. They were numbered in the order in which they were excavated. In post-hole 61 remains of a small, mortar bonded, rubble built foundation (F102) for a wall running parallel with The King's Drive were recorded. Remnants of this feature were also recorded in post-holes 59 and 60. Modern bottle glass and pottery (not retained) were recovered from beneath this foundation layer indicating the wall is of recent date. In post-hole 69 (located c.80m from the north end of fence) two angular limestone cobbles (F103) were recorded (Plate 4). No bonding material was present but the way in which the cobbles were over-lapped (and roughly shaped) suggested they had been deliberately placed in this position, possibly suggesting remnants of another wall. However this feature was not visible in the adjacent post-holes. Within this post-hole, deposit (101) had less modern material than in other post-holes but no artefactual remains were recorded in association with feature F103 so it is not possible to assign it a date to the stones.

The post-holes and trench for the bollard were excavated entirely through modern deposits. The only feature that may have any archaeological significance is possible wall remnant F103 recorded in post-hole 69. The lack of any associated dating evidence and the limited size of the intervention precludes any meaningful interpretation and dating.

Plate 4: Plan view of limestone cobbles F103 within post-hole 69 (Scale 0.25m)

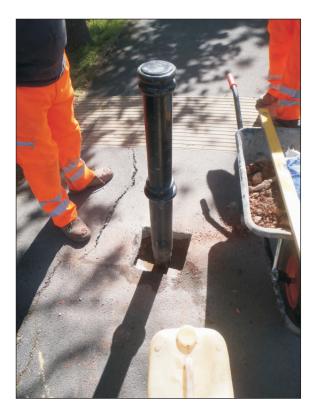
The bollard was a 1m high iron cylinder with a rounded top (Plate 5). The hole for its concrete base measured 200 \times 200 \times 350mm. The deposit sequence consisted of 0.04m of modern tarmac overlying two bands of associated hardcore (Plate 6).

Plate 5: Bollard in place

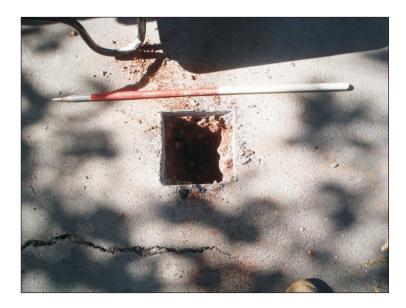
Plate 6: Post-hole for bollard
