# ROYAL EYE INFIRMARY, APSLEY ROAD, PLYMOUTH

## Results of an archaeological trench evaluation and historic building recording

Document No: ACD774/2/1

Date: June 2014

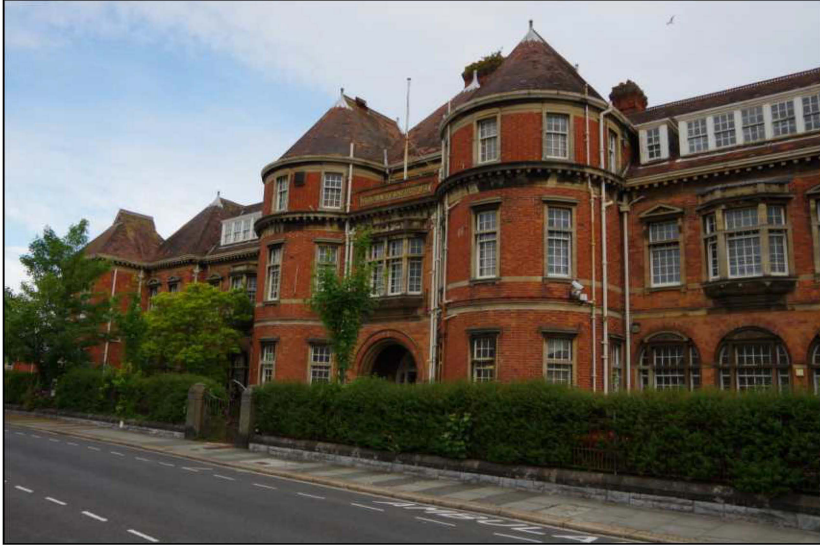
- 2.1 The site lies on a triangular parcel of land between Apsley Road, Beechwood Avenue and Dale Road, in the centre of Plymouth, 600m to the north of the medieval and early post-medieval town. The site contains the 1901 eye infirmary (Plate 1) and attached 1938 extension, as well as associated car parking and landscaping. The area is generally flat, with a very slight drop to the north, and is situated at a height of around 20m aOD. Solid geology comprises Devonian mudstone and siltstone of the Torpoint formation.

Plate 1: The south front of the original 1901 building, looking northwest

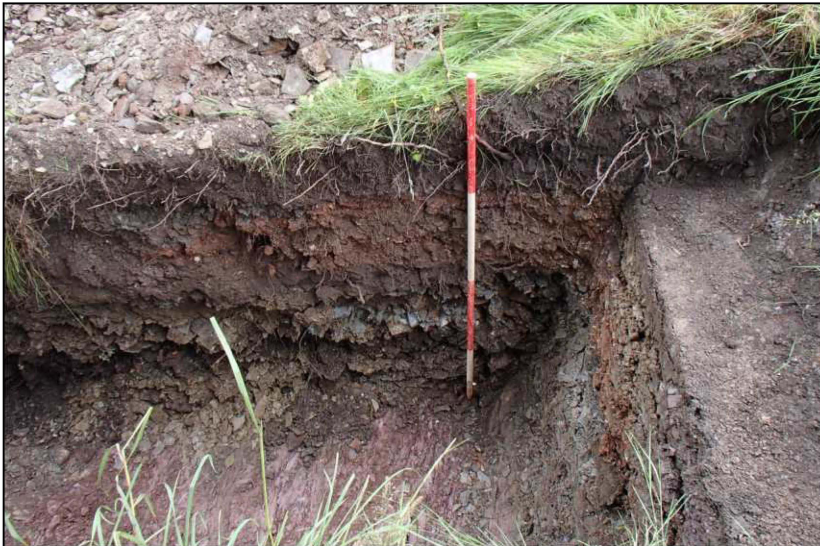
- 5.2** No archaeological features were revealed in the trench evaluation. The deposit sequence comprised a turf/topsoil layer (100), measuring 0.35m deep, from which a fragment of industrial china with a willow pattern design was noted. Below this was a made-ground deposit (101) consisting of dumps of crushed limestone, shillet, frogged bricks, with inclusions of tile, fragments of window glass, butchered animal bone, ceramic sewer pipe and slate, to a depth of 1.95m below ground surface. All of the finds were of late 19th-century or modern date. Below this, the natural geology (102) consisting of purple shillet, was exposed.

Plate 2: Evaluation trench, looking south. 1m scale

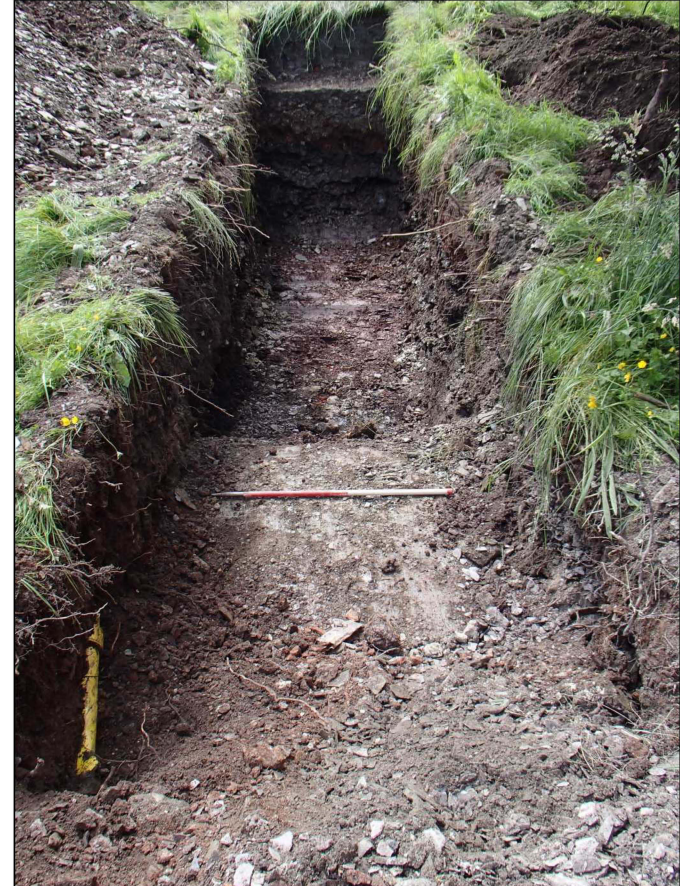
Plate 3: Evaluation trench, west-facing section, south end. 1m scale

- 7.1 During the archaeological trench evaluation no evidence for the Stonehouse Leat was found. The evaluation determined that the area to the east of the hospital consisted of modern made ground to a depth of almost 2m, with these deposits lying directly on top of solid natural geology. From this observation, it is clear that when the infirmary was constructed the local area was completely landscaped. It is therefore highly unlikely that any remains of the Stonehouse Leat survive within the site.
- 7.2 The 1901 eye infirmary is a late construction for this type of building, although falls into a group of health and welfare buildings constructed in Devon at this period; 'hospital' buildings constructed on new sites, as well as infirmaries within existing workhouses.

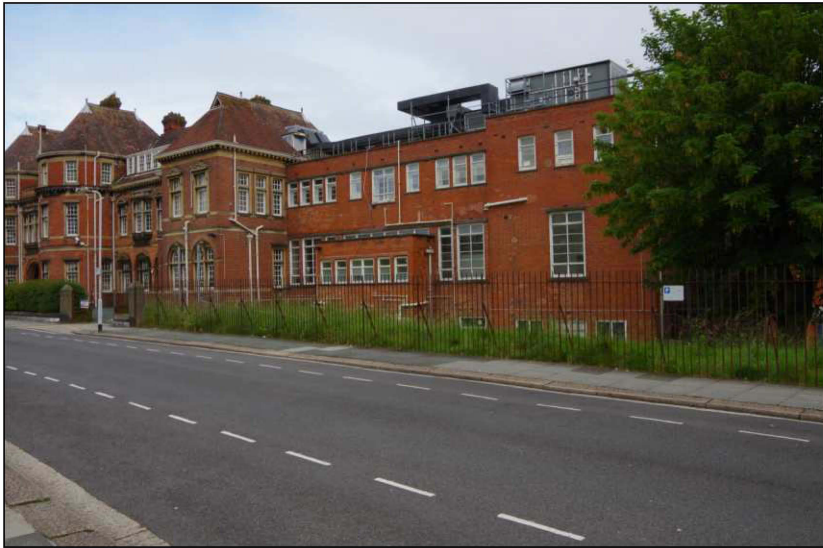
The 1938 extension to the hospital is constructed using red brick laid in Flemish bond with a concrete string course over the ground and first floor windows on the south elevation and over the ground floor windows on the north elevation (Plates 4-5). It is more utilitarian in style than the original building, with little detailing – the concrete string courses being the principal features. It was however designed to blend in with the existing hospital, perhaps in part since it shares floor levels, which is reflected in the levels of the windows (although these are generally shallower than the primary building). The use of red brick and the overall massing does not overpower the infirmary. At the time of its construction it would have been a very modern style, and it is typical of utilitarian buildings of the mid-20th century, including those constructed during the Second World War and 1950s rebuilding.

The north elevation is on one plane, on the same alignment as the main range of the earlier building (Plate 5), but set back from the adjacent end wing. The south elevation is set back from the elevation of the earlier building and has two projecting bays, a two-storey bay in its central part containing ground floor toilets, and a full height bay at the southeast corner (Plate 4).

Plate 4: The south elevation of the 1938 extension, looking northwest

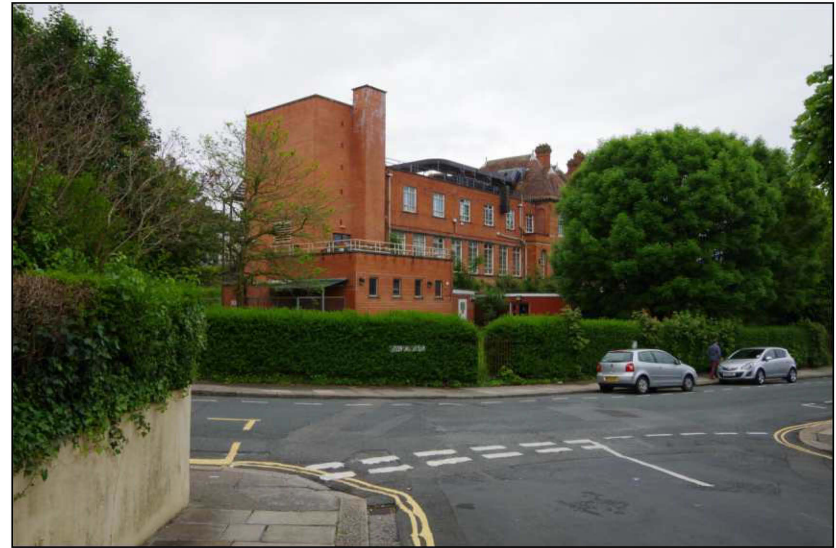
Plate 5: The north elevation of the 1938 extension, with 1970s tower, looking southwest

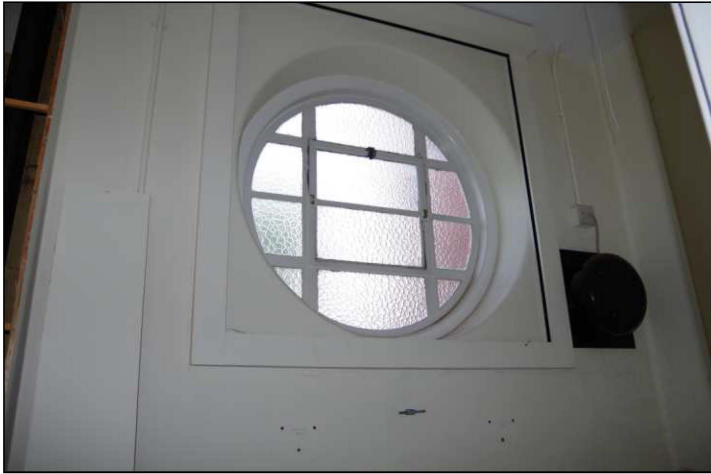
The building retains the majority of its original metal-framed windows, formed of 3, 4, 6 or 12 panes. All are rectangular except for one circular window at the east end of the north elevation (plate 6). They vary in size, with larger windows on the south elevation generally lighting corridors and public spaces. The windows on the north elevation providing light to the wards and consulting rooms are generally large. A few of the original windows in the basement level have been replaced with wooden-framed windows. On the south side of the east elevation there is a metal fire escape, with glass-panelled fire doors on each floor giving access to it (Plate 7). On the ground floor beneath the fire escape is a brick store with double wooden doors.

Plate 6: The round window in the north elevation, looking north

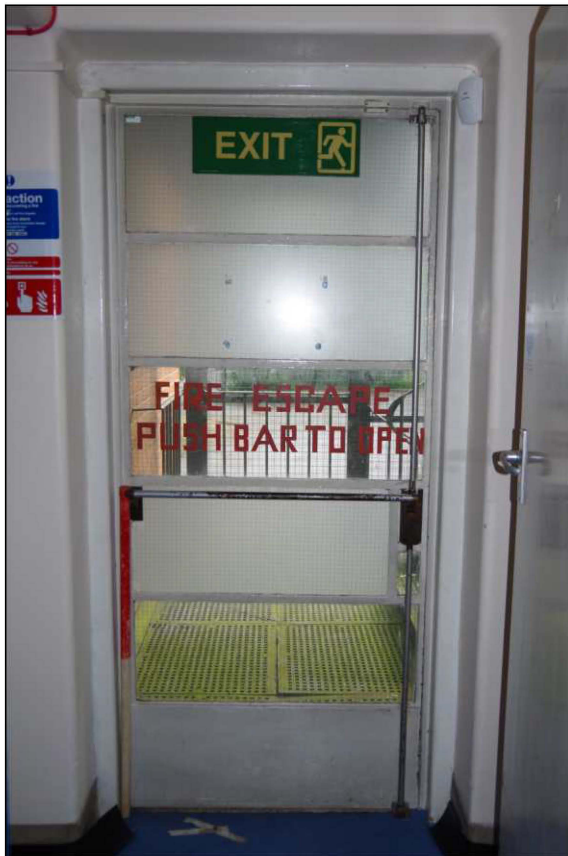
Plate 7: An internal fire door, looking northeast.  
1m scale

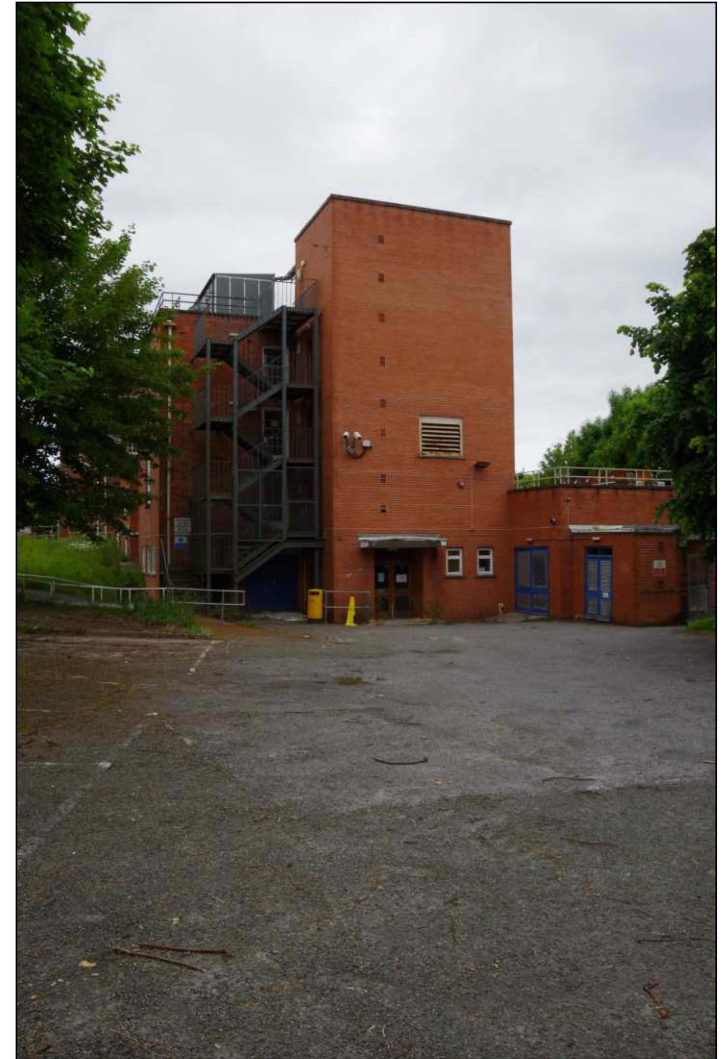
Against the east elevation a tower, constructed in brick laid in stretcher bond, was added in 1977–78 (Burley 2013, 28), along with a separate boiler house and out-building to the north. The tower is taller than the extension and dwarfs the flat roof of the latter.

On the east elevation of the tower there are double doors and two windows on the ground floor, and a large slatted vent on the first floor (Plate 8). On the north elevation there are double wooden doors on the second floor that give access to the roof of the boiler house. Above this opening there is a regularly-spaced series of ceramic vents.

Plate 8: The 1977-78 tower, looking west. 1m scale

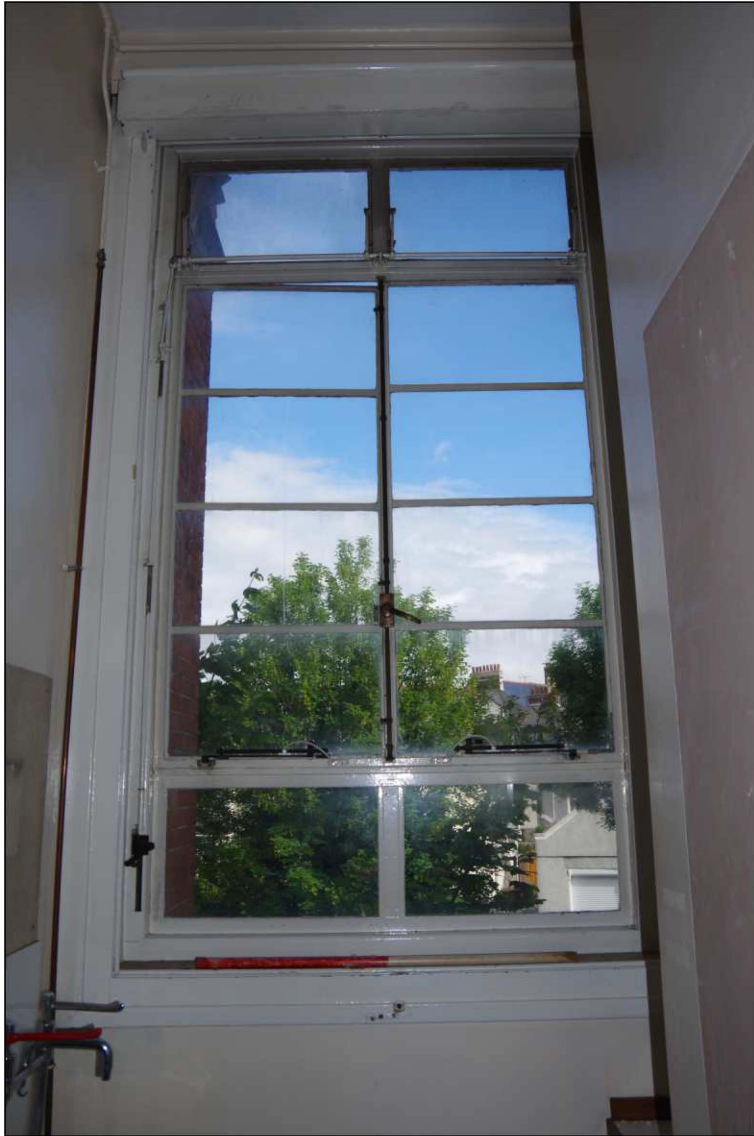
The interior has a very light and airy feeling due to the many windows. The windows have top and bottom panels that open along with their central panels. They have metal catches and metal winder poles to operate the opening of the top panes (Plate 9). On the first floor, secondary internal glazing has been added.

Plate 9: Details of internal fittings to a primary window, looking north. 1m scale

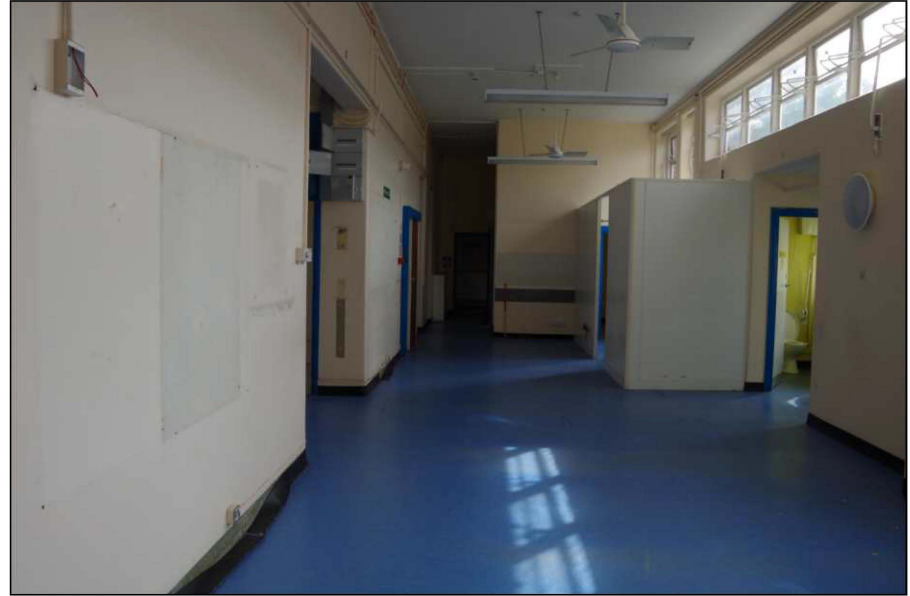
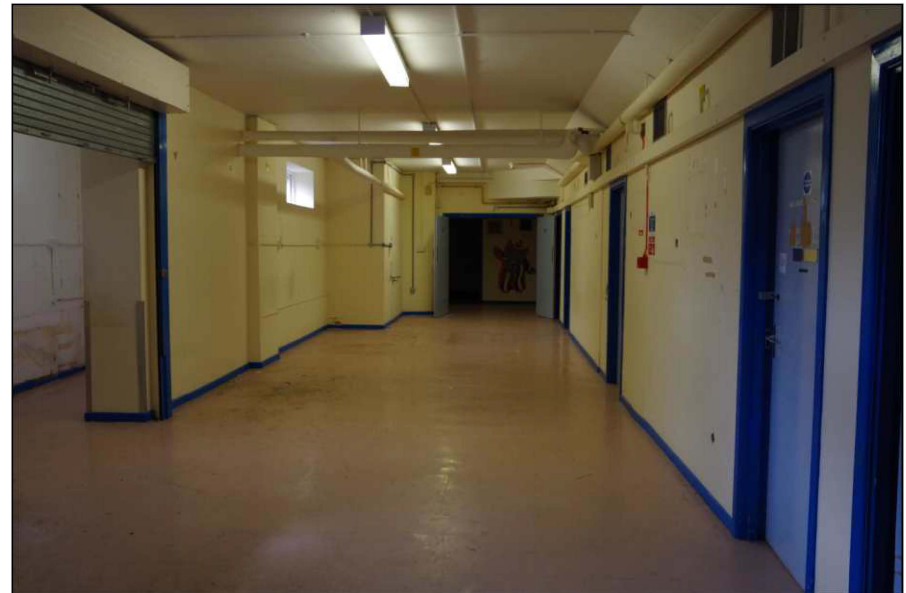
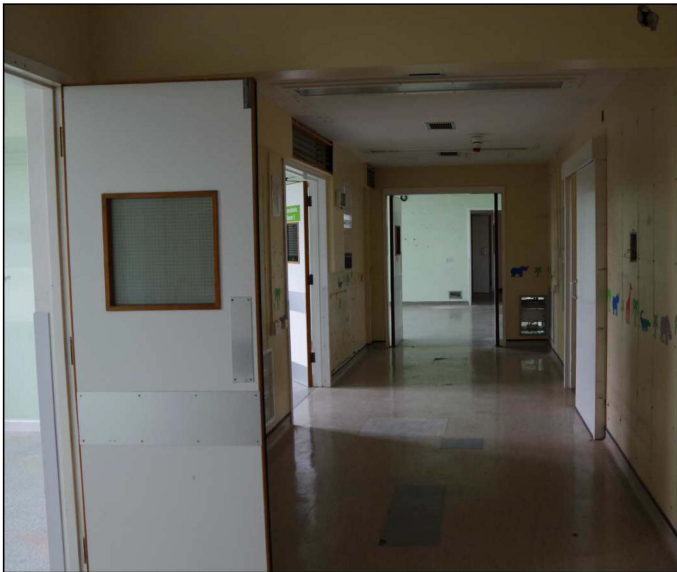
The rooms all have a modern finish with plastered walls and ceilings and lino floors (Plates 10-12). The current layout of the building consists of consultation and treatment rooms in the basement level and on the ground floor, along with an additional reception on the basement level (Plate 13). The plant room and boiler room on these floors are still in use and were not entered. On the first floor are two operating theatres, an anaesthetic room, and a staff corridor with changing facilities and scrub-up area. The relationship between the extension and original buildings is hardly discernable internally with the movement of patients and staff easily flowing between the two. The 1938 architect's plans show that windows in the east elevation of the infirmary were blocked up and parts of the eastern wings removed to allow for the provision of openings into and larger spaces within the extension.

Plate 10: The ground floor, looking northeast. 1m scale

Plate 11: The first floor, looking southwest

Plate 12: The basement, looking southwest

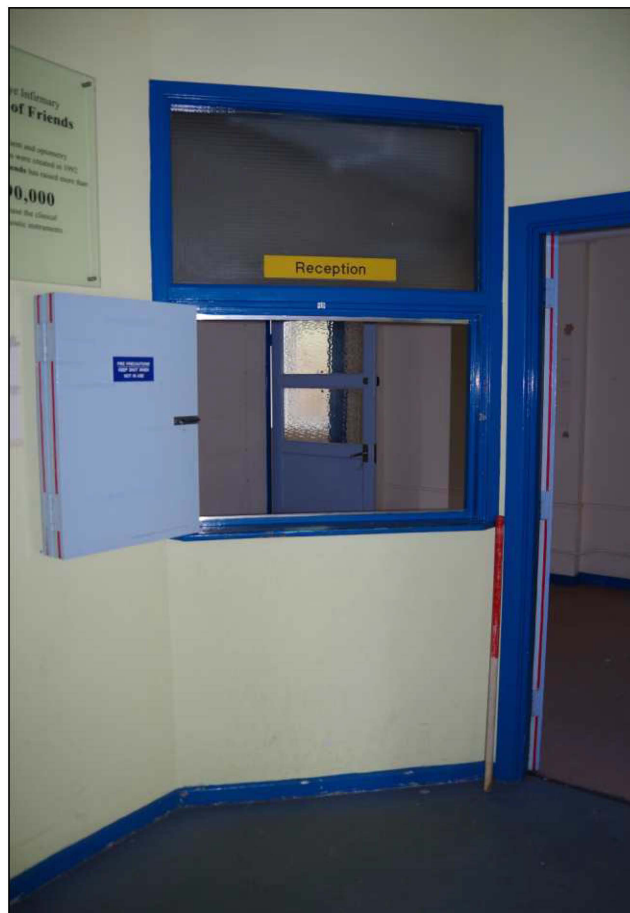
Plate 13: The reception in the basement, looking north.  
1m scale

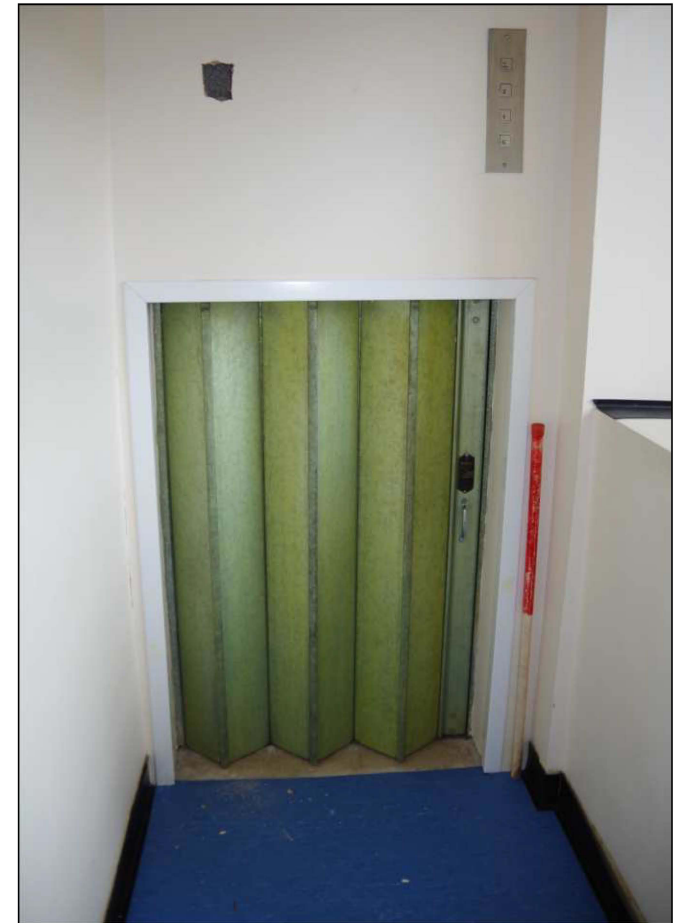
Plate 14: The goods lift, looking northeast. 1m scale

- 7.4 The building was modernised and reordered in 1977-78. New plant and boiler rooms were added, as was a goods lift. Internally, an operating theatre added to the first floor, surrounded by rooms associated with this function. At an unknown date the operating theatre was reduced in size and a second created in an adjacent room. X-ray light boxes and electrical switches are still present in these rooms.

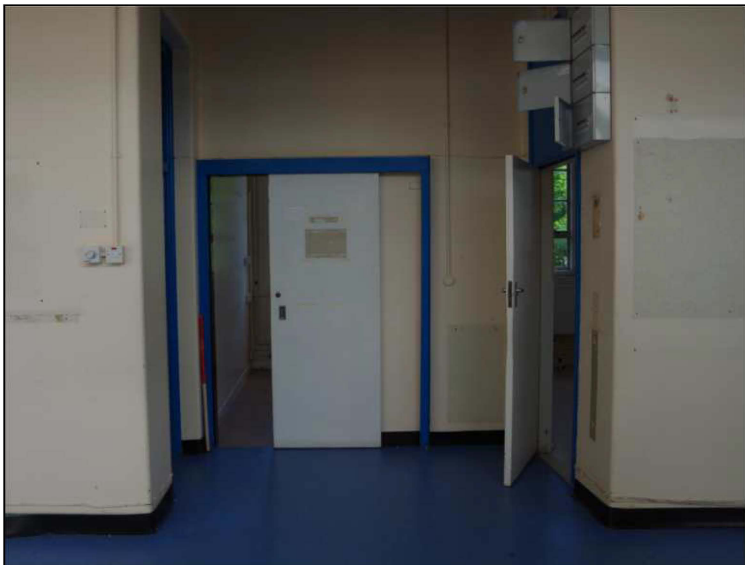
The current interior is the result of modernisation and internal reordering in 1977-78, as well as later alterations. On the ground floor new consultation rooms have been added by subdividing larger consulting and testing rooms. On the first floor the toilets were removed and the wards reconfigured to create a large central operating theatre surrounded by smaller rooms housing associated functions such as anaesthetics, changing and scrubbing up. The operating theatre has subsequently been reduced in size and a second smaller operating theatre created within the former anaesthetic room. Within the stairwell at the east end of the extension a goods lift has been added serving all floors (Plate 14). Many of the doorways in the extension have sliding doors (Plate 15), and from their location in relation to the floor plan these date to 1977-78.

Plate 15: An example of a sliding door, looking northwest.  
1m scale

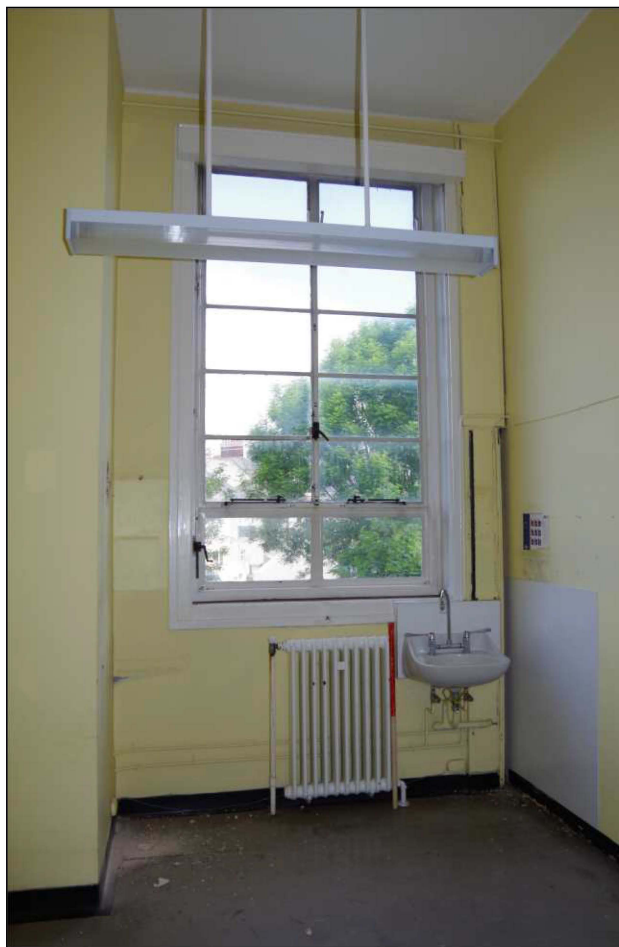
Very few fixtures and fittings remain. On the basement level and ground floor there are some small sinks, along with the original radiators in the consultation and treatment rooms (Plate 16). In the reception area on the basement level a small safe remains displaying the label 'Thomas Withers & Sons Ltd. Established 1855. Fireproof safes. Trademark. Without which none are genuine. West Bromwich' (Plate 19). In the operating theatres on the first floor there are panels containing controls for the rooms' lights, as well as lightboxes for X-rays. (Plates 18 and 19).

Plate 16: A sink and radiator on the ground floor,  
looking southeast. 1m scale

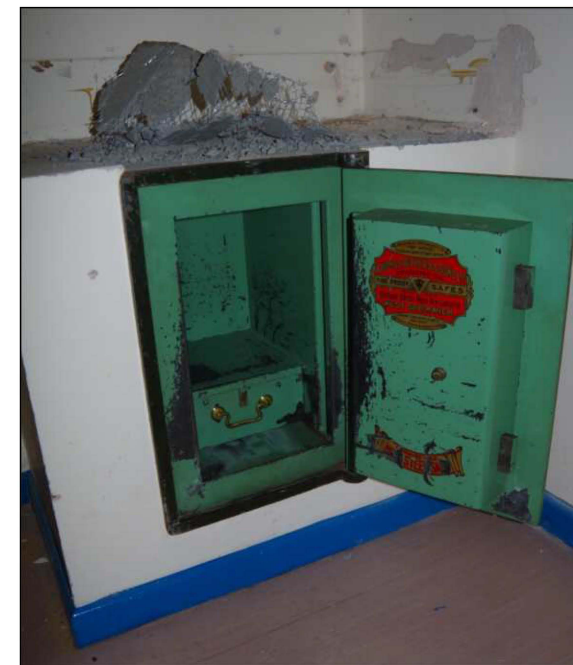
Plate 17: The safe in the reception room, looking  
southeast

- 7.3 The 1938 extension to the 1901 eye infirmary must have been planning to cope with increasing demand during the inter-war period, which can be seen in the original architect's plans with the provision of a 100-seat waiting room. It was constructed in a modern, utilitarian style, which was much plainer than the 'modern' style adopted in hospitals of the interwar period (English Heritage 2011), although its design was carefully considered in relation to the existing infirmary. Its style is typical of 1940s and 1950s buildings. The only internal fitting probably dating to this period is the safe in the basement.

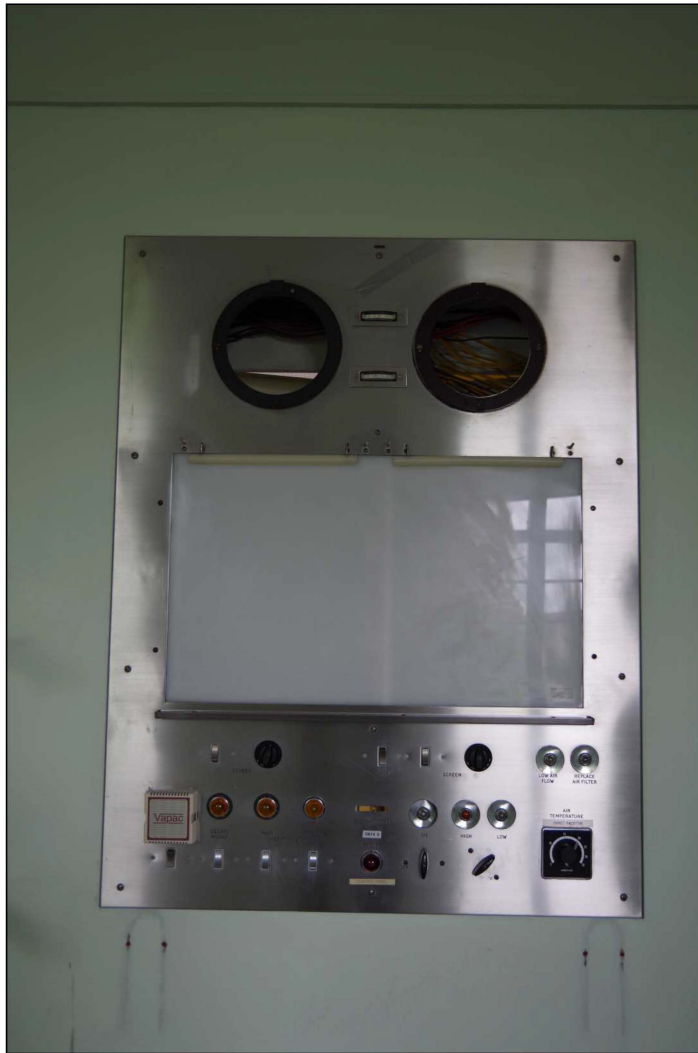
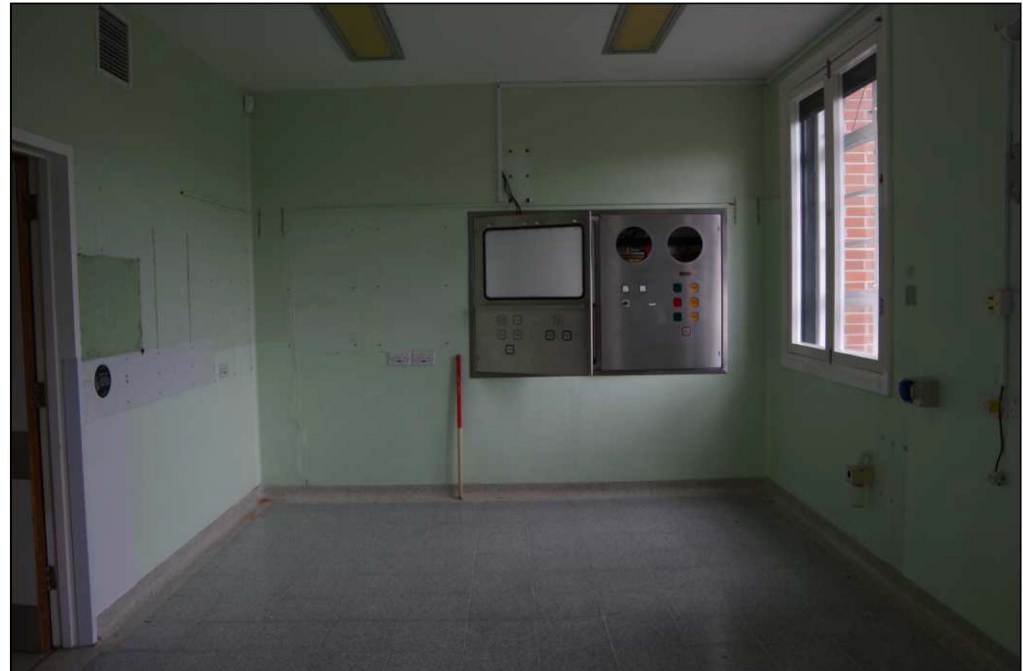
Plate 18: The X-ray light box and control panel in the operating theatre, looking southeast

Plate 19: The X-ray light box and control panel in the operating theatre, looking southwest. 1m scale
