Land to the rear of 7 Priory Road, Wells, Somerset

Results of an archaeological trench evaluation

Document No: ACD940/1/0

Date: July 2014

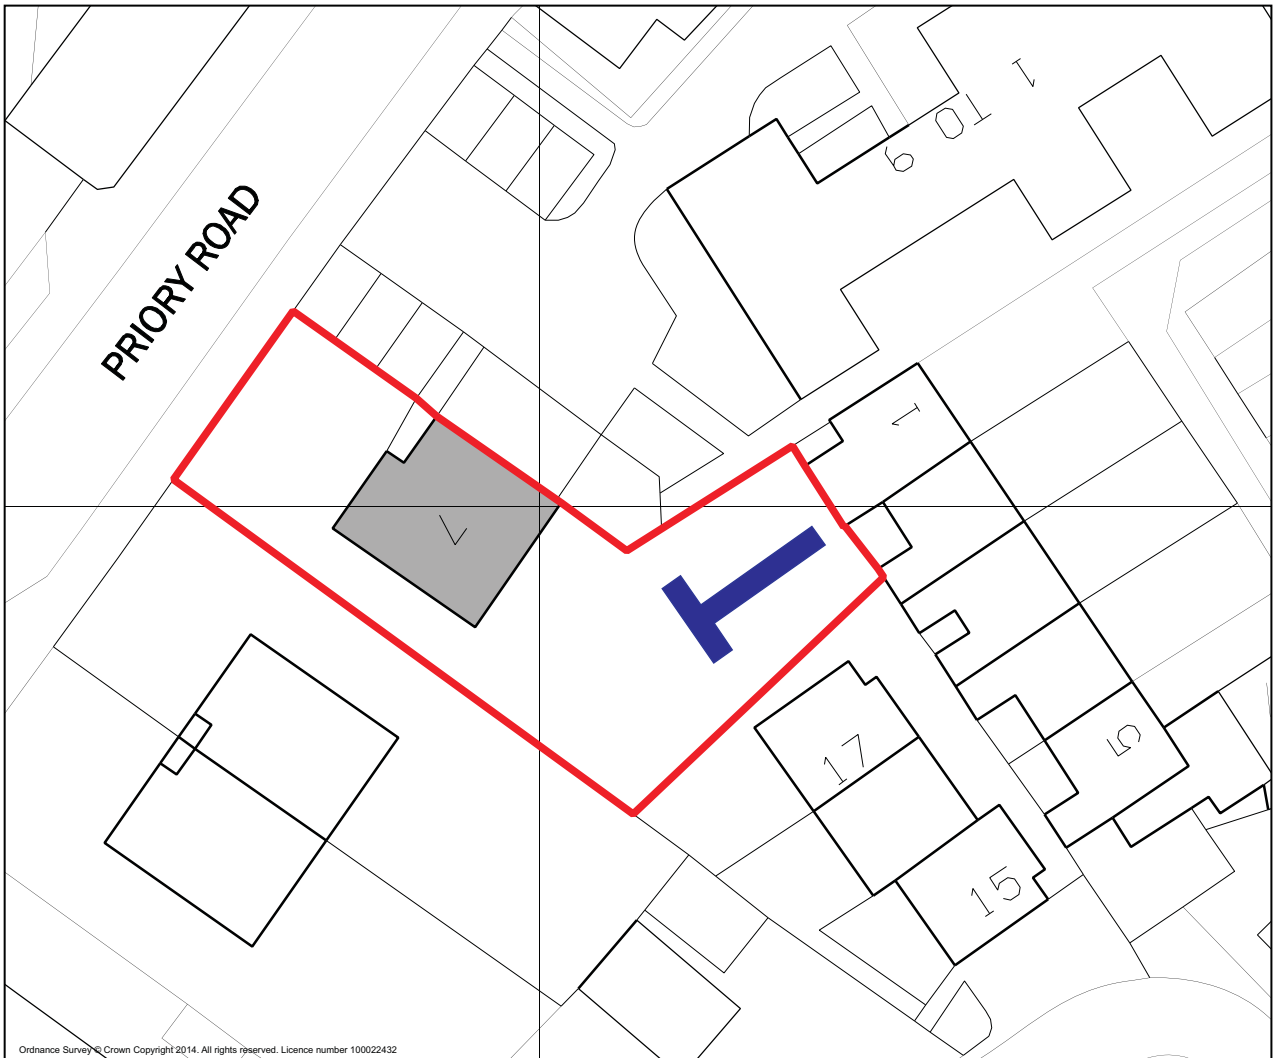
Fig. 1: Site location and trench  
location plan

- Property boundary
- Building
- Evaluation trench

### 1. INTRODUCTION (Fig. 1)

- 1.1 This document sets out the results of an archaeological trench evaluation at 7 Priory Road, Wells, Somerset (ST 54765 45444), carried out in support of a planning application for the erection of a single dwelling and associated works.
- 1.2 The archaeological work was commissioned by Bell Cornwell on behalf of Napier Smythe and carried out by AC archaeology on the 1st and 2nd July 2014.
- 1.3 The site is located within the curtilage of property No. 7, on the southeast side of Priory Road, Wells, lying at approximately 39m aOD, under tarmac surface to the rear of the existing property. The underlying geology is Mercia Mudstone Group - Mudstone and Halite-stone. Sedimentary Bedrock formed approximately 200 to 251 million years ago in the Triassic Period, overlain by Alluvial Fan Deposits - Clay, Silt and Sand.
