FORMER GRANBY HOUSE, ST JOHN'S ROAD,
BEDMINSTER, BRISTOL

Results of an archaeological trench evaluation

Bristol City Council Planning Reference: 14/00307/F

Document No: ACD955/2/1

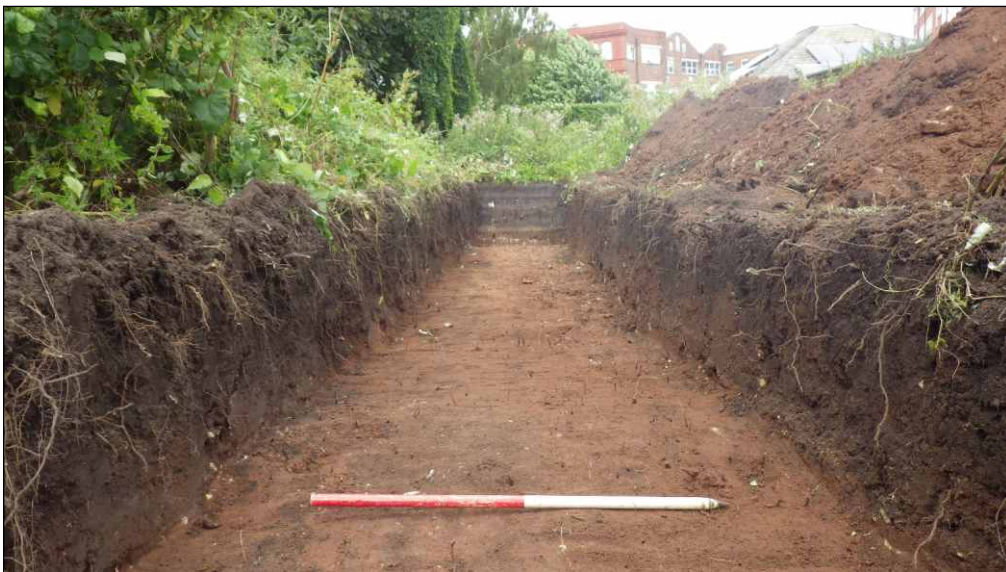
Two modern pits were exposed (F103 and F104), located towards the south-east end of the trench. Both pits contained traces of asbestos, and were therefore not excavated.

Plate 3: Trench 1, general view to the north-west with modern pit F103 visible just beyond the 1m scale

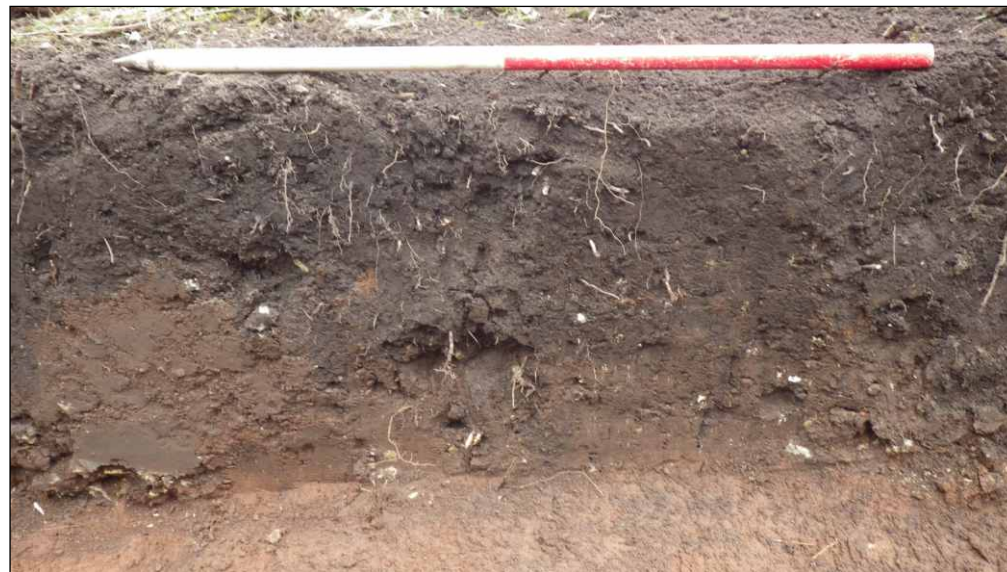
Trench 1 was located along the strip of land to the rear of houses on the south-west side of St John's Road. It was excavated onto natural subsoil (102) at a depth of 0.73-1.04m below current ground levels. The overlying layer sequence consisted of 0.35m of mid reddish-brown silty sandy clay loam with sparse tabular limestone pebbles, and sparse remnants of building debris (101), which was overlain by a thick modern cultivation soil (100) consisting of a dark greyish-brown sandy clay loam with sparse small gravel inclusions. The level of the natural subsoil dropped away towards the north-west and also slightly to the north-east towards the rear of the housing on St John's Road.

Plate 4: Trench 1, representative section of deposits, viewed from the north-east. 1m scale

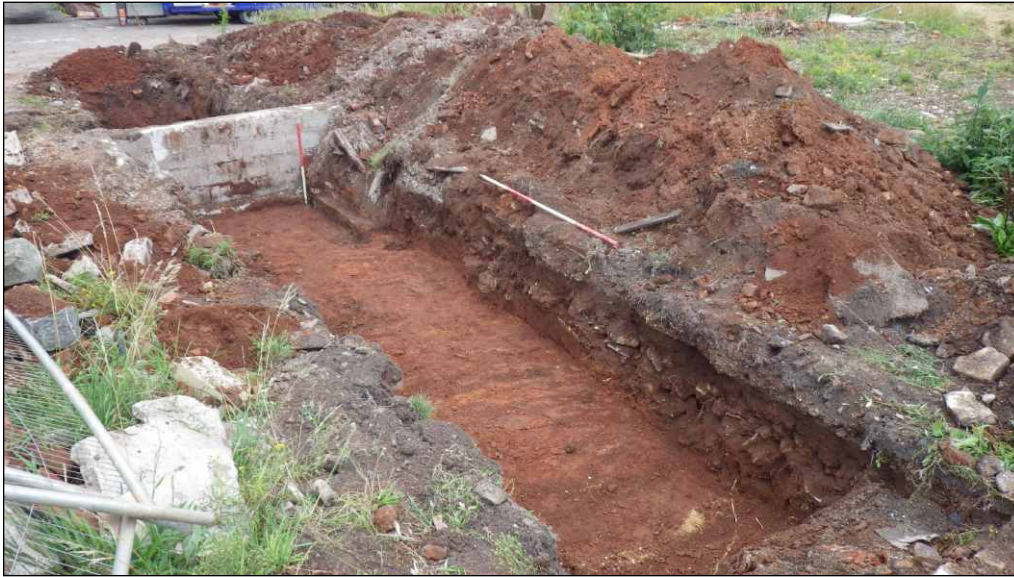
The trench uncovered substantial remains of the foundations of Granby House, together with associated 20th century additions to the building and services (Plate 5). The house had been constructed within a terrace cut F220/F221 that truncated the natural subsoil across the full length of the trench.

Plate 5: Oblique view of south-west facing section of trench 2 showing footings and construction cuts associated with Granby House, view to the north. 1m and 2m scales

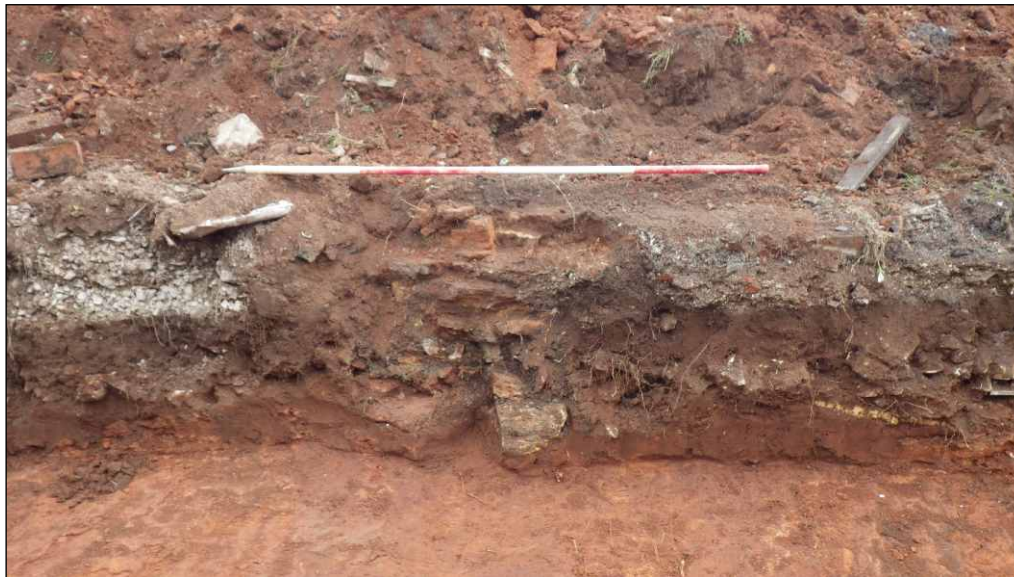
Wall F211 was abutted to the south-east by a deposit of made ground (212), c. 0.50m thick, consisting of a mid brown sandy clay loam with sparse limestone fragments of varying sizes, mixed gravels and remnants of CBM. This was overlain by a small deposit of soily made ground (209) and a broader thicker deposit (210) of the same mortared material as 208, measuring up to 0.20m thick and likely to represent a sub-base for the internal floor of the house.

Plate 7: Trench 2, internal wall F211 within terrace F221, viewed from the south-west. 2m scale

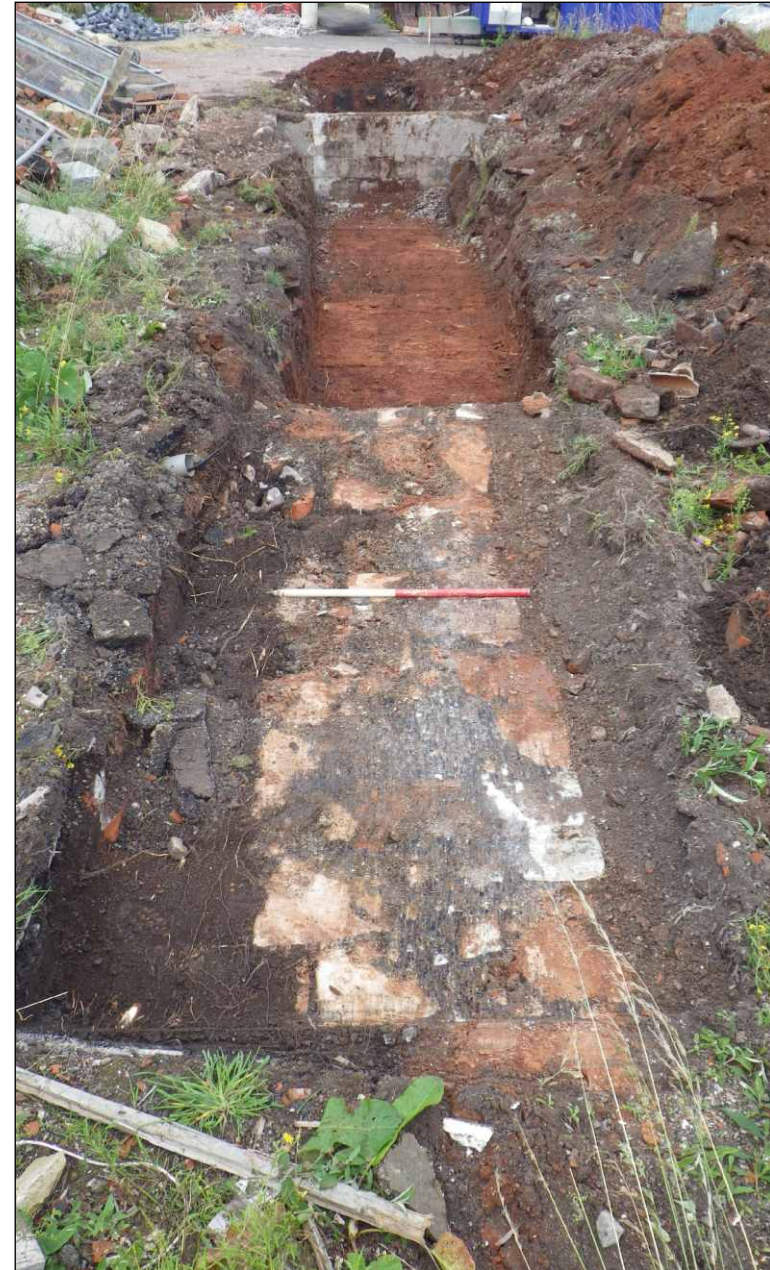
At the south-east of the trench, the south end of the south-west wall of Granby House was located (F207), following the length of the trench for approximately 7.50m before turning in a westerly direction, to form the southern edge of a bay window (Plate 6). The wall footing was constructed of Redcliffe sandstone with some brickwork bonded in a pinkish white mortar. Remnants of a small internal partition wall (F211) aligned south-west were also present (Plate 7). This footing was constructed using a mixture of faced and un-faced Redcliffe sandstone with some limestone blocks of varying sizes, laid in horizontal courses bonded with a white sandy mortar mix. It measured up to 0.80m wide by 0.60m high. The top course of this footing consisted of one large piece of Redcliffe sandstone measuring 0.60m wide and 0.14m thick, providing a solid base for the (now largely demolished) wall. Above this was a remnant of a mortared surface (208) consisting of a hard grey sandy mortar with abundant smaller mortar and CBM flecks and coarse gravels, topped by a single squared block of Redcliffe sandstone.

Plate 6: Trench 2, general view showing the south-west wall of Granby House (F207), view to the north-west. 1m scale

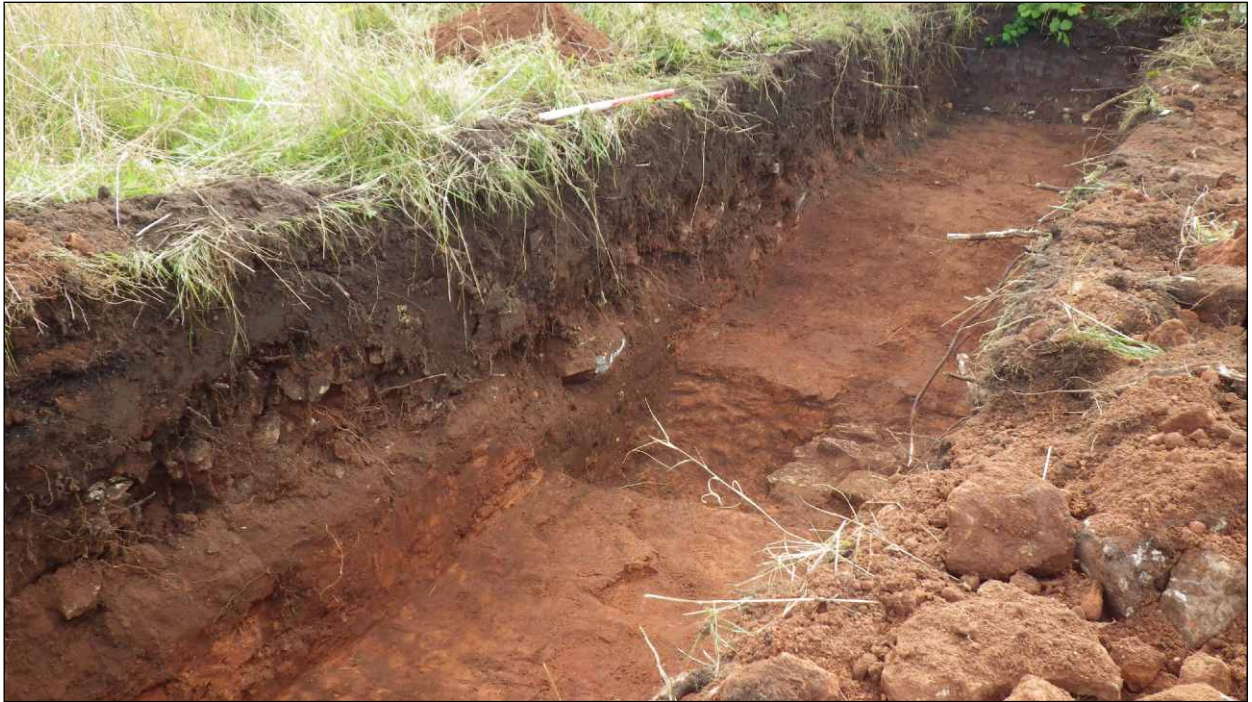
Trench 3 was located parallel to St John's Road in the former front garden of the house. Due to the presence of possible asbestos-containing materials within the footprint of the demolished house, as a precaution the north-east to south-west aligned extension of this trench, proposed to investigate the impact of the construction of Granby House on surviving deposits, was not dug. The trench was excavated onto natural subsoil (303), present at a depth of 0.89-1.41m below ground level. This was overlain by a mid-reddish brown silty sandy clay subsoil (302), which in turn was overlain by a made-ground deposit (301), measuring up to 0.40m thick, consisting of light-mid reddish-brown silty sandy loam with very sparse sub-angular gravels. This deposit was sealed by modern cultivation soil (300) consisting of a mid greyish-brown silty loam with sparse sub angular gravels (Plate 8).

Plate 8: Trench 3, oblique view of south-west facing section showing made ground deposit 301 and F304, view to the east. 1m scale

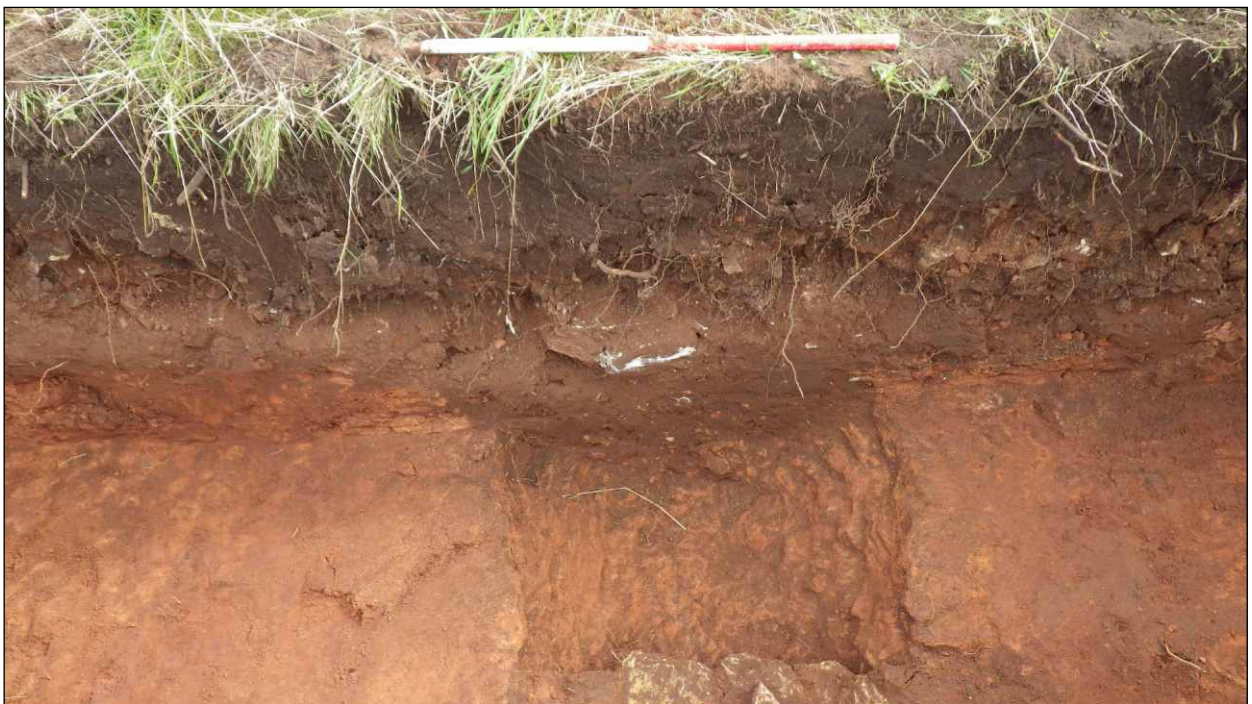
One linear feature, F304, was recorded aligned perpendicular to the trench (Plate 9). F304 consisted of a cut truncating original subsoil deposit (302) with steep to moderate sloping sides and a flat to sub-convex base. It contained a single fill (305) consisting of mid reddish-brown silty sandy loam with common sandstone cobbles. Against the south-western edge of the trench these cobbles appear to have been laid deliberately towards the base of the cut. It was sealed by deposit 301.

- 6.4** Possible ditch feature F304 represents the only potential archaeological feature that pre-dates the construction of Granby House. However being cut from the level of the buried subsoil deposit (302), it is unlikely to be older than post-medieval in date. The character of its fill may indicate that it is a land drain.

Plate 9: Trench 3, section through F304 showing stones in fill 305 in the foreground, viewed from the south-west. 1m scale
