Church of St Melaines, Mullion, Cornwall

Results of an archaeological watching brief

Planning reference Cornwall Council PA1 1/05867

> > Document No: ACD683/2/0

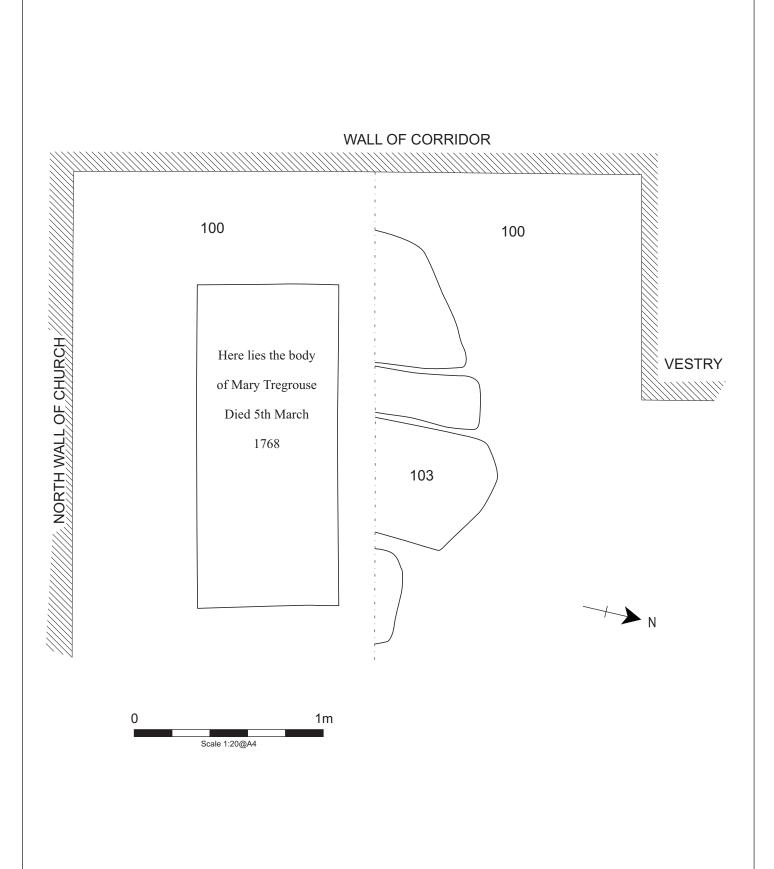
Fig. 2: Plan of slates 103

- **5. RESULTS** (Figs 2-3; Plates 1-5)
- 5.1 Ground reduction and footings excavations for the new meeting room (Fig. 2; Plate 1) Topsoil 100, which consisted of dark grey-brown firm silty clay, was partially removed across the footprint of the building. A number of sherds of post-medieval pottery was recovered from topsoil layer 100. The external foundation trench was excavated to a maximum depth of 0.60m from the surface. In the northeast corner of this area a subsoil layer (101), consisting of mid brown friable silty clay, was exposed under 100. In the southwest corner of the new building three large slabs of slate (103) were partially exposed. These are likely to be associated with the adjacent grave of Mary Tregrouse (d.1768), and were left *in situ*.

- 7.5 The excavations for the new meeting room were not deep enough to expose burials present at the level of natural subsoil, and the only feature was a group of laid slates that are probably associated with an adjacent 18th-century tomb.

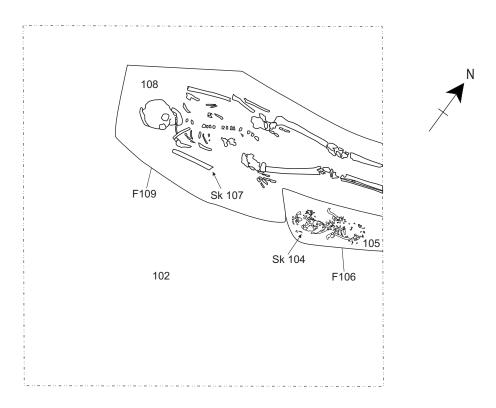
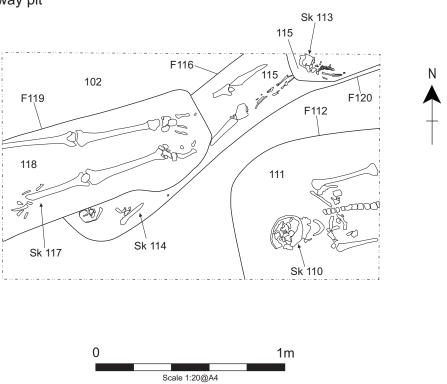
Fig. 3: Plans of sewage tank and soakaway pits

This pit measured 2m x 2m and was excavated to a maximum depth of 0.65m, at which depth natural was exposed. Two intercutting, east-west aligned, graves (F106 and F109) were exposed, cut into the natural subsoil. Overlying deposits comprised 0.09m of mid brown silty-

This pit measured 2m x 1m and was excavated to a maximum depth of 0.65m. Natural subsoil was exposed at a depth of 0.65m. A total of four southeast-northwest aligned graves (F112, F116, F119 and F120) were exposed. Graves F112 and F116 cut the natural subsoil, whilst graves F119 and F120 had truncated 116. Overlying deposits comprised 0.09m of mid brown silty-clay subsoil (101) overlain by 0.56m of dark grey-brown silty-clay topsoil (100). Both layers contained charnel deposits of bone.

a) Sewage tank pit

b) Soakaway pit

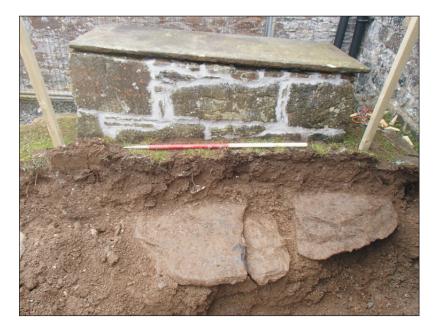
Plate 1: Slate slabs 103, viewed from the north, with the tomb beyond. 1m scale.

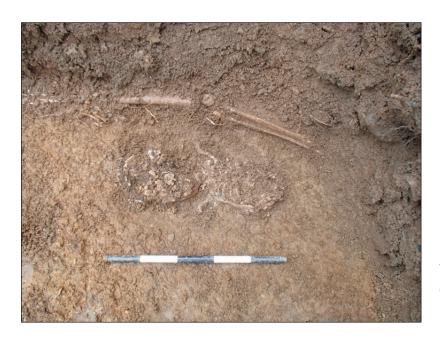
Plate 2: Grave F106, viewed from the east. 0.50m scale.

The earlier of two burials, grave F106, was partially exposed, at its western end to a length of 0.56m. It measured 0.25m wide, continued beyond the limit of excavation to the east, and had been truncated by grave F109 to the north. The surviving exposed skeletal remains (104) comprised the articulated upper torso and skull, lain in a prone position, head to the west. Bone was poorly preserved; the arms and lower torso were missing (probably due to decomposition), whilst the pelvis and legs were beyond the limit of excavation. The body was small in stature (probably less than a metre in height) and probably therefore an infant. The skeletal remains were covered by grave fill 105, a mid yellow-brown redeposited natural clay. No finds were recovered.

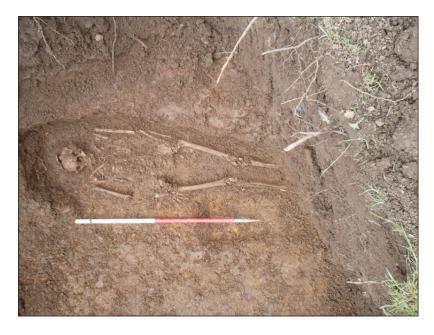
Plate 3: Grave F109, viewed from the southeast. 1m scale.

Grave F109 was exposed to a length of 1.55m, measured up to 0.56m wide, and continued beyond the limit of excavation to the east. The surviving exposed skeletal remains (107) comprised the entire body except the feet (which were beyond the limit of excavation), lain in a prone position, with hands below the legs and head to the west (107). Fragments of undecomposed wood survived around the skeleton and are likely to be remains of a coffin. Bone was poorly preserved. The body measured approximately 1.5m in height. Skeletal remains were covered by grave fill 108, a mid yellow-brown redeposited natural clay. No finds were recovered.

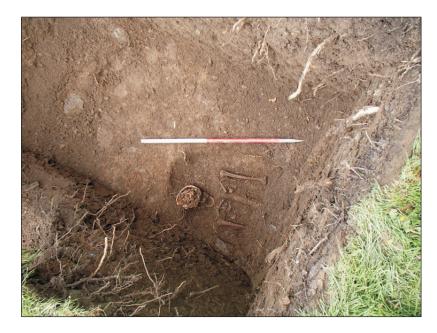
Plate 4: Grave F112, viewed from the south. 1m scale.

Grave 112 was partially exposed to a length of 0.8m and width of 0.8m, and continued beyond the limit of excavation to the east and south. The surviving exposed skeletal remains comprised the articulated upper torso and skull, lain in a prone position, head to the southwest (110). Bone was poorly preserved, and the lower torso, pelvis and legs were beyond the limit of excavation. The body was large in stature and likely to be an adult. Skeletal remains were covered by grave fill 111, a mid yellow-brown redeposited natural clay. No finds were recovered.

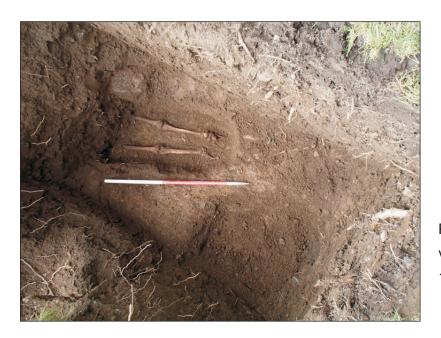
Plate 5: Grave F119, viewed from the southeast. 1m scale.

Grave 119 was partially exposed to a length of 1.25m. It measured 0.5m wide, and continued beyond the limit of excavation to the west. The surviving exposed skeletal remains comprised the articulated legs and feet, lain in a prone position, head to the northwest (117). Bone was poorly preserved. The body appeared large in stature and likely to be an adult. Skeletal remains were covered by grave fill 118, a mid yellow-brown redeposited natural clay. No finds were recovered.

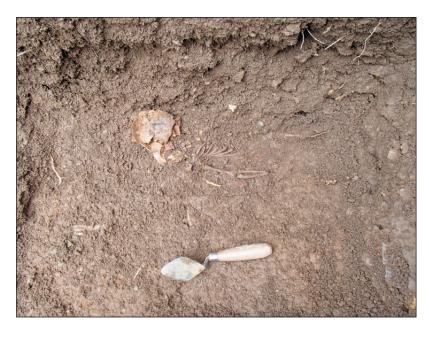
Plate 6: Grave F120, viewed from the south.
