# Stoke Canon Flood Defence Scheme, Devon

Results of an archaeological watching brief

Document No: ACD766/2/0

Date: September 2014

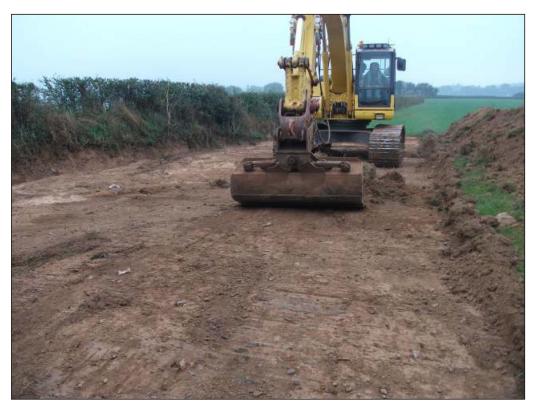
Plate 1: Plot 1, looking south

Plot 1 was located to the north of Stoke Canon, to the south of Burrow Cross and adjacent to Green Lane. An area 70m long by 4m wide was excavated to a depth of 200mm, with only the topsoil (100) being partially removed (Plate 1). This comprised light reddish-brown, loose, sandy loam with common medium sized sub-rounded water-derived gravels. Late post-medieval and modern pottery was noted but not retained, and two pieces of residual worked flint which includes one piece of a broken blade were collected.

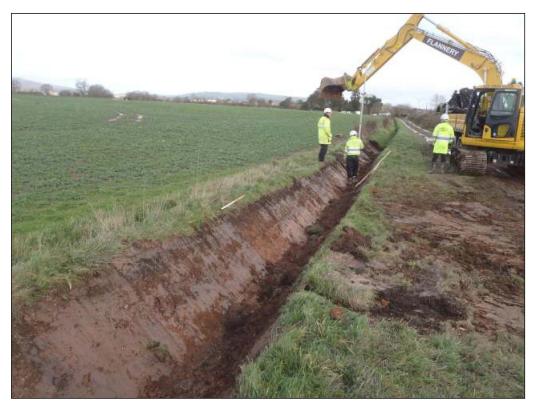
Plate 2: Plot 3, looking north-east

*Plot 3* was on the west side of the village, adjacent to the railway line. The works here involved the widening, to c.1.5m and deepening to 1.2m, of a 300m long existing drainage ditch along the eastern side of the field (Plate 2). Modern disturbance and truncation of the deposits was exposed at both ends of the ditch. The undisturbed deposits in the central part consisted of 0.44m of dark brown, friable, clay silt topsoil with frequent small-medium-sized sub-angular water-derived gravels and sparse clinker (300). This overlay 0.3m of mid brown, friable clay silt subsoil with occasional water-derived gravels and a lens of clinker and charcoal towards the base of the deposit (301). Below this was a 0.36m deep deposit of mid reddish-brown, compact silty clay with occasional iron panning and sparse water-derived gravels (302). This overlay the natural light-medium reddish-brown, compact sand/silty sand with frequent iron panning (303).
