# WEARY PLOUGHMAN INN, BRXHAM ROAD, CHURSTON FERRERS, TORBAY

An architectural assessment

Torbay Council planning references 2014/0696PA and 2014/0697LB

Document No: ACD984/1/0

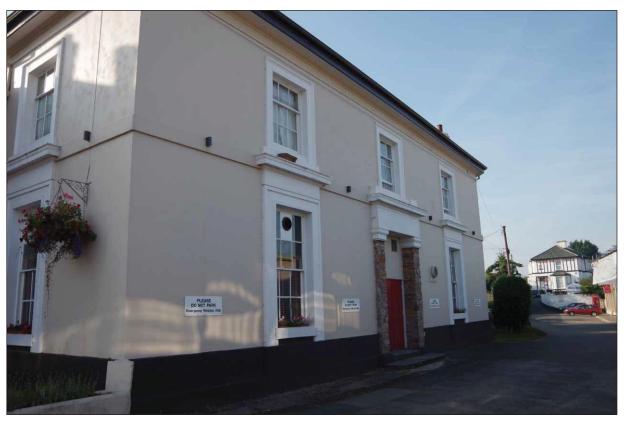
Plate 1: The principal northwest elevation viewed from the north

The principal (northwest) façade has symmetrical fenestration with single sash windows either side of a central doorway on the ground floor. The northeast window appears to be earlier and has 6 panes over 6 panes with flattened glazing bars; it is hornless. One of the panes has been replaced in the 20th century with a vent. The southwest window has 6 panes over 6 panes with chunky window bars and short horns. The central doorway is flanked by doric pilasters constructed of limestone blocks that support an entablature. The door itself is a modern wooden replacement. On the first floor there are three 3 panes over 6 panes hornless sash windows. All the windows are set within the wide moulded architraves; on the ground floor these have straight edges, whilst on the first floor the moulding is rounded. A tall plat band defines the level of the first floor, and this supports narrow projecting applied cills under the first-floor windows.

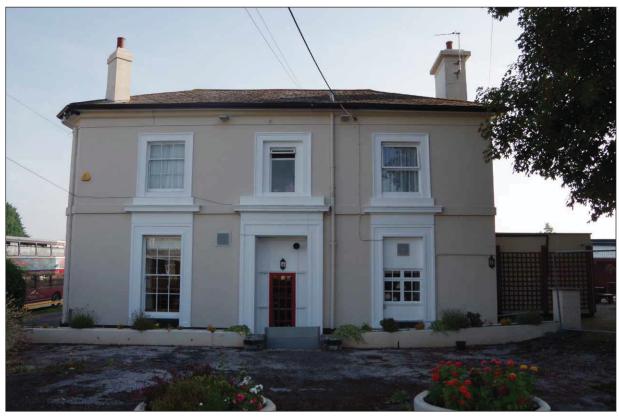
Plate 2: The southwest elevation viewed from the southwest

The southwest elevation also has a symmetrical façade with single sash windows either side of a central doorway on the ground floor. The northwest sash window has 6 panes over 6 panes with thin window bars and long horns. The southeast window is a smaller replacement casement within a larger aperture for a sash window. The central doorway has a moulded surround and entablature, with a modern glass panelled door. On the first floor there are three windows, which are shallower than those on the northwest and northeast elevations. The northwest sash window has 3 panes over six with rounded horns, whilst the other two windows are modern fixed and top-opening pane replacements. The external treatment to the window openings and plat bands are identical to the northwest façade.

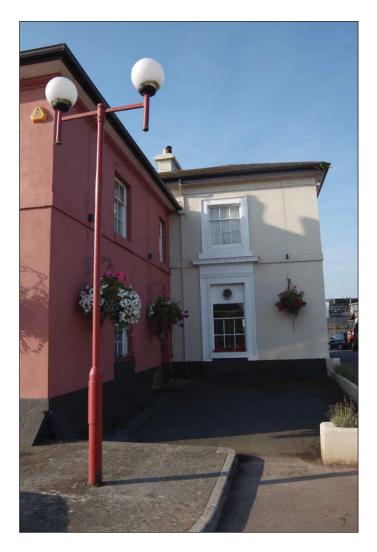
Plate 3: The northeast elevation of the west block viewed from the northeast

The northeast elevation incorporates a single sash window on each floor, set towards the front of the building in front of the east block. The ground floor window has one pane with a modern vent over 6 panes with flattened glazing bars and without horns. The first-floor window has 3 panes over 6 panes without horns. They are both set within surrounds as found on the southeast and southwest elevations, again divided by a plat band.

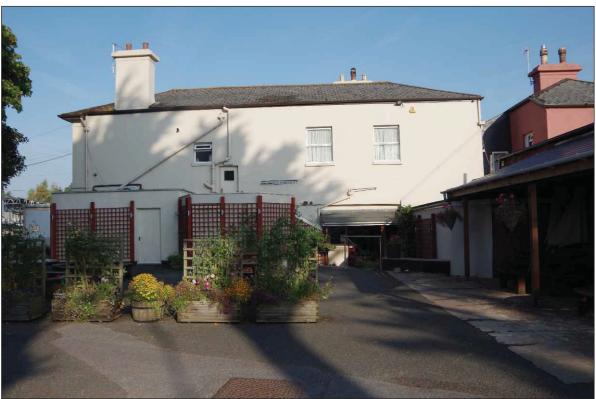
Plate 4: The rear southeast elevation showing the extensions viewed from the southeast

The southeast elevation has a modern entrance door on the ground floor leading to a partially covered terrace, above which there is a roof scar from the demolished 1950s/1960s extensions. On the first floor there are three modern windows and a low fire escape door with a staircase to the ground floor.

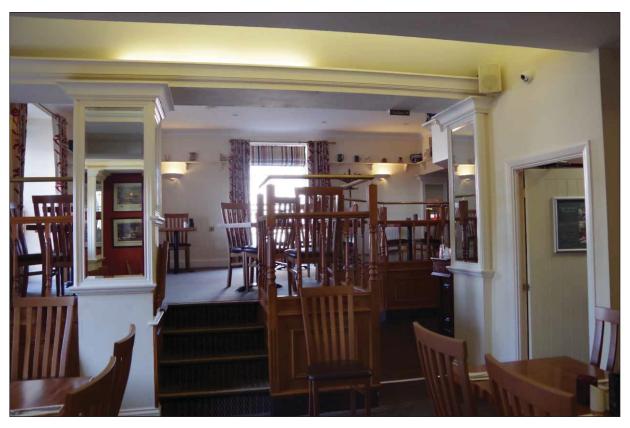
Plate 5: The interior of the west block showing the cornice in the northwest room viewed from the south

Due to the use of the first floor as guest accommodation, only the ground floor and cellar were examined. The ground floor has modern decoration and contains very little visible historic fixtures or fittings; modern finishes are not described. Elements of its original layout can be discerned. It contained four heated principal rooms on the ground floor. The two front rooms may have been smaller than present and separated by an entrance and reception lobby. The northeast room was heated by a fireplace in the dividing wall with the southeast room, now broken through and serving a woodburning stove. The southeast room as probably heated by an off-central fireplace in the northeast elevation, evidence for which takes the form of the projecting internal masonry of the stack on both floors. The fireplace in the northwest room was located within the angle of the northwest corner, whilst the southwest room had its fireplace in the southeast elevation. No evidence for a staircase to the first floor was noted. The northwest room has a raised floor, and retains its cornice. The dividing wall between the eastern walls is partially exposed, and comprises painted as well as rendered rubble masonry.

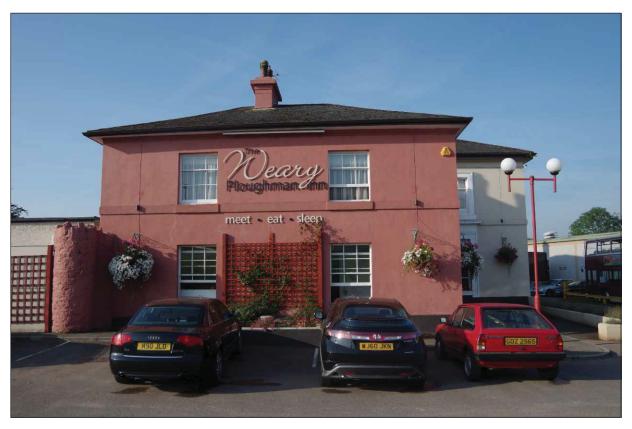
Plate 6: The northeast elevation of the east block showing the gate post to the left viewed from the northeast

This block is lower than the west block, although it has a taller hipped roof with an apex at the same level as the west bock. It features a flat plat band and a cornice under the eaves; due to the difference in heights, the former does not line up with the plat band on the west block. The plat band is present on the northwest and northeast elevations and continues a short distance around the south elevation. Beyond this the wall is not rendered but the rubble masonry is painted. The ground-floor windows are all sash windows of 6 panes over 6 panes with thin glazing bars and without horns; there is one window in the northwest elevation and two in the northeast elevation. There is a single modern wooden door in the northwest elevation forming the present main entrance to the inn. The first-floor windows are all hornless sash windows of 3 panes over 6 panes, with two in the northwest elevation and two in the northeast elevation. All of the windows within this block are within plain openings without the moulded architraves present on the west block.

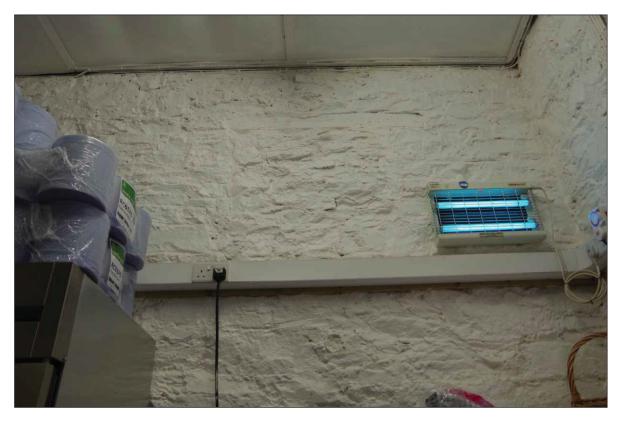
Plate 9: The southwest wall of the rear extension showing the blocked window viewed from the northeast

The southwest and northwest walls of the southern area are constructed of painted sub-angular stone laid in rough courses. There is a break in the northwest wall, which has been utilised for a doorway in the secondary masonry. The southwest wall incorporates a blocked opening below a wooden lintel. The southeast elevation is constructed of brick laid in a stretcher bond, and contains both a single and a double doorway with modern wooden doors. The northeast elevation is constructed of brick in a Flemish bond and is not keyed into the southeast wall. It contains two blocked windows with brick arches and a wide doorway at the northwest end set below a brick arch. The door itself is a modern replacement.

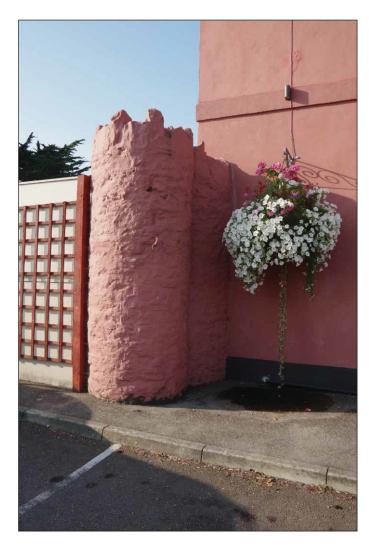
Plate 10: The gate pier viewed from the northeast

Attached to the southeast corner of the west block are the remains of an old gate post that stands approximately 1.60m high. This is constructed of painted subangular stone laid in rough courses; its top is crudely crenelated. Attached to the northeast side of the pier is a metal fitting with a metal loop. The gate pier is associated with the enclosure of a plot of land beside the access road depicted on the second edition Ordnance Survey mapping.
