81 MEDDON STREET, BIDEFORD, DEVON

Results of historic building recording and an  
archaeological trench evaluation

Condition 5 of Torridge District Council planning  
reference 1/0542/2011/EXTM

Document No: ACD969/2/0

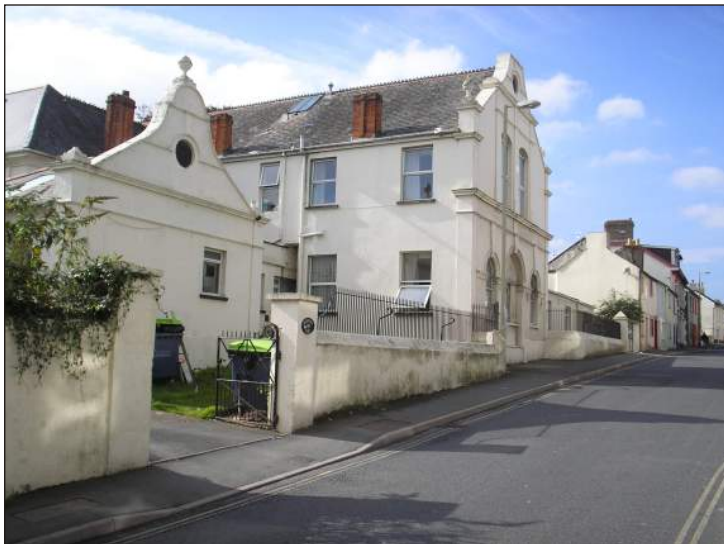
Plate 1: The north elevation photographed in 2007, viewed from the northeast.

The central front (north) entrance was finished with a Dutch gable in front of a steeply-pitched roof topped with ceramic ridge tiles (Plate 1). The central doorway had been blocked and converted to a window. It was flanked by a pair of windows. All were set within round-headed openings rising from a pair of square columns either side of the doorway topped with Tuscan-style capitals – the same decoration being present on a string course at the base of the windows. Tall keystones on each opening terminated within a string course at first-floor level. Above this there was a

further string course on which two tall, round-headed, centrally-set windows sat. Around these was a thin applied, mainly plain but slightly decorated finish comprising columns and horizontal bars terminating in a string course. Above this was a circular blind opening in the top of the gable. The very top section of the gable had been removed (see below). The top of the vertical edges to the gable were finished with spherical finials.

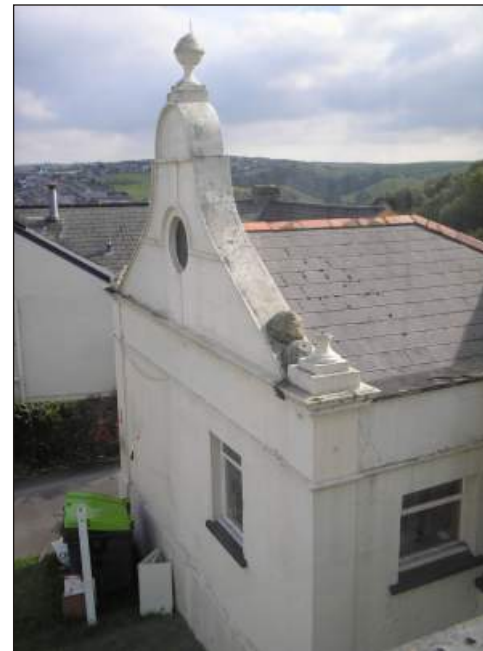
Plate 2: The gable elevation of the northeast room viewed from the first floor of the central block photographed in 2007, viewed from the northwest.

The north elevation of the northeast room was largely plain, and incorporated a single modern window, a thin string course at ceiling level and a thick Tuscan-style string course from which the gable elevation rose (Plates 2-3). The finials above this string course had been removed. Unlike the entrance gable, the top of the gable survived and comprised a semi-circular element finished with a larger spherical finial. The roof was shallower than the entrance range and finished with plain ceramic ridge tiles. It incorporated a dormer window on its east pitch.

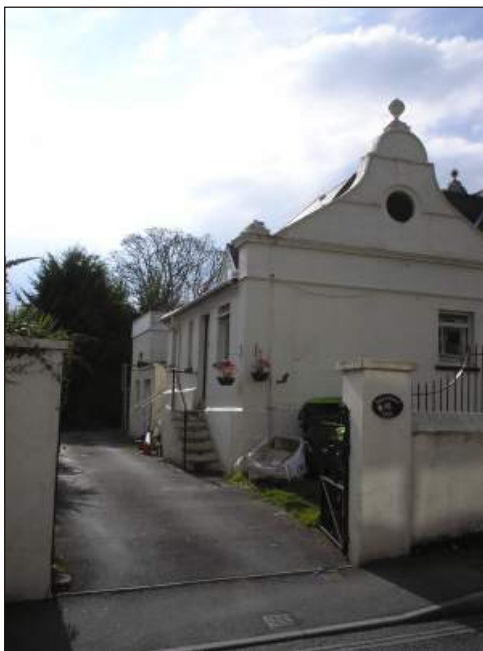
Plate 3: The northeast room, north and east elevations photographed in 2007, viewed from the northeast.

At the front of the building the floor level of the original northeast room was raised above the ground level, reflecting the drop in land to the east. Its east elevation incorporated three windows of varying heights – two original and one addition – and a doorway accessed via a flight of steps (Plate 3). Behind this room, there was a gap in the elevation, then a wall incorporating a doorway, possibly a remnant of the extension depicted on the 1930s mapping, then a higher length of wall incorporating a pair of windows, one above the other, under a flat roof.

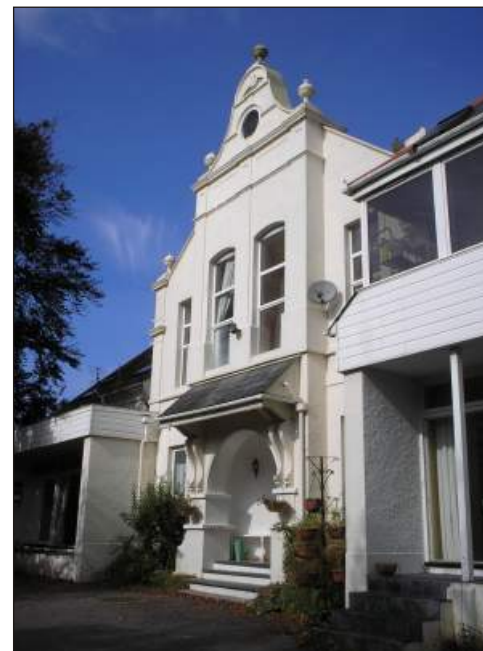
Plate 4: The south elevation photographed in 2007, viewed from the southeast.

The central section of the rear (south) elevation was of a similar design to the north elevation, although slightly plainer (Plate 4). The central section projected out from the rest of the gable. On the ground floor it incorporated a wide open entrance leading into a narrow lobby, and a pitched slate-roofed porch supported on pairs of tall brackets with scroll moulding on their side faces. A pair of flat-headed windows lit the rooms either side of the doorway. On the first floor, the tall windows had slightly arched heads. A further pair of tall flat-headed windows provided light to the rooms on either side.

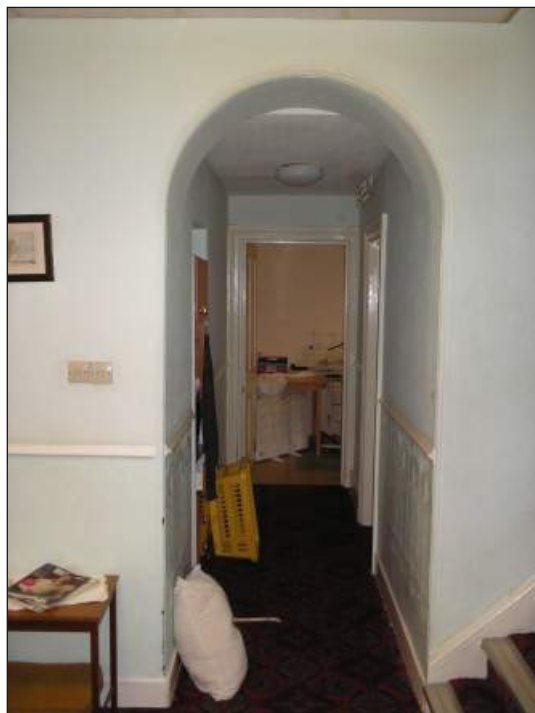
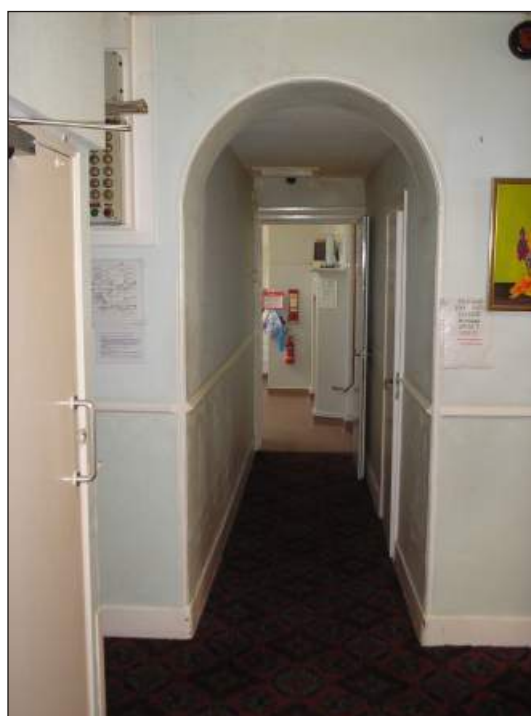
Plate 5: The ground-floor central corridor photographed in 2007, viewed from the east.

Plate 6: The ground-floor central corridor photographed in 2007, viewed from the west.

room either side) appear to have been original features. Beyond these rooms was an east-west aligned corridor that provided access to the rooms on the east and west sides of the building (Plates 5-6).

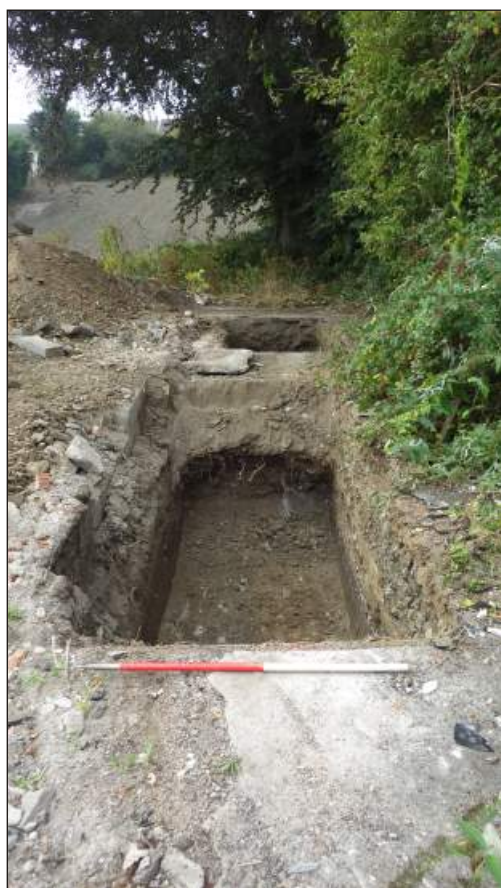
Plate 7: Trench 1, general view from the north. 1m scale.

Trench 1 measured 9m long, was aligned north-south and located along the west edge of the site adjacent to the west side of the dispensary. Due to the presence of a manhole the trench was excavated in two halves. The northern half was 4m long and was excavated down to natural shale and clay at a depth of 1.7m from the surface (36.86, aOD). The southern half was 3.2m long and was excavated down to a depth of 1.4m (36.94m aOD).

The natural was overlain by up to 1.6m of 19th-century and modern dumped layers (104, 105, 109-111 and 102-103, 107-108 respectively), representing levelling deposits for the construction of the dispensary and for later alterations. These were sealed beneath a modern tarmac surface and sub-base (100 and 101). The 19th-century deposits were between 0.40m and 0.6m deep, and in the southern half of the trench these sloped down to the south, with the modern deposits above forming an extension to the terrace or platform on which the dispensary was constructed.

No archaeological features were exposed. A north-south aligned drain that passed through the manhole had been cut from partly down the sequence of modern layers. In the east side of the trench part of the west wall of the dispensary was exposed, comprising sandstone and mudstone foundations and concrete blocks relating to a 20th-century addition.

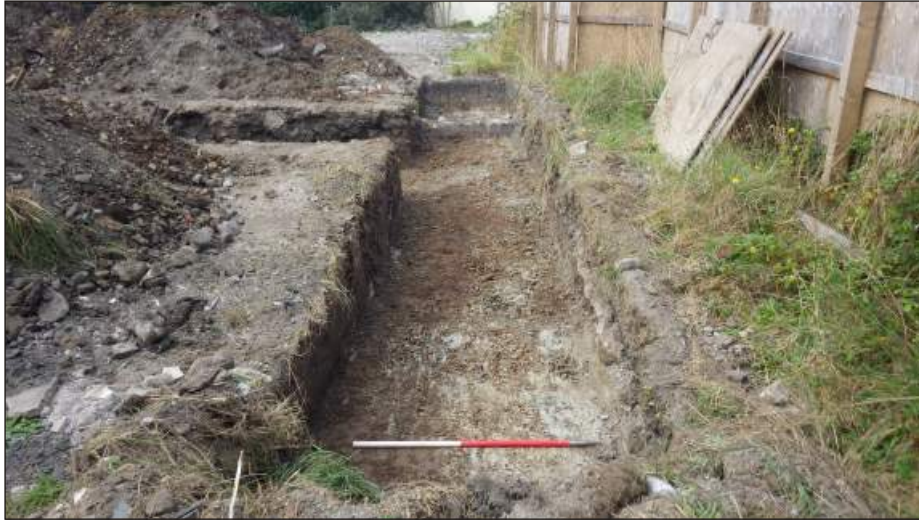
Plate 8: Trench 2, general view from the east. 1m scale.

Trench 2 was located along the north edge of the site, parallel with Meddon Street. It measured 11m long and was excavated down to fractured natural shale and clay at a depth of 0.58m (between 37.04m and 37.47m aOD).

The deposit sequence comprised three layers of 19th-century levelling deposits (201-204) (totalling 0.46m thick) overlaid by a layer of modern topsoil (200).

In the west end of the trench wall F205 was exposed on a north-south alignment. It was constructed of blocks of sandstone, mudstone and siltstone bonded in a coarse rough mortar, and represents the east wall of the 1895 extension to the dispensary.

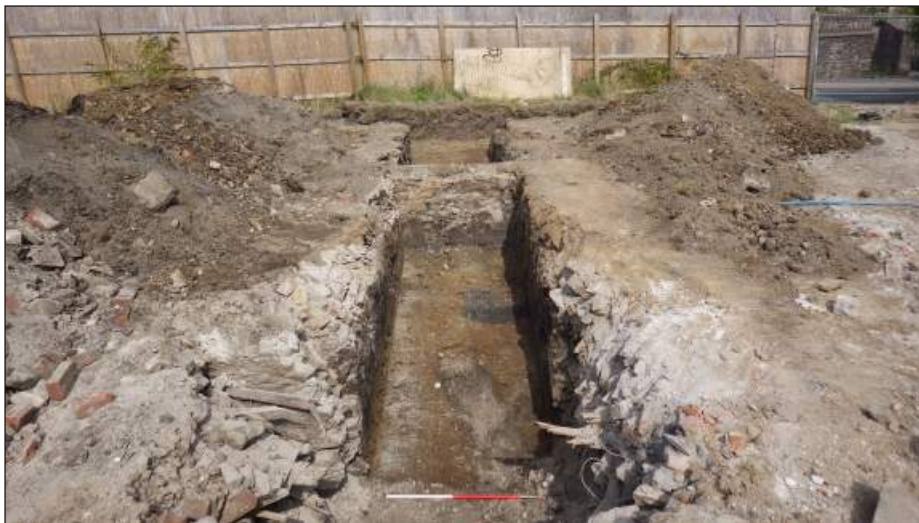
Plate 9: Trench 3, general view from the south. 1m scale.

Trench 3 measured 12m long, was orientated north-south, and located to the south of, and from the middle of, trench 2. It was excavated down to the natural shale and clay, which was present at depths of between 0.58m (37.25m aOD) and 1.85m (36.45m aOD).

The trench exposed two east-west aligned walls forming part of the former dispensary: F311 in the middle of the trench, and F312 towards the south end of the trench. They were constructed of mortar-bonded sandstone and measured 0.65m wide.

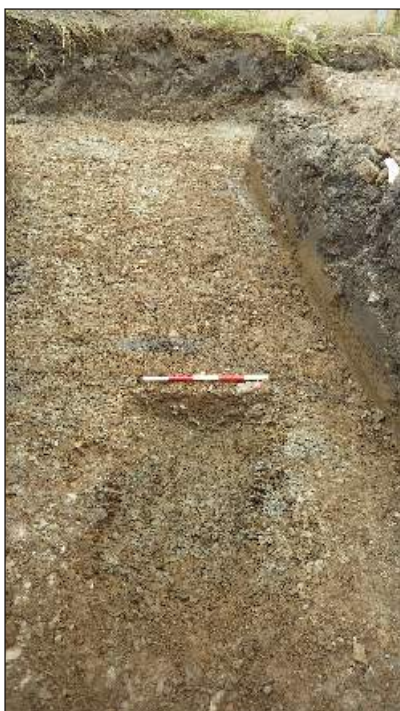
Plate 10: Trench 3, section through ditch F309, viewed from the south-southwest. 0.5m scale.

To the north of wall F311 ditch F309 was exposed on a north-northeast to south-southwest alignment. It measured 0.59m wide by 0.15m deep, and had moderately sloping concave sides with a concave base. It contained a single fill (310) consisting of compact mid grey-brown clay loam with strong orange hues, containing frequent poorly-sorted angular shale up to 160mm long, derived from the natural. It also contained sparse charcoal flecks and during initial cleaning a body sherd, weighing 13g, from a North Devon coarseware vessel dating to 1200-1350AD was recovered from the top of the fill.

A single medieval ditch was exposed within the northeast corner of the site. Its shallow profile and the nature of the underlying geology indicate that the ground level has been subject to historic truncation. The overlying deposits across the site are interpreted as levelling layers for the construction of the 1887 dispensary, with later deposits associated with 20th-century alterations.
